# SAMPLE INSPECTION

## Confidential Inspection Report

Sample St. , Camarillo, CA 93010

Date of Inspection: 2/14/2025 Time: 1015

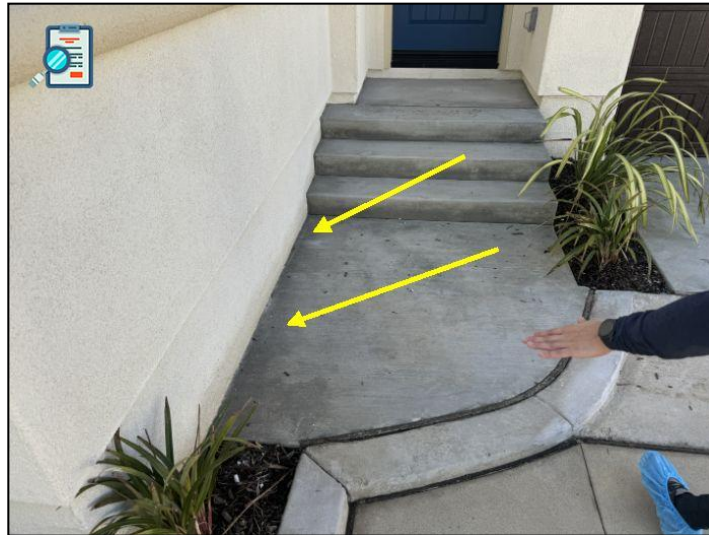
- Signs of possible moisture settlement against foundation wall in front of the house at the time of the inspection. Measured with large level, fall is very slight and level in multiple locations. Recommend monitoring walkway for moisture settlement, further evaluation by qualified contractor and remediation as appropriate.

*level against home*

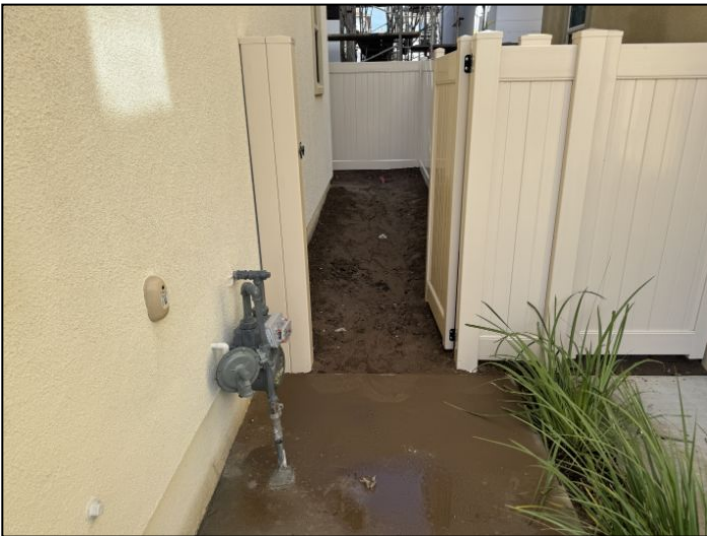
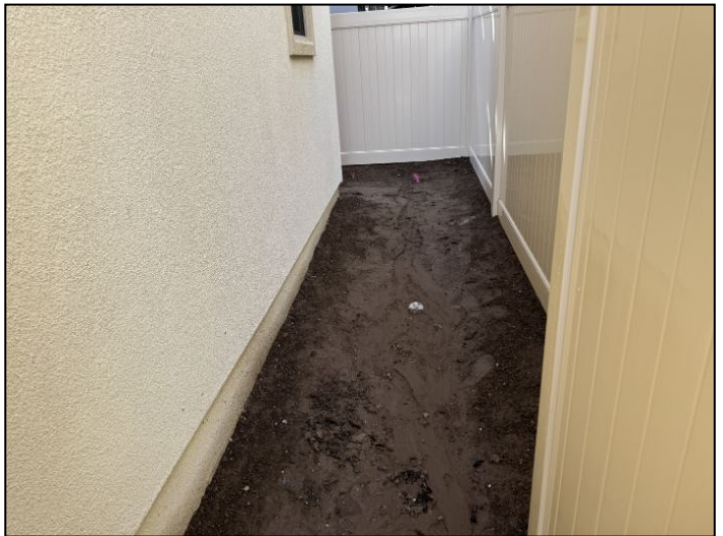
- Significant water/mud movement at the time of the inspection. Recommend installation of landscaping to prevent movement and allow drainage.
- Drainage covers observed as covered at the time of the inspection. Lots of mud post rain. Poor drainage observed at the time of the inspection.

*mud movement*

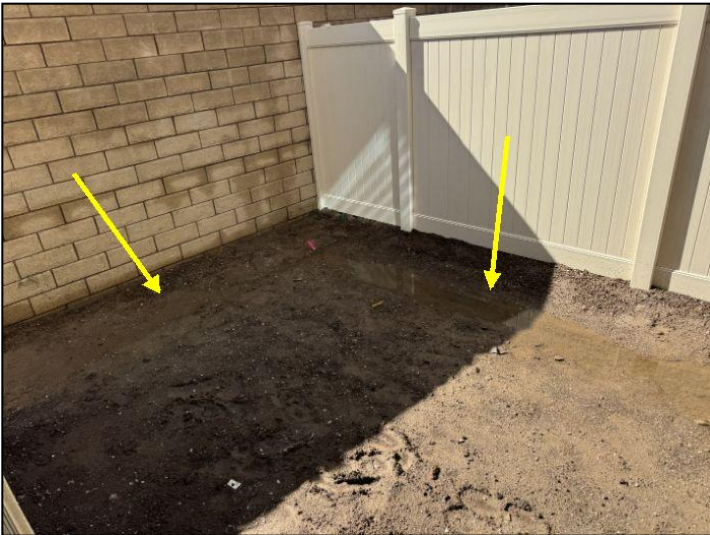
- Significant mud and moisture settlement observed around the home at the time of the inspection. Recommend landscaping and drainage so all moisture is diverted away from the home. Further evaluation by qualified contractor.

*moisture settlement*

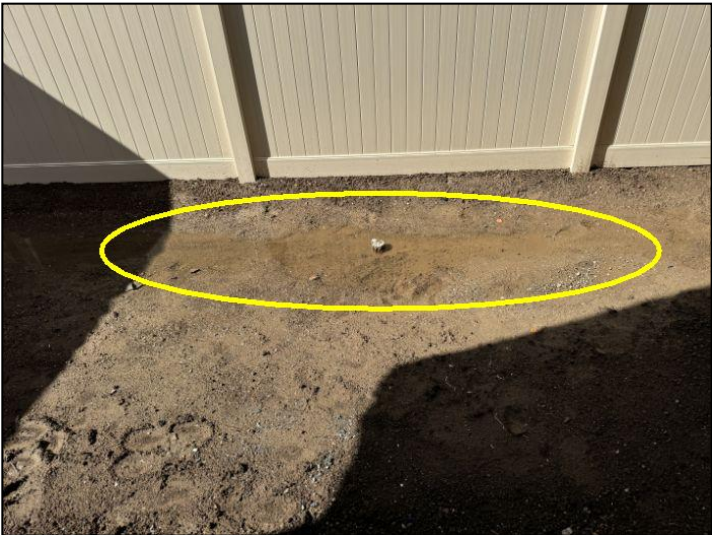
*covered drain with moisture settlement*

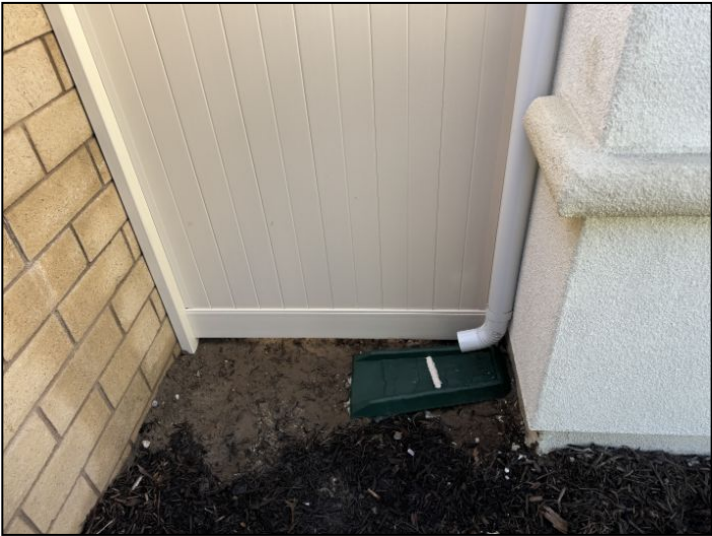
*very muddy/wet*

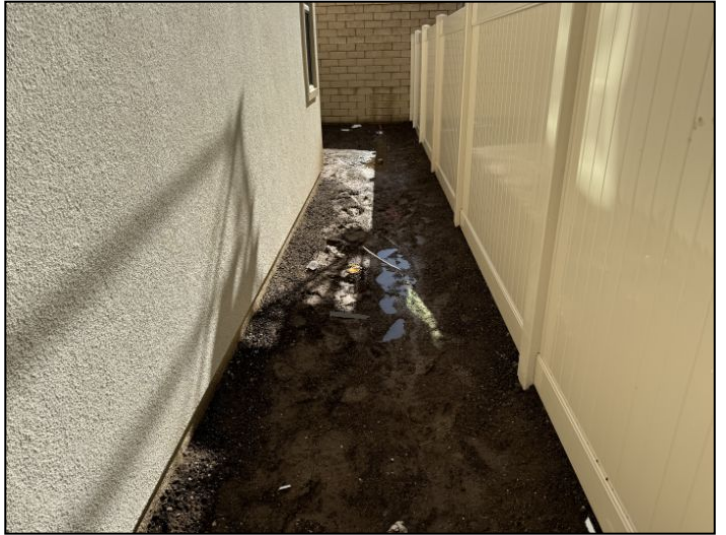
*moisture settlement*

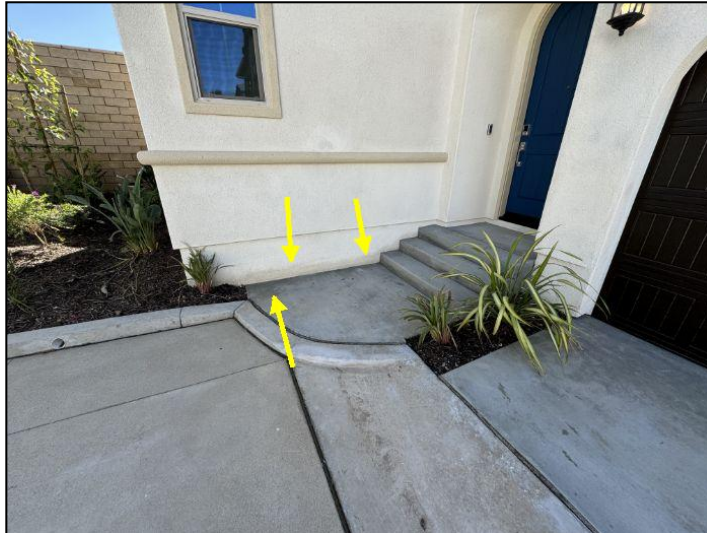
*signs of moisture*

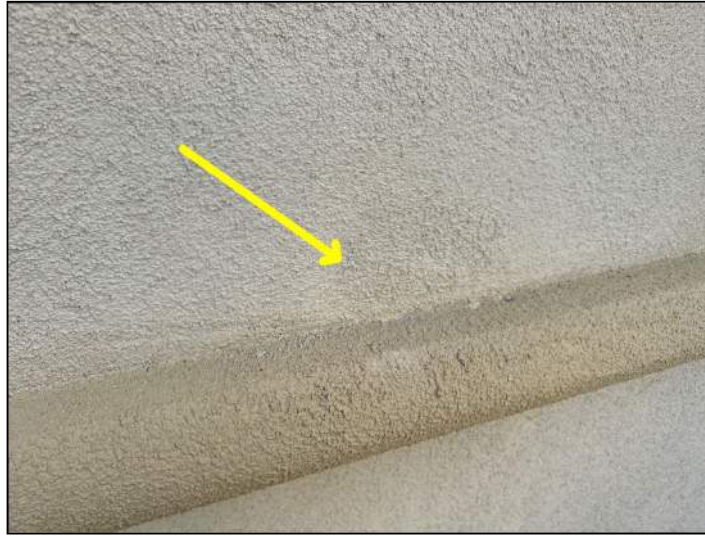
- Previous stucco patch jobs for exterior of structure observed at the time of the inspection.

*exterior patch job*

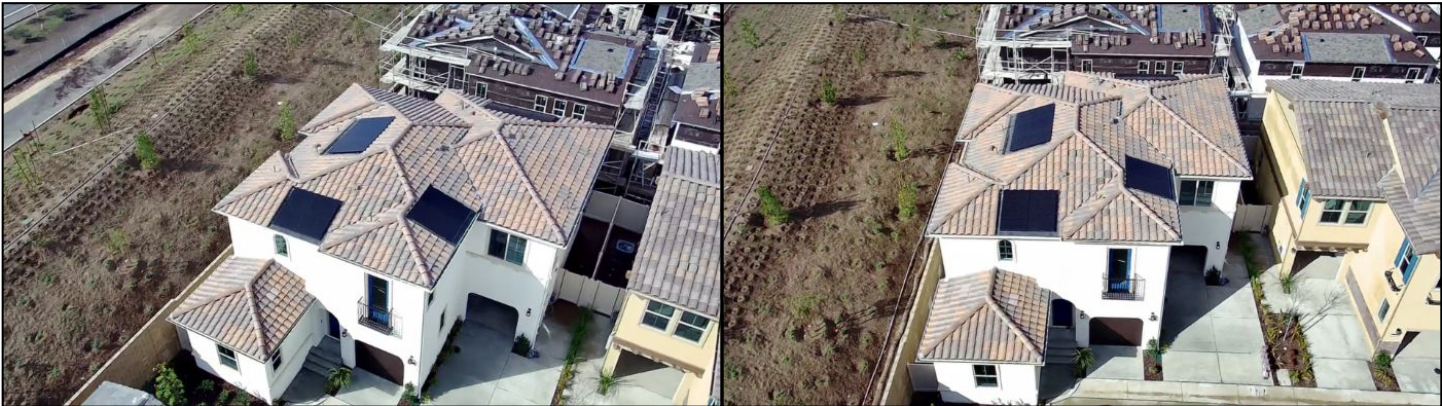
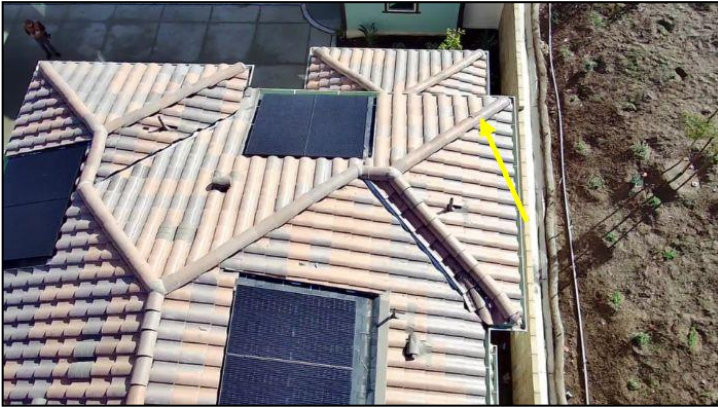
- Inspection limited to use of drone on windy day.
- Possible cracked tile observed at the time of the inspection. Recommend remediation by qualified roofing contractor to prevent moisture intrusion.
- Multiple tiles observed as being slightly out of place at the time of the inspection. Recommend qualified roofing contractor remediate as appropriate.
- Multiple tiles observed as slid out of place at the time of the inspection. Recommend licensed roofing contractor review roof, putting all tiles in place to prevent moisture intrusion.

*possible cracked tile*

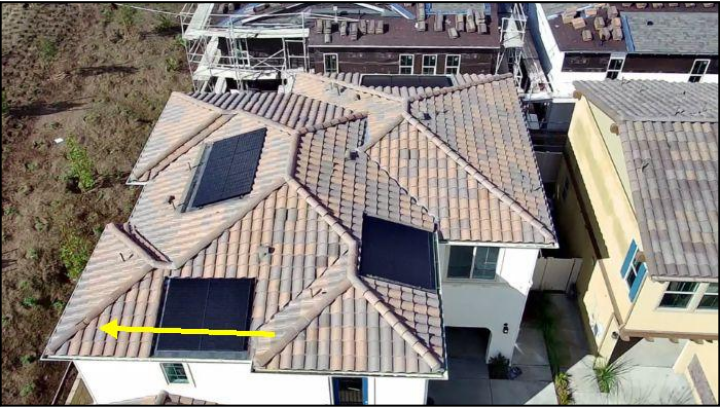
*possible cracked tile*

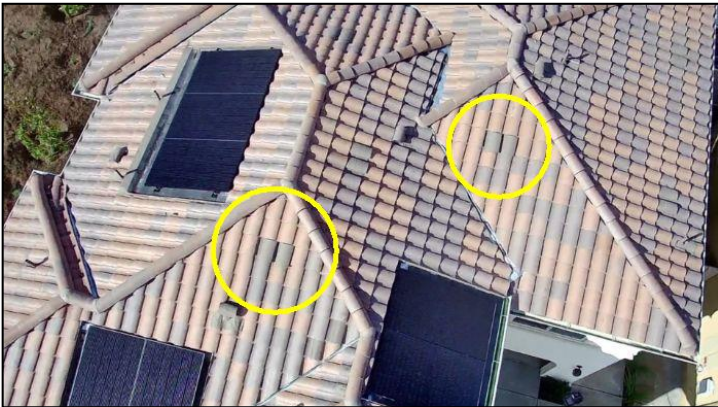
*slightly out of place tiles*

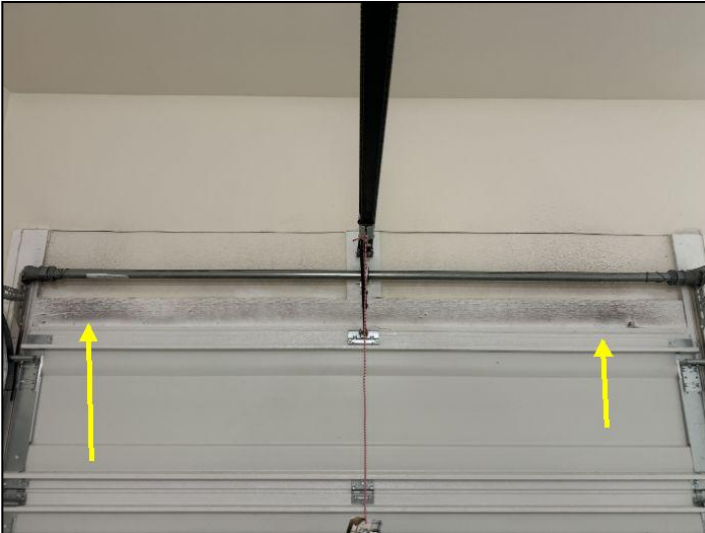
- Light coverage observed on garage wall at the time of the inspection.
- Dirty walls and or lack of primer/paint observed above both garage doors at the time of the inspection. Recommend evaluation/remediation by qualified contractor.
- Regarding window see "interior windows"

*short on paint/?*

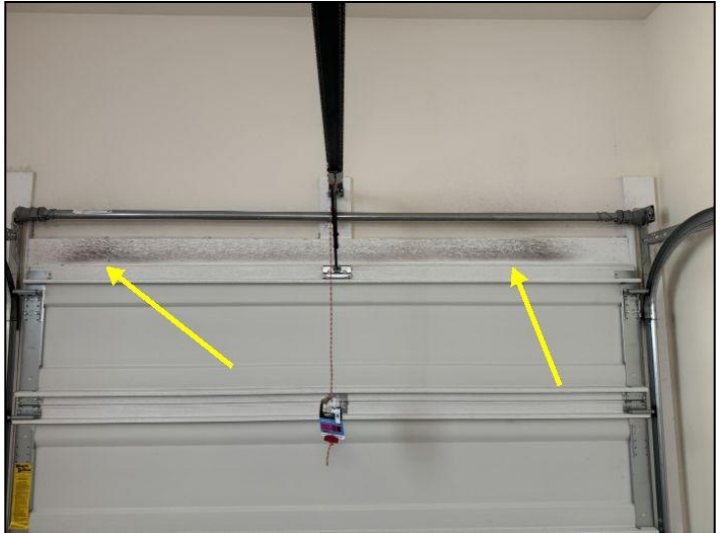
*short on paint/dirt?*

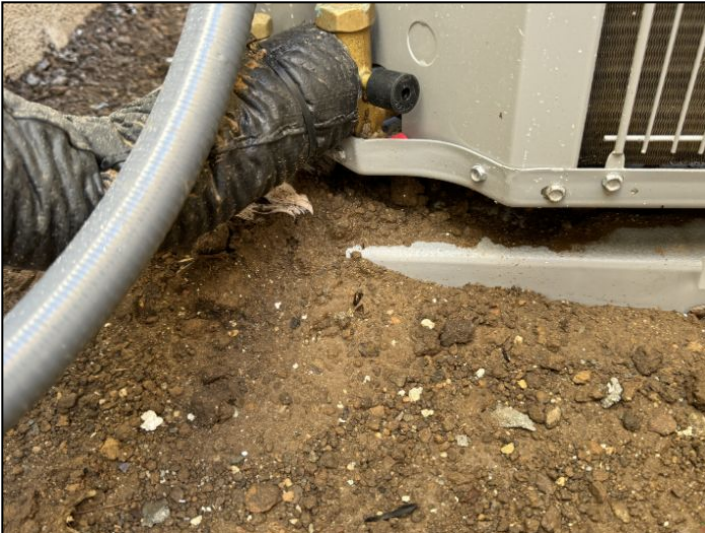
- Mud flow was observed as under the exterior HVAC unit at the time of the inspection. Recommend remediation by qualified contractor to prevent damage to the equipment.

*mud flow under exterior unit*

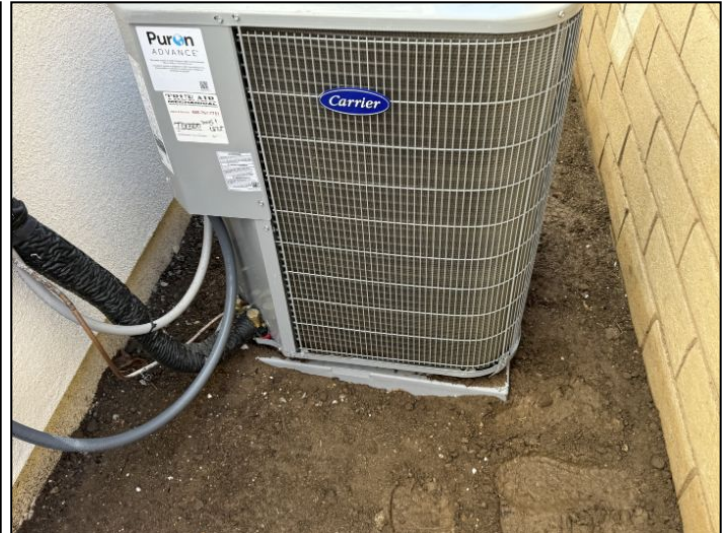
*mud flow burying base*

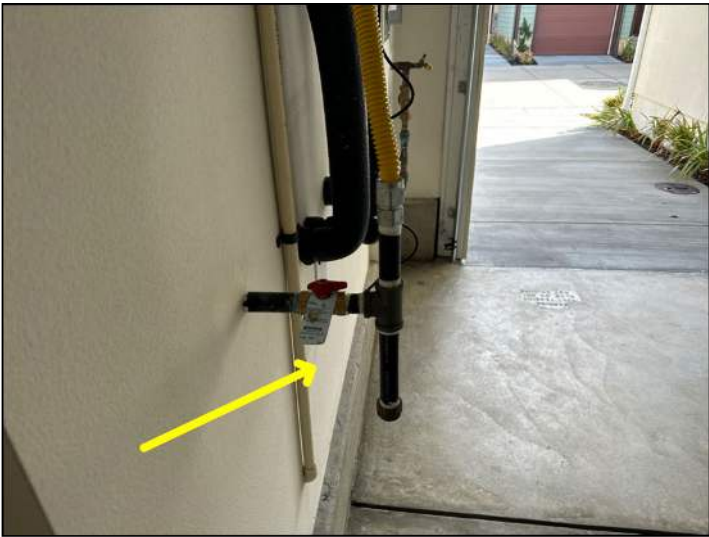
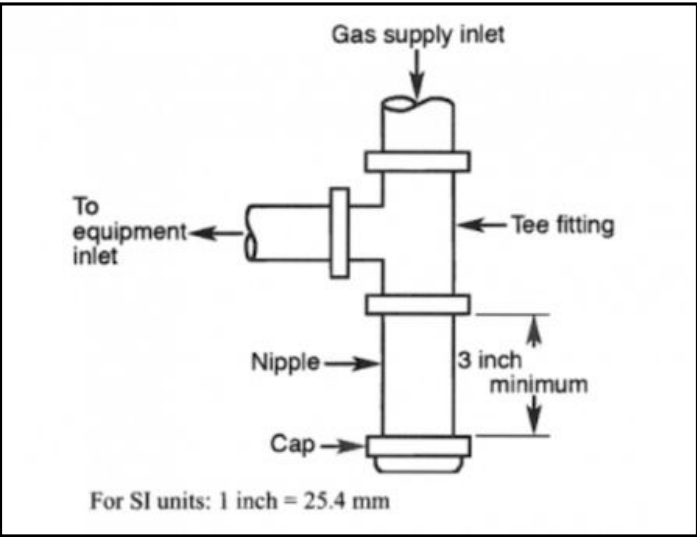
sediment trap diagram

- Incorrect installation of sediment trap observed at the time of the inspection. Gas shut off should be before the trap and angle to the gas line should vertical as opposed to horizontal. See illustration. Recommend licensed plumber remediate.

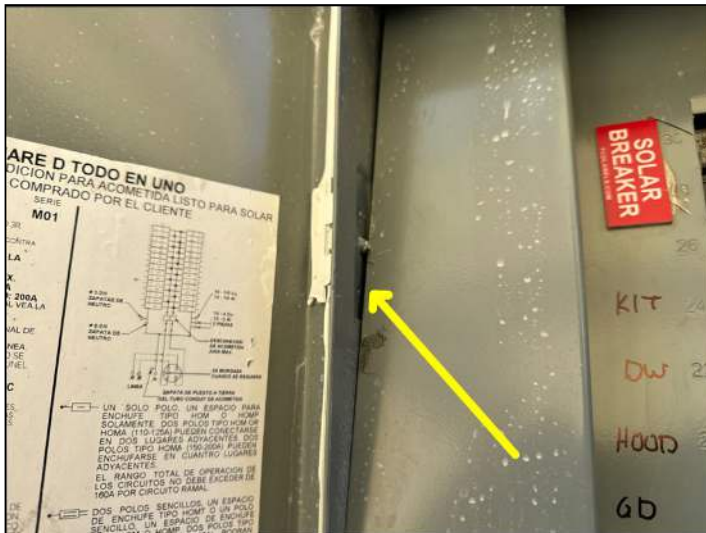
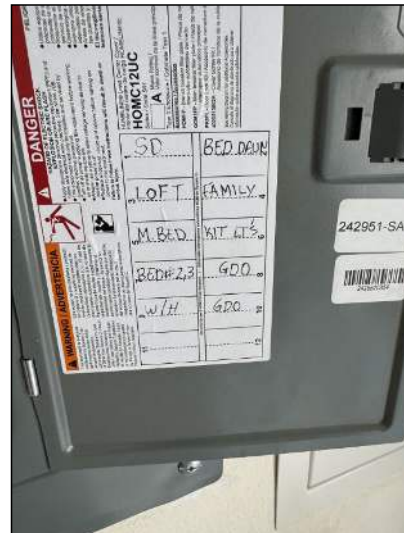
- Main panel dead front cover not removed at the time of the inspection as it was stuck in place.
- Screw on left side of the panel cover observed as obstructing the ability to take the dead front cover off at the time of the inspection risking damage to the breakers and panel. Recommend remediation of obstruction and evaluation of panel cover.
- Dead front cover stuck in place with the possibility of damage if forced open at the time of the inspection. Recommend remediation so cover can come off smoothly for any future service/inspection.
- Sub panel observed with inadequate labeling at the time of the inspection. Panel should be labeled in a fashion that any layman will know what area of the house the breaker is protecting.

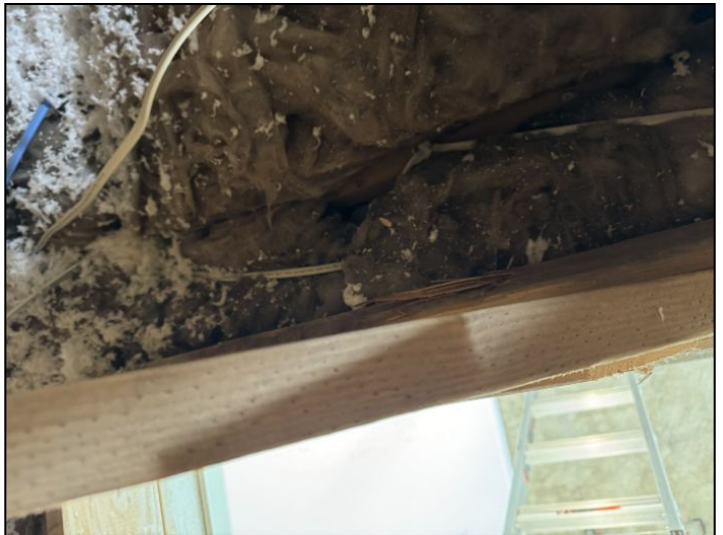
- Attic inspection limited to the accessible areas in front of the furnace.
- Electrical conductors observed as right next to the access points of the attic at the time of the inspection. It is recommended the conductors be moved 6 ft from the access point and secured at intervals not to exceed 54" to prevent any damage to the conductor when accessing the attic. Any conductors within 6 ft need to be protected with guard strips. Recommend licensed electrician remediate.

*electrical conductors right next to access*

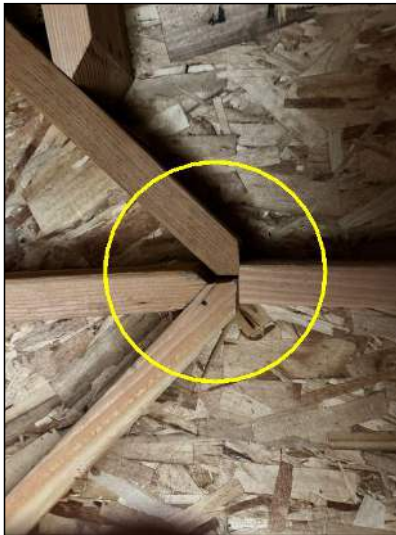
- Attic framing observed as slightly separated at the time of the inspection. Recommend licensed and insured contractor further evaluate attic framing for any separation that needs correcting.

*separation of attic framing*

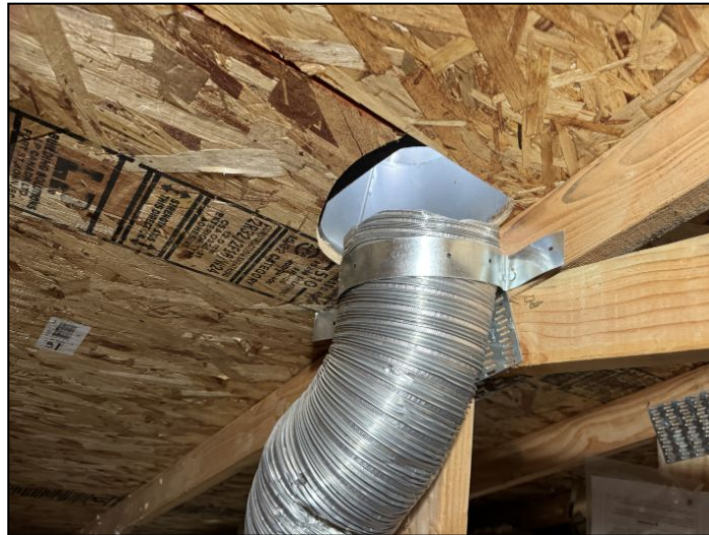
- Exhaust vent observed as short of the attic ceiling at the time of the inspection. This is a defect that can allow moisture into the attic. Recommend remediation by qualified HVAC contractor.

exhaust vent short

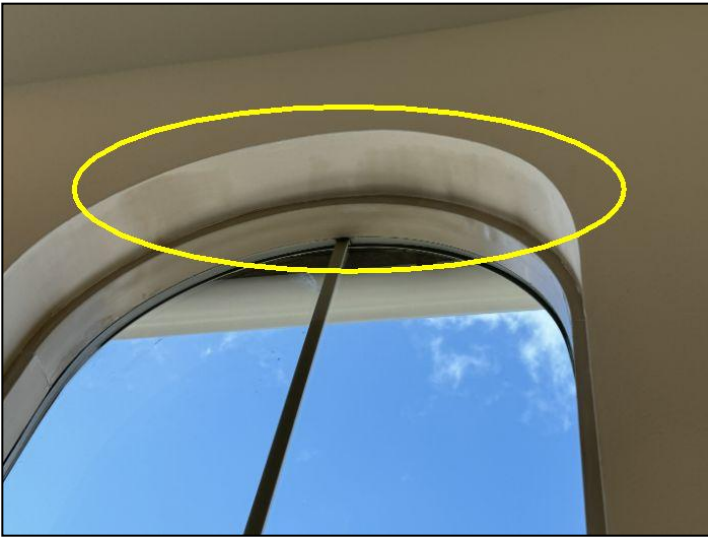
- Unfinished paint job observed above arched windows at the time of the inspection. Recommend remediation by qualified contractor.

*unfinished paint*

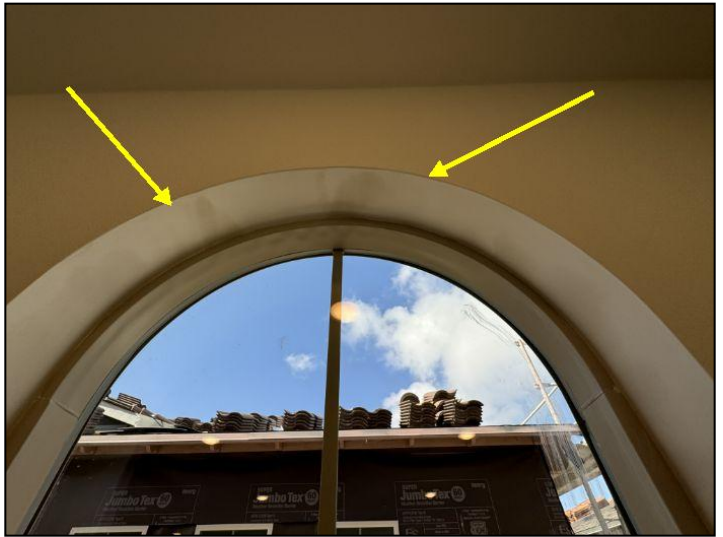
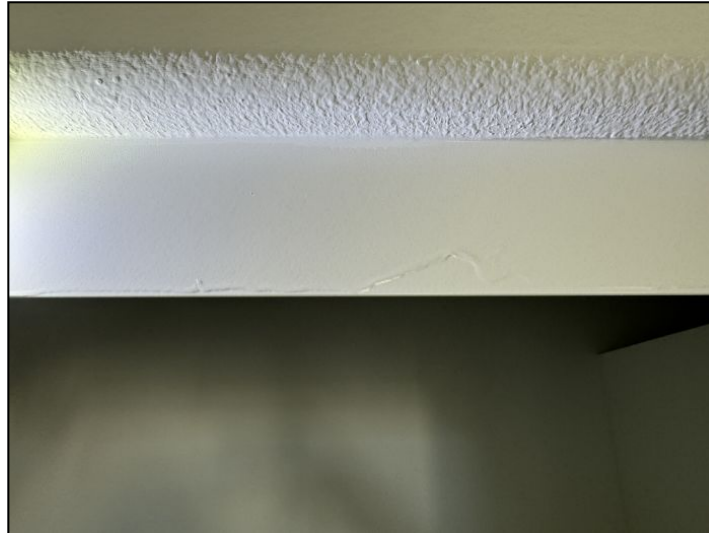
*dripping paint above closet*

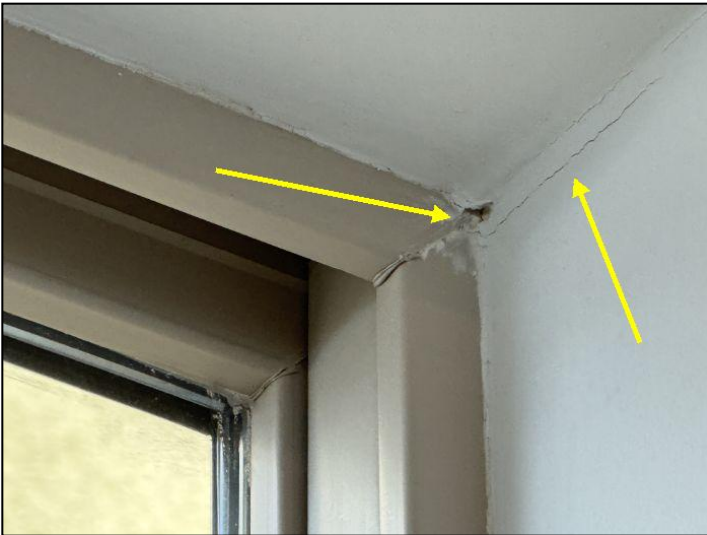
- Observed cracking in corner of window near garage at the time of the inspection. Recommend sealing all gaps and cracks in caulking.
- Most new windows observed as marked with paint and stains at the time of the inspection. Recommend cleaning of windows by qualified contractor and inspecting windows for chips/cracks post cleaning.

*cracking window next to garage door.*

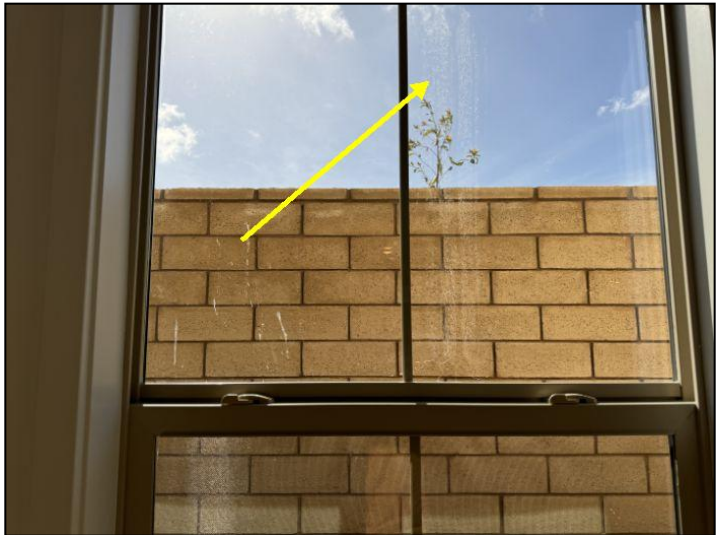
*window staining*

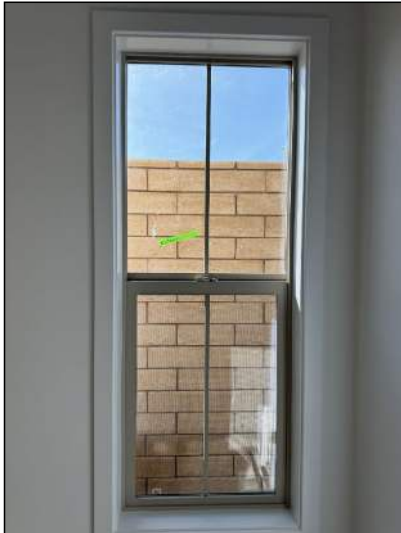
*staining*

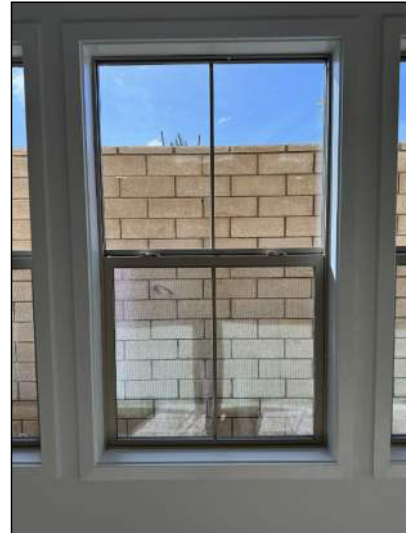
*staining*

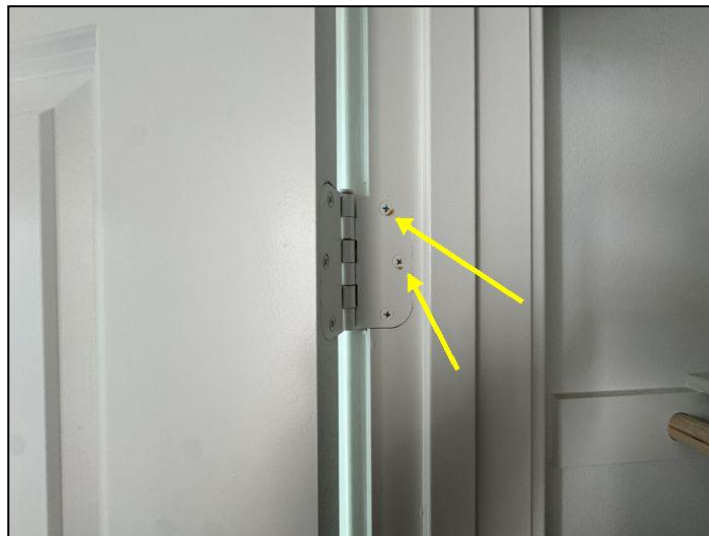
- Rust observed on painted screws for unknown reason on multiple doors at the time of the inspection. Recommend remediation by qualified contractor as there no reason screws should be rusting on new construction.

*rusting screws-closet next to front door*

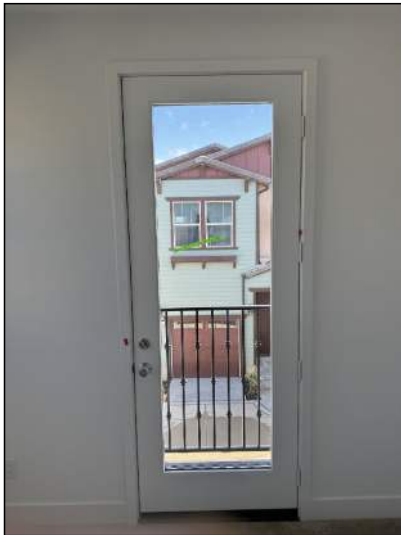
*balcony door*

- Moisture settlement pooling on second floor exterior door at the time of the inspection. Recommend remediation to establish proper fall and avoid moisture settlement and intrusion.

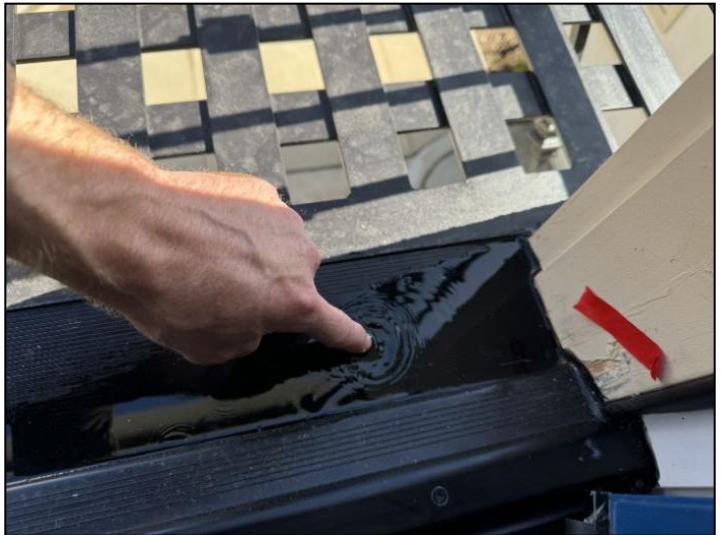
*improper fall/moisture settlement*

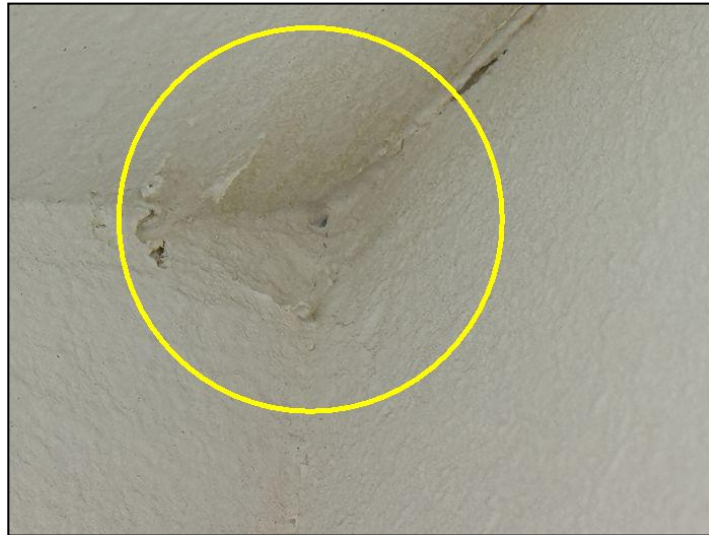
- Drywall abnormality observed in the closet near garage at the time of the inspection. Recommend remediation by qualified contractor.

*inside closet near garage*

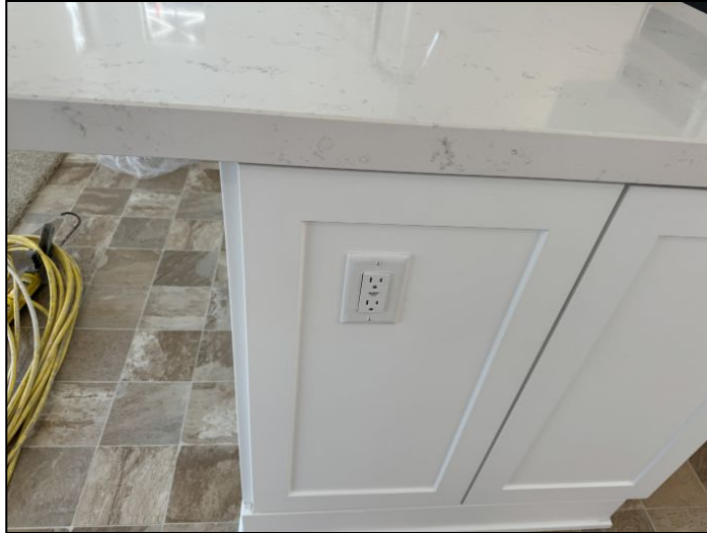
- A kitchen island outlet was observed at the time of the inspection. Rules regarding the need to add or remove kitchen island outlets has evolved through time. The Consumer Product Safety Commission states that between 1991 and 2020, an estimated 9,700 people, mainly children, were treated for burns and other injuries after pulling or running into power cords plugged into receptacle outlets installed below island and peninsula counter and work surfaces. While it may have been allowed/mandatory at the time of install, we recommend awareness of safety hazard and remediation by licensed and insured electrician.

*kitchen island outlet -please read remark in green*

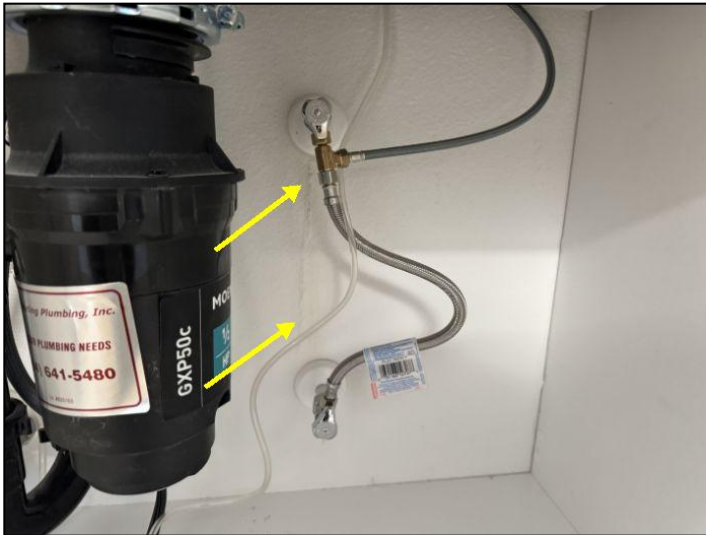
- Signs of moisture intrusion behind kitchen sinks observed at the time of the inspection. Recommend remediation by qualified contractor.

*signs of moisture staining under kitchen sink*

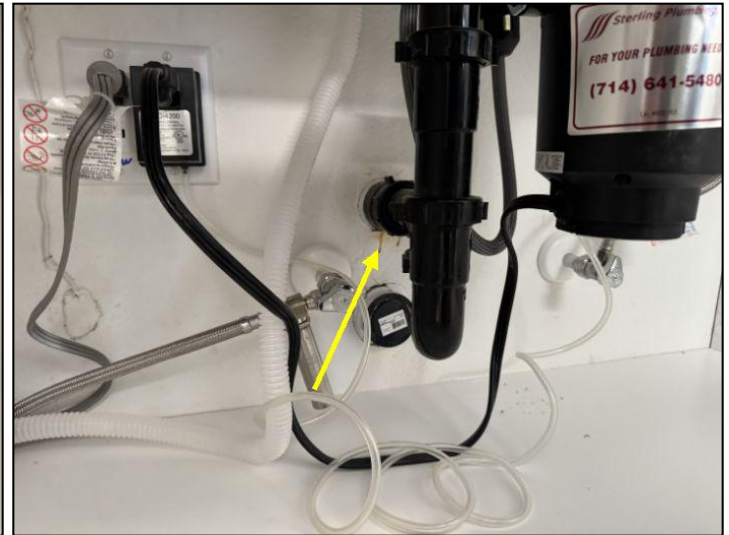
*moisture drip*

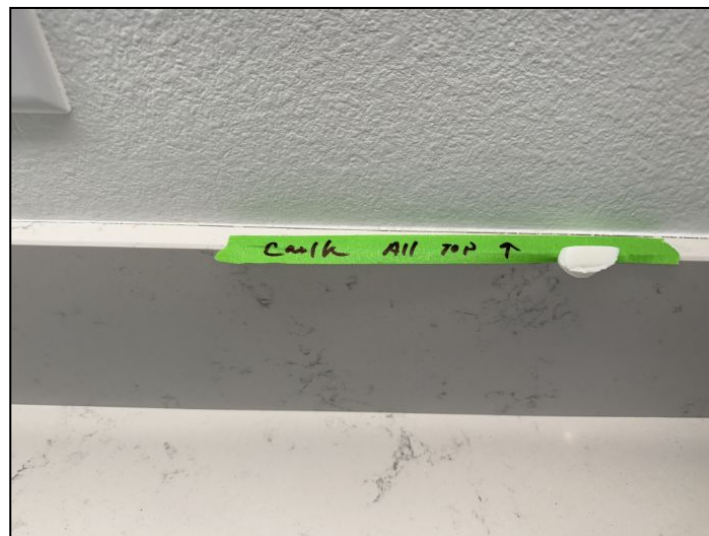
- Cracking observed in caulking/grout at the time of the inspection. Recommend correction to prevent water intrusion.

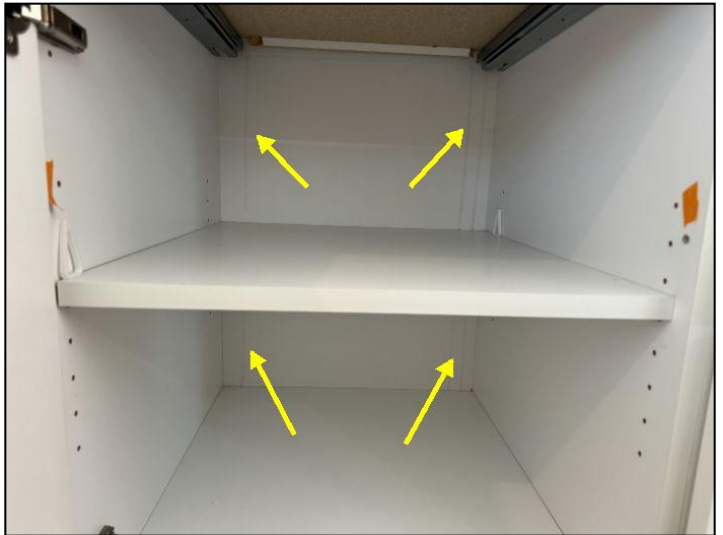
- Kitchen cabinet slightly out of place, right of the range at the time of the inspection. Recommend remediation by qualified contractor.
- Moisture staining under cabinets left of range at the time of the inspection. Recommend remediation by qualified contractor.

*moisture staining*

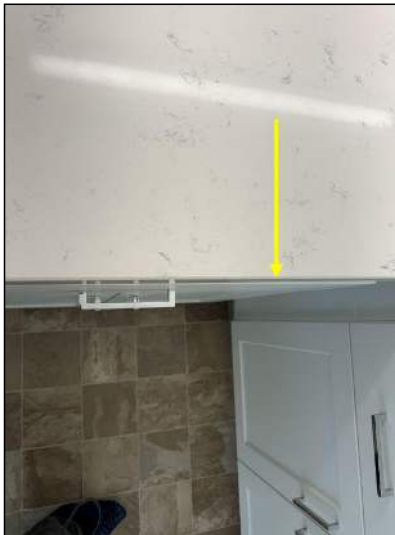
*would not close all the way*

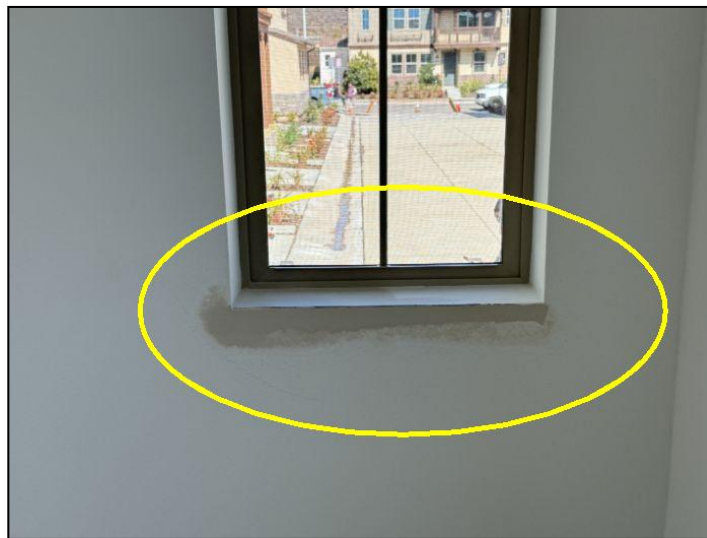
- Incomplete drywall patch jobs noted in the bedrooms at the time of the inspection. Recommend remediation by licensed professional.

*patch in progress*

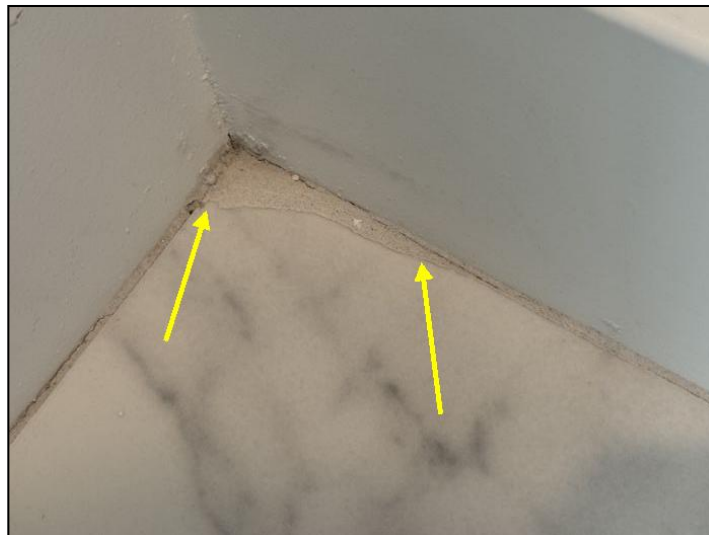
- Excess grout and slight cracking observed on tile in toilet room at the time of the inspection. Recommend remediation by qualified contractor.

*excess grout/cracking -master toilet*

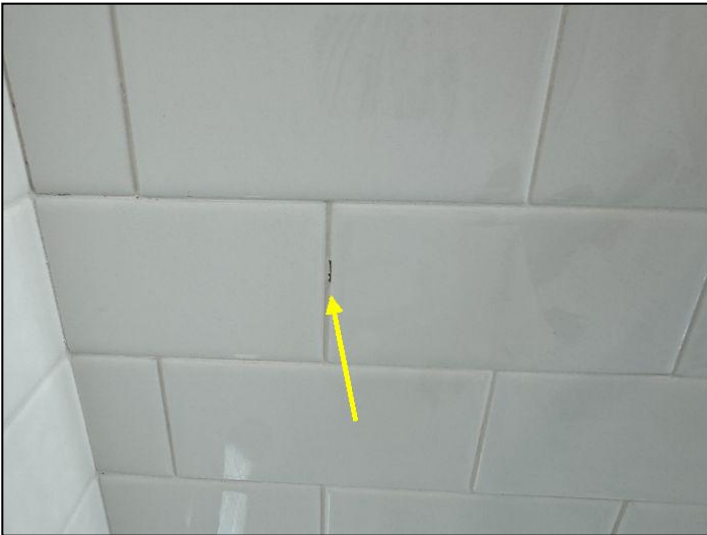
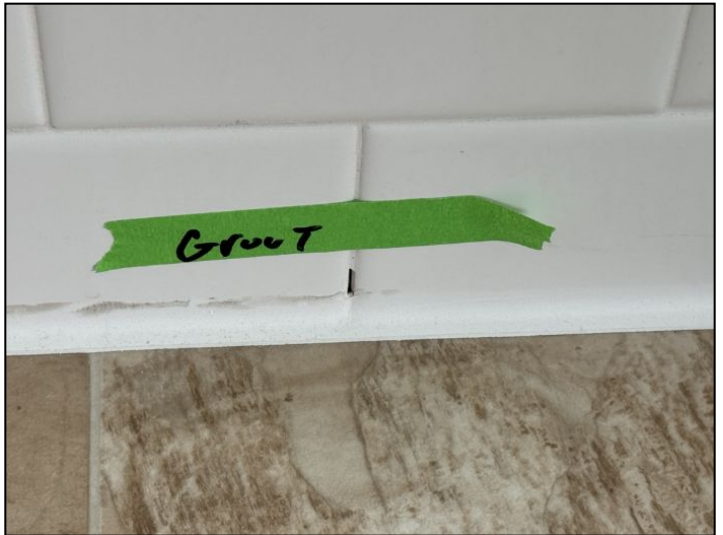
- Minor abnormality observed in shower wall at the time of the inspection. Recommend remediation by qualified contractor.
- Gap where faucet meets wall at the time of the inspection. Recommend remediation by qualified contractor to prevent moisture intrusion into the walls.

*abnormality on tile wall. Front door bathroom*

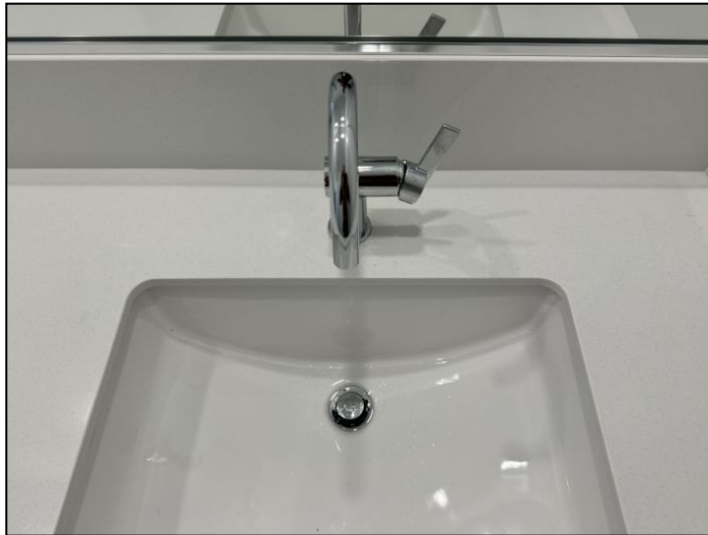
- No hot water observed in second sink in hallway bathroom at the time of the inspection. Recommend further evaluation and remediation by qualified contractor.

*no hot water - hallway bathroom*
