SAMPLE REPORT

Confidential Inspection Report

Inspection prepared for: SAMPLE

Date of Inspection: 1/2/2025 Time: 9am

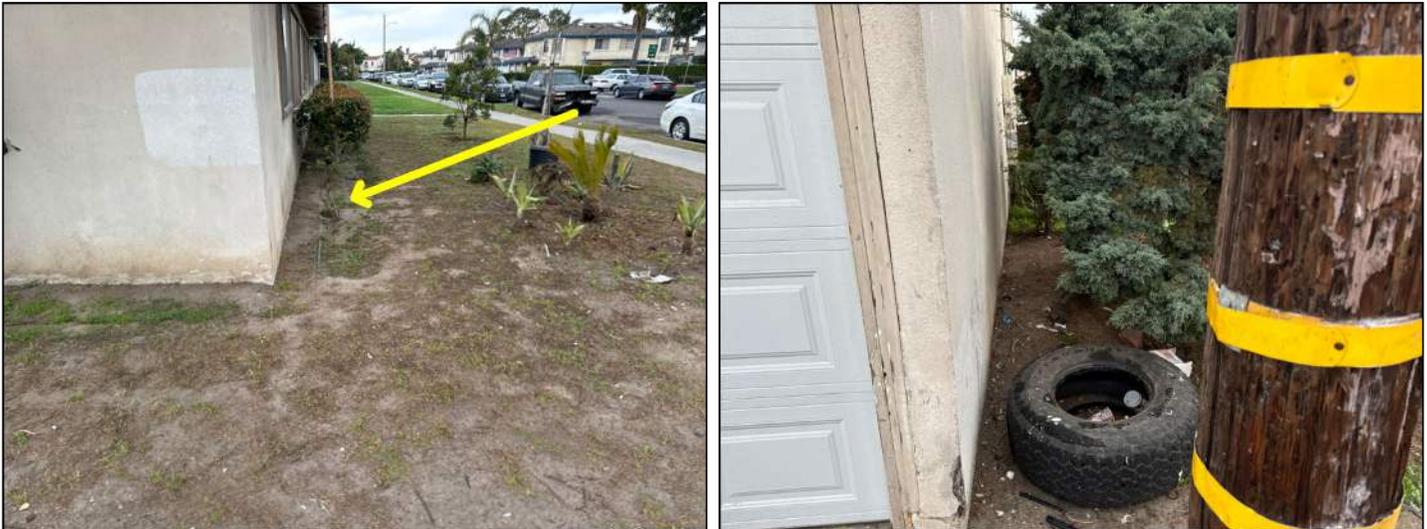
- The exterior grading was observed as improperly sloped in a couple locations around the foundation not allowing for the appropriate fall away from the home. Recommend creating the proper slope away from the foundation to allow for proper drainage and prevent moisture damage to the home. Remediation by licensed contractor recommended.

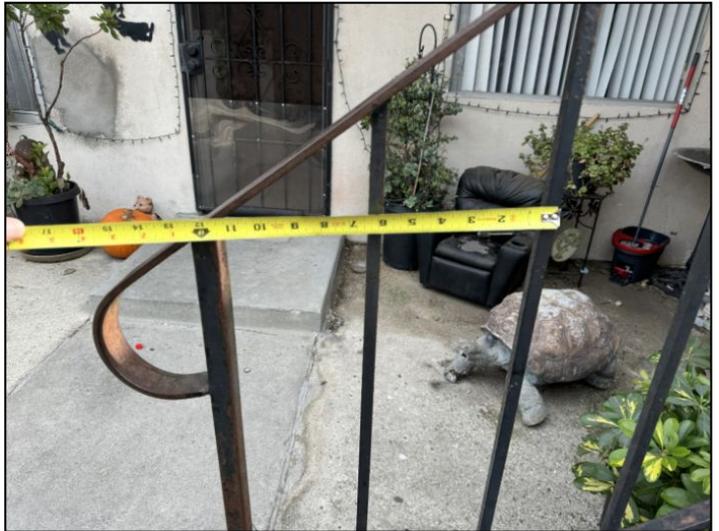
- Open stair risers exceeded the 4 inches allowable for child safety standards observed at the time of the inspection. Recommend remediation by licensed professional.
- The spacing between the stairs and the handrail was observed as larger than the allowable 6 inches at the time of the inspection. Recommend remediation by a licensed professional to prevent small children falling hazards.
- Significant rust/spalling observed on the stairs and balcony at the time of the inspection. This may increase chances of failure. Recommend remediation by licensed and insured contractor to prevent additional deterioration and prevent any failure of a safety guard.
- Observed possible microbial growth on the stairs/balcony at the time of the inspection. Recommend remediation by licensed professional.

larger than 4 inch gap

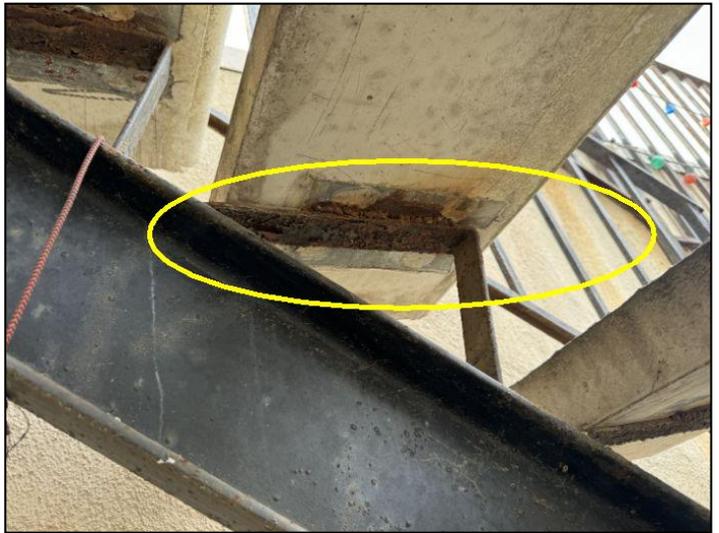
rust on stairs/balcony

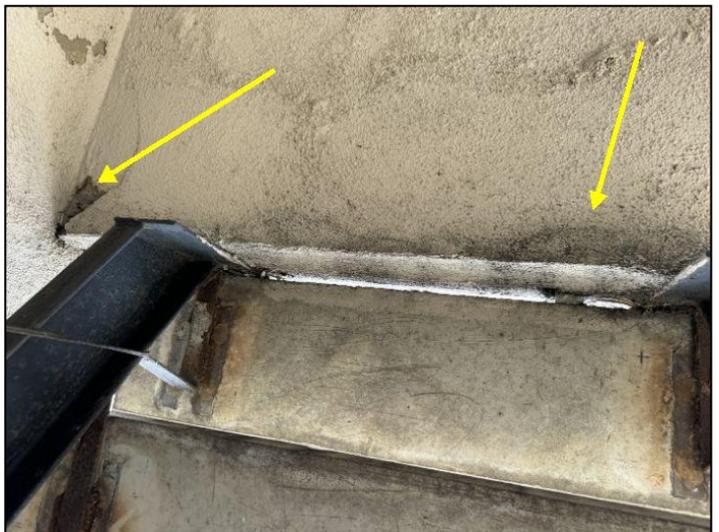
rust

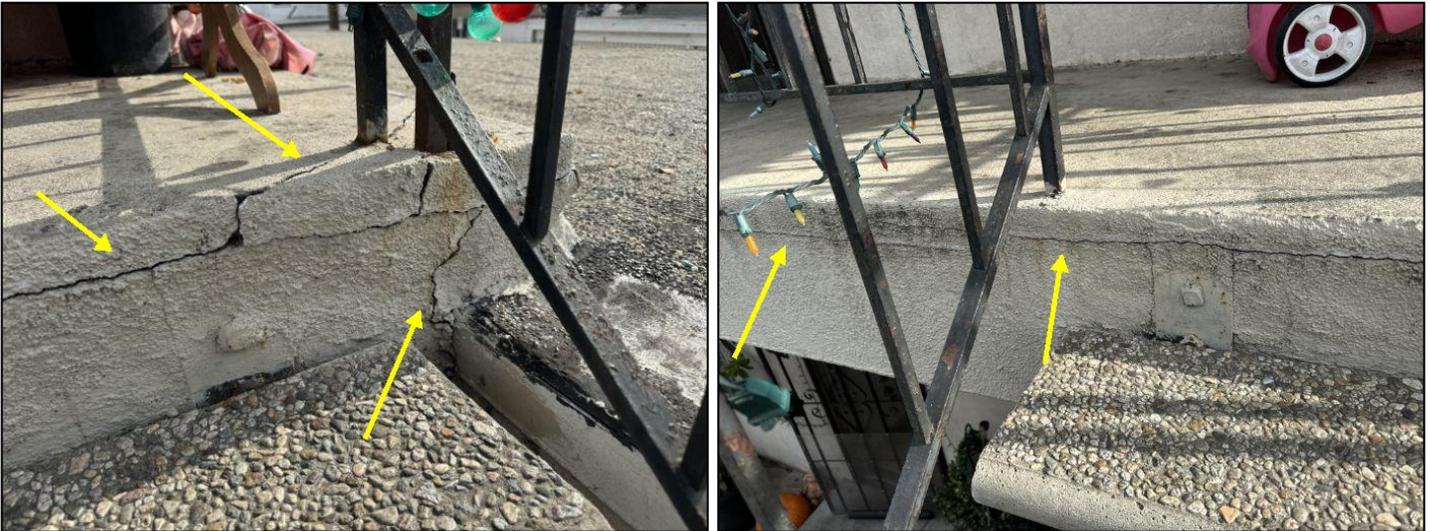
- Horizontal cracking observed on the balcony at the time of the inspection. Recommend structural engineer or qualified contractor evaluate and remediate to prevent further deterioration/failure.

cracking on balcony

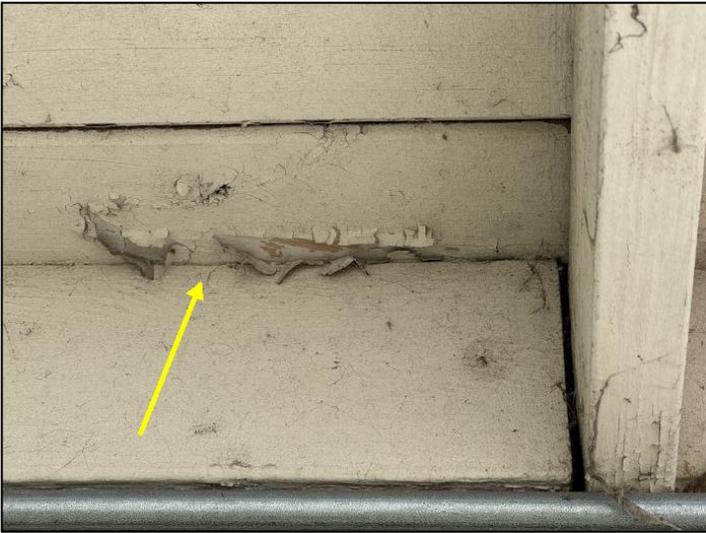
peeling paint

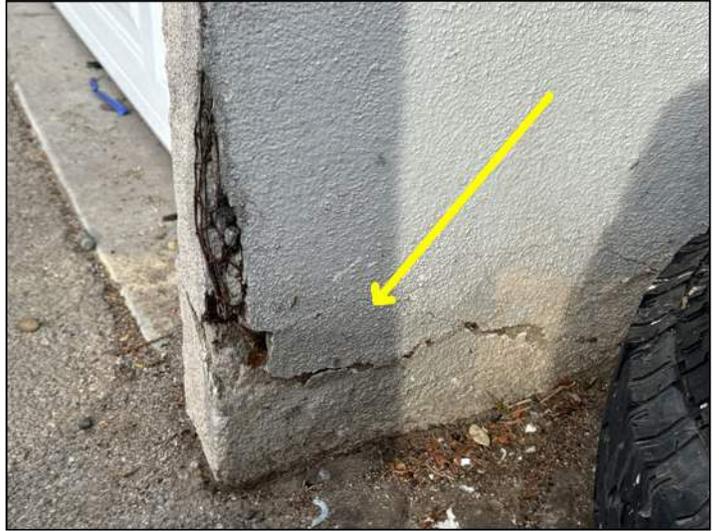
Large crack, exposed stucco

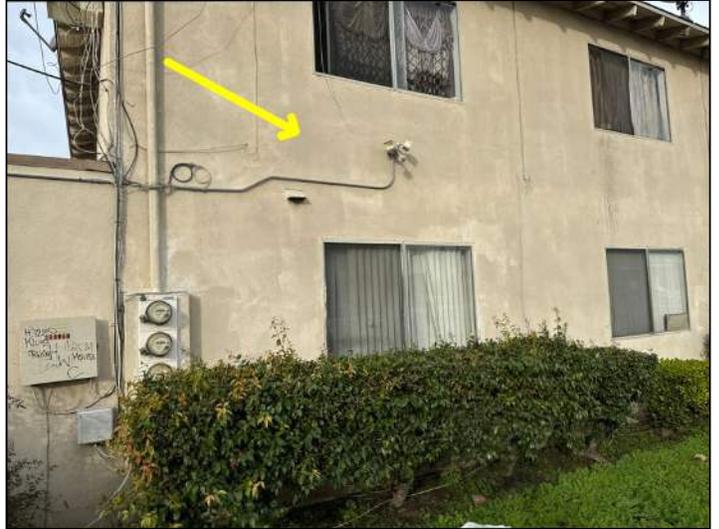
Paint patches

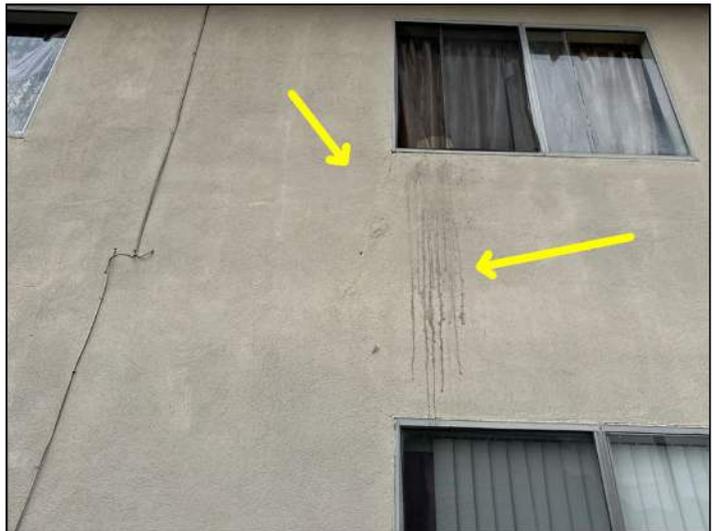
Settlement crack, plus stain

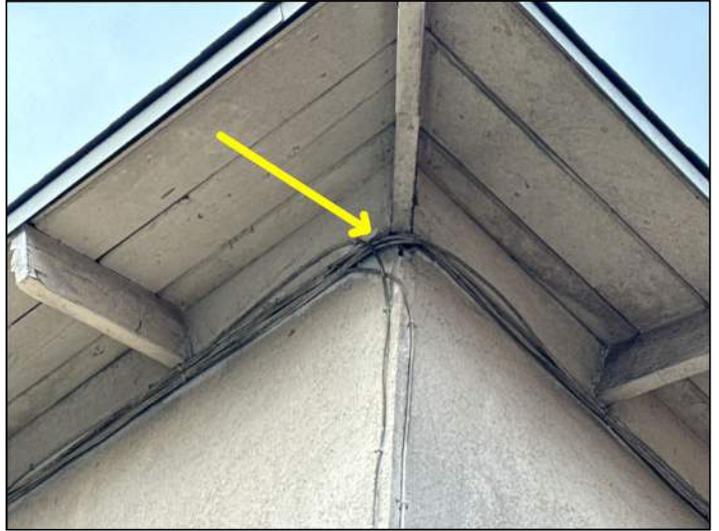
Hole in stucco

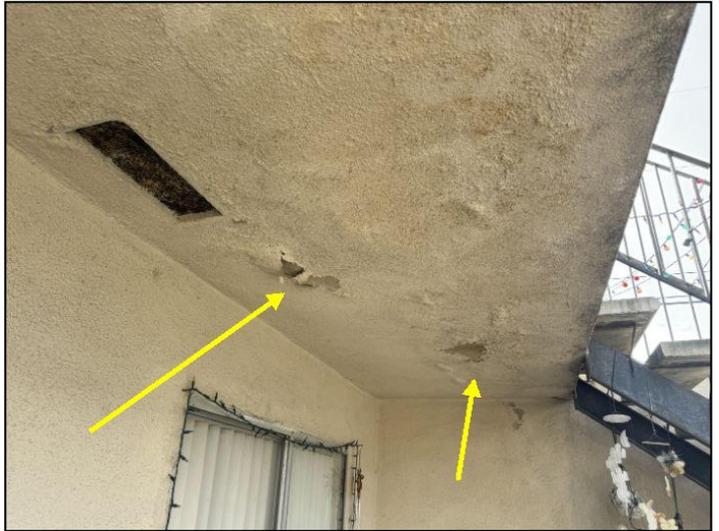
under balcony

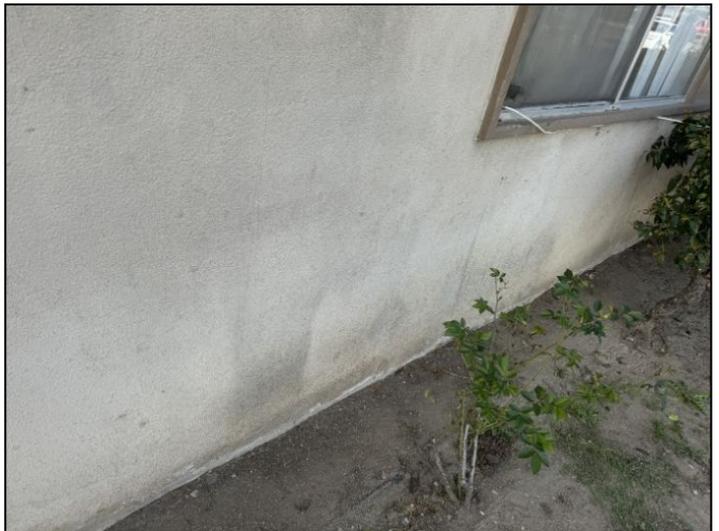
staining

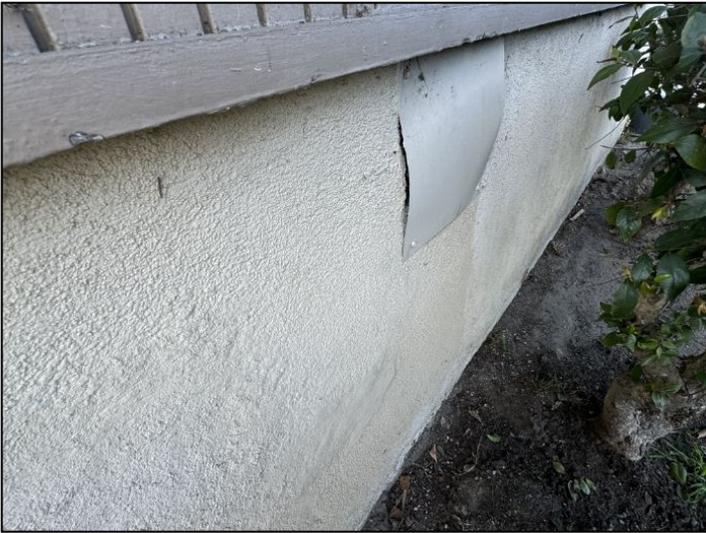
loose access panel

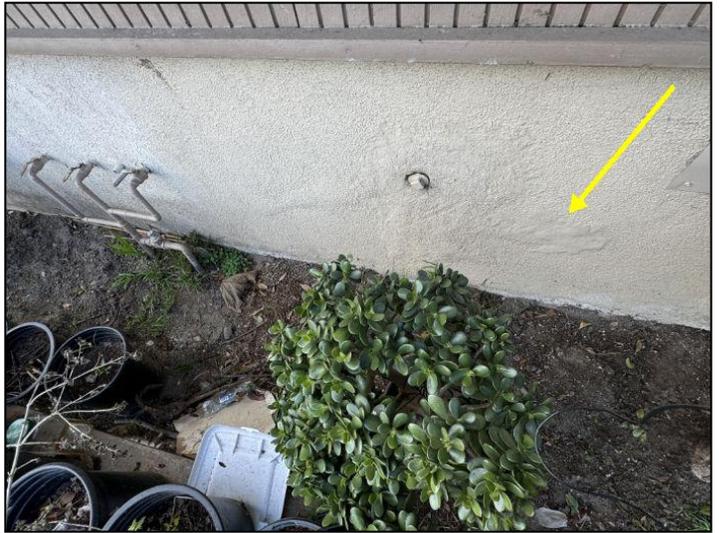
previous patch work

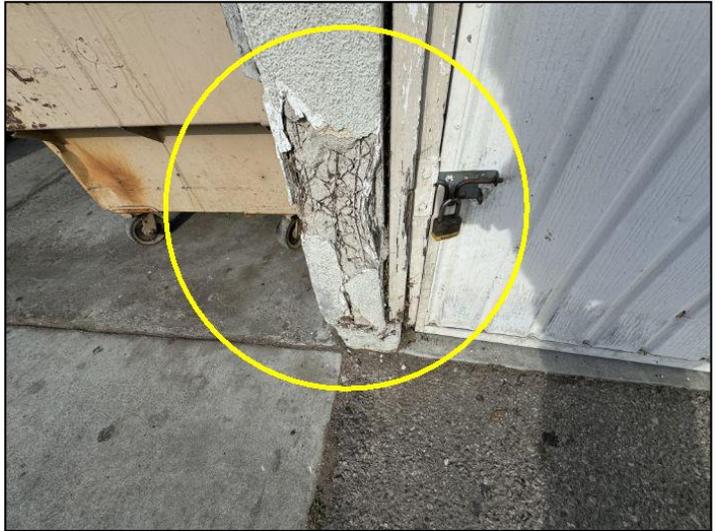
hole in wall

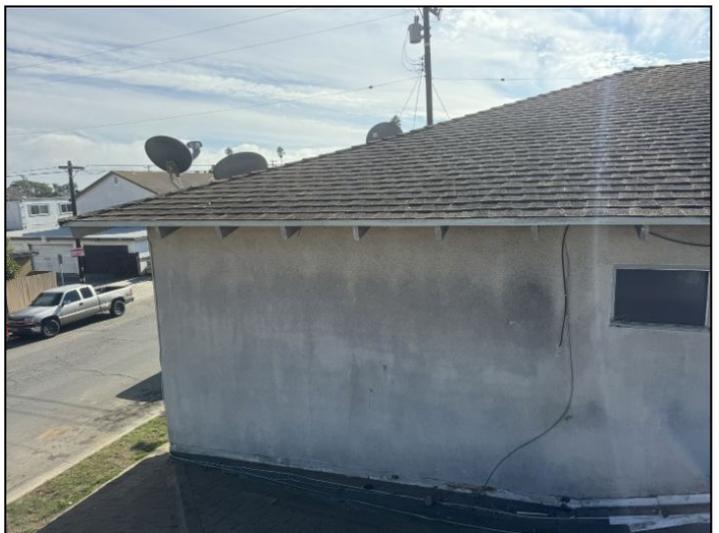
stucco stain from run off

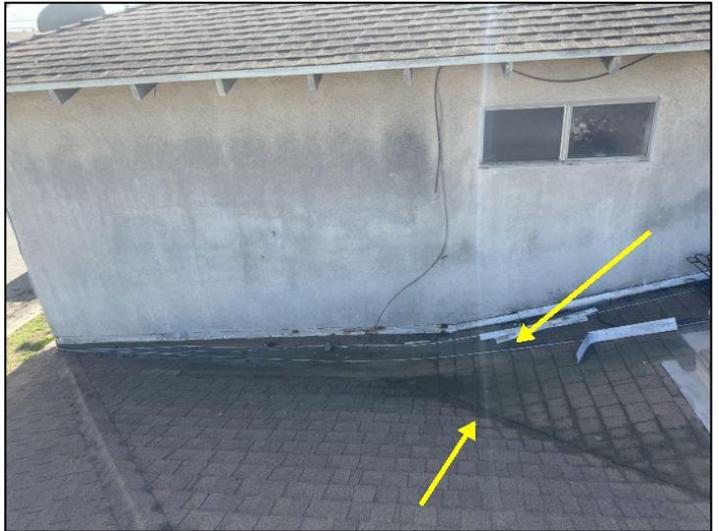
Appears to sag above garage

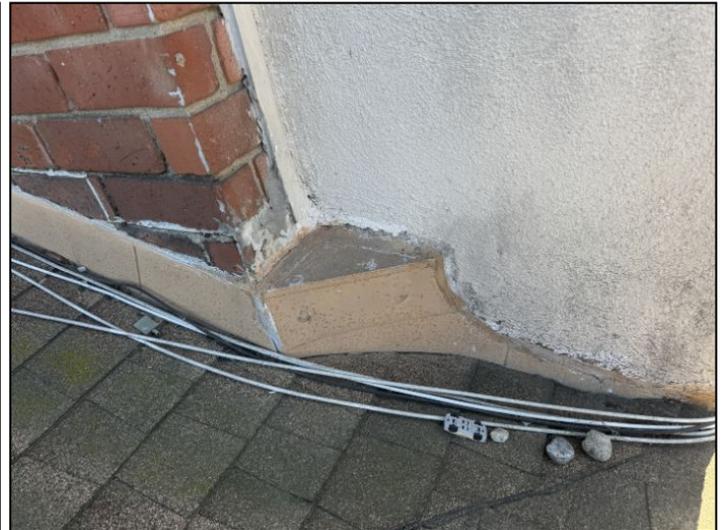
rusted flashing/peeling paint

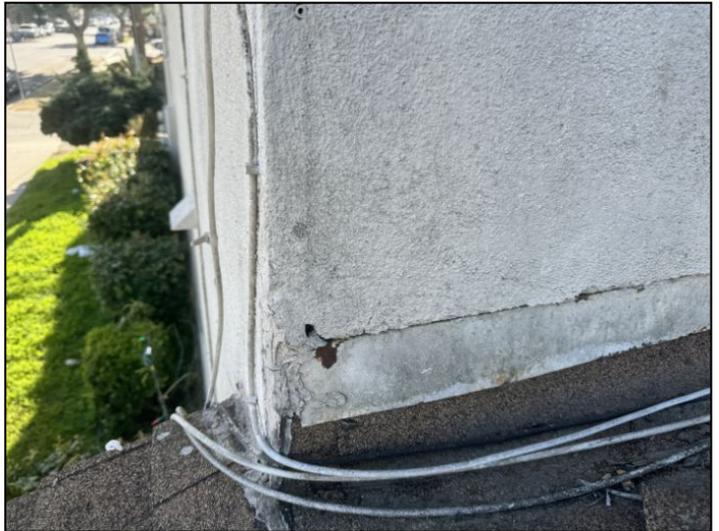
failing flashing

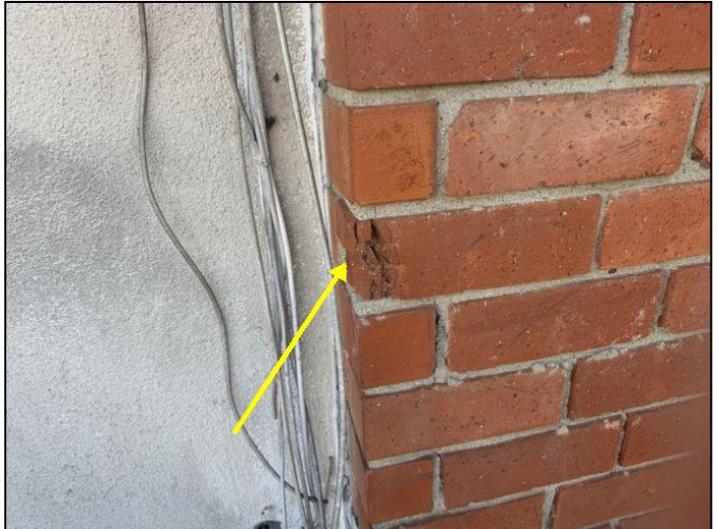
missing grout

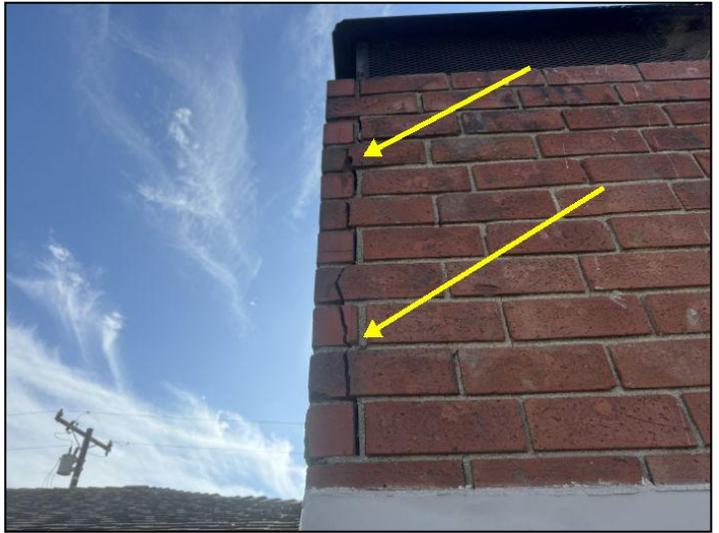
patch work

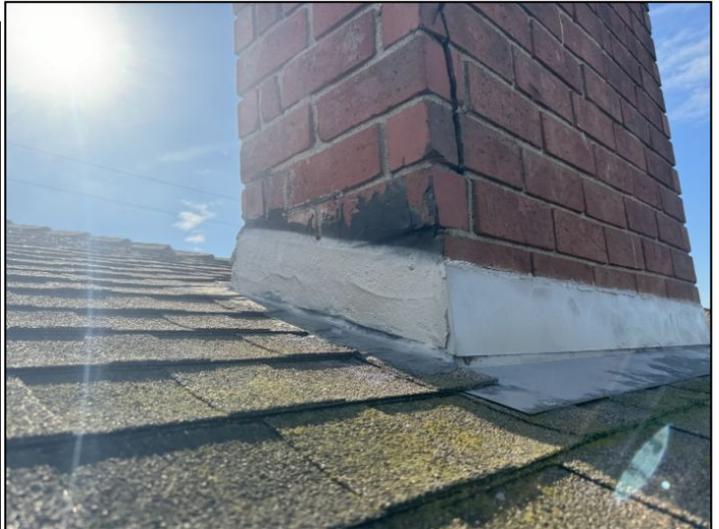
chimney crack

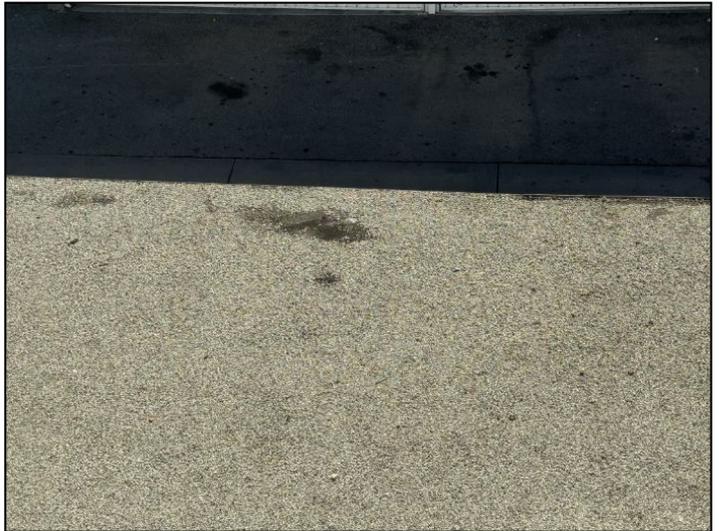
missing granules

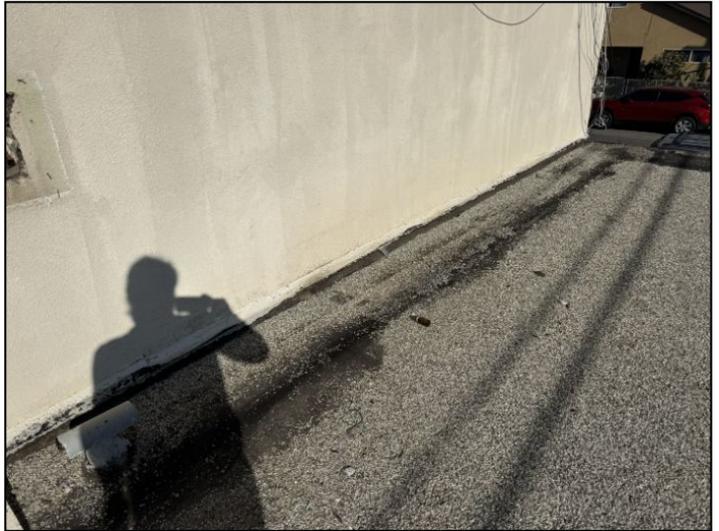
damage from runoff

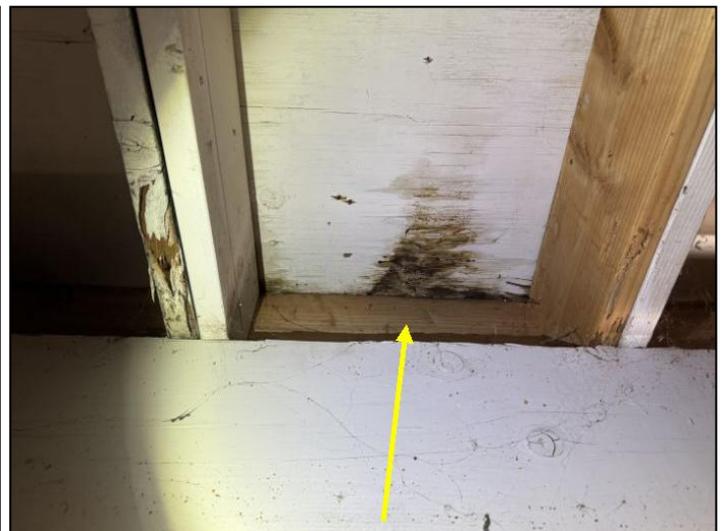
possible pest

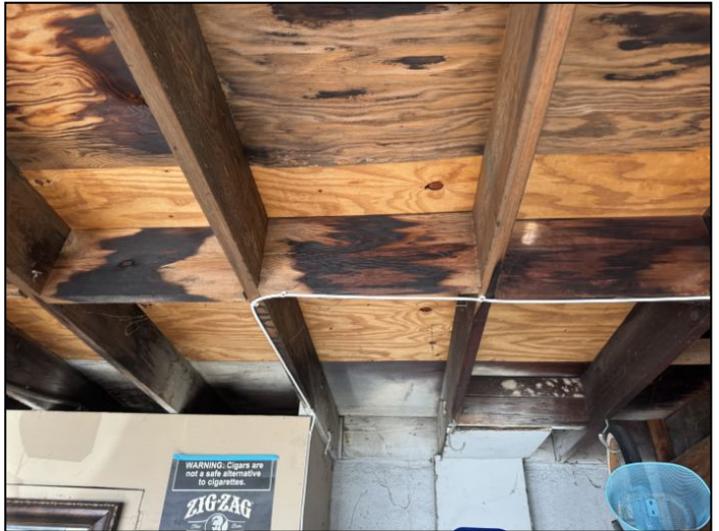
moisture intrusion

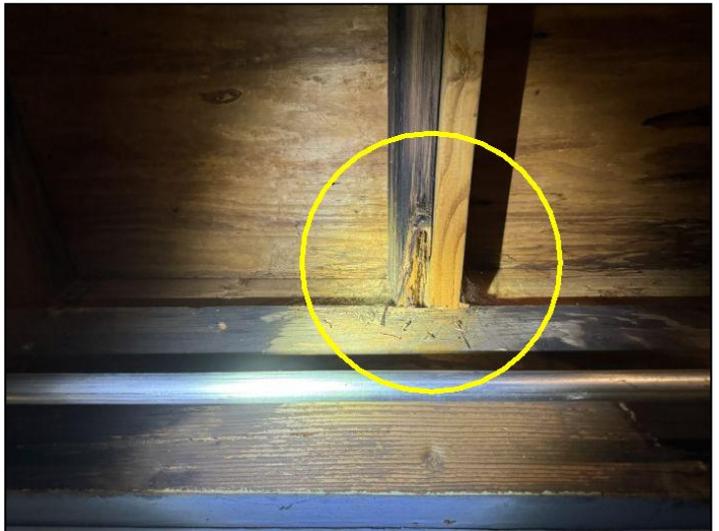
moisture intrusion

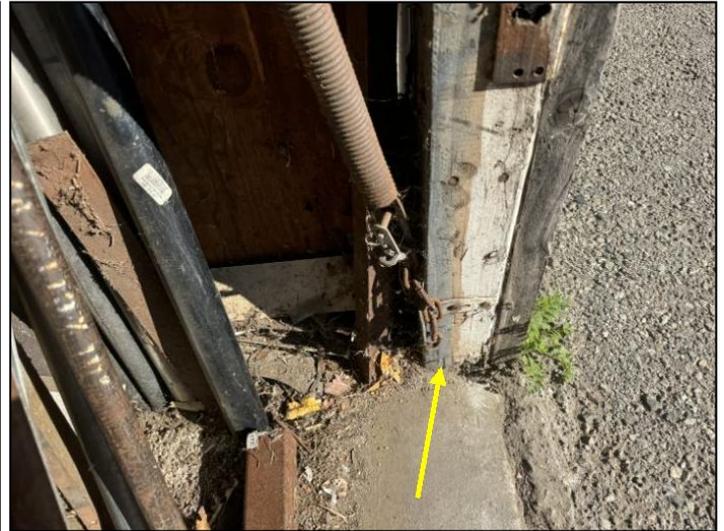
swing door with damage

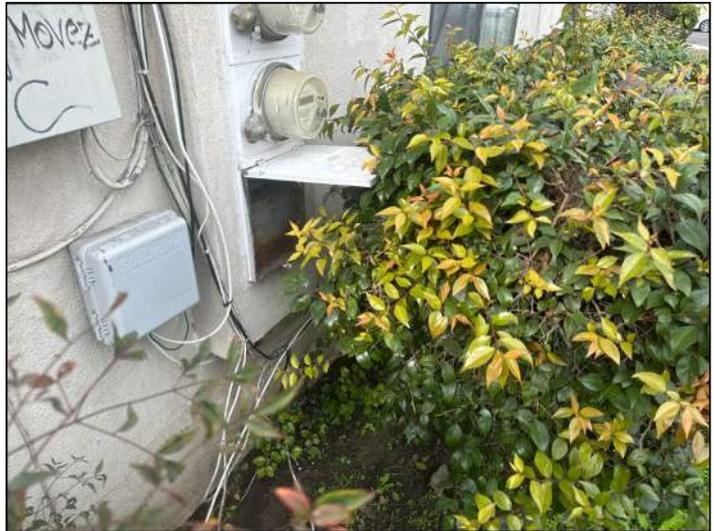
Too close to vegetation

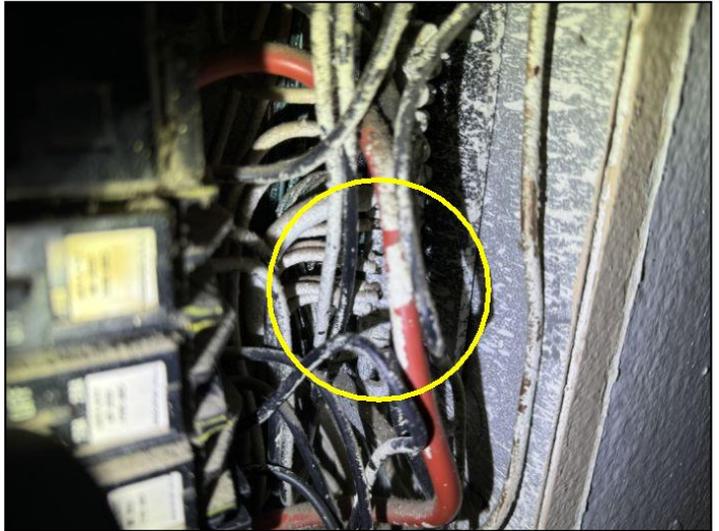
dirt and grime/recommend cleaning out contaminants-apt 2

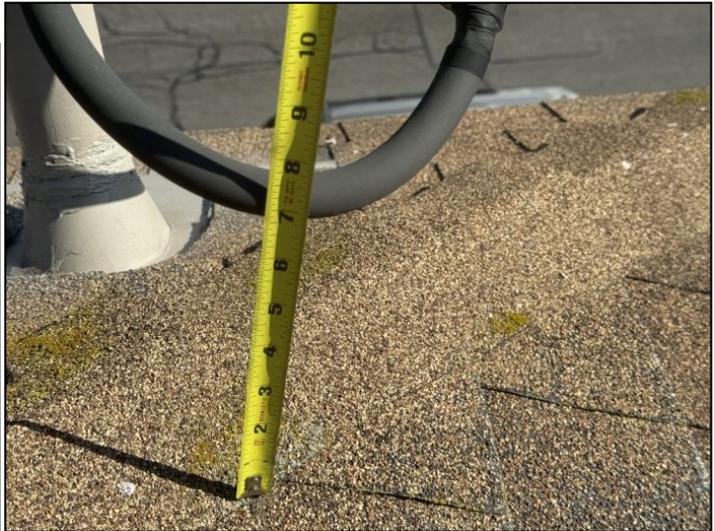
- The Service Entrance Cables were observed as being shorter than the allowable 18 inches from the roof and missing drip loops at the time of the inspection. Recommend qualified electrical contractor remediate.

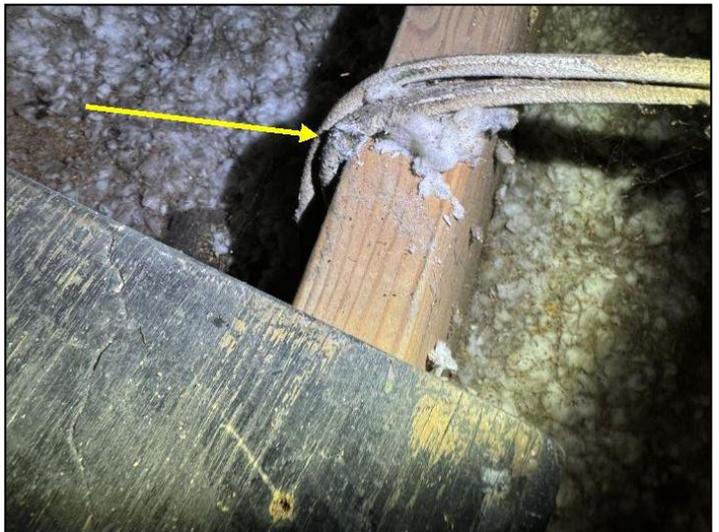
cloth wiring

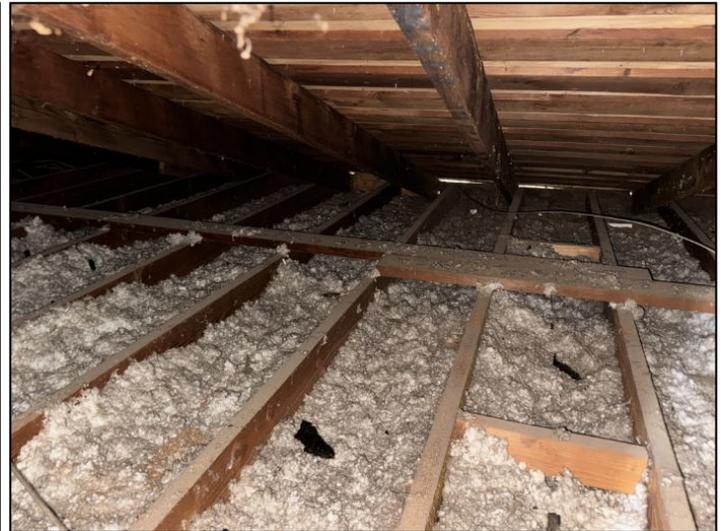
missing insulation

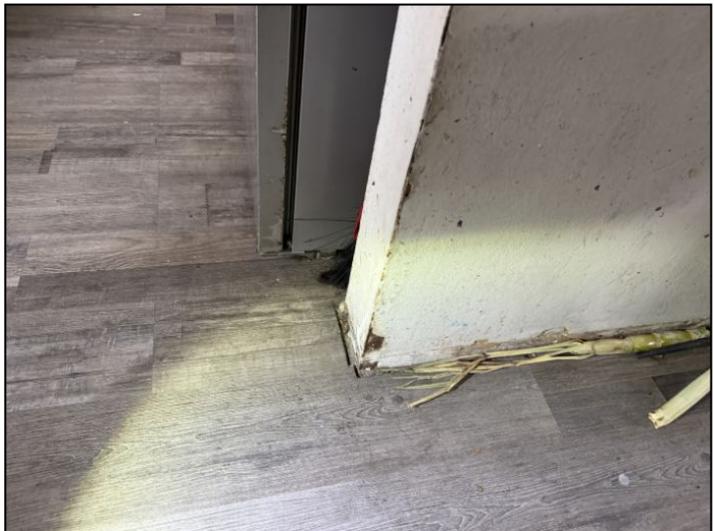
interior walls/possible micorbial growth- apt 1

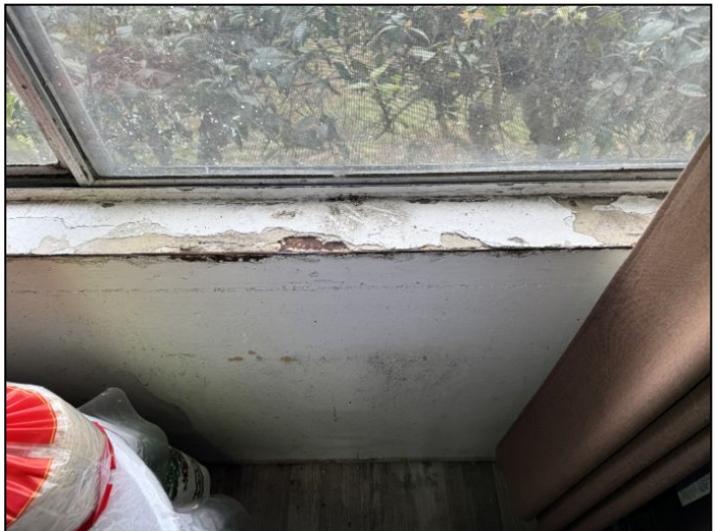
Broken screen

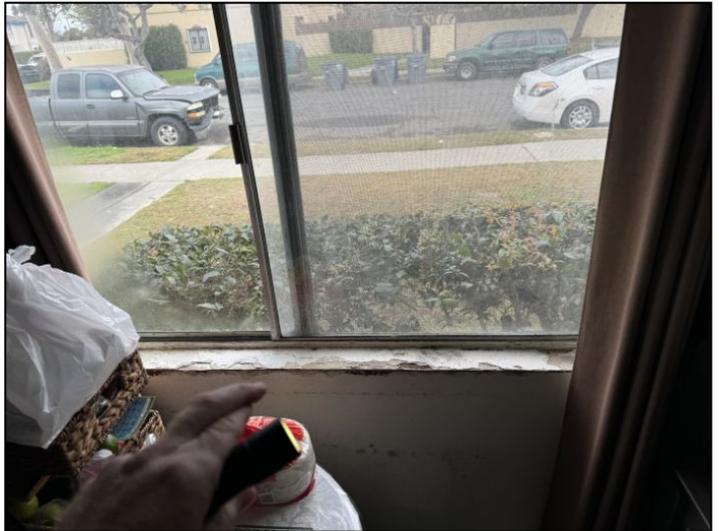
damage/difficult windows

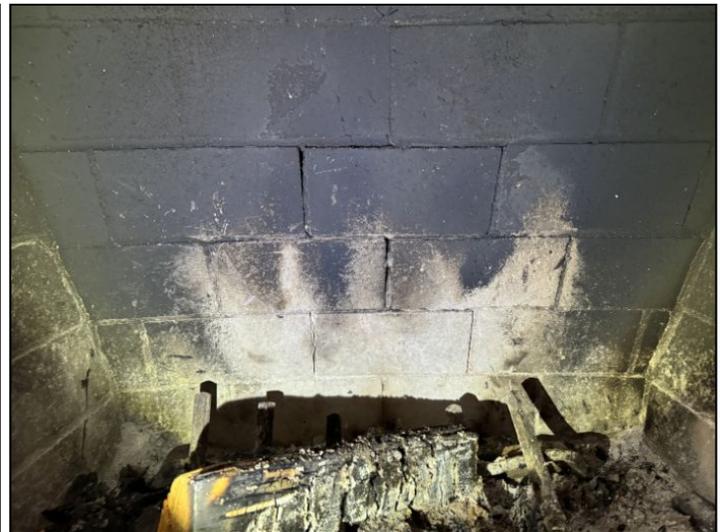
owners belongings-apt 1 fireplace

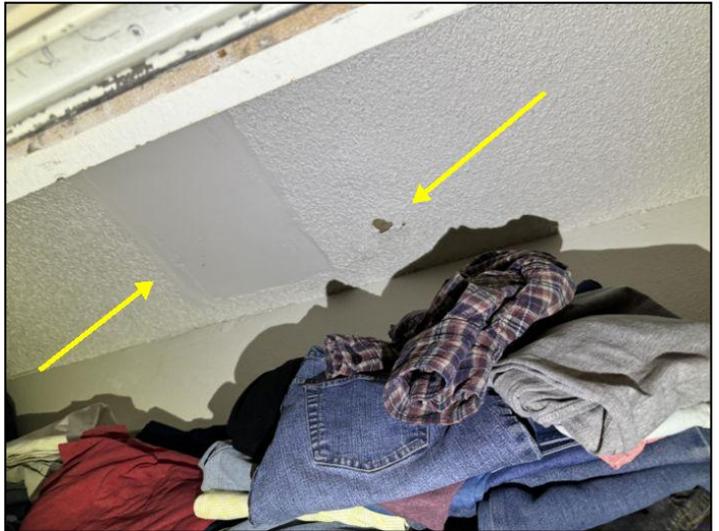
damage to ceiling apt1

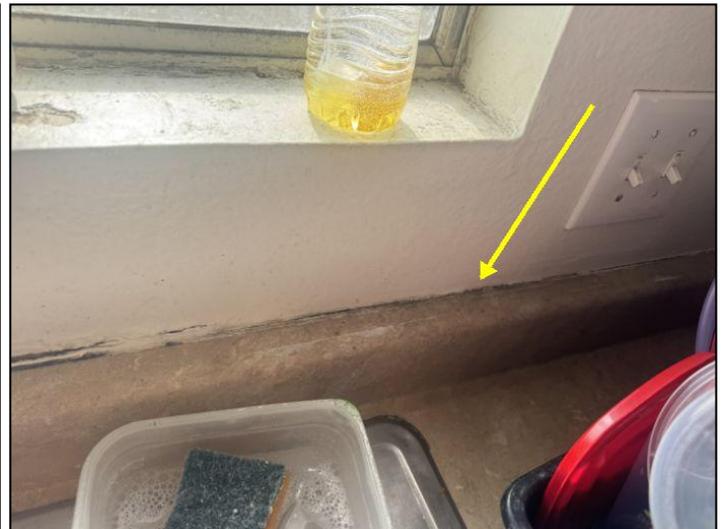
moisture intrusion/corrosion apt1

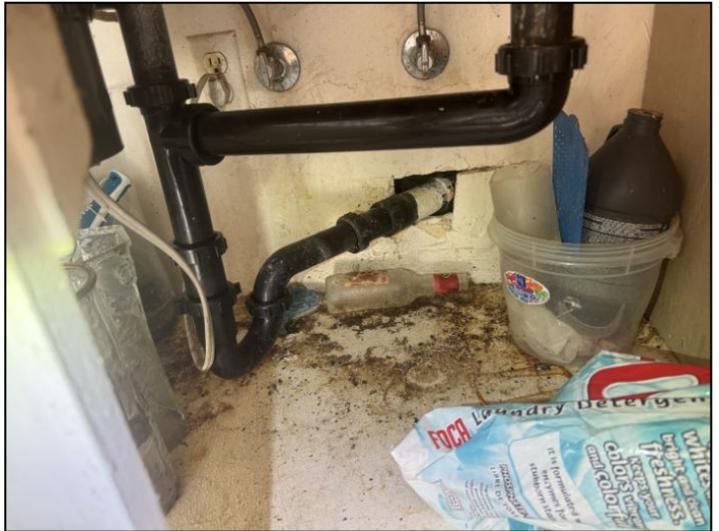
suspected growth/leaking - apt 3

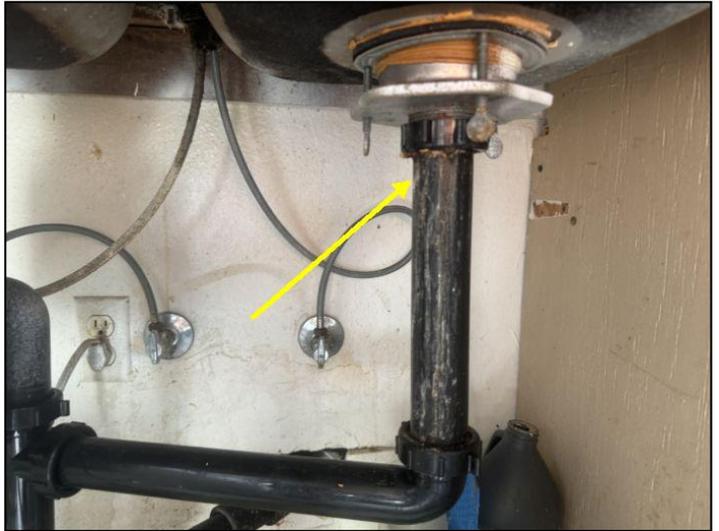
loose faucet- apt 3

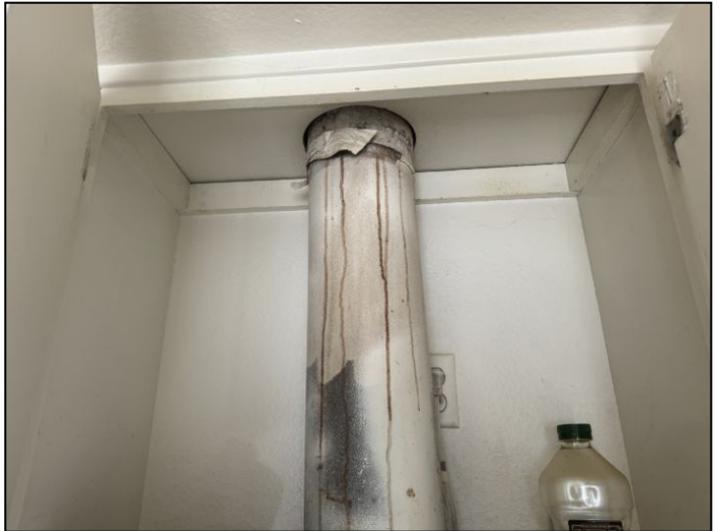
grease covered- apt 1

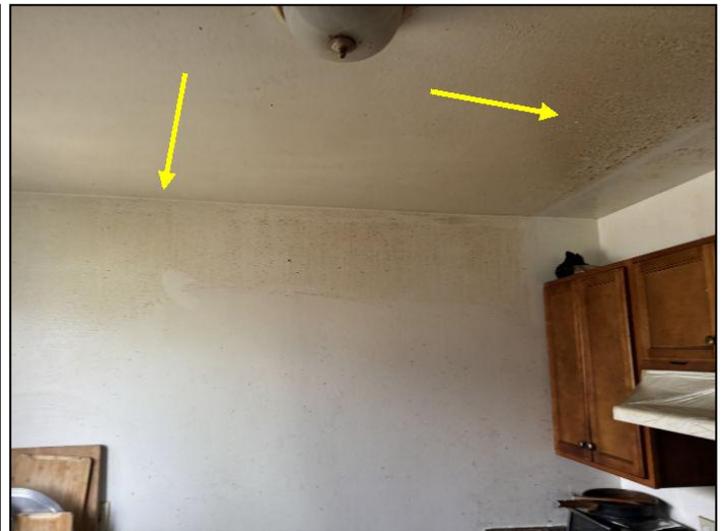
grease covering kitchen

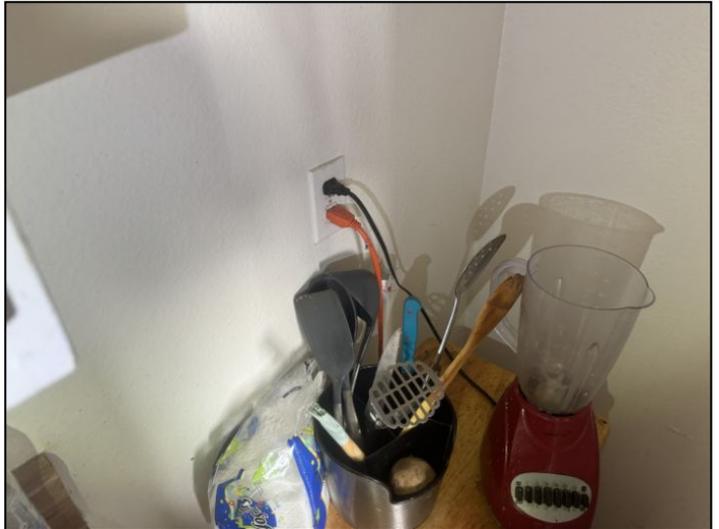
exposed electrical/moisture intrusion- apt 1

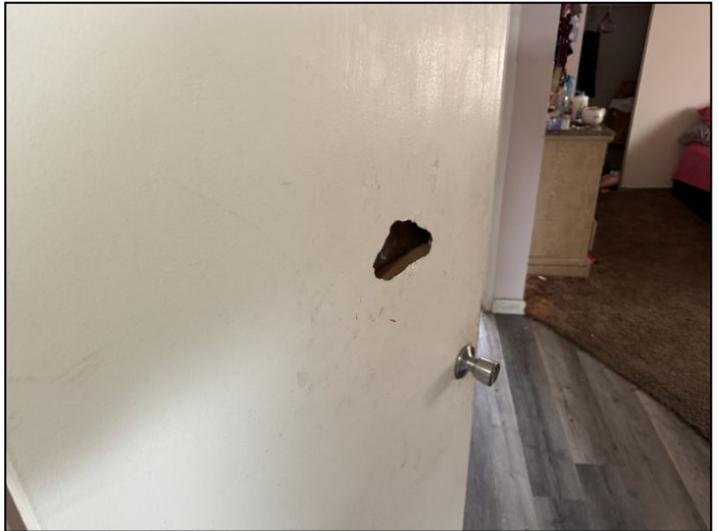
damage to door

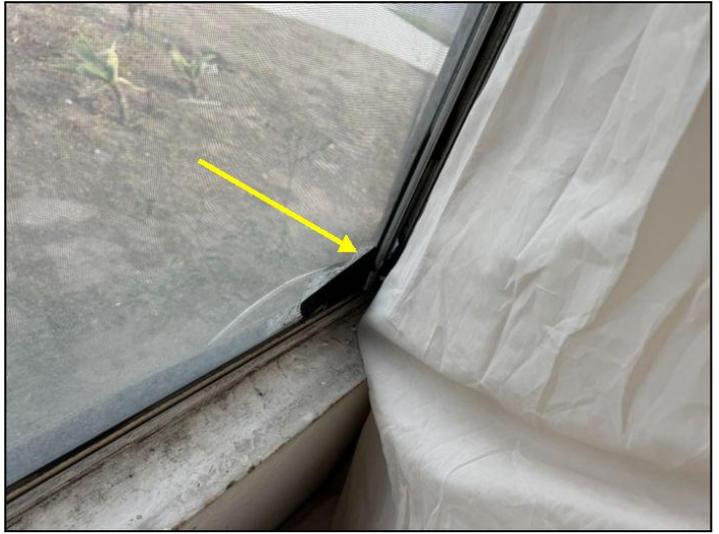
dirt/possible microbial growth/difficult to use -apt 1

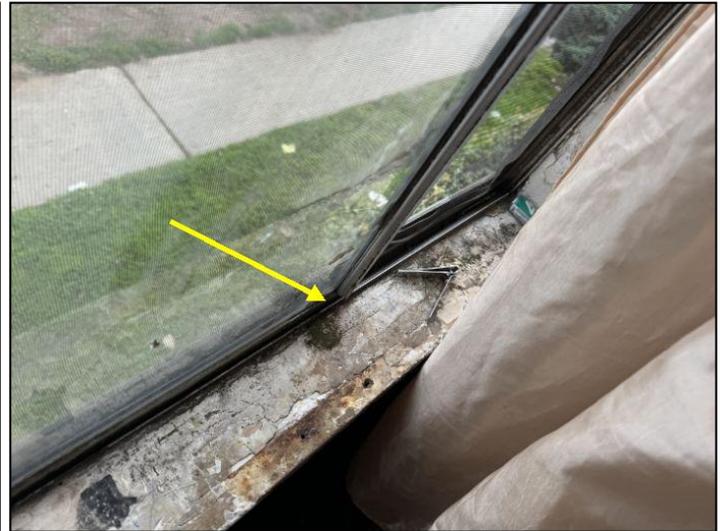
damage to sill - apt 3

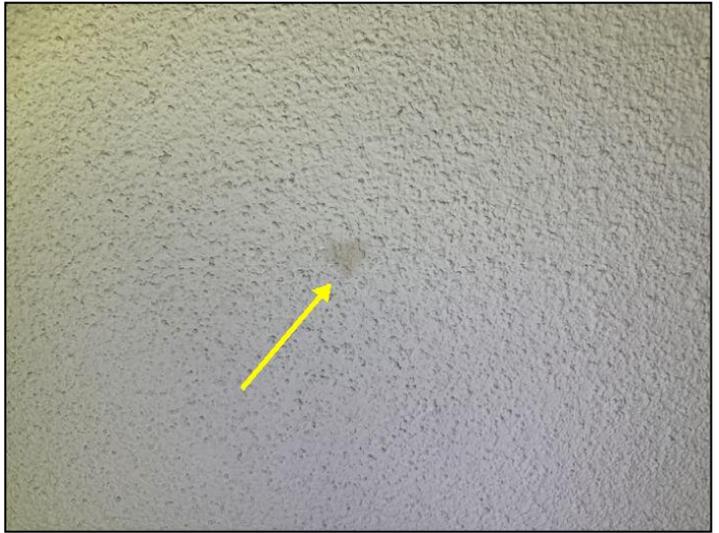
Possible asbestos

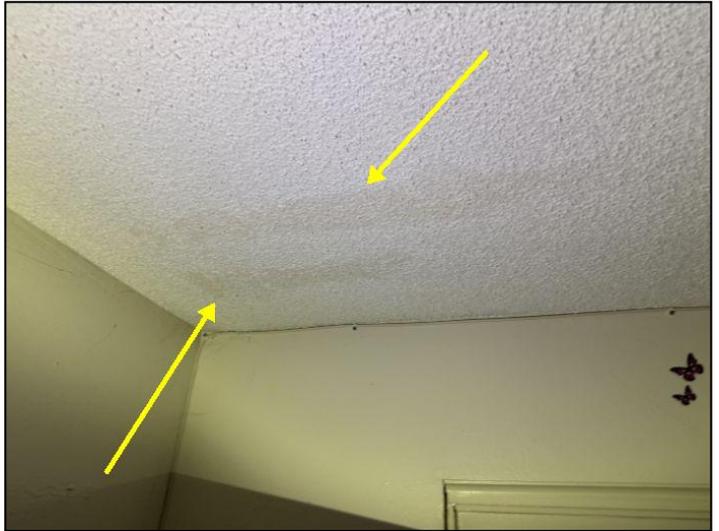
previous patch job - apt 2

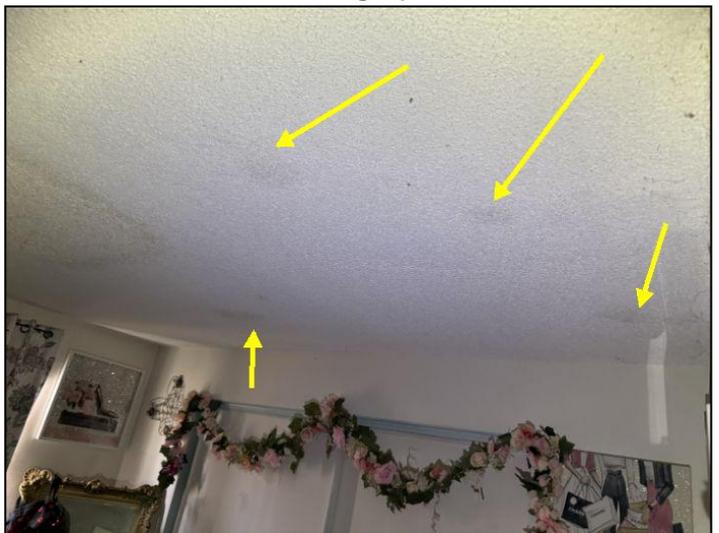
apt 2 previous patch

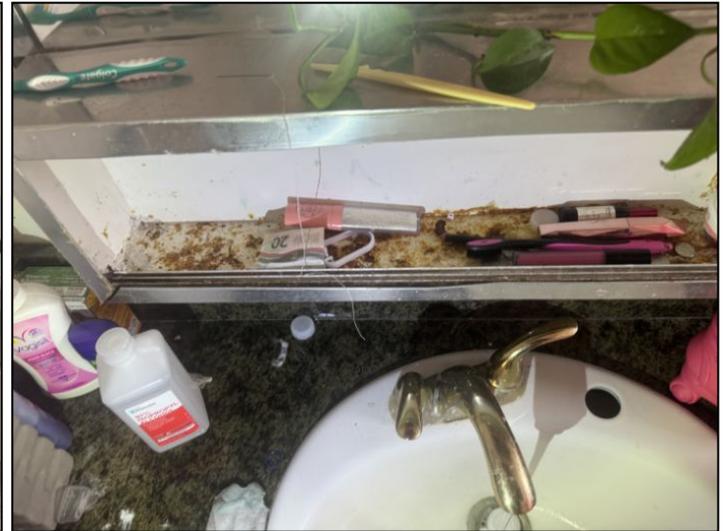
damage - apt 3

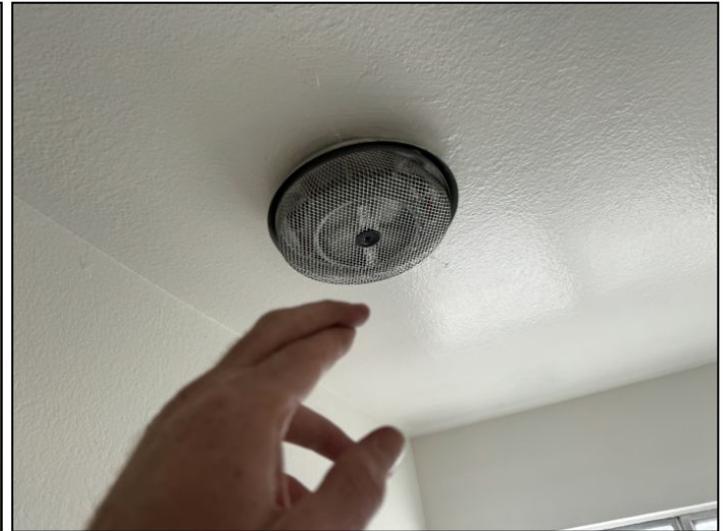
dirty fan- apt 2

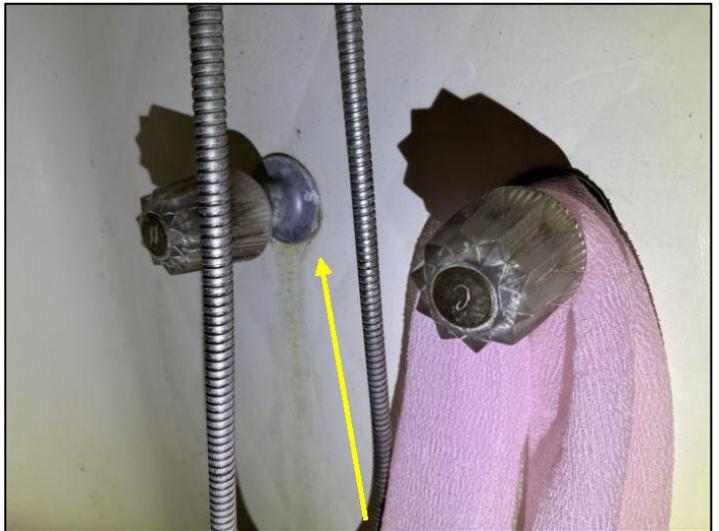
apt 1- gap at faucet

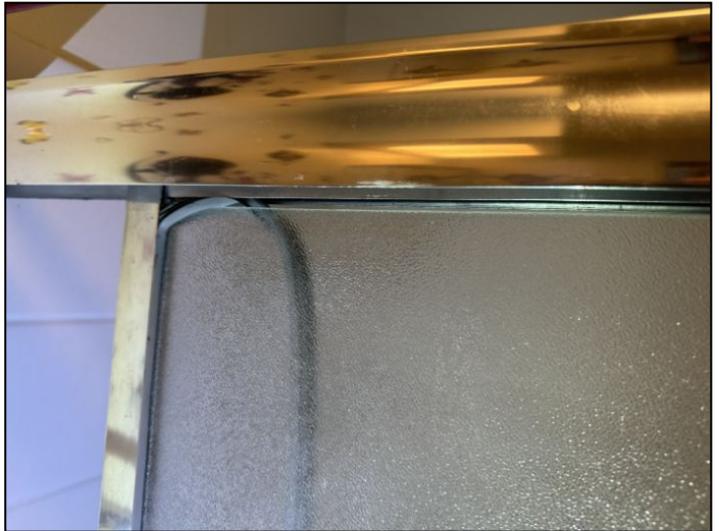
apt 2 non functional door

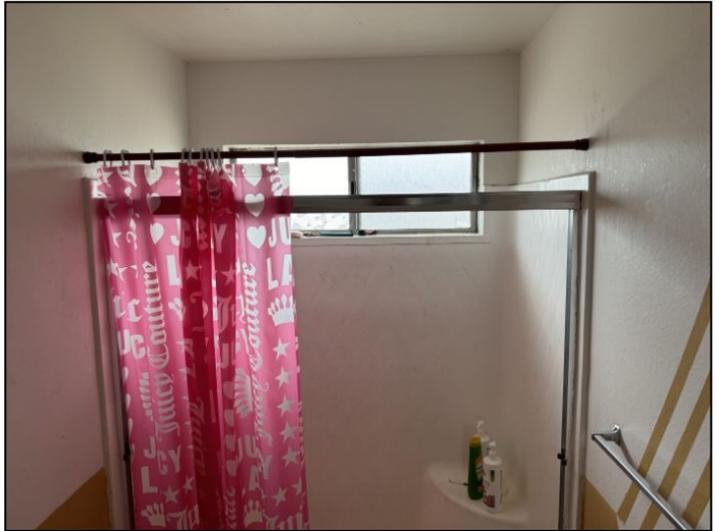
staining in shower - apt 2

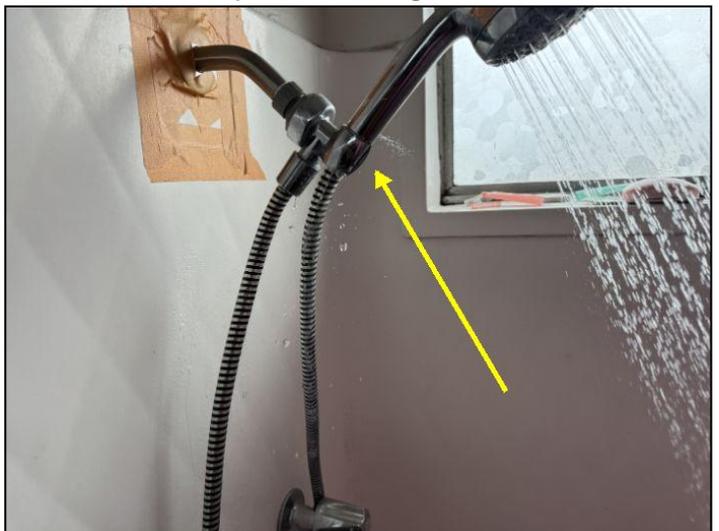
apt 3 - unknown tape

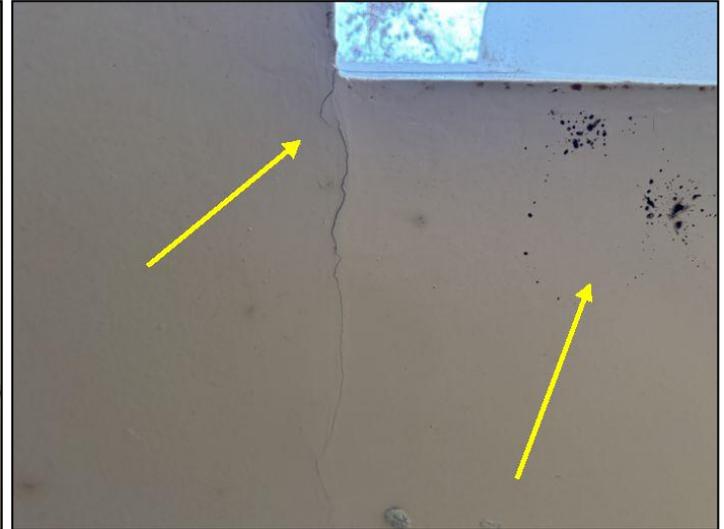
seal top of shower inclosures
