SAMPLE REPORT

Confidential Inspection Report

Inspection prepared for: SAMPLE

Date of Inspection: 1/2/2025 Time: 9am

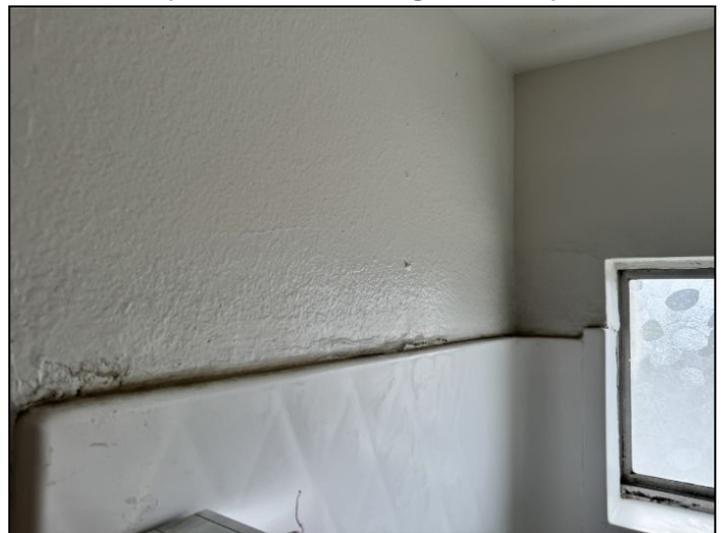
seal cracks - apt 3

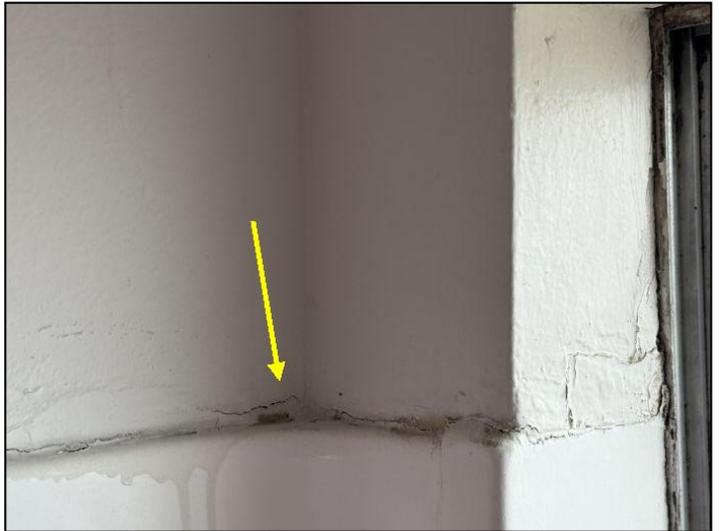
suspected growth - apt 3

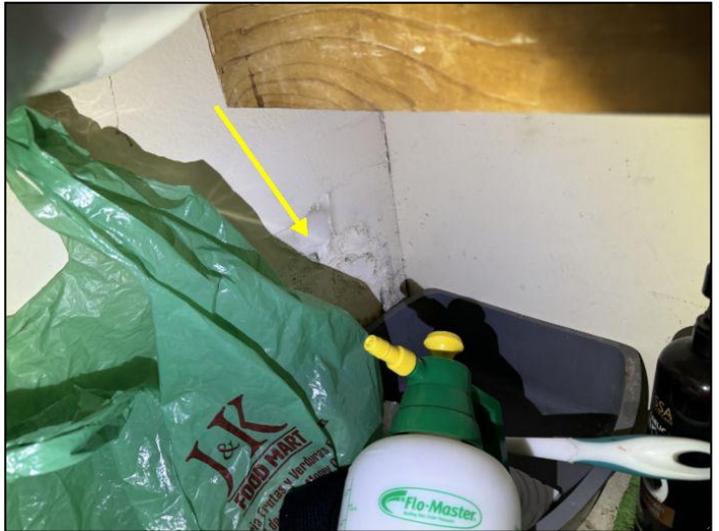
damage to wall/corrosion/cast iron - apt 1

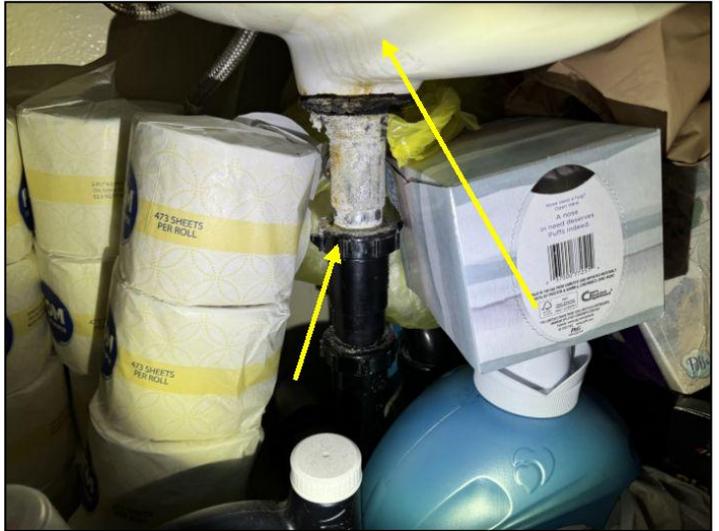
damaged faucet

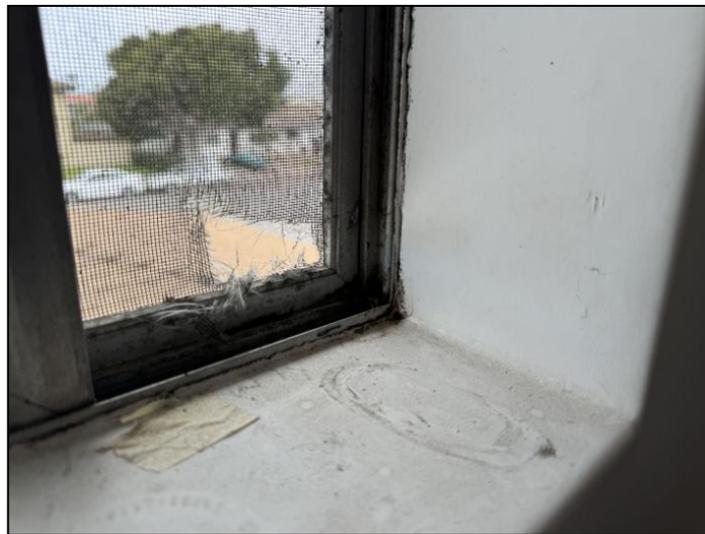
broken screen

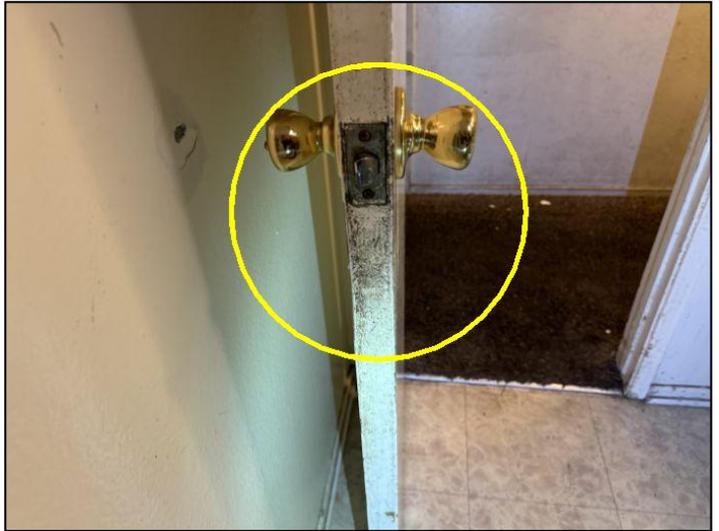
damage to walls-apt 1

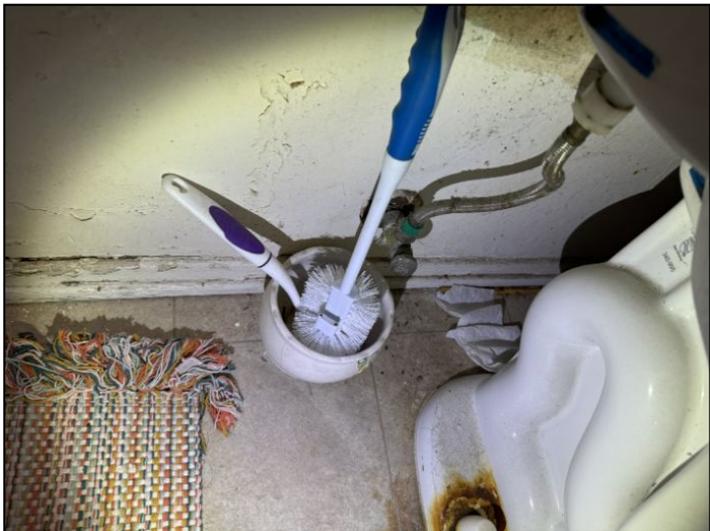
damage to wall/suspected microbial growth

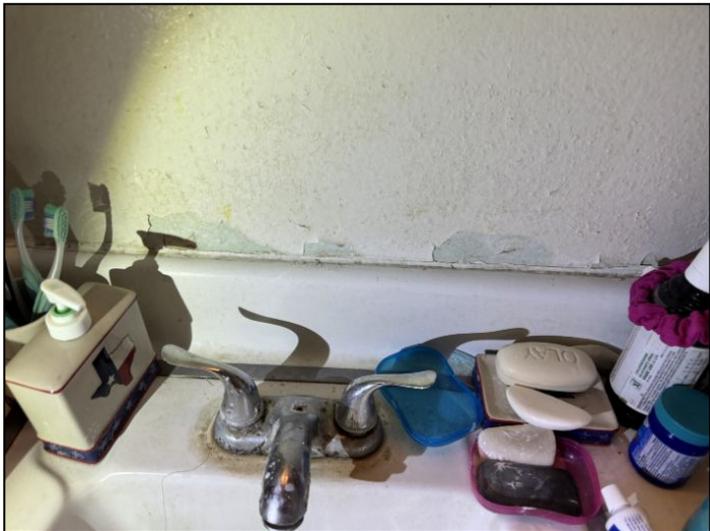
suspected microbial growth -apt 1

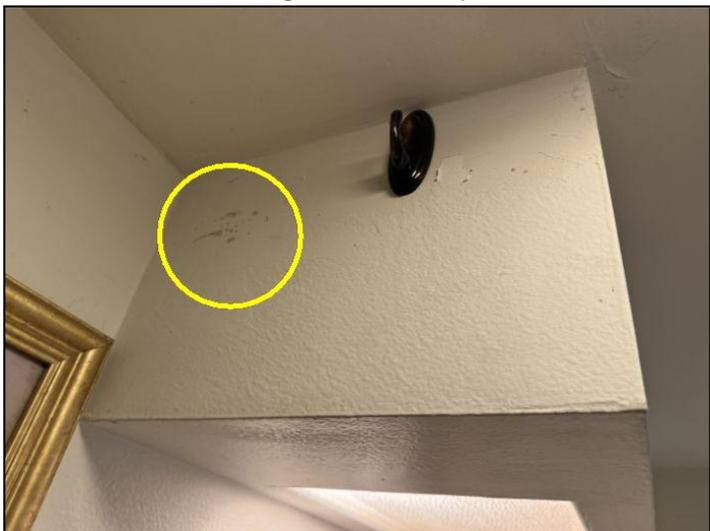
moisture damage- apt 2
