Confidential Inspection Report

, Oxnard , CA

Date of Inspection: 9/1/2025 Time: 10am

***BEST COAST
HOME INSPECTIONS***

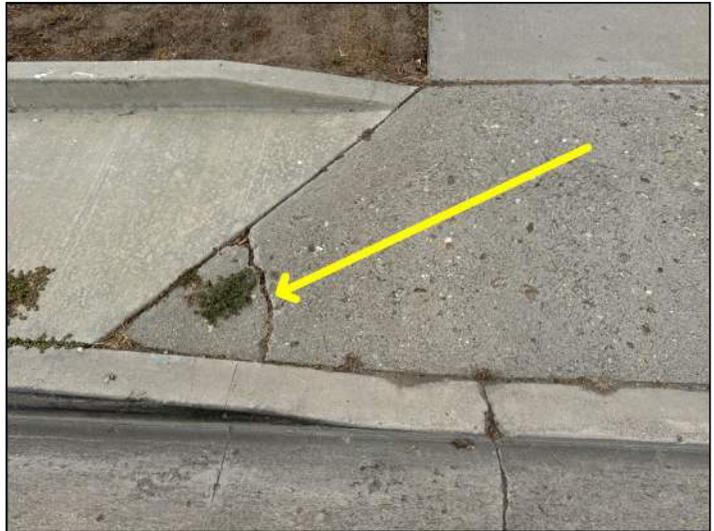
- Moderate cracks in driveway at the time of the inspection. Repair and/or monitor for expansion and development of trip hazards.

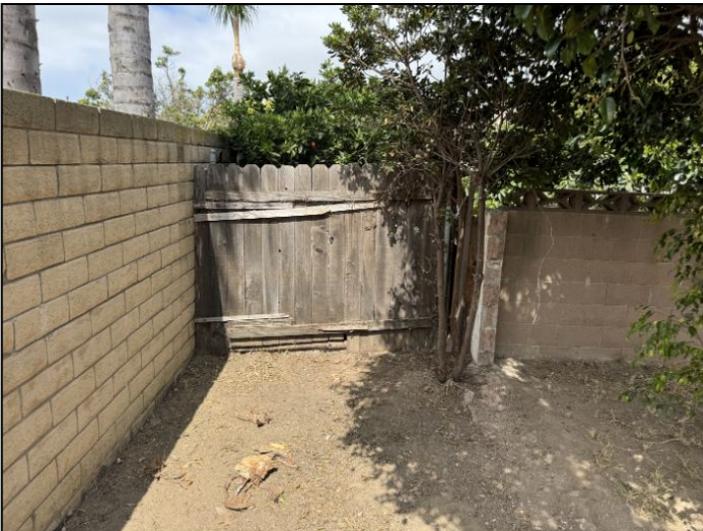
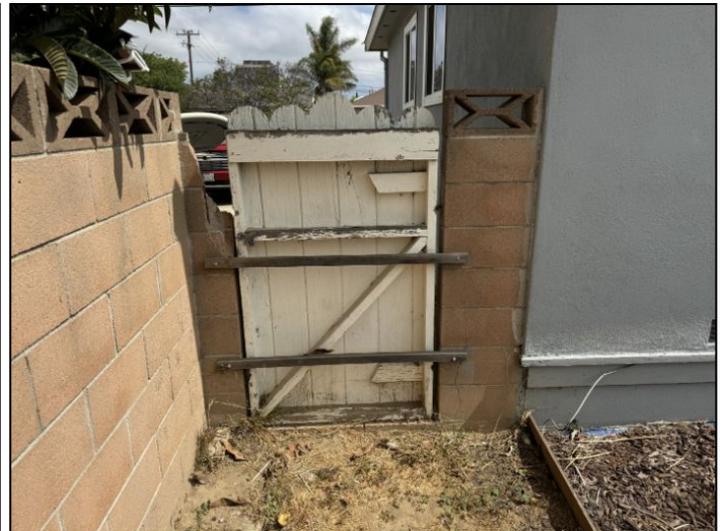
- Gates locked/blocked and non operational at the time of the inspection. Recommend further evaluation by qualified contractor efficiency of use

end of life gate

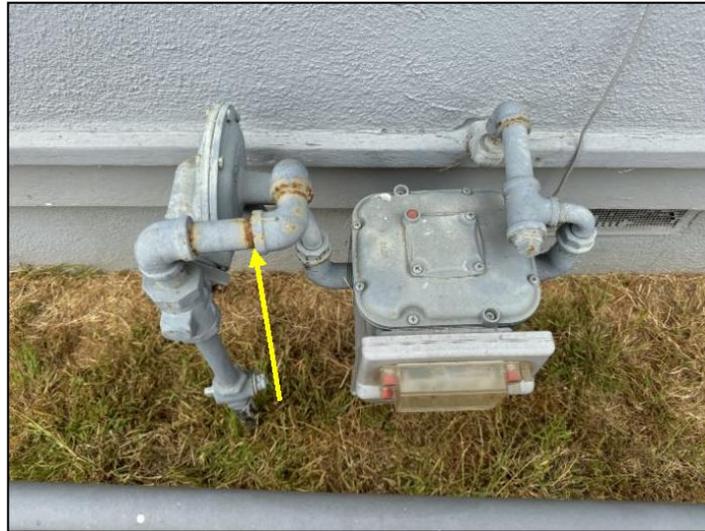
- Main gas meter was located within 36 inches of door and electrical at the time of the inspection. The main gas meter regulator vent terminations should not be within 36 inches of an ignition source, electrical equipment and openings to the building. This clearance extends ten feet above and 36 inches below the regulator vent terminations. Recommend contacting utility company for further evaluation and remediation of gas valve clearances. Please see diagram.
- Rust observed on the main gas valve at the time of the inspection. Recommend gas company remediate to prevent further rust/deterioration.

Too close to opening

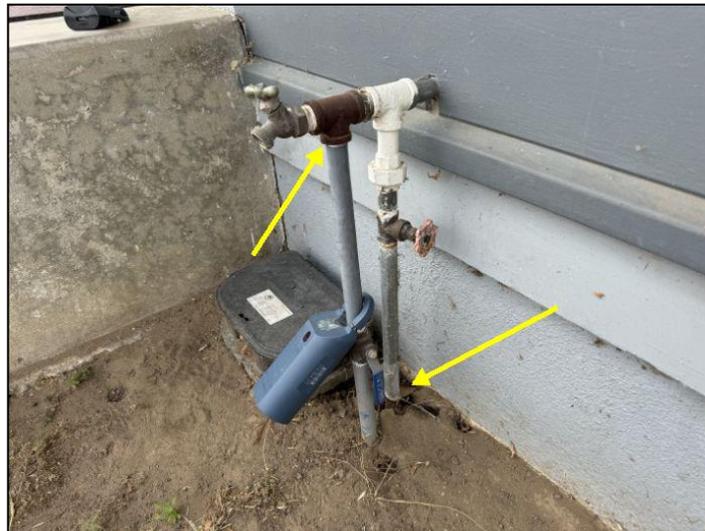
- Galvanized waterline observed at the front of the house at the time of the inspection. Rust and deterioration observed at the time of the inspection. Recommend further review for the need to replace galvanized waterlines to prevent addition deterioration/leaking.

deteriorating galvanized water line

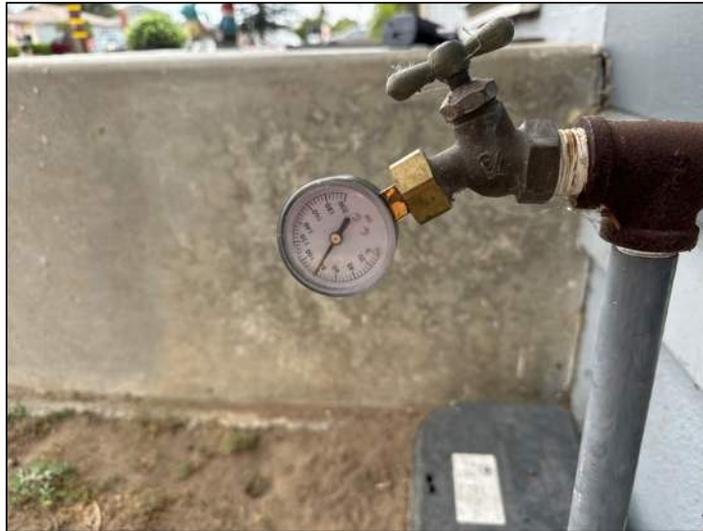
- 80 psi
- 80 psi observed at the time of the inspection. Anything above 80 psi is considered too high and may put undo stress on your pipes. Recommend adjusting pressure down to a max of 70psi.

80 psi

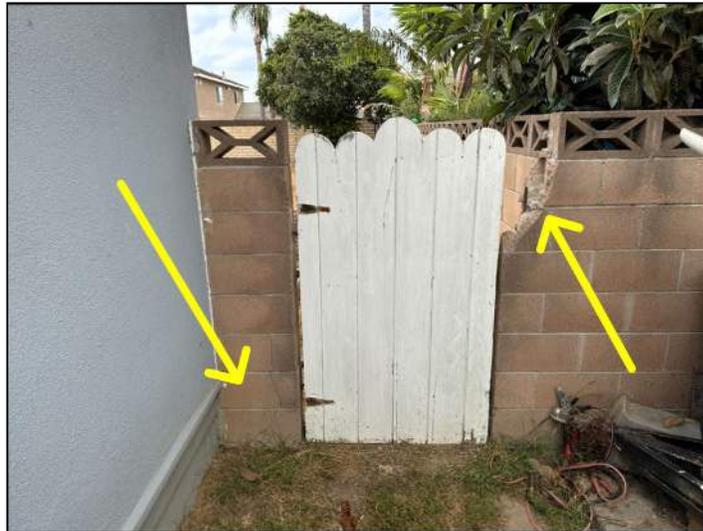
- Cracking and significant damage to concrete block wall observed at the time of the inspection. Recommend further evaluation and remediation by qualified contractor.

Damaged wall

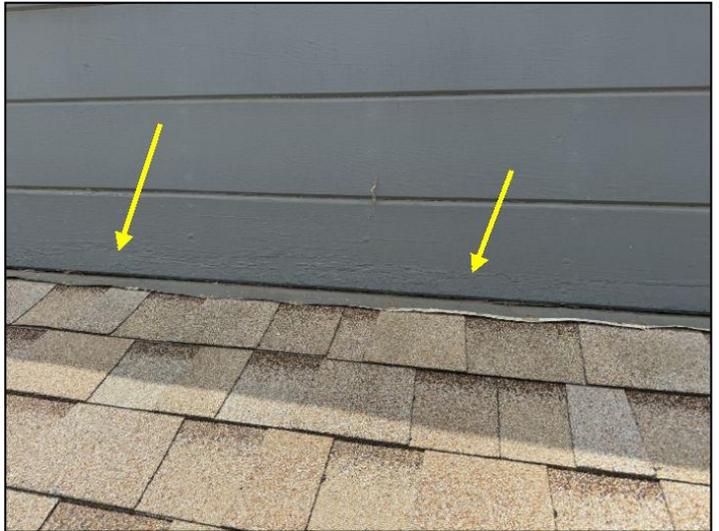
- Peeling paint observed on the siding at the time of the inspection recommend for the evaluation/remediation by qualified contractor
- Wood siding above the roof observed with age and possible moisture intrusion. Recommend further evaluation of siding by qualified contractor for the addition of counter flashing to prevent addition moisture intrusion.

signs of moisture intrusion

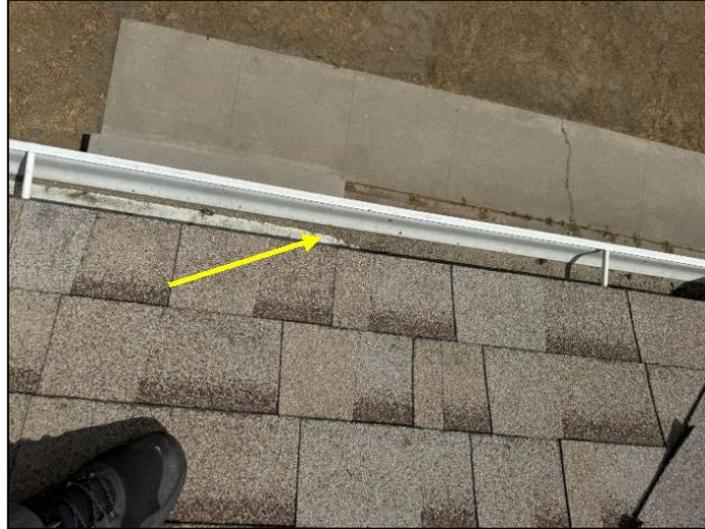
- Granule loss observed in the gutter, showing a bit of age and wear and tear. Recommend review of disclosures regarding age of roof and any warranties included.

granule loss

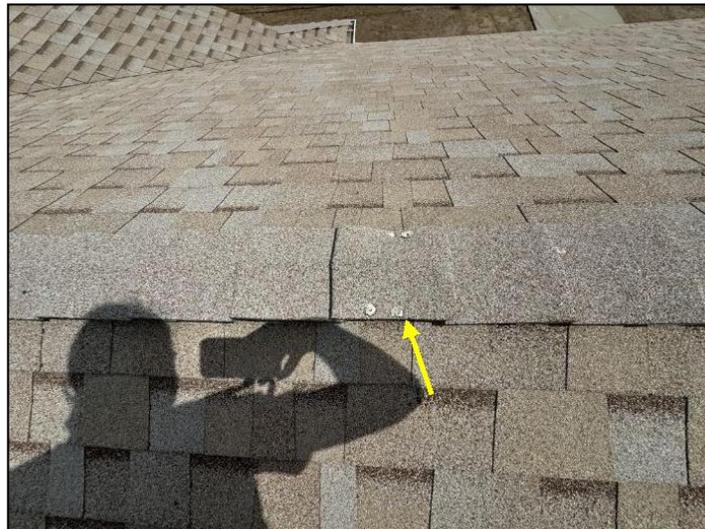
- Fasteners observed with the start of failing sealant on the roof at the time of the inspection. Sealant for nails and flashing should be monitored and maintained. Recommend sealing all penetrations to prevent moisture intrusion. Recommend further evaluation of flashing and remediation by licensed and insured contractor.

failing adhesive over nails

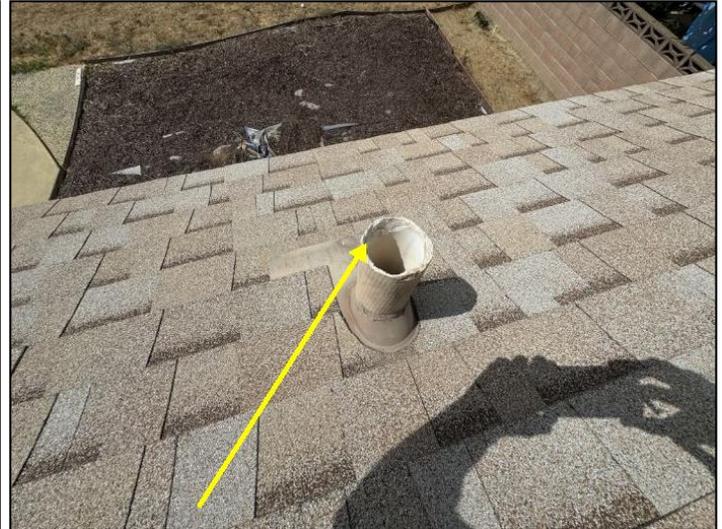
- Damage observed to transite asbestos flue at the time of the inspection. Recommend qualified contractor remediate.

damage transite asbestos flue (water heater)

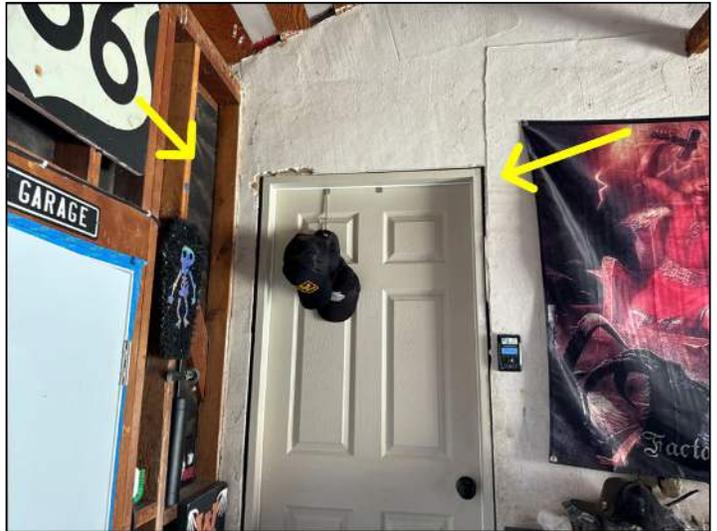
- Break in the firewall wall at the time of the inspection. The wall and ceiling between the garage and the home is considered a firewall. Any break in a firewall could allow a garage born fire into the home and constitutes a fire hazard. Recommend remediation by licensed contractor.
- Damage to drywall observed at the time of the inspection. Recommend further evaluation/remediation by qualified contractor to maintain firewall.
- Garage top place observed as notched over 50 percent to make room for the laundry vent at the time of the inspection. Recommend remediation by qualified contractor for the addition of a metal plate for reinforcement.
- Evidence of wood destroying pest in the framing in the back of the garage at the time of the inspection. Recommend further evaluation and remediation by licensed pest control company.

break in firewall

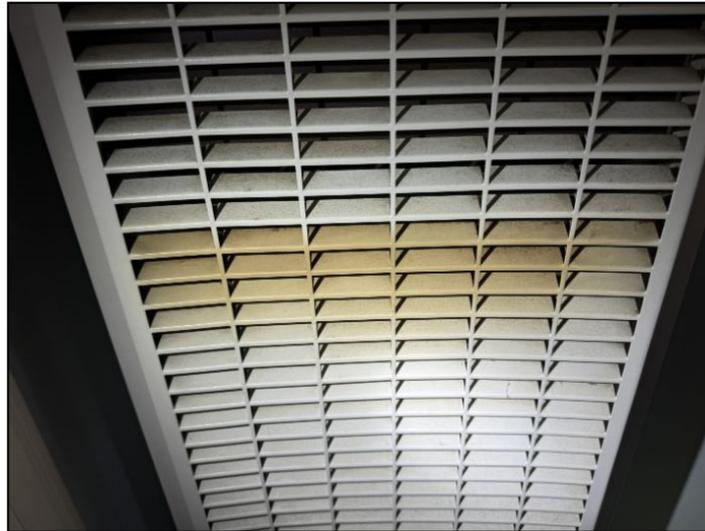
- Functional under normal operating controls at the time of the inspection.
- Recommend removal of all combustibile materials from around the wall heaters for safety.
- Wall furnace observed as musty when turned on indicated lack of use. Recommend servicing of heating units by qualified HVAC contractor.
- Wall heater observed as browning with excess heat at the time of the inspection. Recommend further evaluation of unit for safety of use.

signs of excess heat

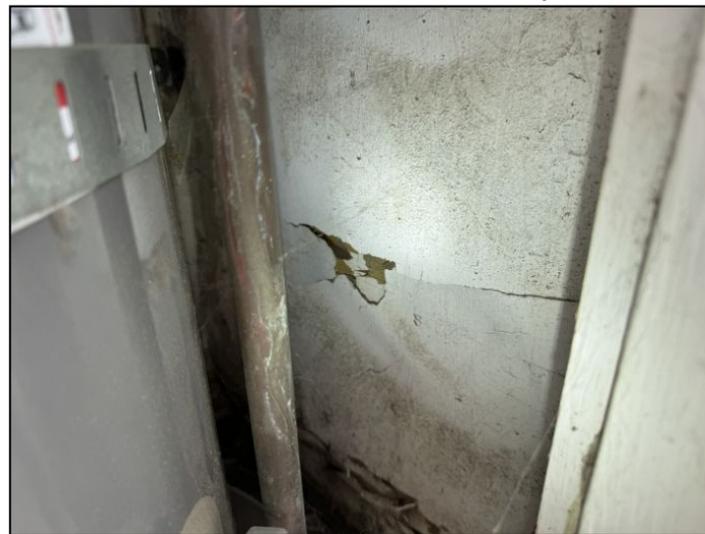
damage/possible microbial growth

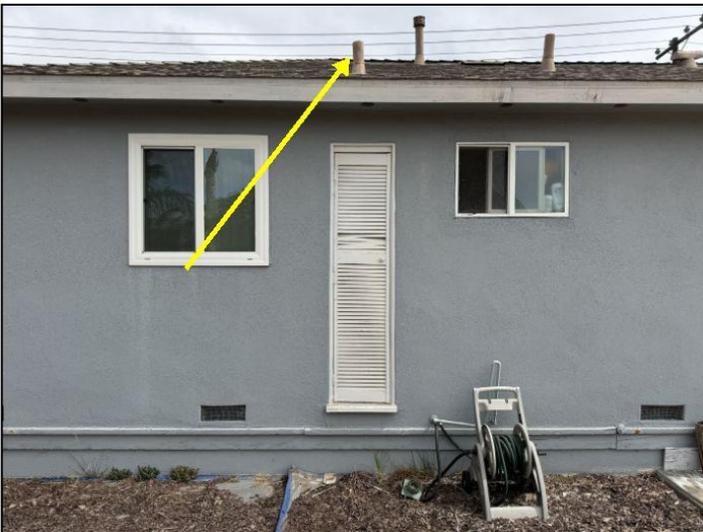
- Water heater flue missing cap at the time of the inspection. Recommend remediation by licensed plumber to prevent additional deterioration.
- Single walled vent observed from the top of the water heater as having less than 6 inch clearance combustibles and to the ceiling at the time of the inspection. This is a fire hazard. Single walled vents need six inches of clearance to combustible material and we recommend having licensed and insured HVAC contractor remediate as appropriate to maintain clearance to combustibles.

transite asbestos flue with no cap

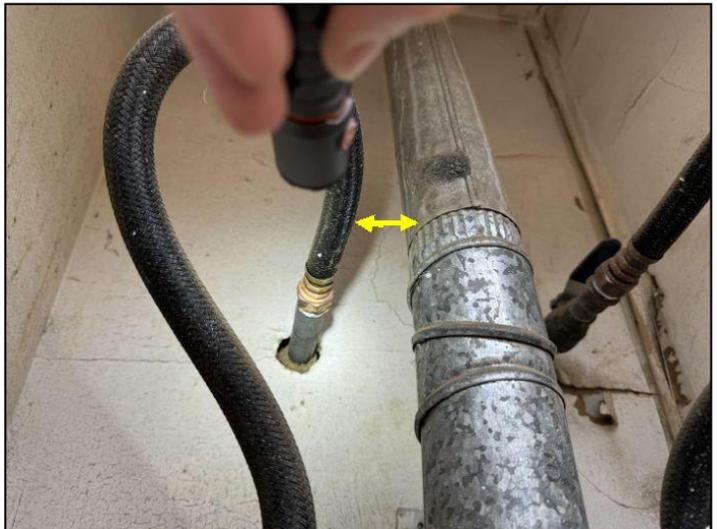
less than 6 inches

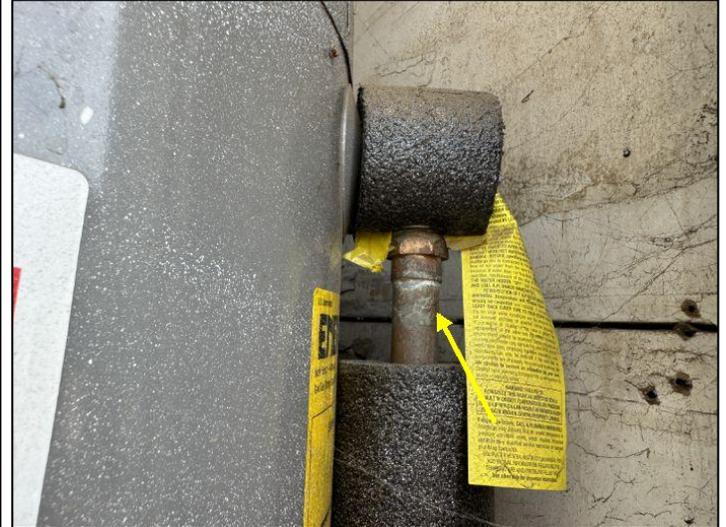
corrosion on tpr downspout

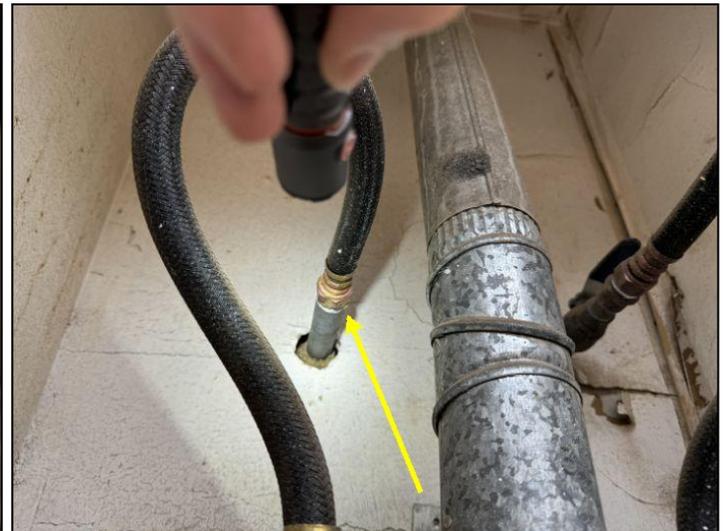
corrosion at connection/black braided line

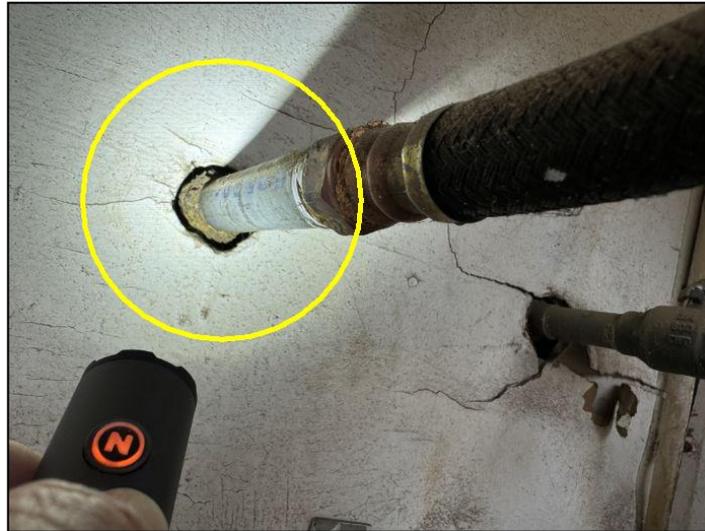
corrosion at pipe connection

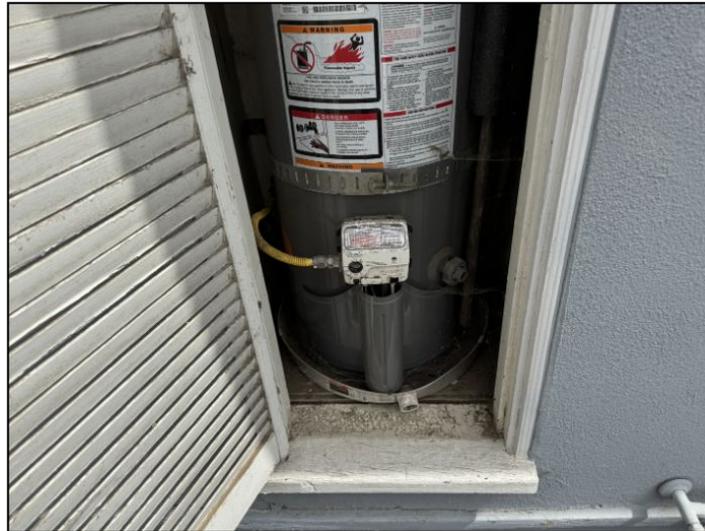
- Overflow line observed as emptying directly to garage floor at the time of the inspection. We recommend that the line extend to the exterior of the enclosure. In the event of its use, extending the line to the outside will prevent water damage to anything of value stored in the garage.

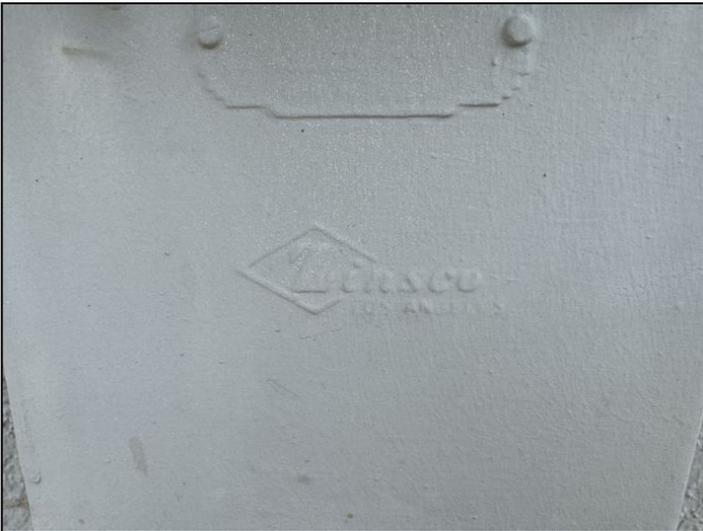
- There was a Zinsco panel observed at the time of the inspection. Zinsco components are prone to problems that can lead to failures, lack of proper protection of circuits and other serious issues, including fire and electrocution. For safety reasons, you should consult with a qualified electrical contractor to discuss the necessity, options and cost for replacement. You should contact your insurance company to confirm that this panel will not be a barrier to obtaining a policy. Recommend licensed and insured electrician evaluate electrical systems as a whole.

Zinsco panel

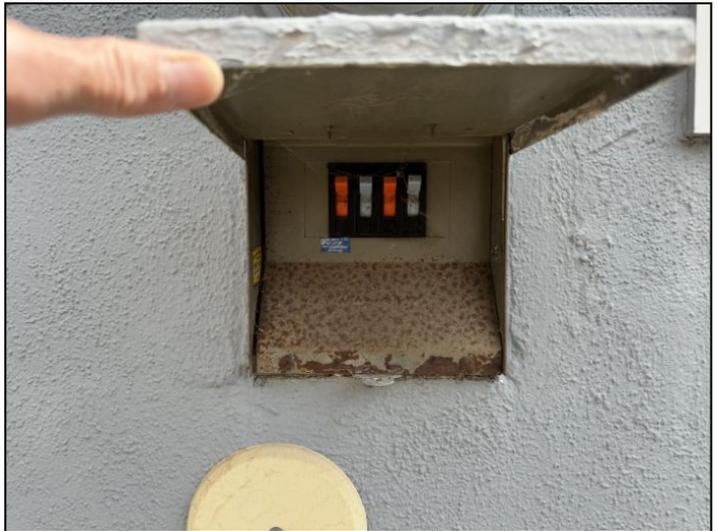
rust to panel cover

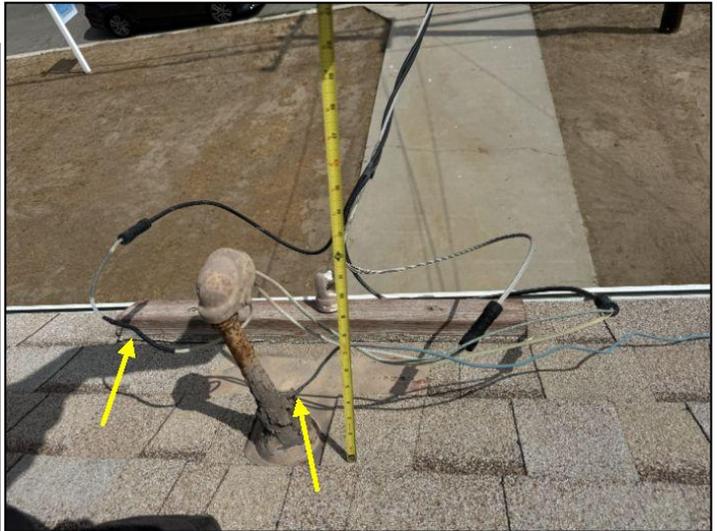
- The Service Entrance Cables were observed as being shorter than the allowable 18 inches from the roof and missing drip loops at the time of the inspection. Recommend qualified electrical contractor remediate.
- Damage to the cable feeds service entrance observed at the time of the inspection. Recommend further evaluation/remediation by qualified electrical contractor.
- Recommend full evaluation of cable feed and unconventional wiring by licensed electrician. Recommend evaluation of entire system for safety of use.

unconventional wiring at cable feeds

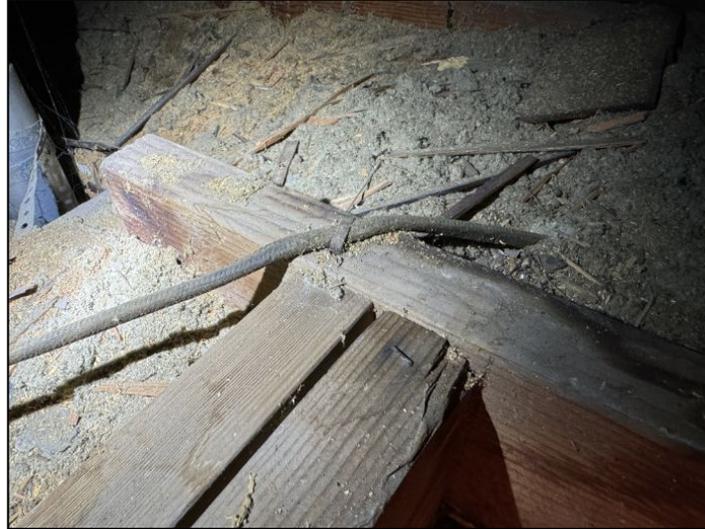
- Ceiling attic inspection limited to visual inspection from the area just inside the access point in the home.
- Electrical conductors observed as right next to the access points of the attic at the time of the inspection. It is recommended the conductors be moved 6 ft from the access point and secured at intervals not to exceed 54" to prevent any damage to the conductor when accessing the attic. Any conductors within 6 ft need to be protected with guard strips. Recommend licensed electrician remediate.

cloth wiring next to access

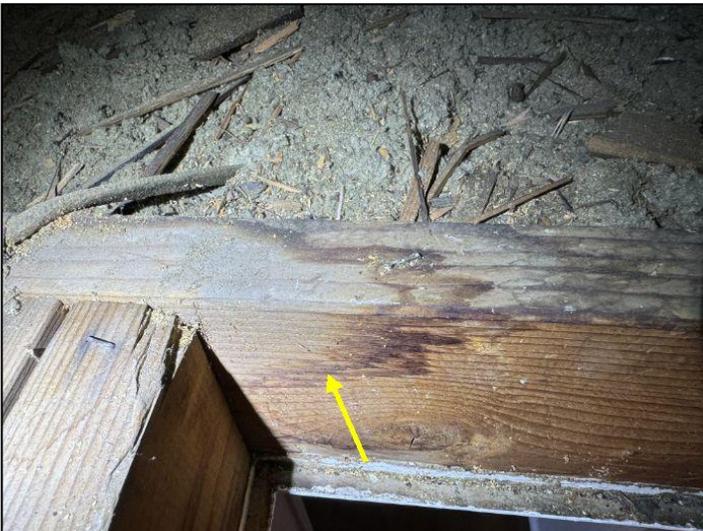
- Evidence of moisture intrusion in attic, dry at the time of the inspection observed. Recommend qualified roofing contractor for proper evaluation.
- Evidence of pest activity in the attic observed at the time of the inspection. Rodent dropping observed at the time of the inspection. Recommend evaluation and remediation by licensed professional.
- Cracks / hole(s) showing daylight visible at the time of the inspection. Recommend repair by license professional to prevent moisture and pest intrusion.

dry moisture staining

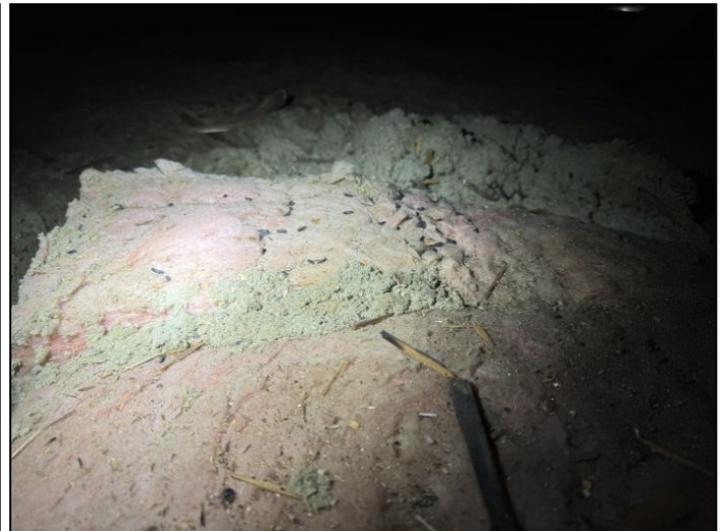
pest droppings

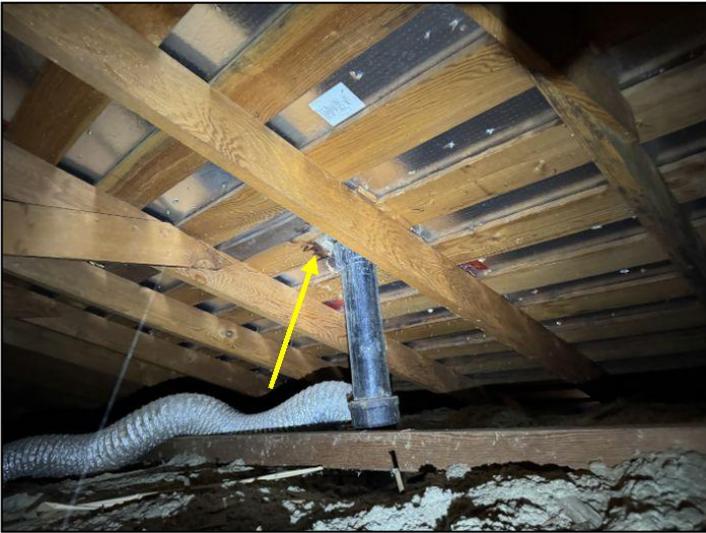
moisture staining/intrusion

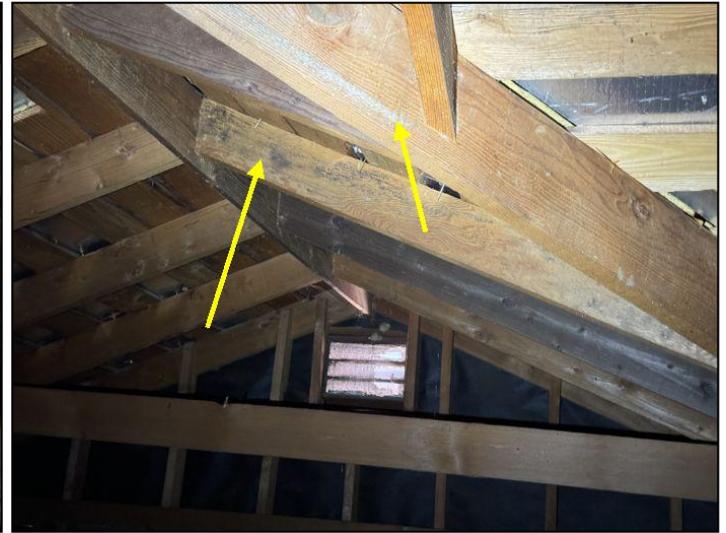
possible microbial growth

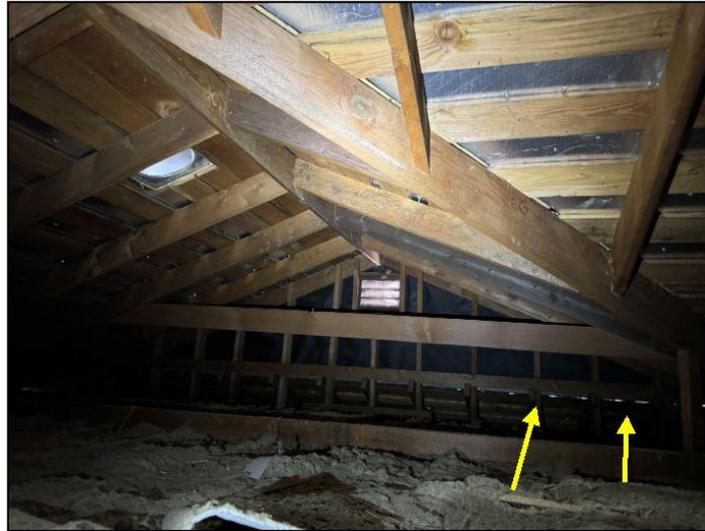
light intrusion - seal all gaps and cracks.

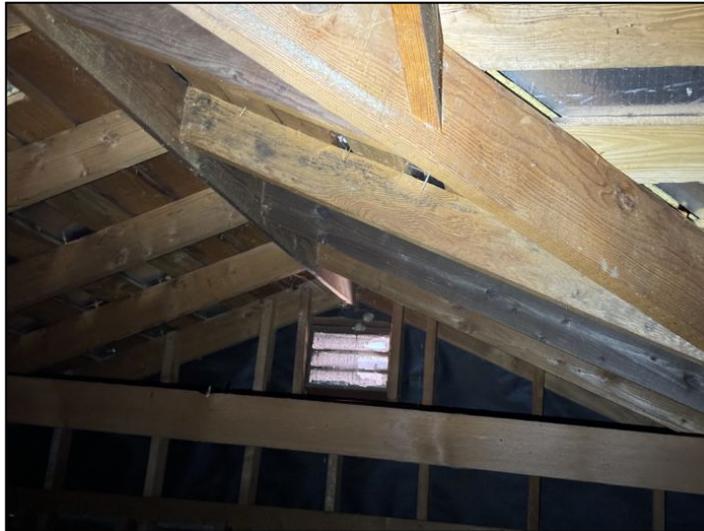
- Gable vent screen observed as dirty at the time of inspection. Recommend cleaning of vents for proper air flow.

blocked venting

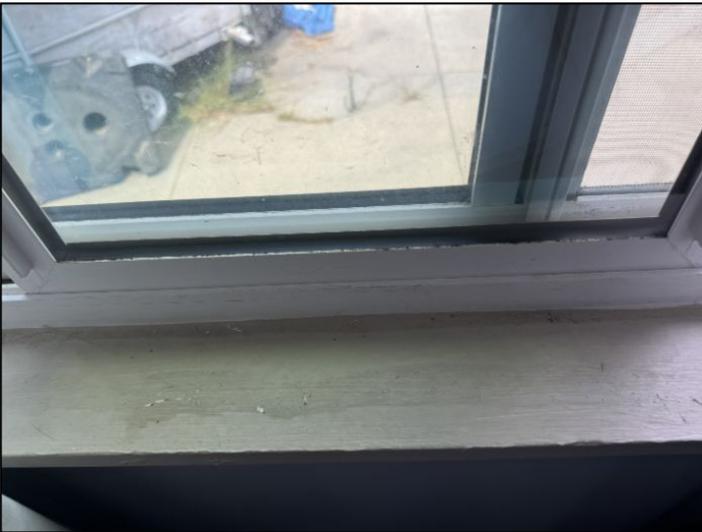
dirt/possible microbial growth on window sills

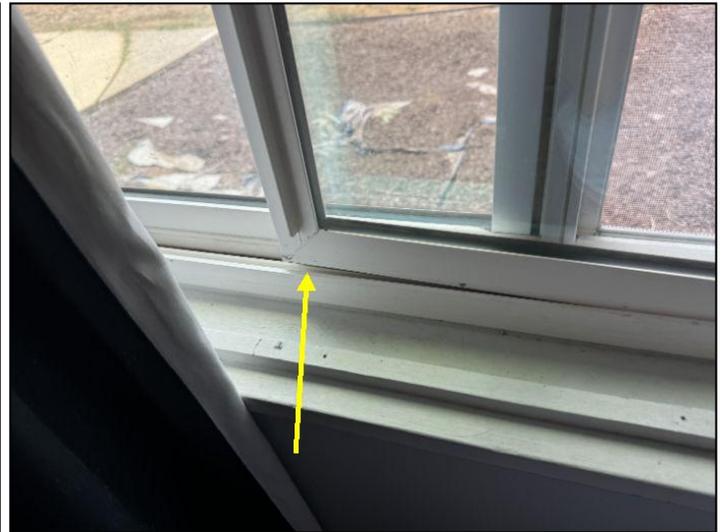
loose windows

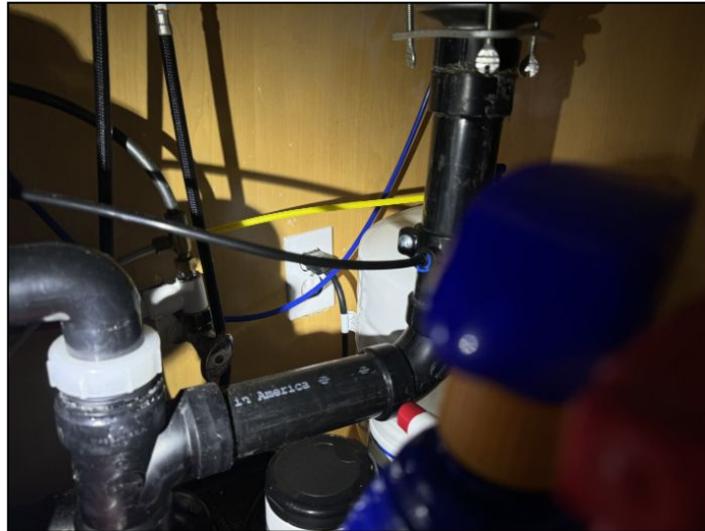
- Missing GFCI protection present in the kitchens at the time of the inspection. We recommend hiring a licensed electrician and installing GFCI protected receptacles for every outlet in the kitchen for safety and every outlet within 6 ft of water, including bathrooms, laundry and exterior.

no gfci

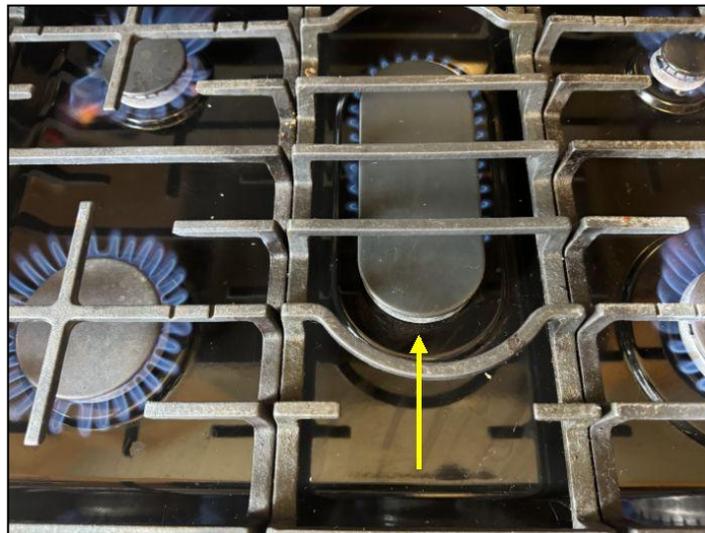
- Center burner on cooktop did not light all the way at the time of the inspection. Recommend remediation by qualified contractor.

central burner didnt light

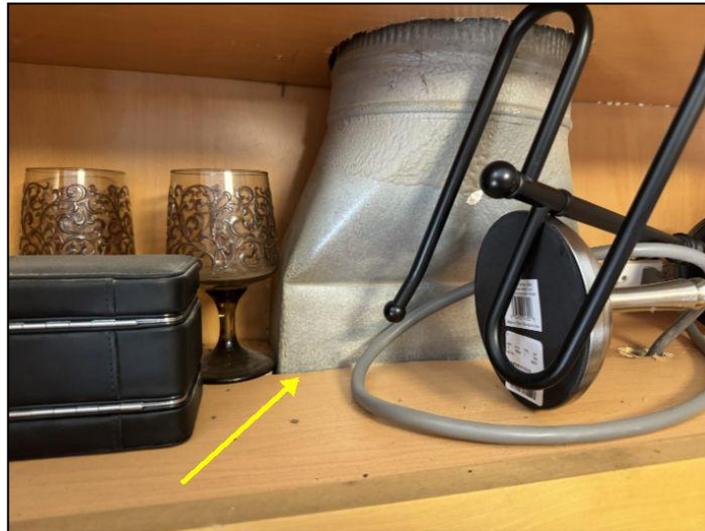
- Exhaust observed as leaking into the cabinet at the time of the inspection. Recommend remediation by qualified contractor to seal vent appropriately.

air escaping

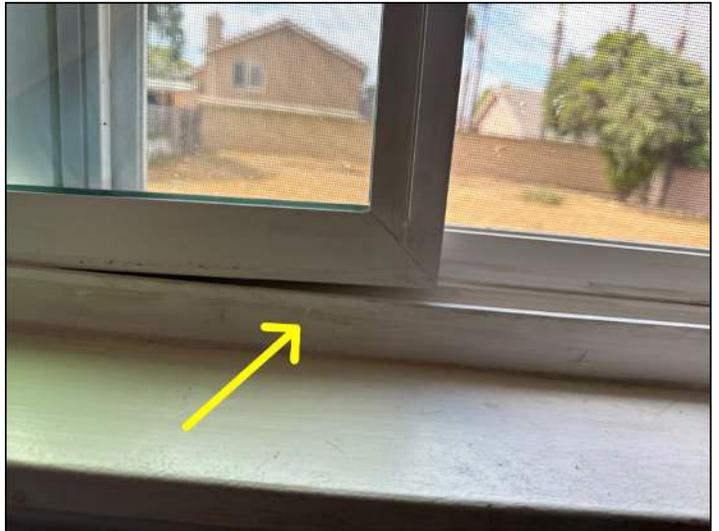
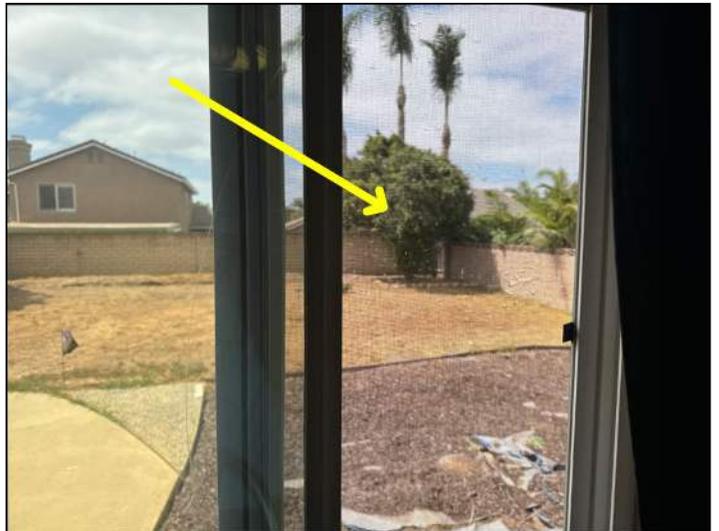
- Damaged screens observed.
- Window observe, loose on tracks at the time of the inspection recommend servicing of windows by qualified contractor
- Broken glass observed in kitchen window at the time of the inspection. Recommend mediation by qualified contractor.

Broken glass

Damage the screen

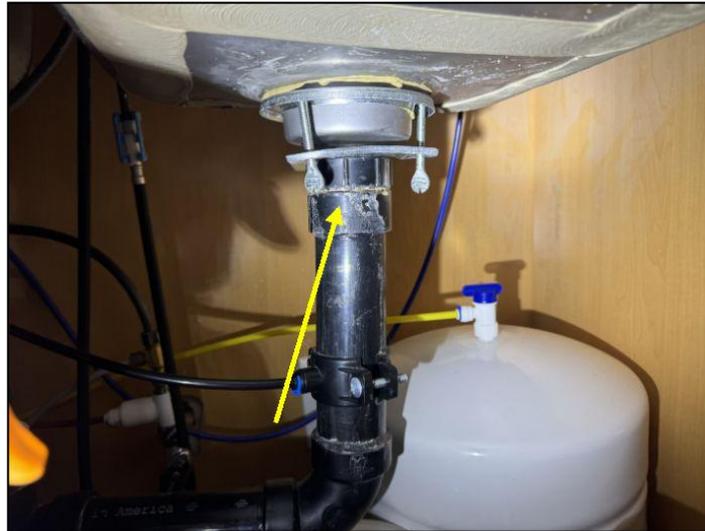
- Signs of corrosion on plumbing under the sink at the time of the inspection. Recommend remediation by licensed plumber.

corrosion kitchen sink

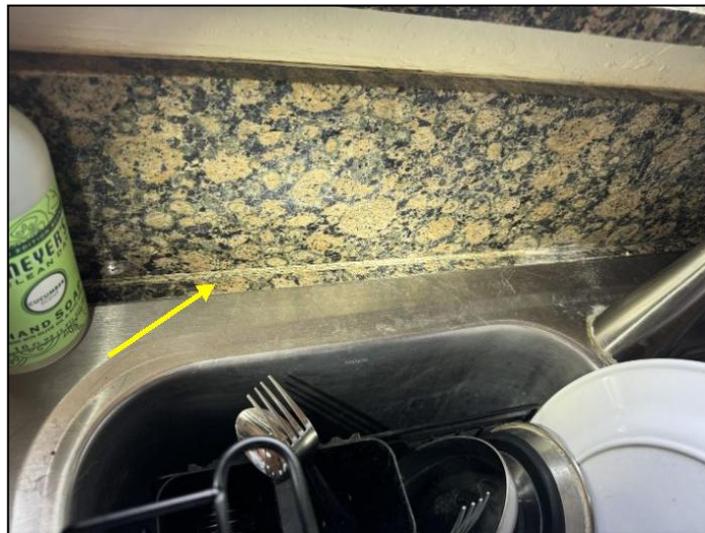
- Cracking observed in caulking/grout behind the sink at the time of the inspection. Recommend correction to prevent additional water intrusion.

crack in caulking

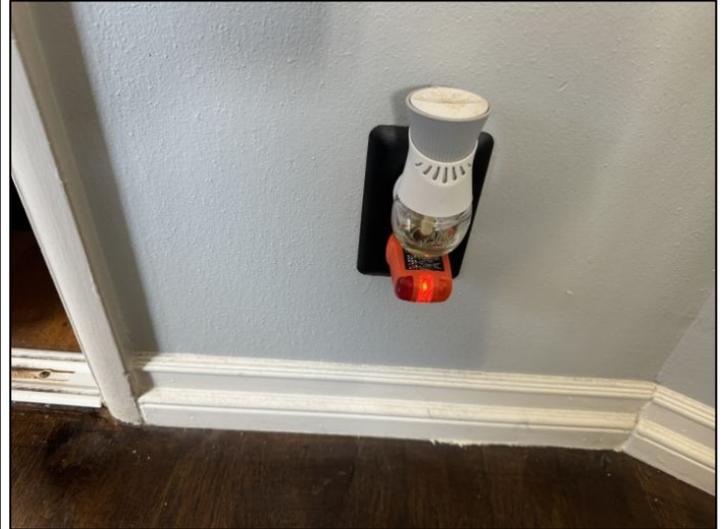
open ground outlets

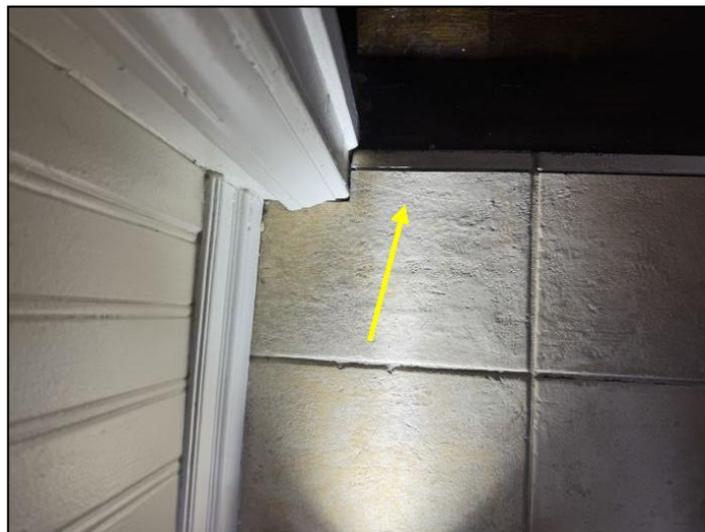
- Cracks observed in bathroom floor at the time of the inspection. Recommend further evaluation/remediation by qualified contractor to determine cause and fix as appropriate.

crack in tile

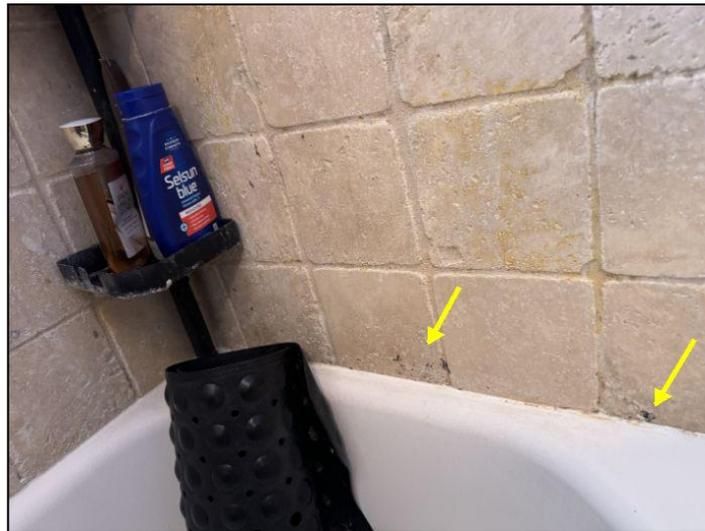
- Suspected microbial growth observed in the shower at the time of the inspection. Recommend removal and replacement of all dirty caulking to maintain effective water seal. Recommend qualified professional evaluate and remediate.

suspected microbial growth

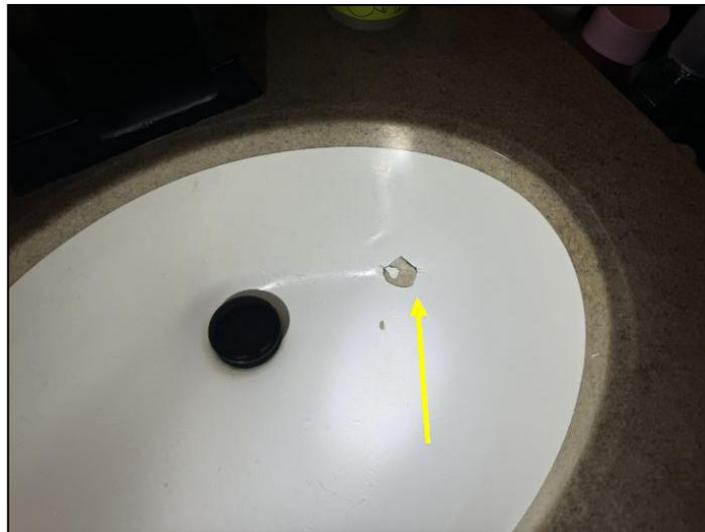
- Crack in sink observed at the time of the inspection. Recommend licensed professional remediate.

damage to sink

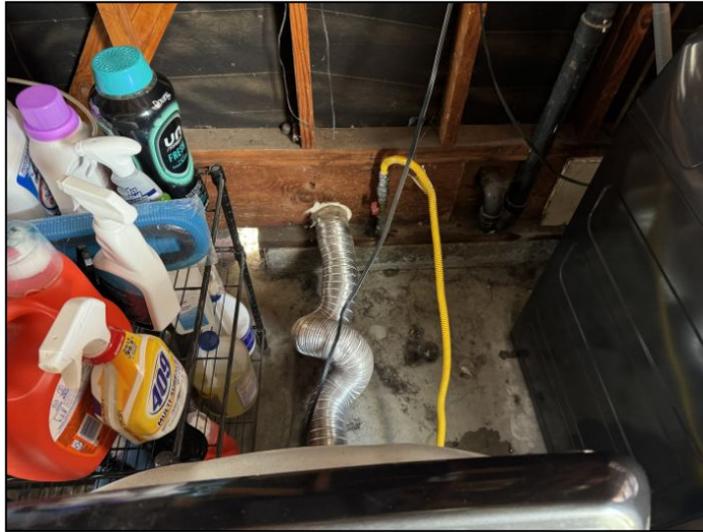
- Flexible transition dryer vent observed behind the dryer at the time of the inspection. These are allowed as transition ducts connecting the dryer to the exhaust at 8ft or less. Recommend awareness regarding the fact that flexible transition ducts can get smashed and kink when moving the dryer. A clogged or kinked dryer vent can be a fire hazard. Therefore, we recommend being aware when moving dryer and having dryer vent cleaned as appropriate to allow for proper venting. We recommend evaluating replacing flexible vent with solid to prevent any clogging/fire issues.

flex vent

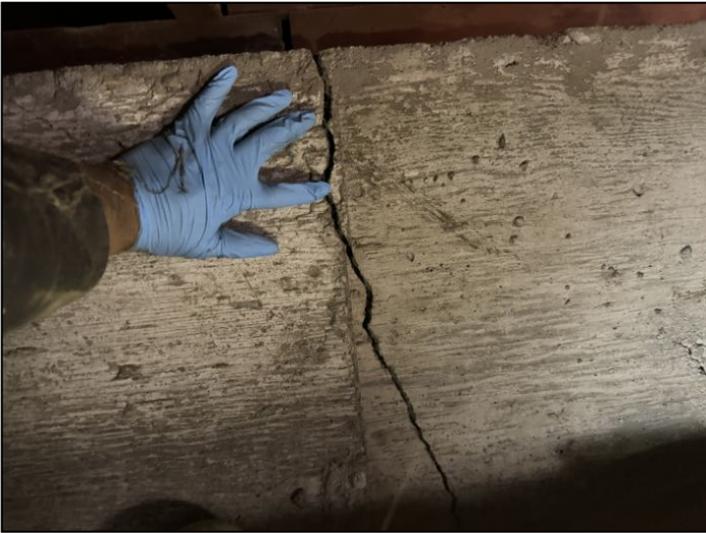
crack in foundation wall (running through crawlspace)

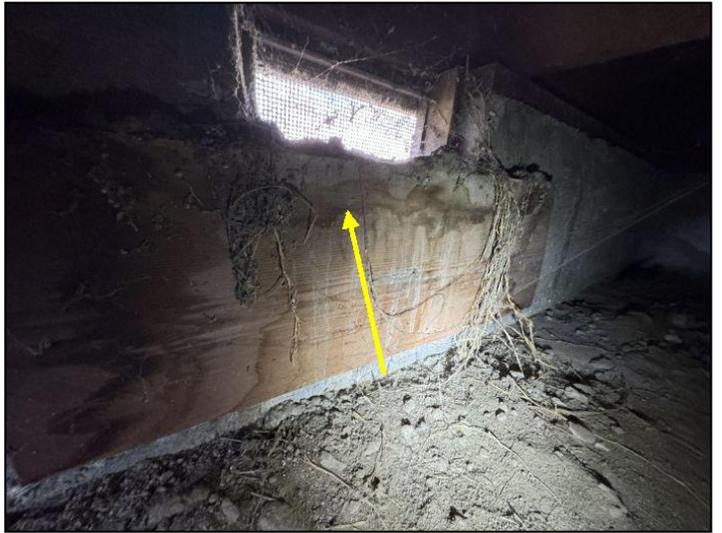
moisture intrusion at vent

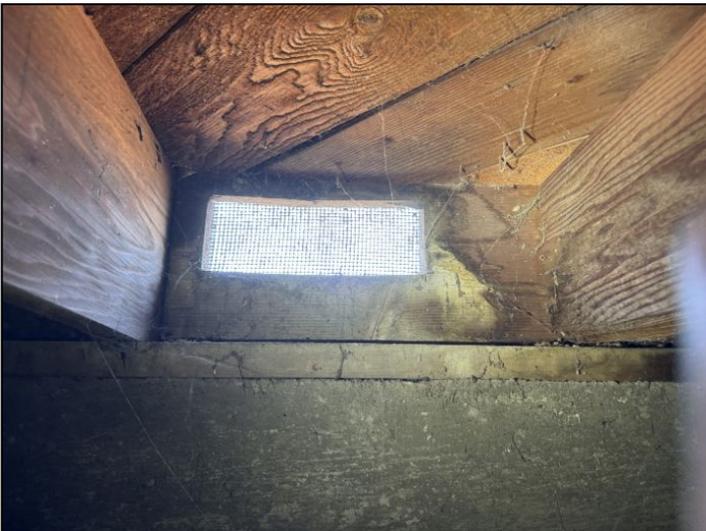
moisture front of house - see "grading"

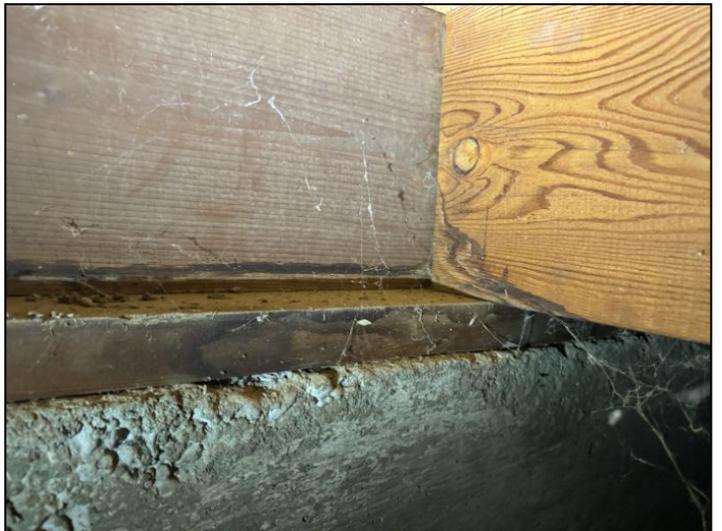
moisture front of house- see "grading"

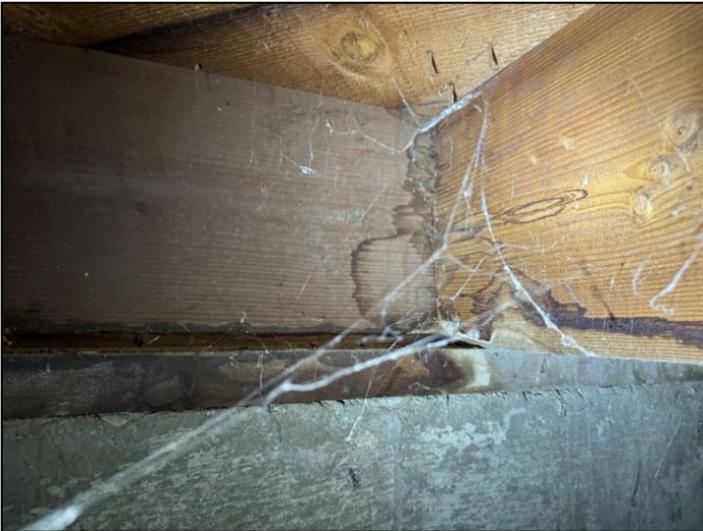
moisture -front of house - see grading

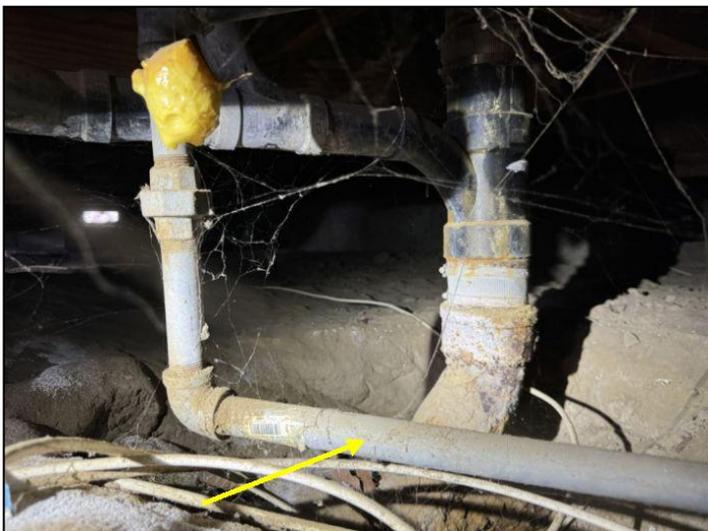
gas line at floor level

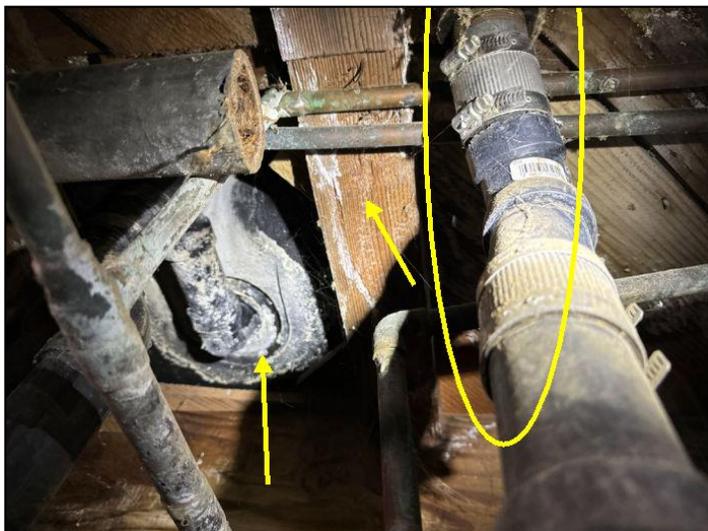
moisture intrusion/plumbing patchwork

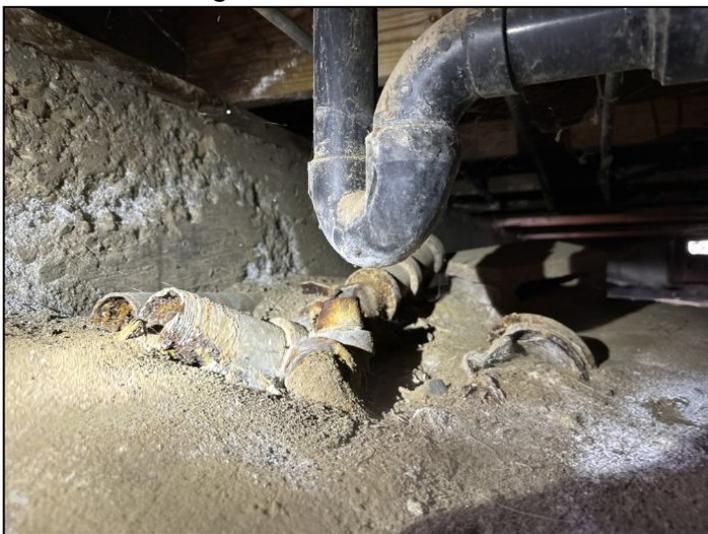
abandoned cast iron pipes

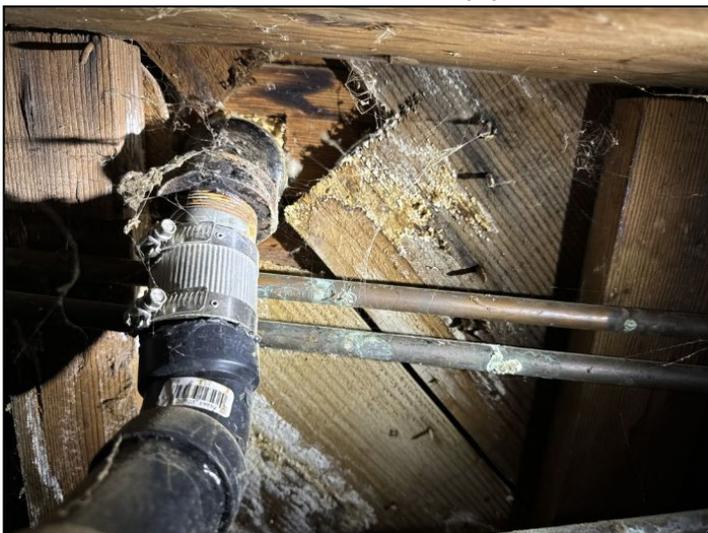
drain patchwork/possible microbial growth
