Confidential Inspection Report

, Oxnard , CA

Date of Inspection: 9/1/2025 Time: 10am

***BEST COAST
HOME INSPECTIONS***

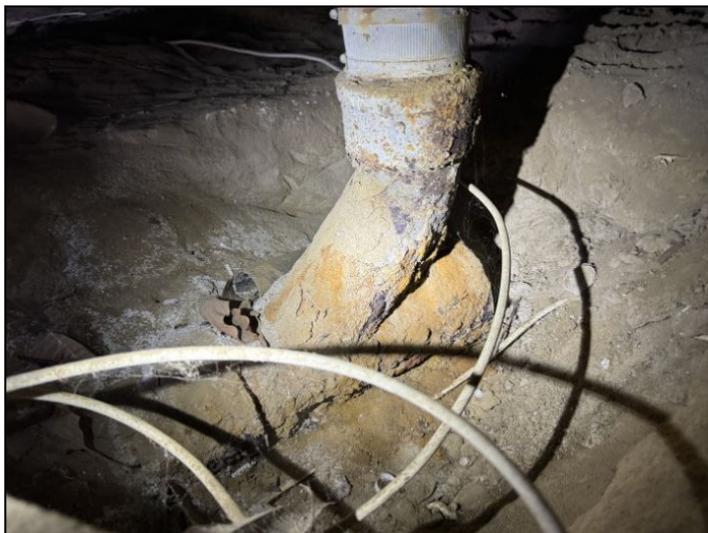
rusted cast iron drain

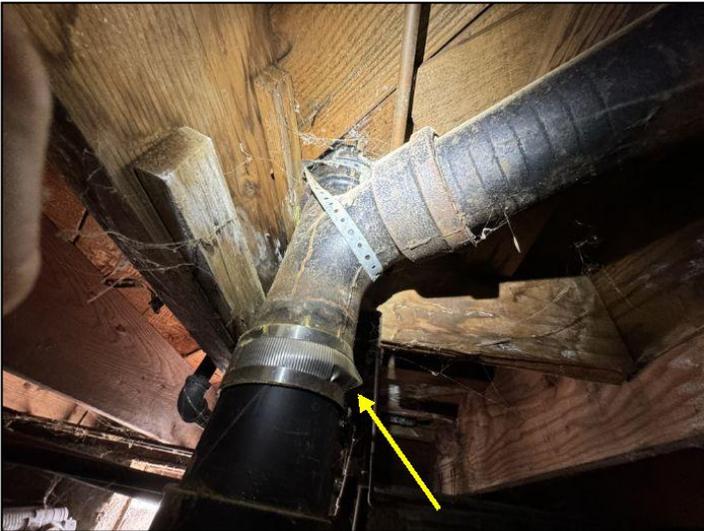
- Damaged/buckled connection observed to drain line at the time of the inspection. Recommend remediation by licensed plumber.
- Rust observed on the gas lines at the time of the inspection. A degree of surface rust is normal, recommend having plumber assessing plumbing further evaluate gas line rust and installation for safe use.

buckled connection

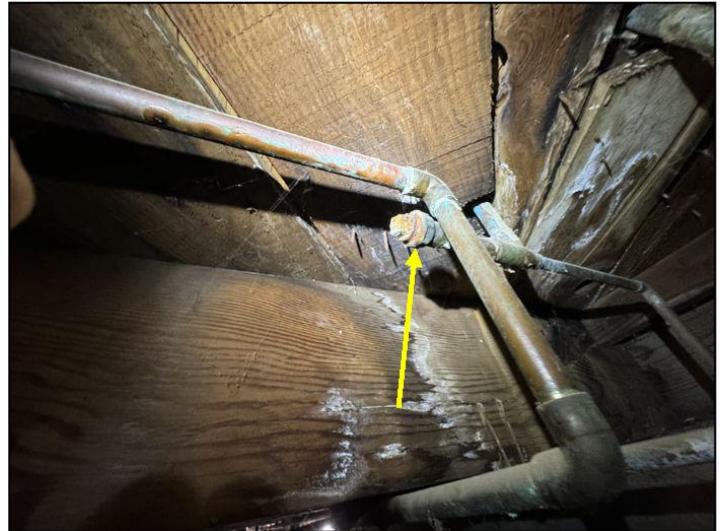
- Corrosion/deterioration observed to both the copper water line and the drain line at the time of the inspection. Recommend remediation by licensed plumber.

corrosion/rust to water line

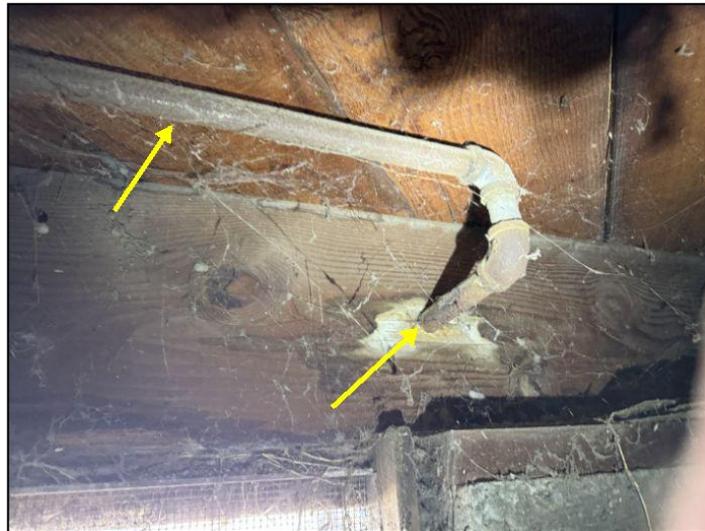
moisture/rust on gas line- entry point

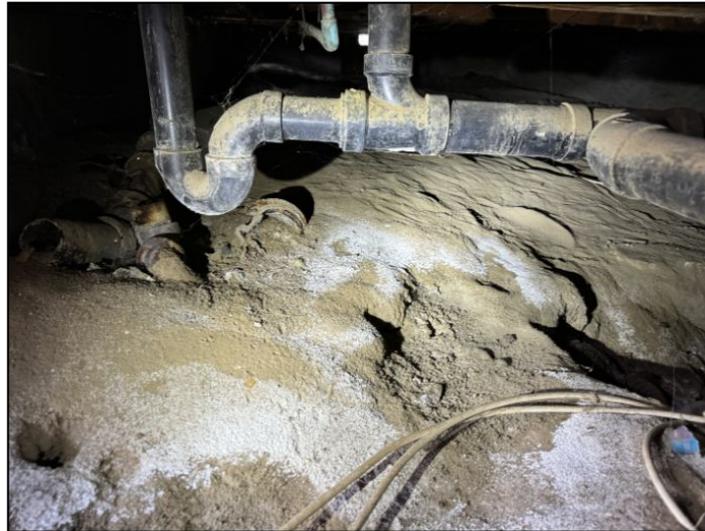
- Evidence of past moisture intrusion in the crawlspace at the time of the inspection. See "grading". Recommend monitoring moisture settlement and maintaining all moisture flow away from the foundation.
- Efflorescence observed to the ground under the crawlspace indicating moisture at the time of the inspection. Recommend further evaluation and remediation by qualified contractor.

significant moisture intrusion. efflorescence

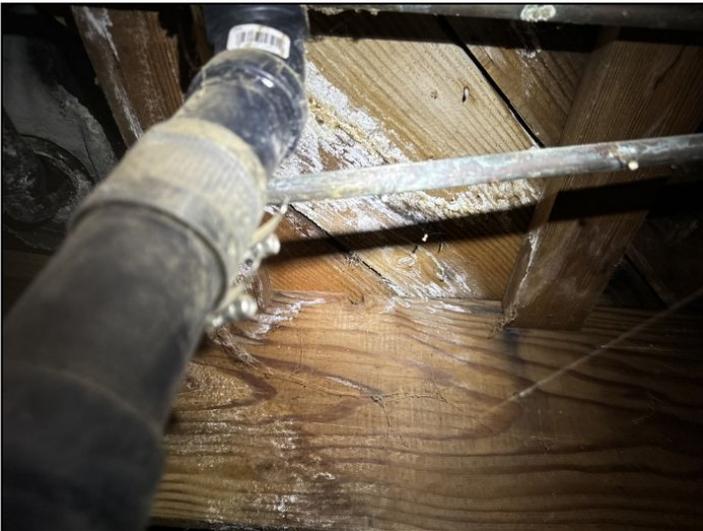
- Moisture intrusion and possible microbial growth observed on the underside of the flooring at the time of the inspection. Recommend further evaluation and remediation by qualified contractor.
- Active moisture intrusion observed as "wet" at the time of the inspection. Recommend further evaluation and remediation by qualified contractor.
- Signs of possible wood pest at the time of the inspection. Recommend qualified pest contractor evaluate.

moisture intrusion/possible microbial growth

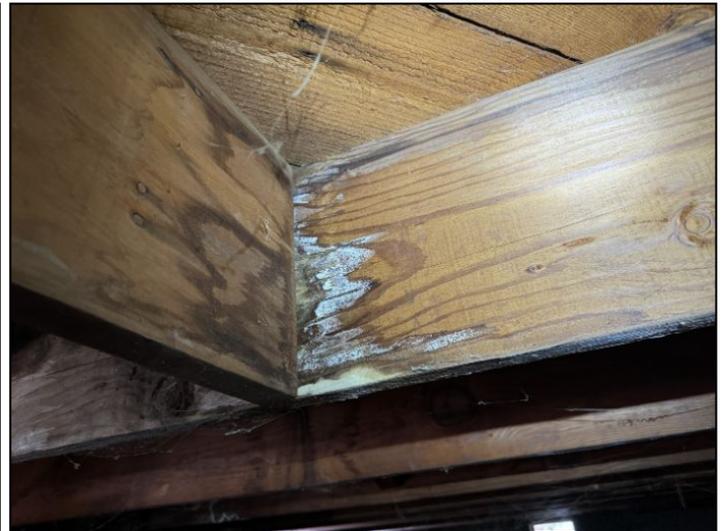
moisture/possible growth

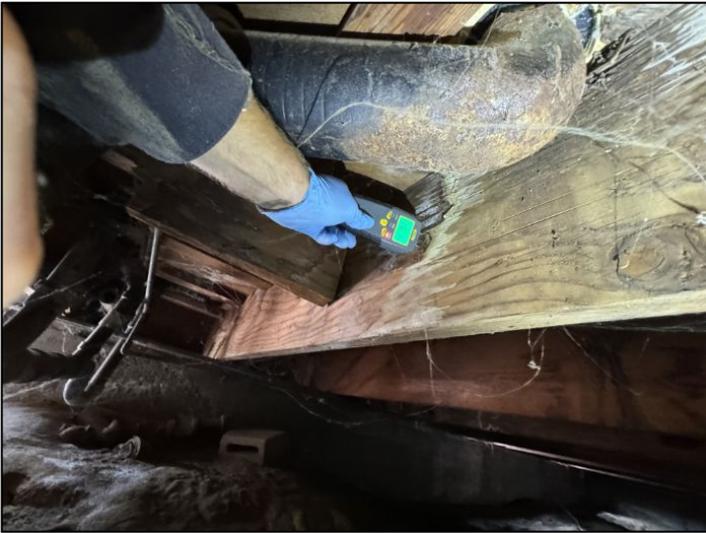
high moisture reading

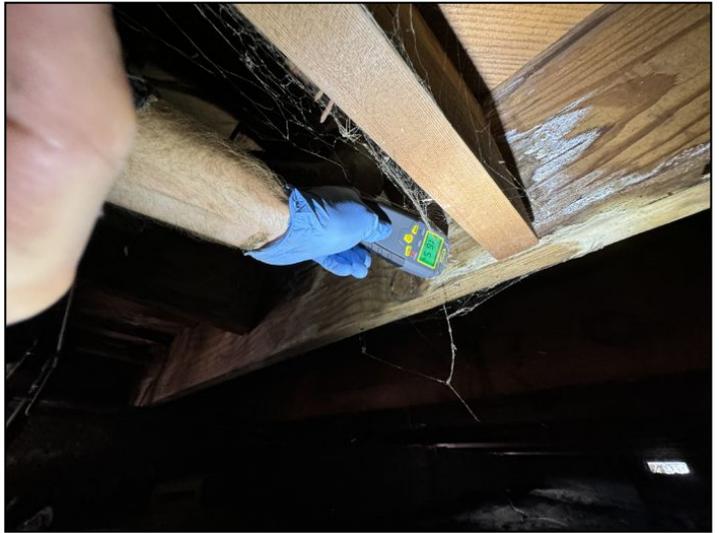
high moisture reading

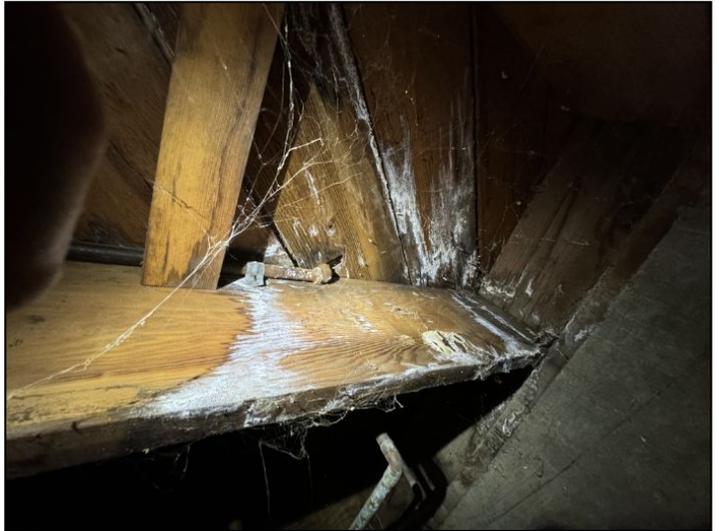
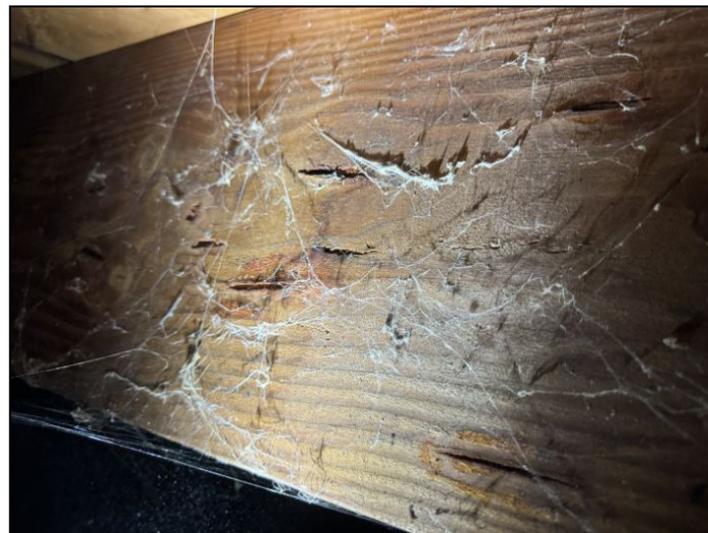
possible pest

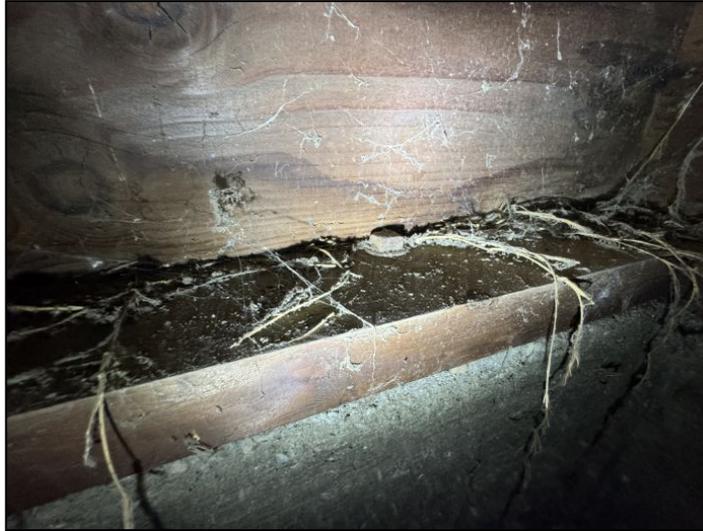
- Original anchor bolts observed with round washers at the time of the inspection. Due to the upgrades over time and the CA risk of earthquake, recommend further evaluation by qualified foundation contractor on the need to seismically upgrade the foundation/framing.

anchor bolts
