BEST COAST HOME INSPECTIONS

Confidential Inspection Report

VENTURA CONDO , Ventura , CA 930003

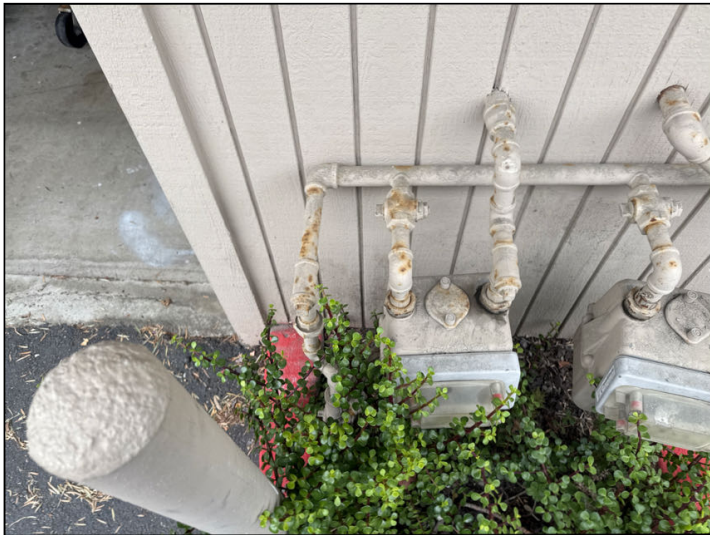
- Main gas meter observed without the addition of an earthquake prevention device. Recommend installation of device to shut of gas in the event of an earthquake.
- Mild rust observed on the main gas valve at the time of the inspection. Recommend monitoring and gas company remediate to prevent further rust/deterioration.

main gas valve

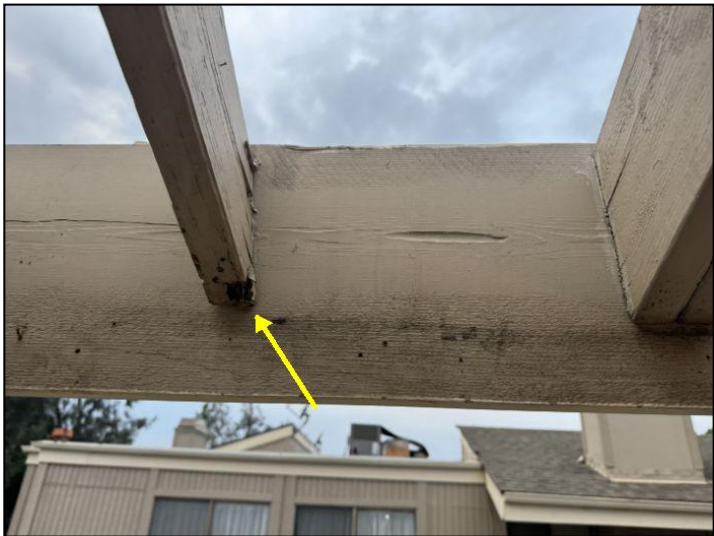
- Damage to exterior of structure observed at the time of the inspection. Cracking/gaps and possible signs of wood destroying insects observed. Recommend contacting HOA regarding all exterior damages and maintenance.
- Possible organic growth observed on patio at the time of the inspection. Recommend remediation by qualified contractor.

possible pest damage

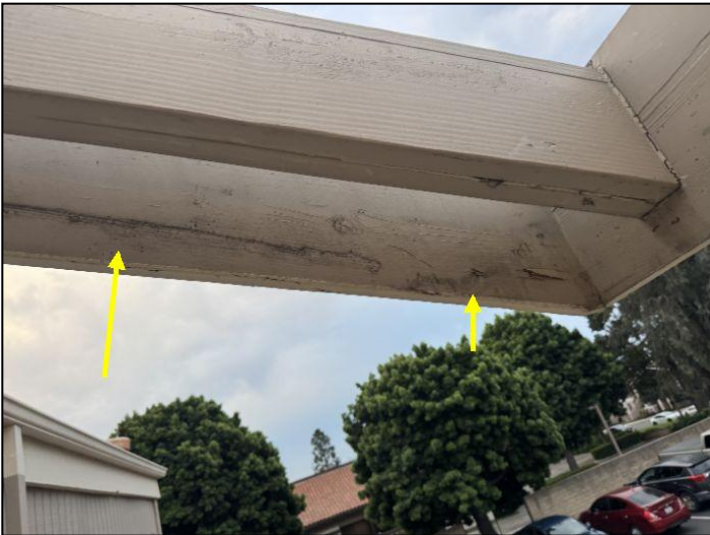
possible organic growth

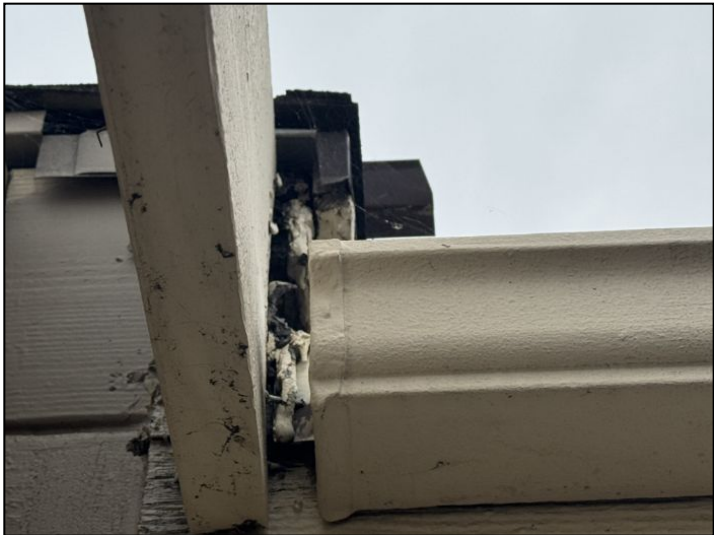
damage

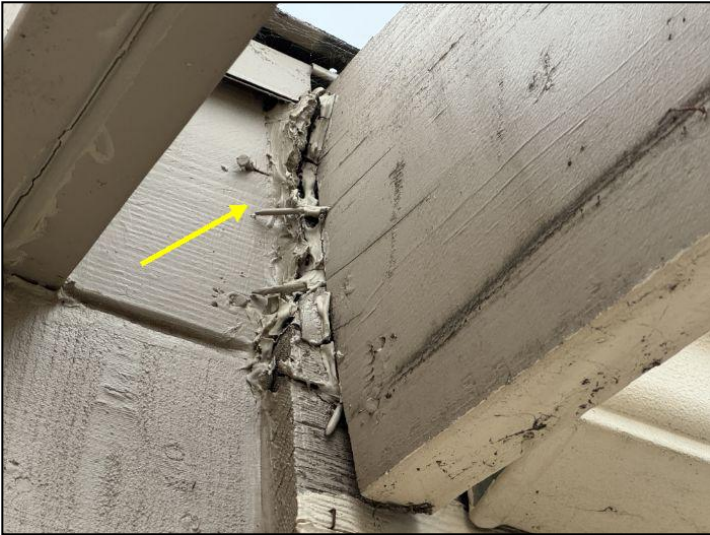
improper fix

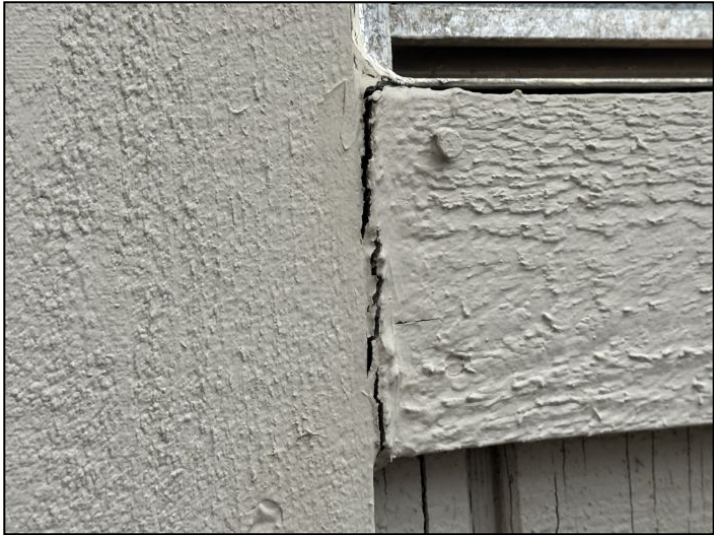
seal all gaps and cracks

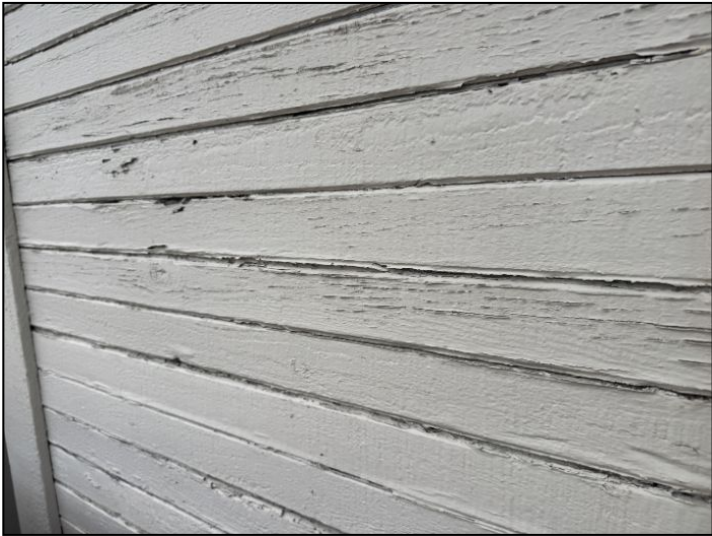
exterior chimney wood damage

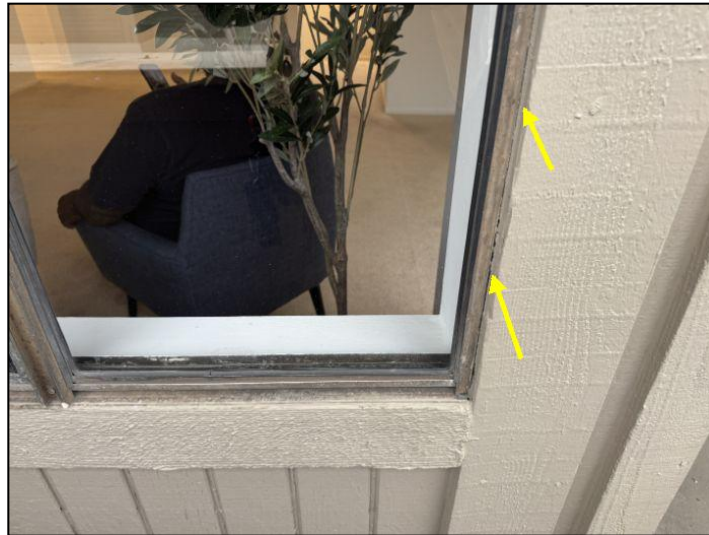
- Split caulking observed around window trim. Suggest sealing/caulking as part of routine maintenance to prevent moisture and pest intrusion.

seal around windows

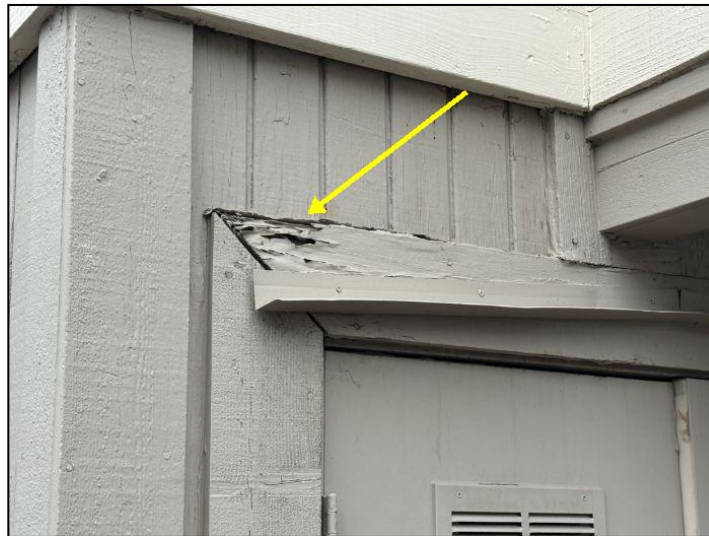
possible wood destroying insects/moisture damage

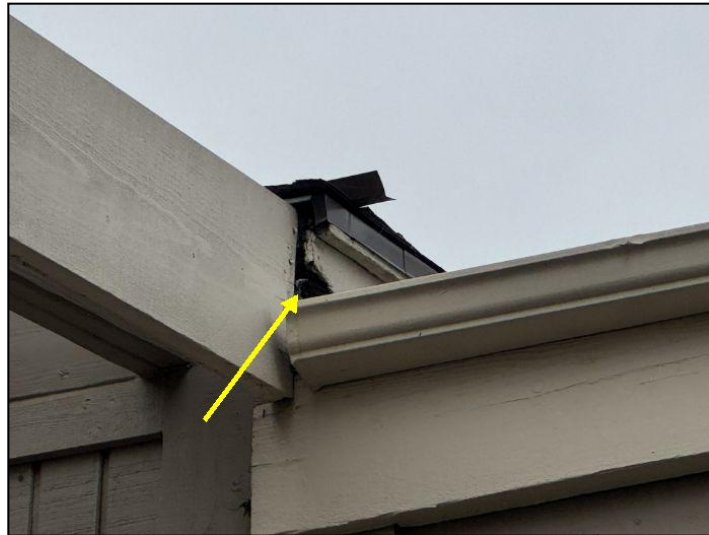
- Damage to patio rafter and under eaves observed at the time of the inspection. Recommend evaluation and remediation by licensed contractor.

rot/wood damage above patio

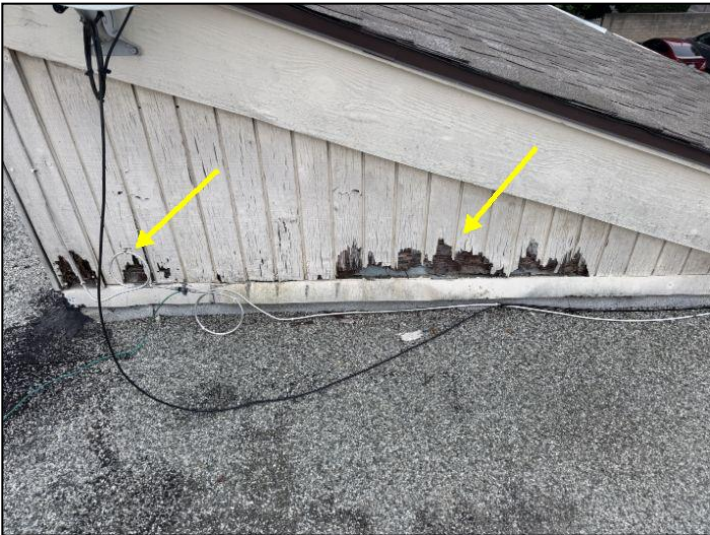
- Shingles worn down exposing the fiberglass observed at the time of the inspection. This is a sign the roof is showing wear and tear that can affect the roof's functional life. Recommend evaluation and remediation by licensed and insured roofing company.
- Damage to siding on roof at the time of the inspection. Wood rot and possible wood destroying pest observed. Recommend remediation by licensed and insured contractor.
- Missing gravel and excessive sealant observed on the roof at the time of the inspection. Recommend reviewing HOA maintenance and previous work. Recommend licensed and insured roofer remediate as appropriate.

significant damage on roof

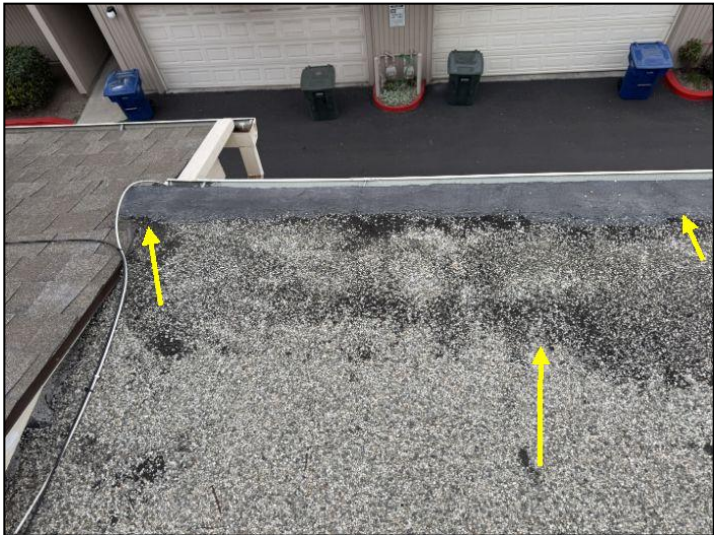
excessive sealant and missing gravel on roof

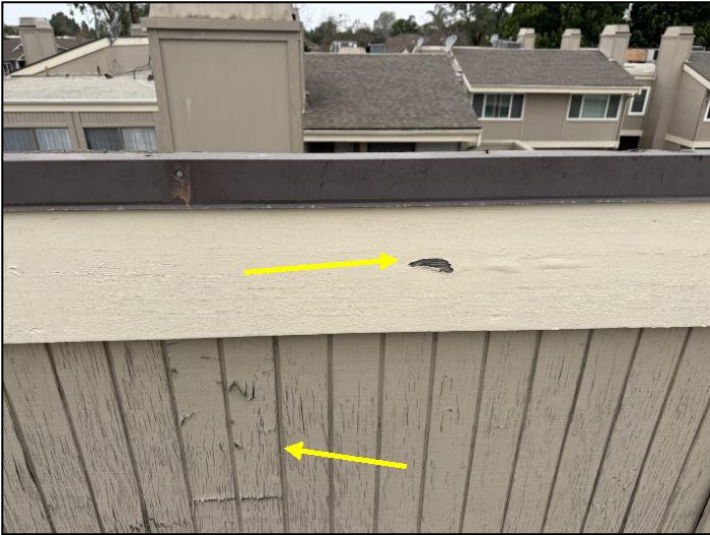
damage

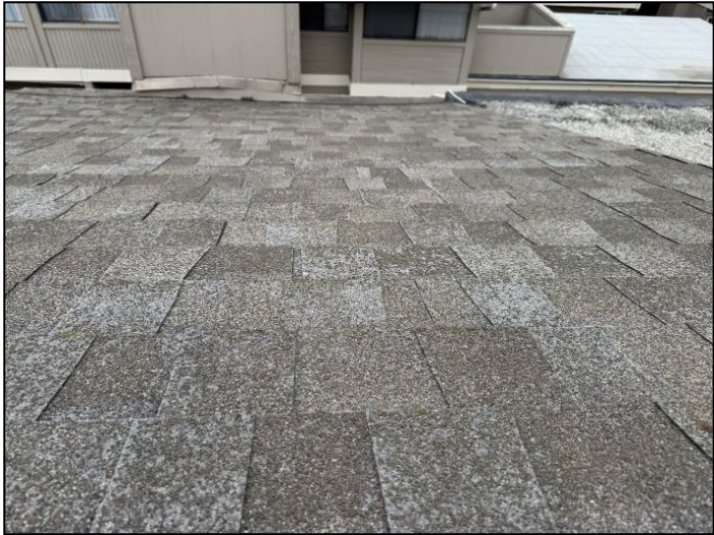
exposed fiberglass

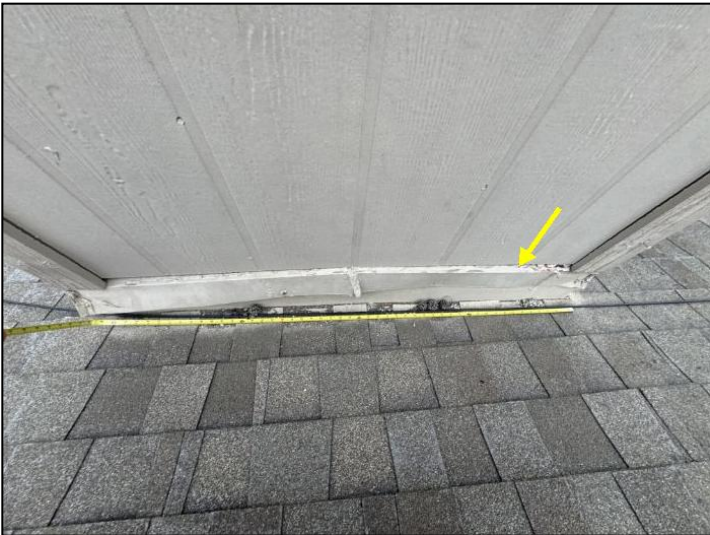
- The chimney was observed as being without the application of a cricket flashing at the time of the inspection. A cricket is designed to keep runoff from pooling on the uphill side of the chimney. Recommend evaluation by a licensed roofing contractor for the addition of a cricket at the chimney.
- Flashing at base of chimney was observed as having some small gaps and holes at the time of the inspection. Recommend licensed and insured roofing contractor remediate to ensure a continued waterproof seal.

damage to flashing behind chimney-cricket recommended

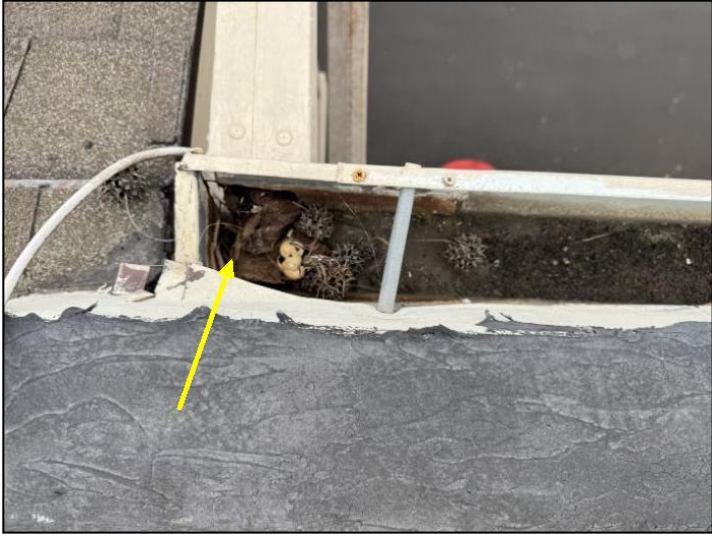
- Gutters full of organic debris at the time of the inspection. Gutters play an important role in diverting water away from the building. Recommend remediation to improve gutter function.

debris

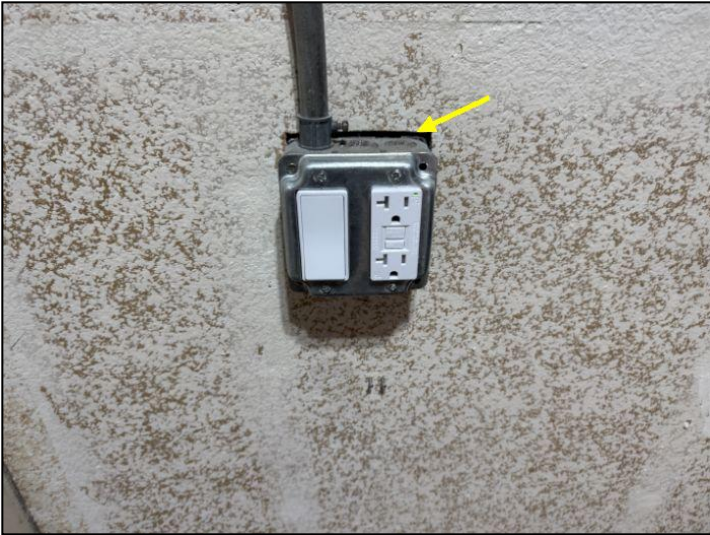
- The common wall between the garage and home has damage or improperly covered areas at the time of the inspection. This is a defect. Fire potential to the home is at a greater risk as most home fires originate in the garage. Recommend further evaluation and remediation by repairing all gaps, cracks and openings to insure a proper firewall between to home and the garage. Recommend qualified contractor remediate.

gap in firewall

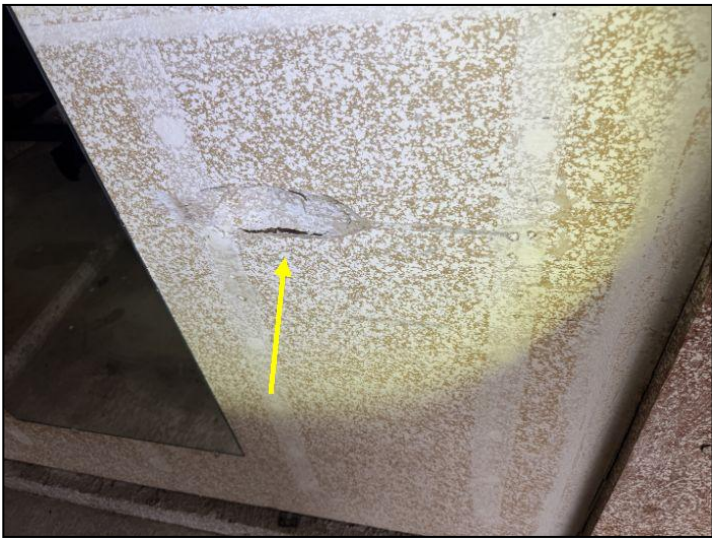
wall damage

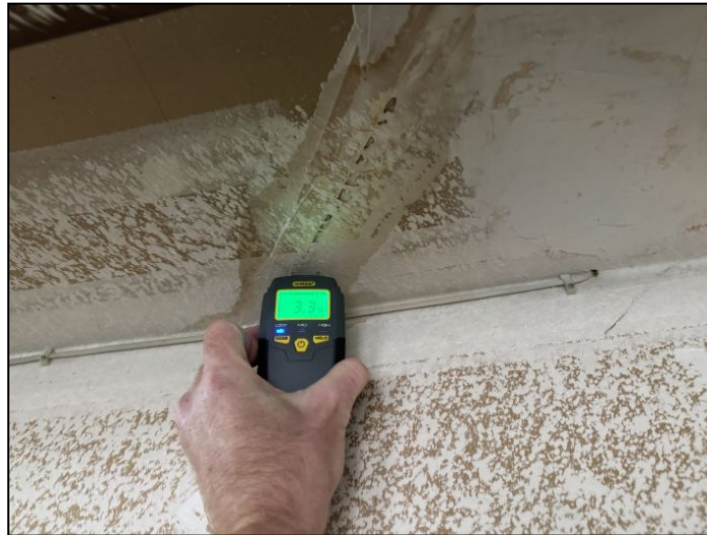
- Moisture stain observed in the ceiling of the garage at the time of the inspection. Indications of past or present leak, dry at the time of the inspection. Recommend review of disclosures regarding moisture stains and further evaluation/remediation by a licensed contractor as appropriate.

moisture staining in garage- low moisture at the time of the inspection.

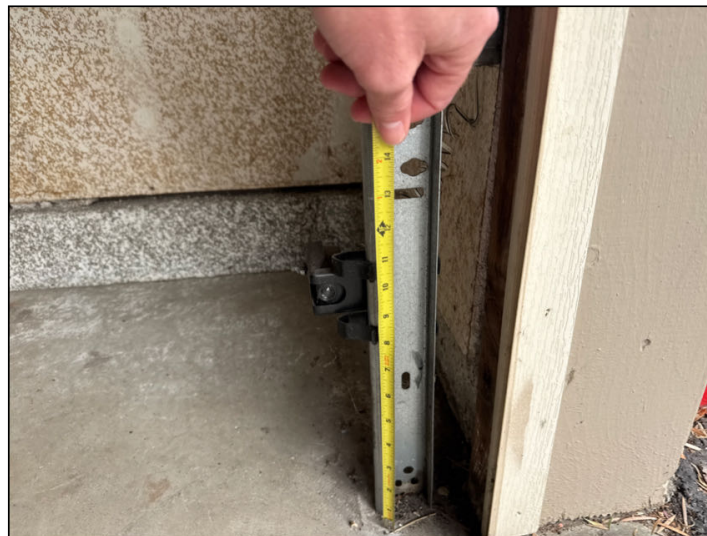
- Pressure sensor observed as function at the time of the inspection.
- Eye beam system present and operating at the time of the inspection.
- Reverse eye sensor, while functional at the time of the inspection was higher than the recommended 4 to 6 inches above the ground. Recommend remediation by qualified contractor.

too high

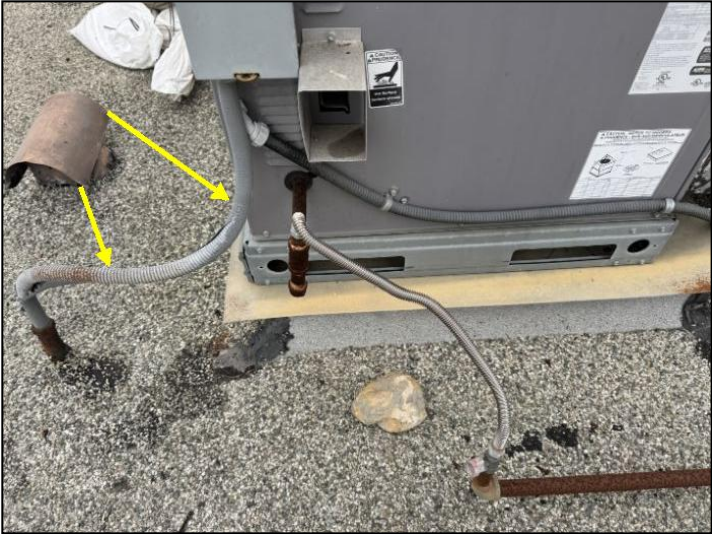
- Functional under normal operating controls at the time of the inspection.
- As indicated by the serial number, the furnace was manufactured in 2017.
- Electrical conduit feeding the roof top unit observed with damaged insulation/cover at the time of the inspection. Recommend remediation by licensed and insured contractor.

damage to electrical conduit

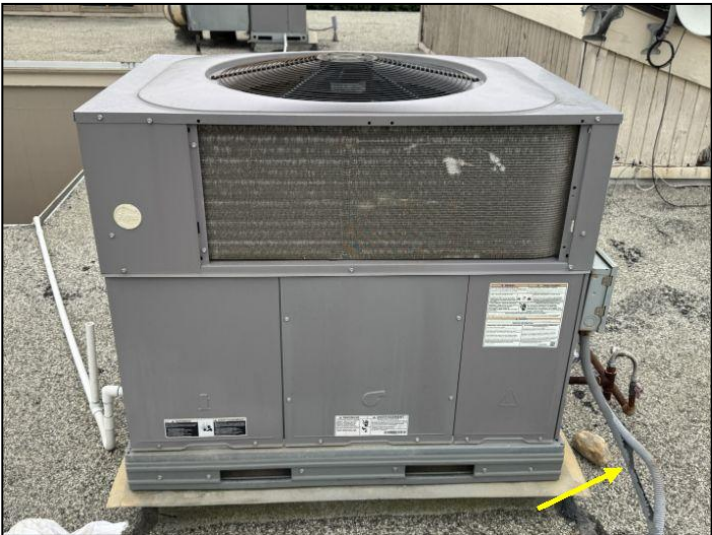
electrical conduit damage

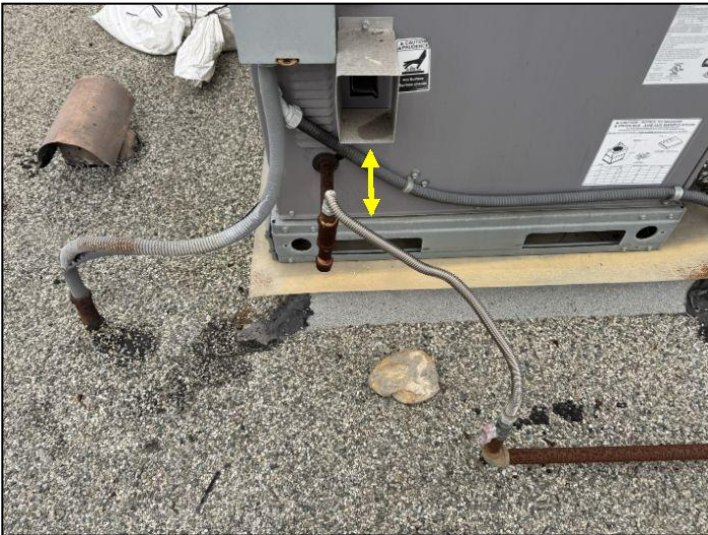
- Hot exhaust when heater in use expelling directly onto the flexible gas line below it at the time of the inspection. Gas heater exhaust contains corrosive combustion by products. Overtime, this heat and corrosion can weaken the flexible gas line, potentially causing leaks. Recommend remediation by licensed and insured HVAC contractor.
- Significant build up on gas lines and furnace at the time of the inspection. Recommend further evaluation and remediation by licensed and insured HVAC contractor to prevent any future gas leaks.

hot exhaust directly onto flex gas line

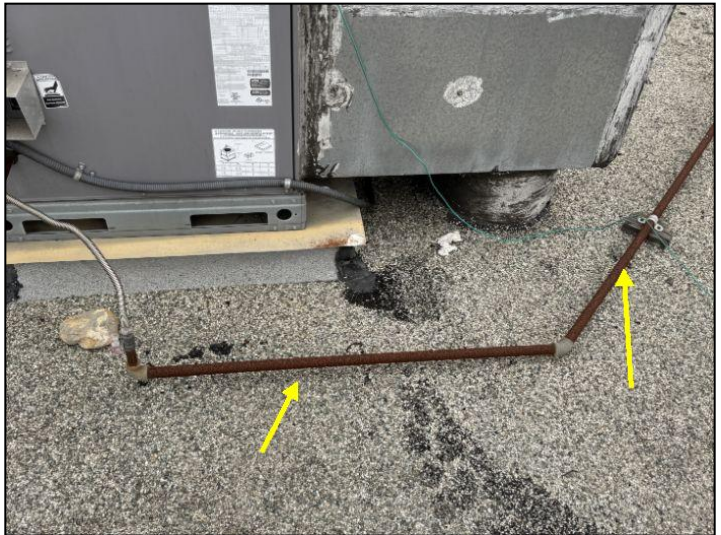
rust

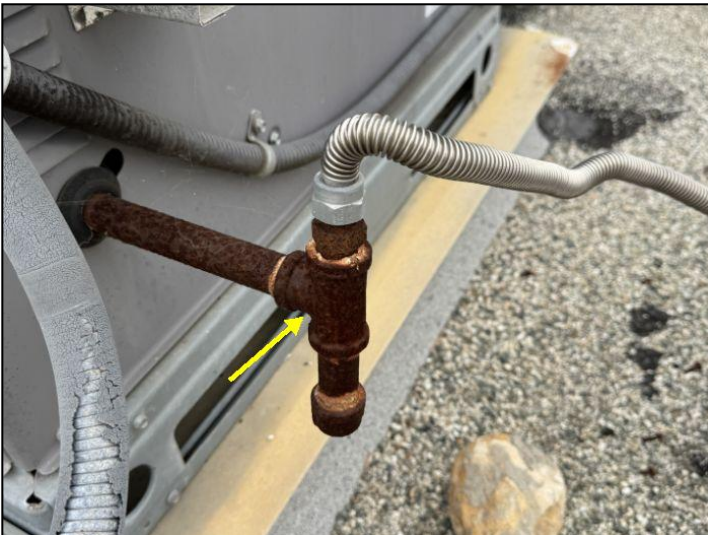
rust on gas line

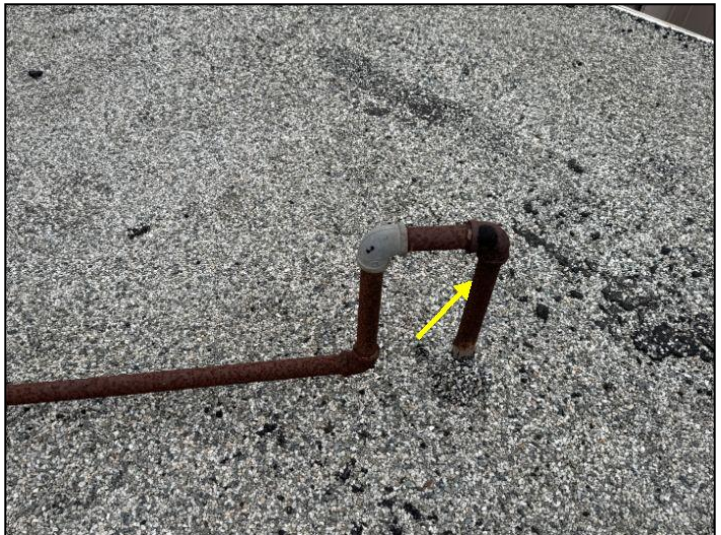
rust

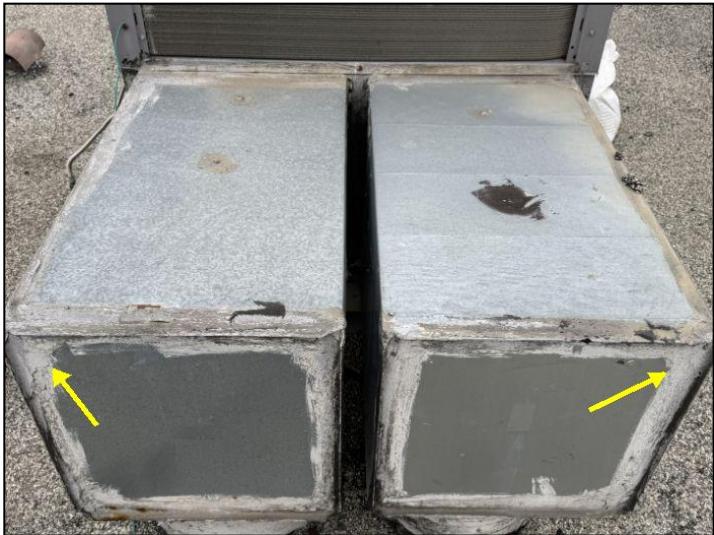
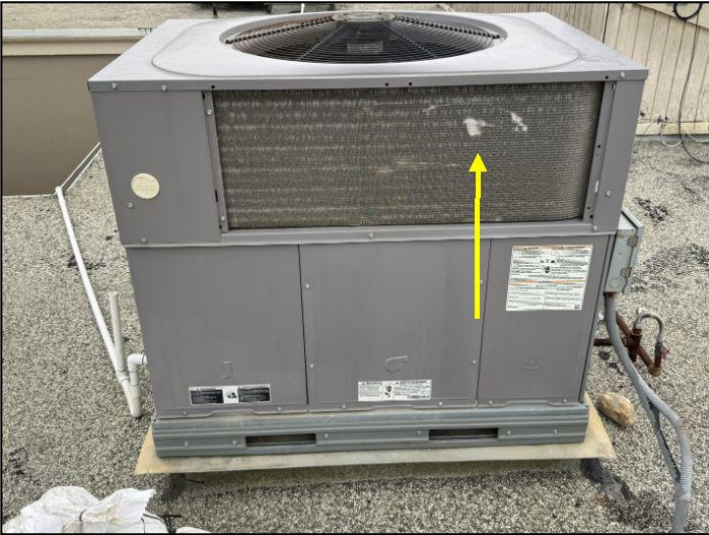
- Air conditioner not run on the day of the inspection as the temperature outside was less than 60 degrees. Recommend running cooling cycle under normal operating controls when weather permits before the end of escrow.
- Rooftop HVAC unit observed without a shut off nearby. Recommend the addition of a shut off for safely servicing the unit for maintenance. Recommend qualified contractor.
- Do to the number of defects and condition of the roof top package unit, we recommend having an HVAC contractor assess the unit as whole and service it for safety and function.
- Sealant on duct work observed as weathered and cracking at the time of the inspection. Recommend further review and remediation as appropriate by licensed HVAC contractor.
- Damage to the exterior of the unit observed at the time of the inspection. Recommend HVAC contractor evaluate/remediate.

damage to fins

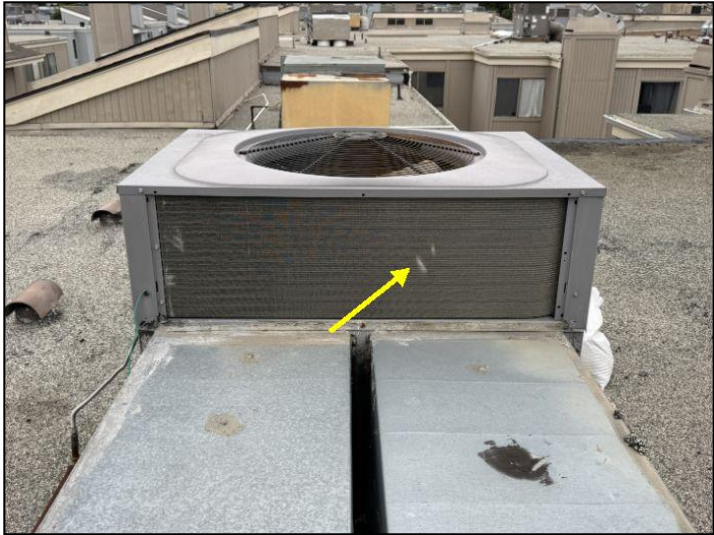
damage to fin observed

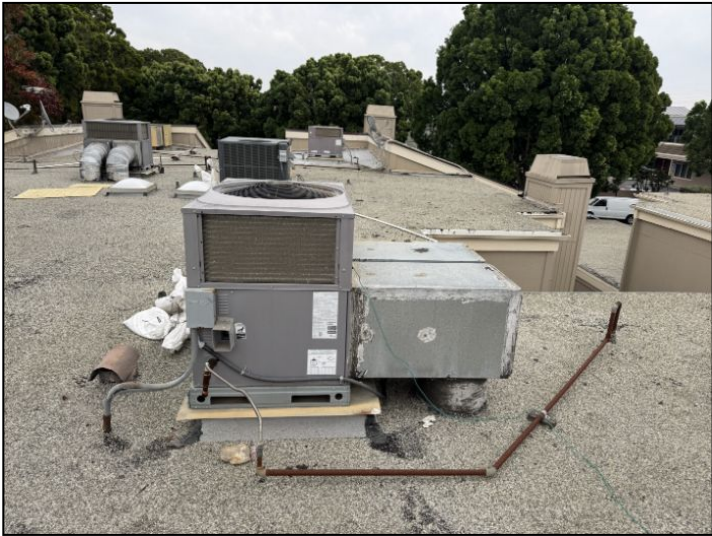
recommend review of unit as a whole by qualified contractor

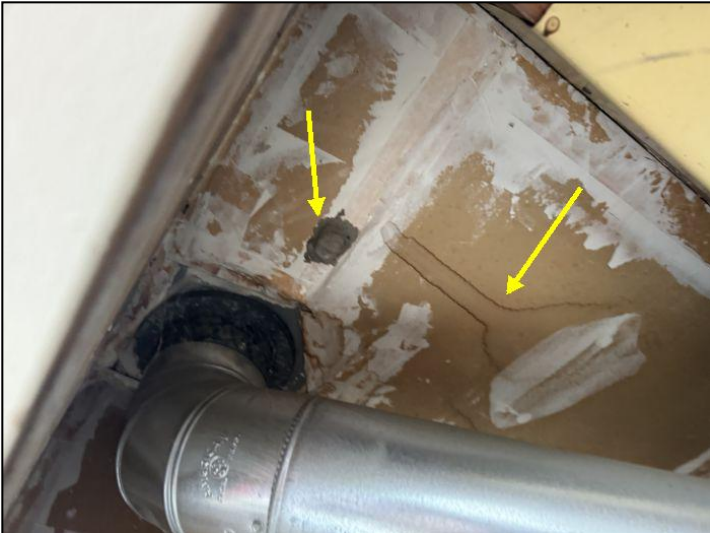
- Moisture staining at ceiling penetration observed at the time of the inspection indicating past or present leak. Recommend evaluation and remediation by qualified contractor.
- Pest nest observed in water heater closet at the time of the inspection. Recommend remediation as appropriate.
- Spiderwebs/debris in water heater closet at the time of the inspection. Recommend having all debris cleaned out of closets.

moisture staining/pest nest

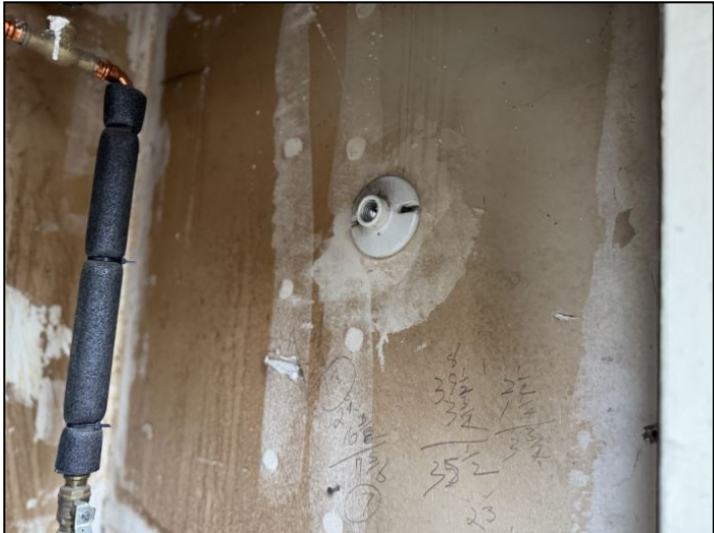
missing bulb

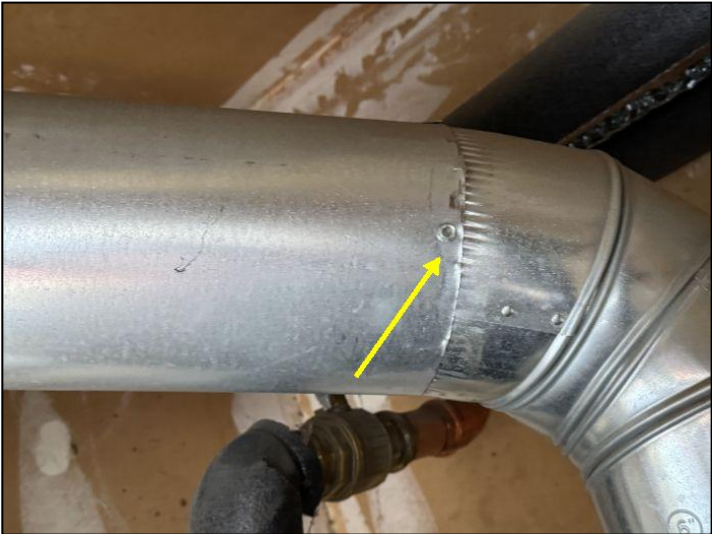
- Water heater vent observed as lacking appropriate fasteners at the time of the inspection. Recommend licensed and insured HVAC contractor remediate with the addition of at least 3 fasteners per connection point.

missing fasteners

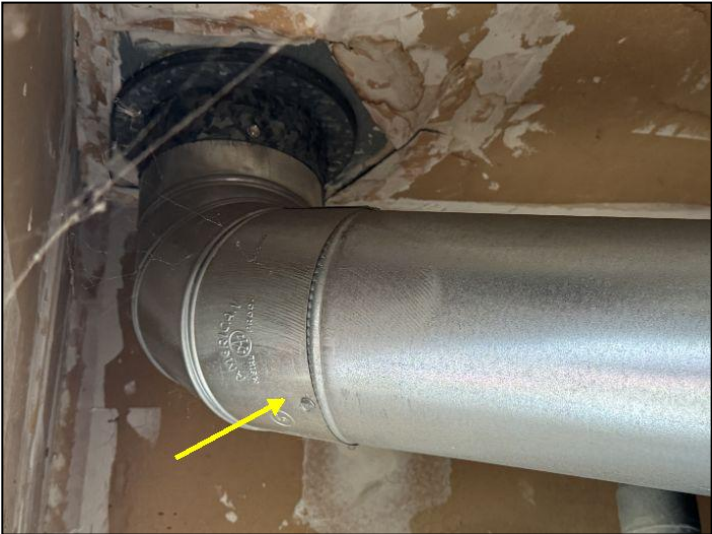
missing fasteners

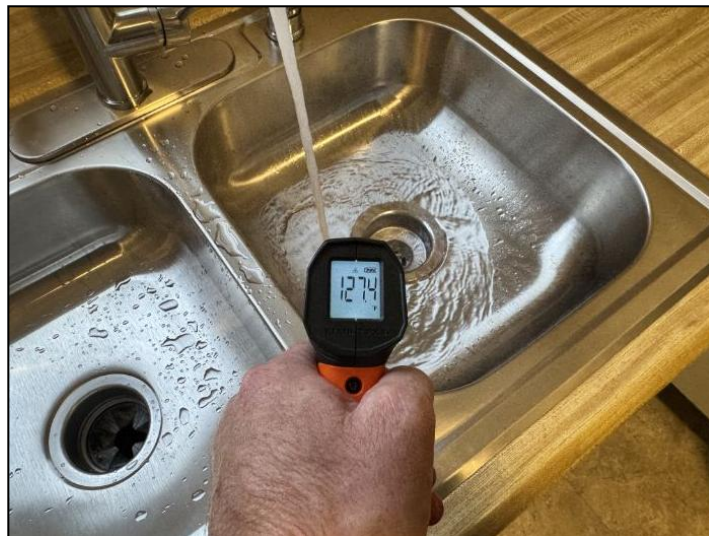
- Water temperature measured at 127.4 which is a scalding hazard. Recommend reduction of temperature to 120 to prevent scalding.

127.4 too hot

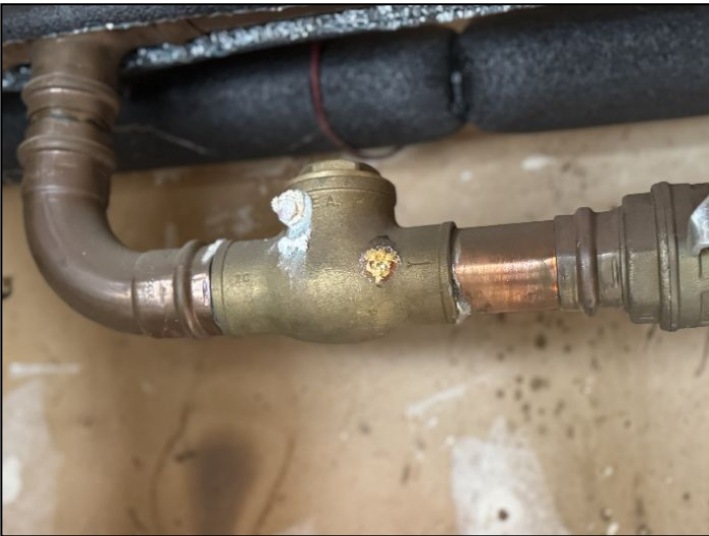
- Corrosion observed on water line connection on the top of the water heater at the time of the inspection. Recommend hiring licensed and insured plumber to remediate to prevent further corrosion.

Corrosion

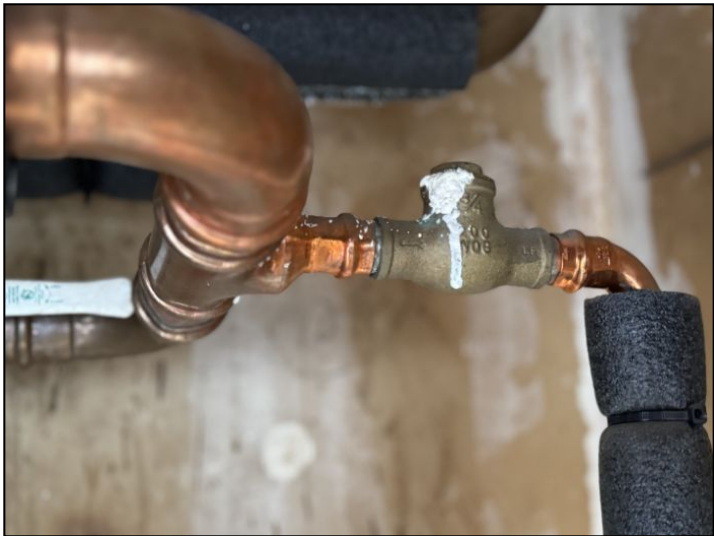
corrosion

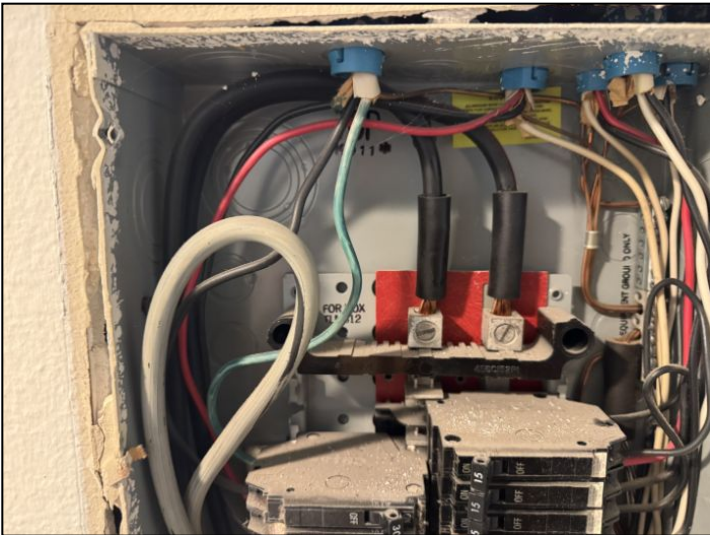
- Multi-Wire branch circuit observed in the panel at the time of the inspection. When two separate breakers share a neutral is it necessary to tie the breaker handles together. Recommend further evaluation and remediation by qualified electrical contractor.
- White neutral conductor re identified with green at the time of the inspection. This is defect as green can only be used for ground. Recommend licensed electrician label the now green conductor with red or black and additionally on the AC unit side.
- Debris observed in the electrical panel at the time of the inspection. Recommend licensed electrician clean panel of all contaminates.
- Loose attachment screw for dead front cover for electrical panel observed at the time of the inspection. Recommend remediation by licensed electrician for securing panel cover.

multi branch circuits

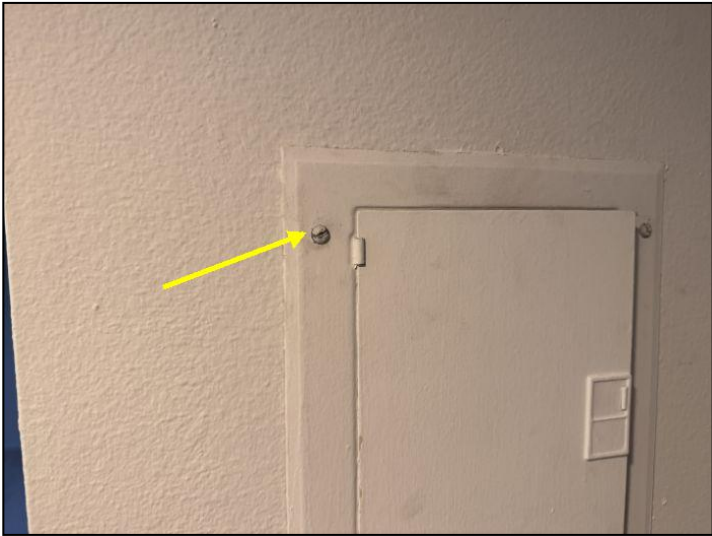
loose screw

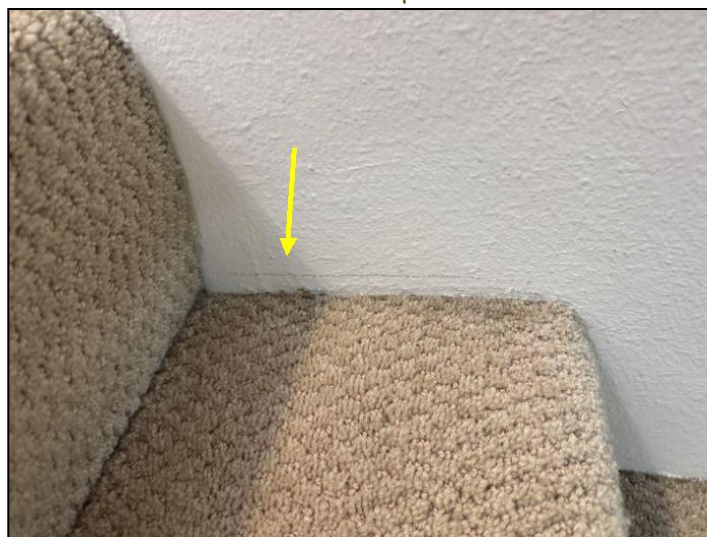
- Markings on wall throughout house from the installation of carpet.

marks from carpet installation

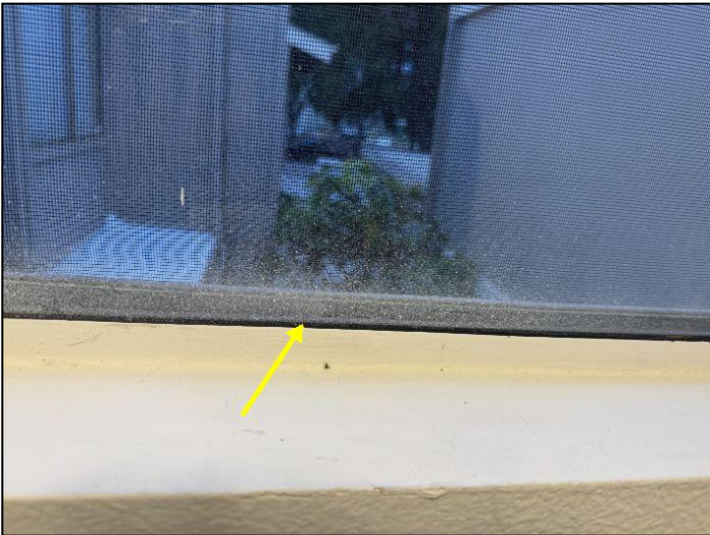
- Paint over spray observed on multiple windows at the time of the inspection. Recommend remediation by qualified contractor.
- Damaged screens observed.

overspray

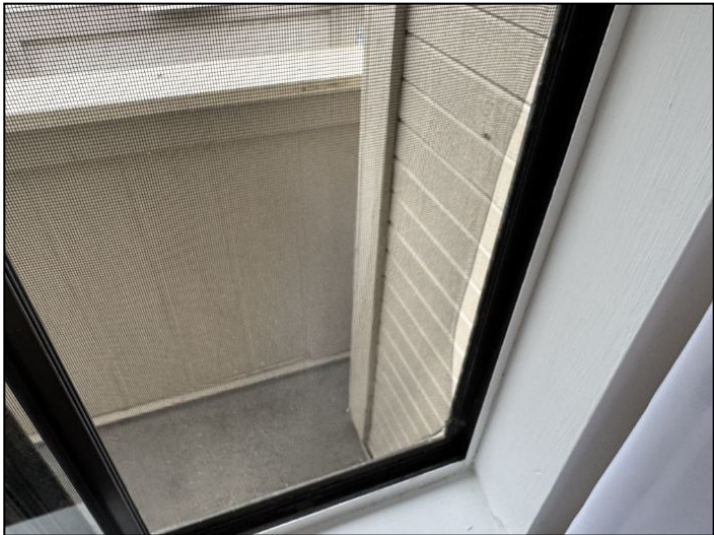
broken screen

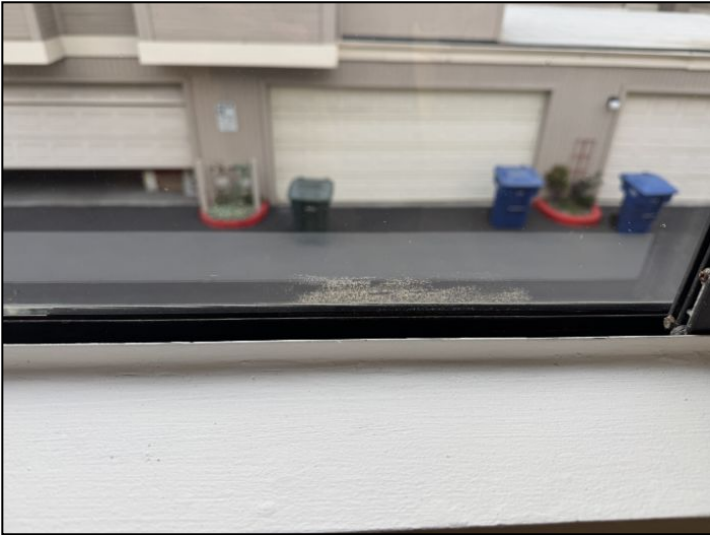
overspray on windows

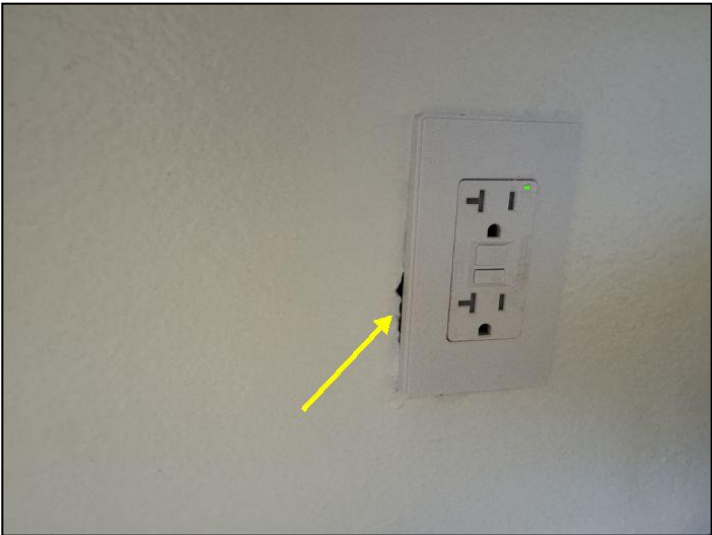
- Loose outlet cover observed at the time of the inspection. Recommend having all outlet covers tight against the wall. Recommend remediation by licensed electrician.
- One or more outlet covers observed as installed with slight gaps. Recommend installation of covers and outlets without any gaps. Recommend licensed electrician remediate.

gap around outlet

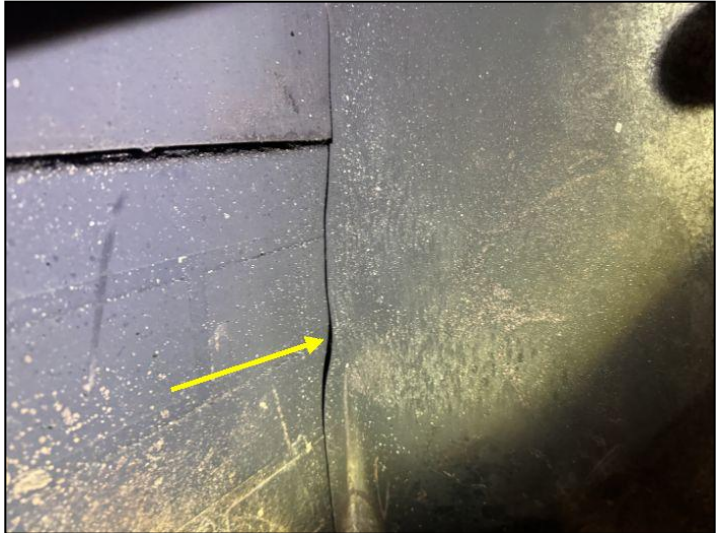
- Bend in metal wall of fireplace observed at the time of the inspection. Recommend review and remediation as appropriate by licensed professional.

bend on right side

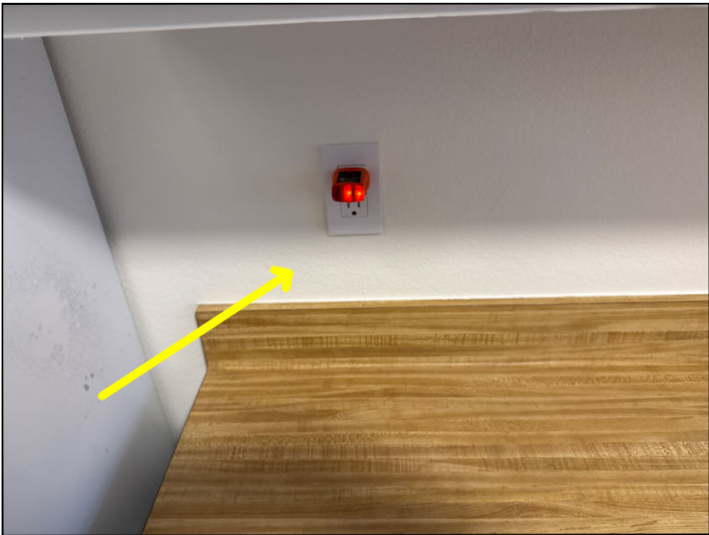
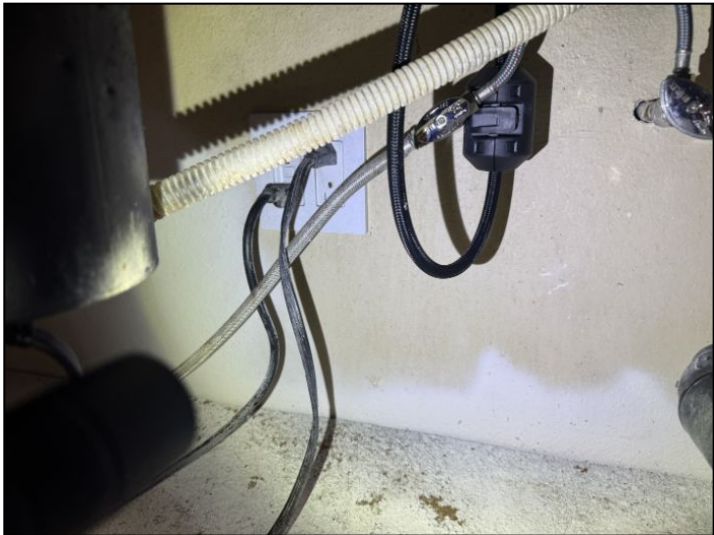
- Missing **GFCI** protection present in the kitchens at the time of the inspection. We recommend hiring a licensed electrician and installing GFCI protected receptacles for every outlet in the kitchen for safety.
- Missing GFCI protection observed in the kitchen sink at the time of the inspection. For safety, we recommend licensed electrician replace all outlets in the kitchen with GFCI protection to prevent electrical hazard.

recommend GFCI under sink

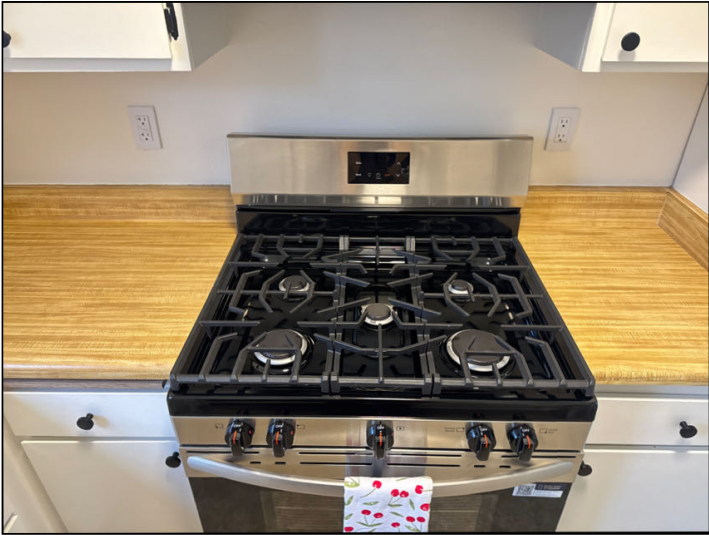
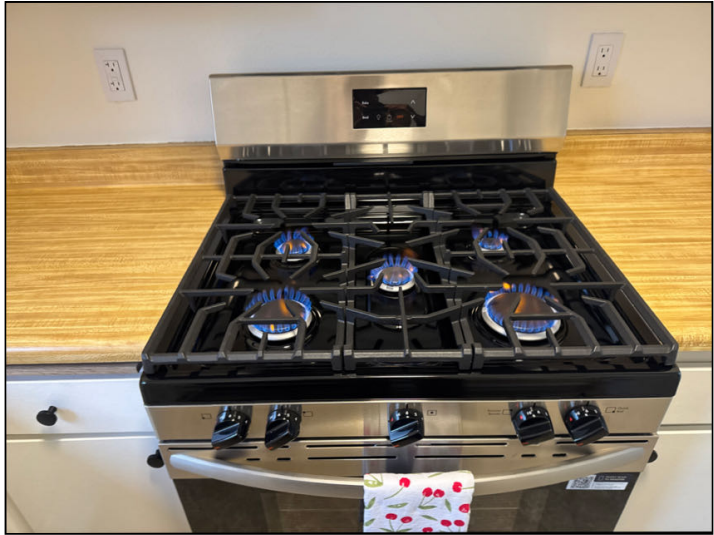
- Observed as functional at the time of the inspection.
- Oven observed as missing anti-tip bracket and was not fastened to the floor at the time of the inspection. This is a safety defect. All free standing, slide in ranges include an anti-tip device essential for safety of use. Recommend a qualified contractor secure range so it cannot tip over.

No anti-trip

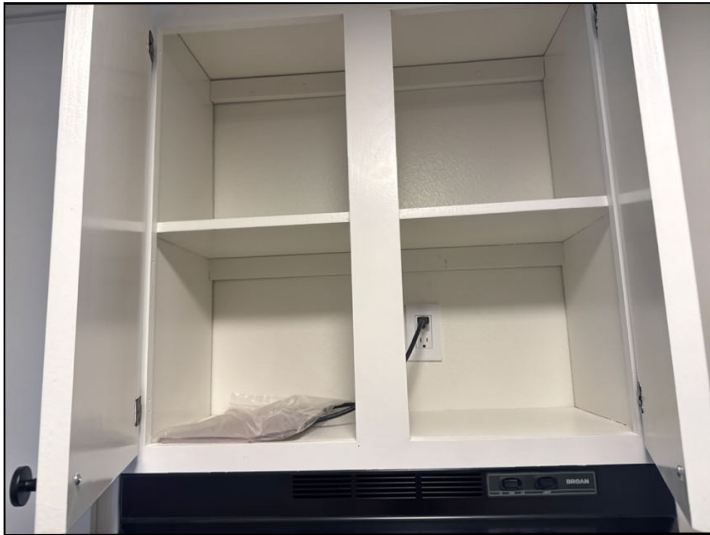
- No vent in kitchen at the time of the inspection. Recommend evaluation of the addition of a vent to the exterior to exhaust kitchen fumes.

No vent

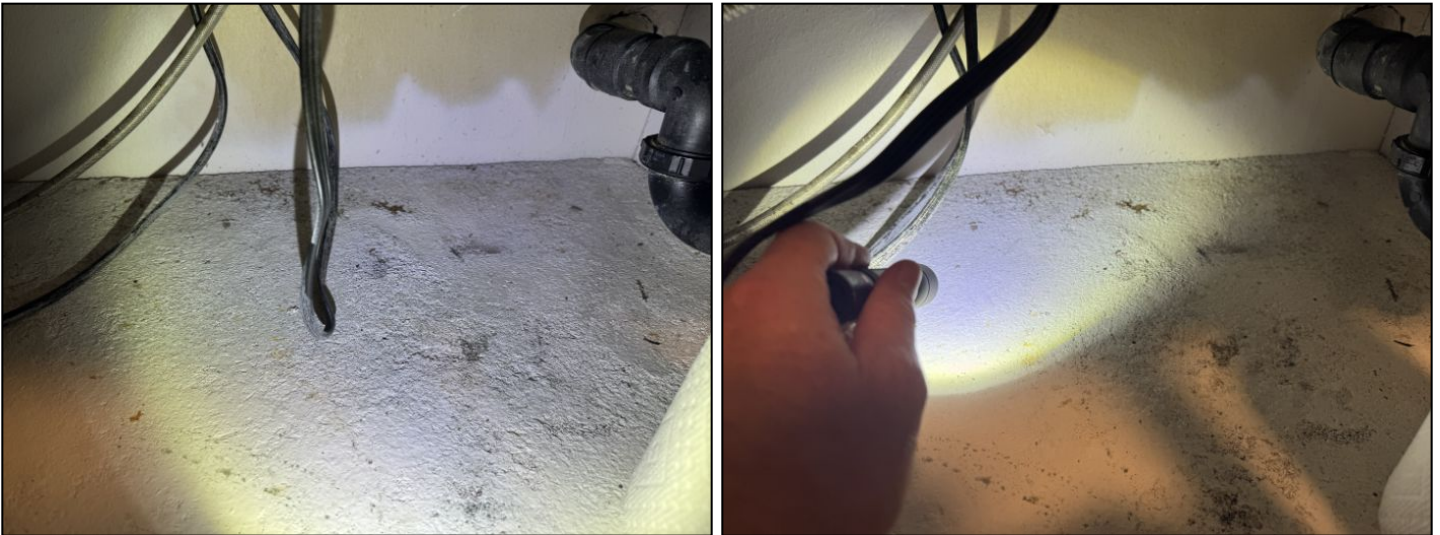
- Stains at sink cabinet floor, possible microbial growth. Dry at the time of the inspection.

aged under sink/past moisture/possible microbial growth

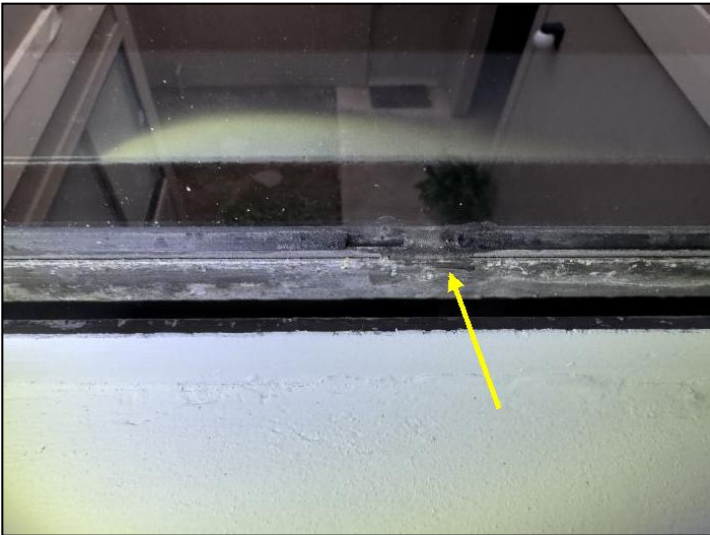
- Efflorescence observed on multiple window sill indicating past moisture intrusion. Recommend monitoring for moisture intrusion and remediation as appropriate by licensed professional.

efflorescence and deterioration of seal
