BEST COAST HOME INSPECTIONS

Confidential Inspection Report

VENTURA CONDO , Ventura , CA 930003

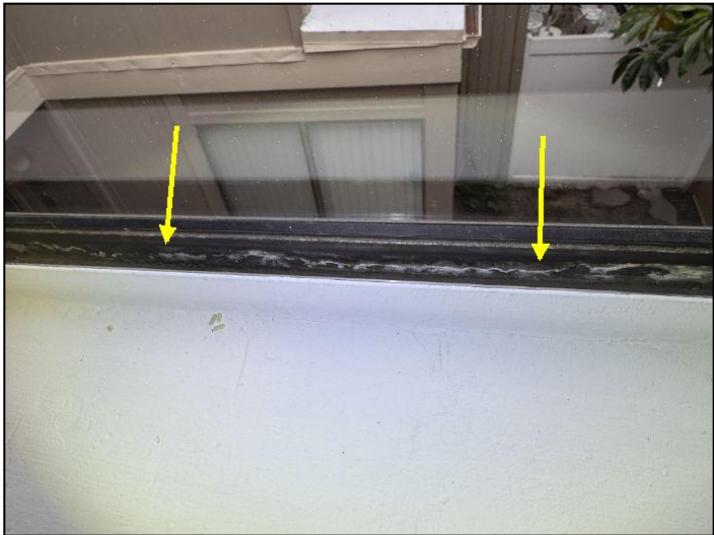
signs of moisture

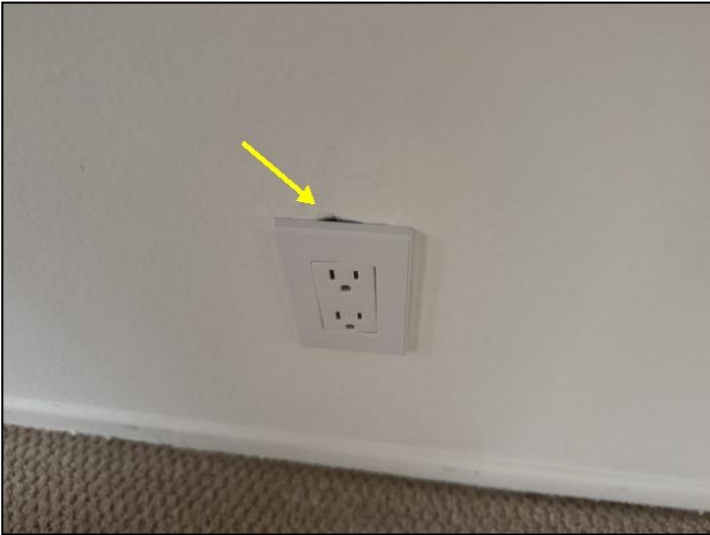
- Observations:
- Missing switch cover was observed at the time of the inspection. This is a safety hazard that could lead to electrocution. Recommend hiring licensed electrician to remediate.
 - Gap observed around electrical outlet at the time of the inspection. Recommend remediation by licensed contractor.
 - Multiple non functional light switches observed. Recommend remediation by licensed and insured electrician.

Bedroom-gap around outlet

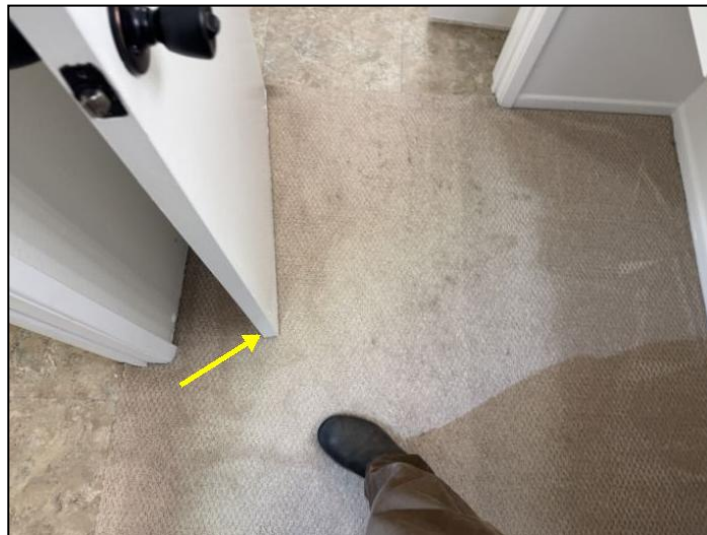
- Bedroom doors observed as tight against the carpet at the time of the inspection. Recommend remediation by qualified contractor.

both bedroom doors tight on carpet

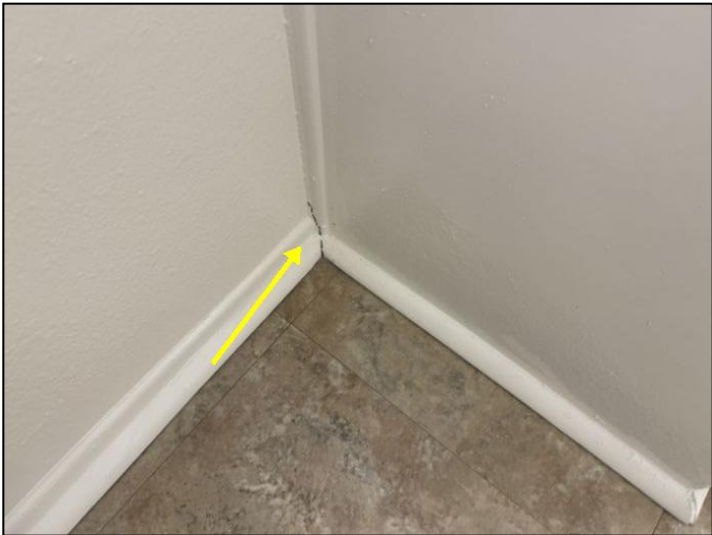
- Cracking noted in the bathroom(s) between the floor and baseboards at the time of the inspection. Recommend remediation by qualified contractor.

seal crack, half bath wall

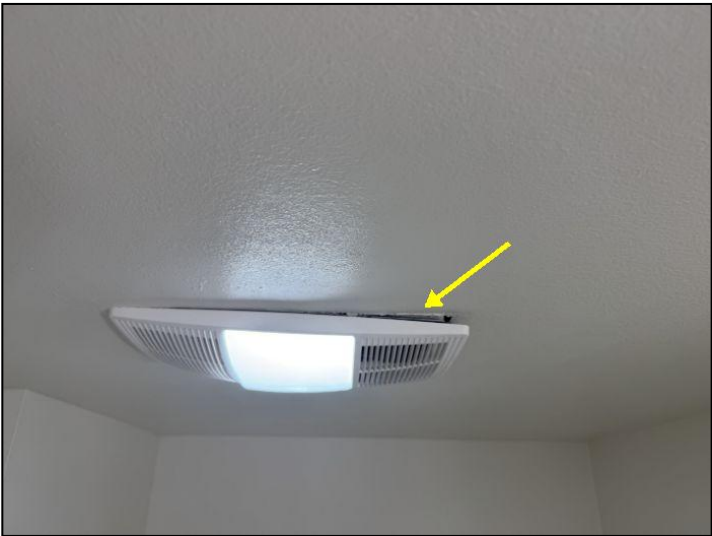
- Cover loosely attached at the time of the inspection. Recommend remediation by qualified professional.

loosely attached

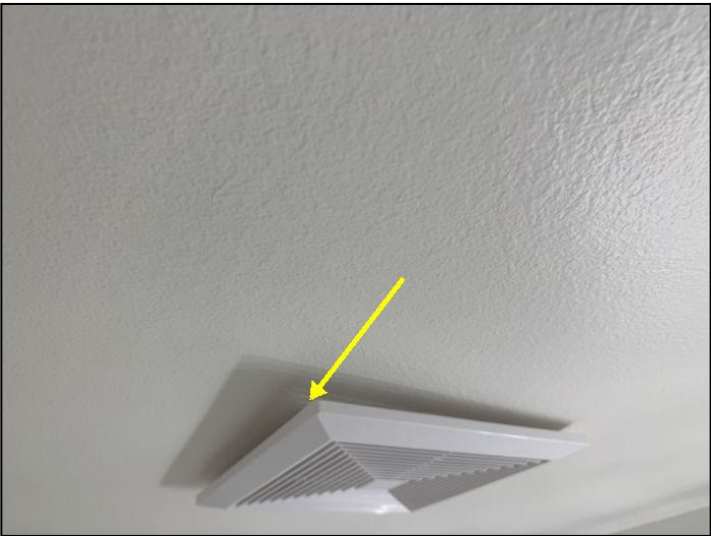
loose bath fan

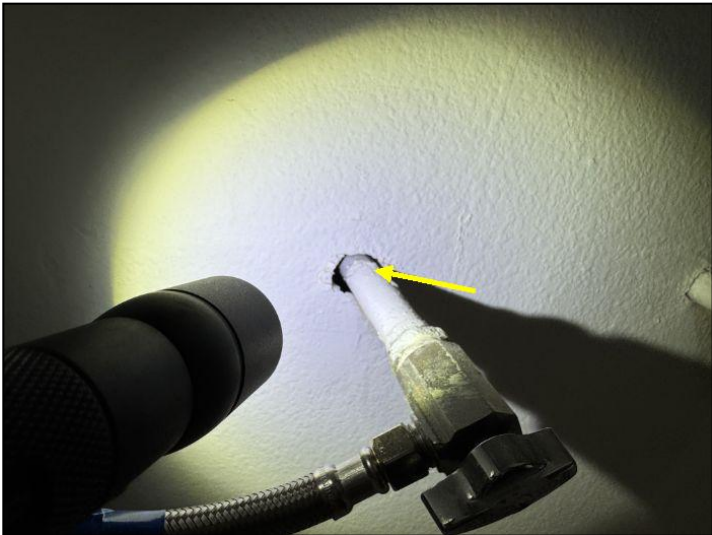
- Unable to determine if painted plumbing is galvanized or copper at the time of the inspection. Recommend review of disclosures regarding plumbing material.

copper or galvanized?

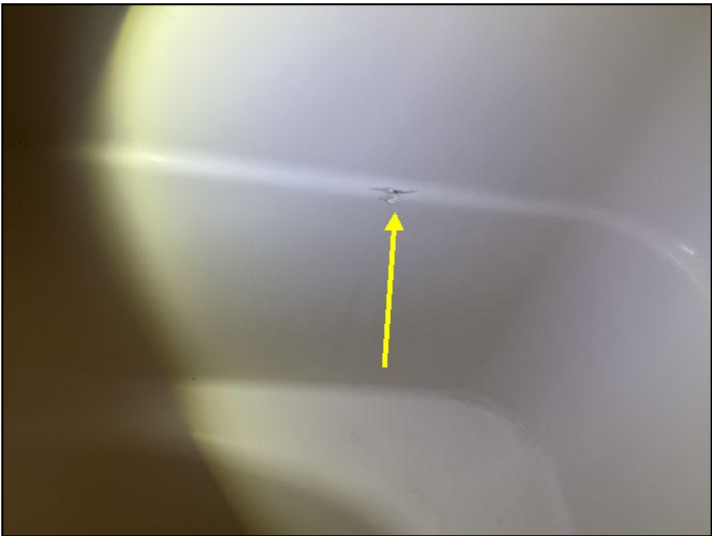
- Cracking observed on shower wall in multiple locations at the time of the inspection. Recommend further evaluation and remediation by qualified contractor to prevent moisture intrusion.
- Painted over moisture damage observed on the corner of the master shower door at the time of the inspection. Recommend remediation by qualified contractor.

crack in shower wall

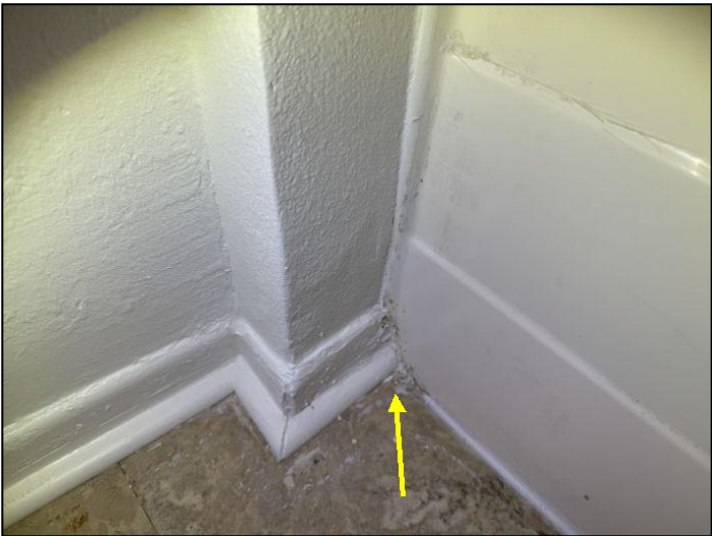
painted over damage

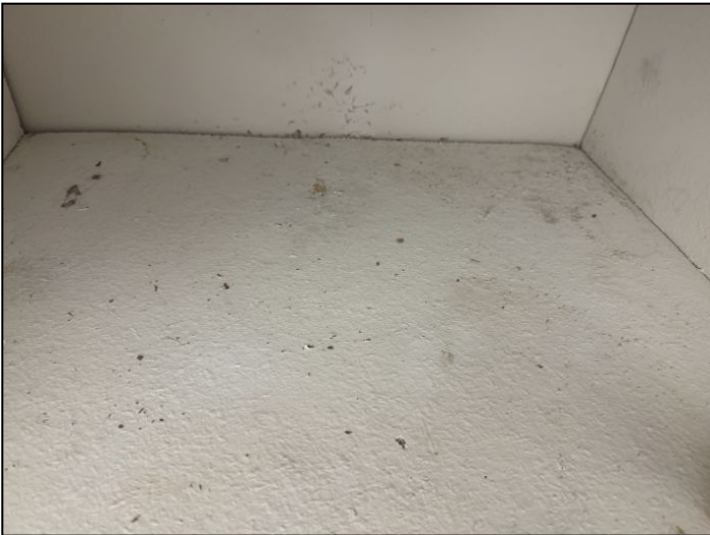
painted over previous wear and tear

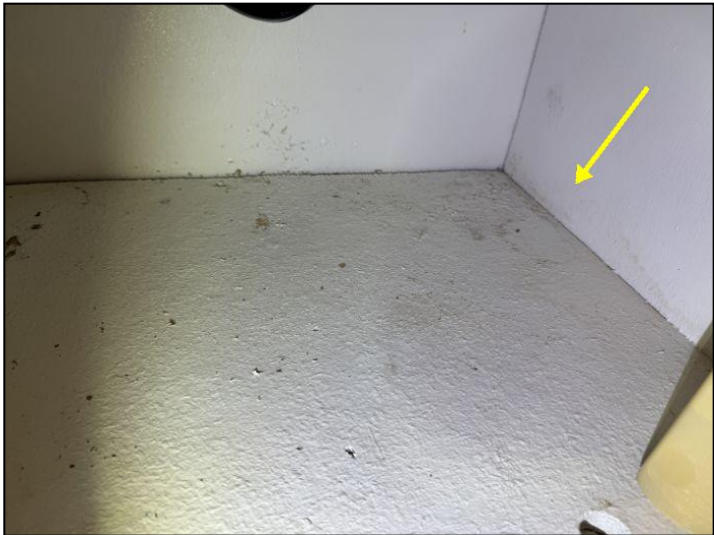
- Moisture staining observed under sink. Dry at the time of the inspection.
- Bathroom sink observed as cracking and peeling on the underside. While functional at the time of the inspection. Recommend monitoring for continued damage.
- No drain stopper observed in shower.

previous moisture staining

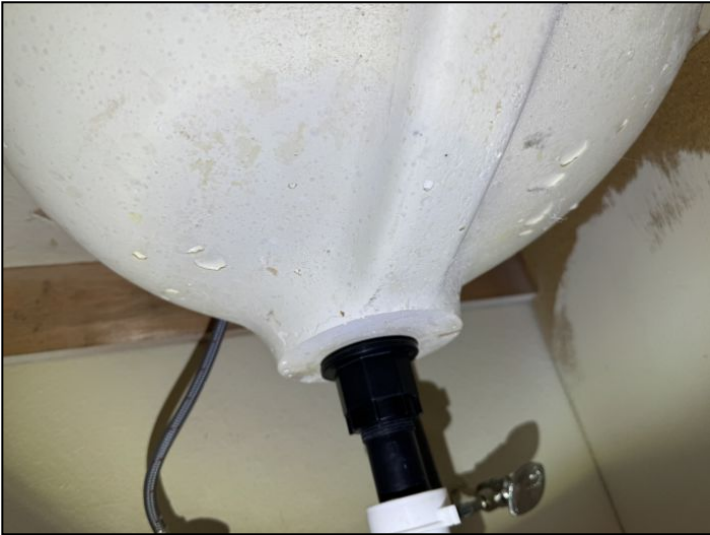
functional but cracking underside

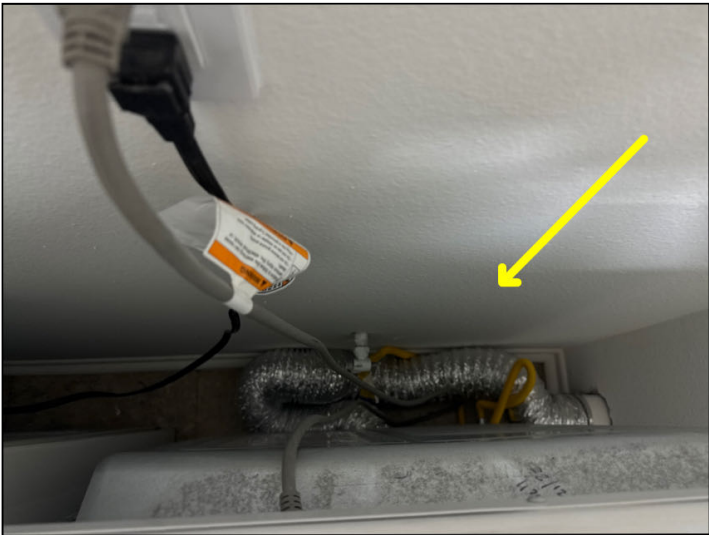
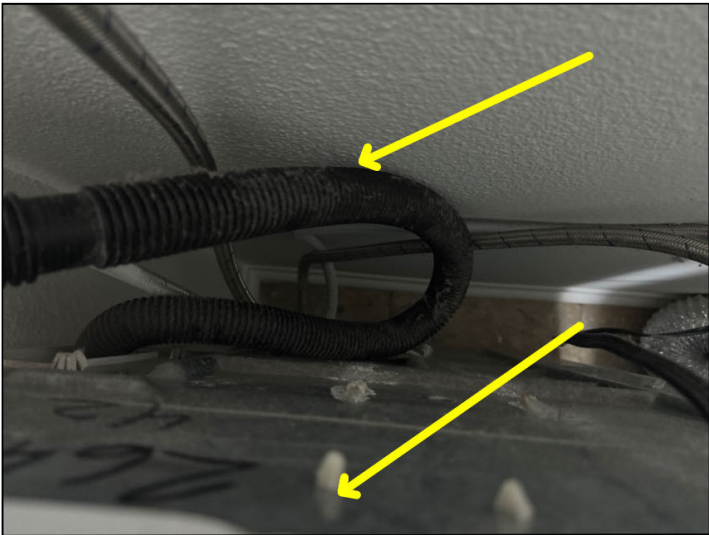
- Flexible transition dryer vent observed behind the dryer at the time of the inspection. These are allowed as transition ducts connecting the dryer to the exhaust at 8ft or less. Recommend awareness regarding the fact that flexible transition ducts can get smashed and kink when moving the dryer. A clogged or kinked dryer vent can be a fire hazard. Therefore, we recommend being aware when moving dryer and having dryer vent cleaned as appropriate to allow for proper venting. We recommend evaluating replacing flexible vent with solid to prevent any clogging/fire issues.
- Lint observed behind washer at the time of the inspection. Recommend monitoring for dryer exhaust leak.

lint
