BEST COAST HOME INSPECTIONS

Confidential Inspection Report

, Oxnard , CA 93035

Date of Inspection: 5/5/2026 Time: 9am

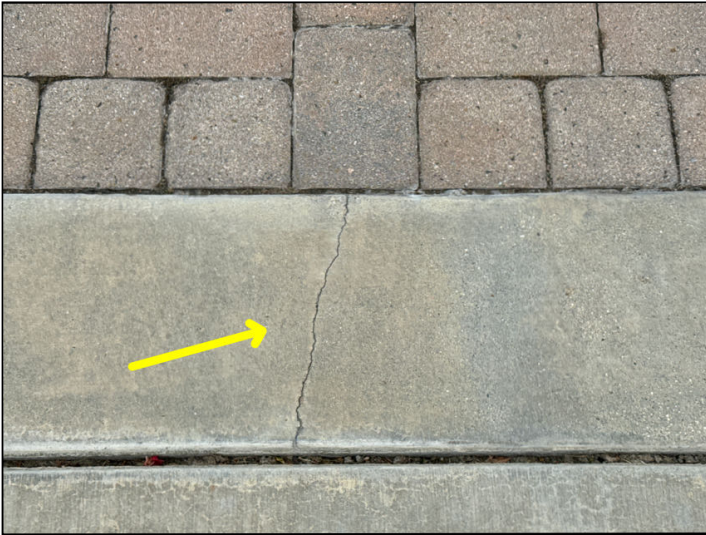
- Minor settlement, or "hairline" cracks in driveways and walkways, are normal for properties of any age. They should, however, be monitored for expansion and sealed as necessary.
- Moss from roof runoff and drainage on driveway observed at the time of the inspection. Recommend cleaning up and monitoring for appropriate drainage.

Minor cracking

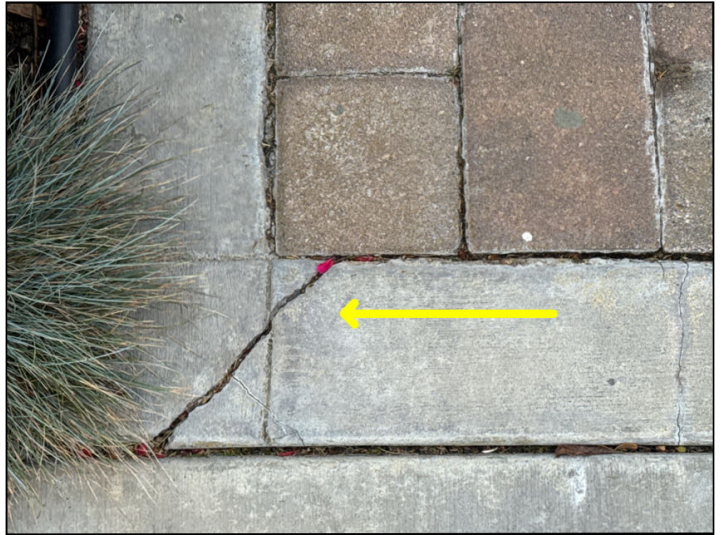
minor cracking

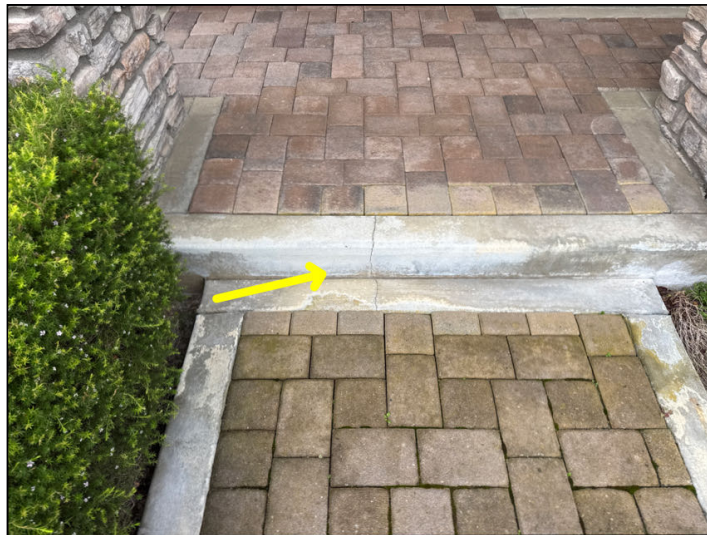
minor cracking

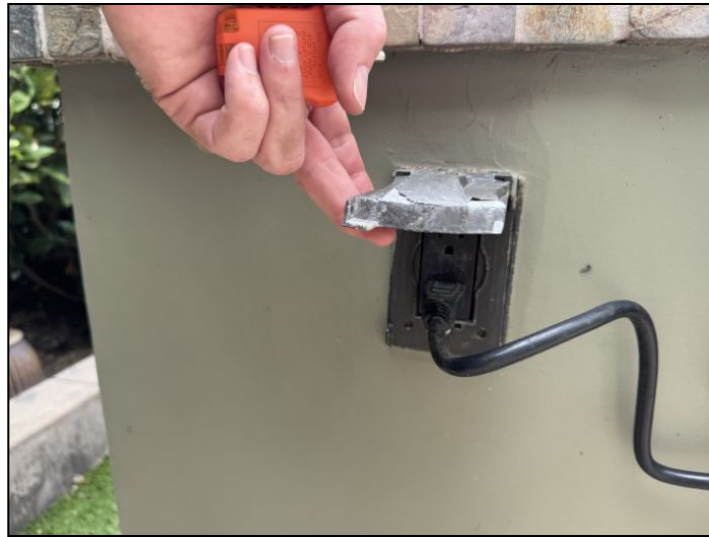
- Use of extension cords in an apparent permanent installation observed at BBQ at the time of the inspection. This is a defect and safety concern. Extension cords are recommended for temporary use only and constitute a fire hazard in a permanent application. Recommend removal of all extension cords in the backyard.
- Exterior patio BBQ outlet observed as non functional at the time of the inspection. Recommend further evaluation by licensed electrician.

no function at inspection

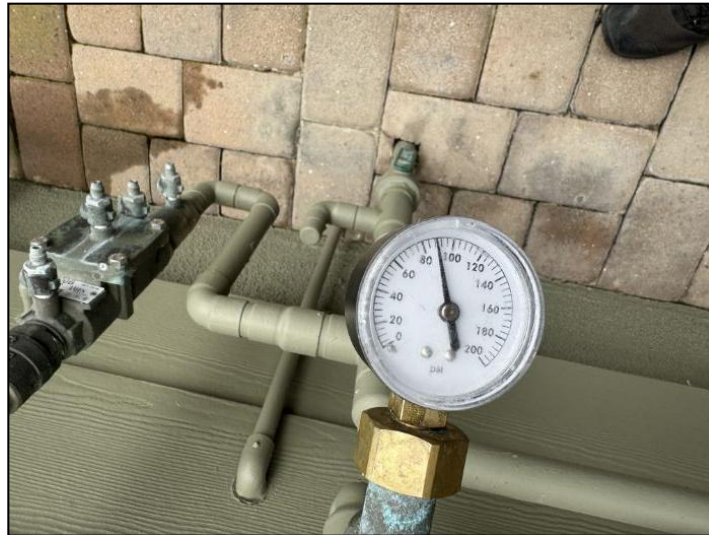
- 90 psi water pressure noted at the time of the inspection. Recommend hiring licensed professional and adjusting the water pressure down to 70psi to prevent damage to pipes.

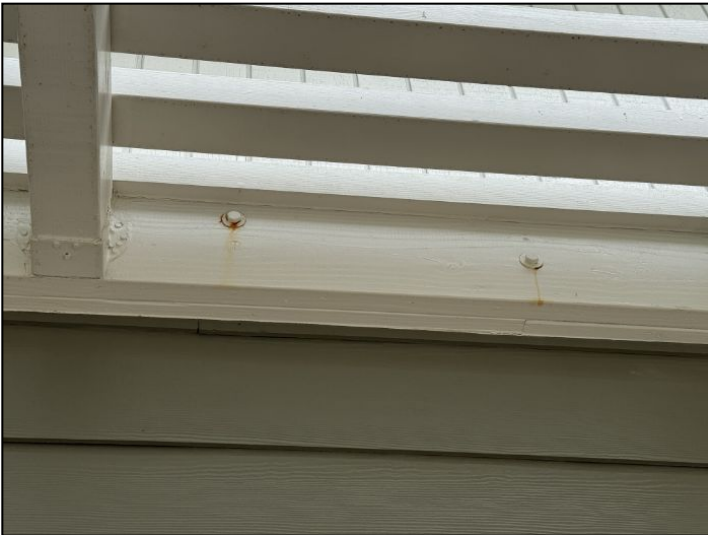
- Rust on bolts observed. Recommend monitoring and necessary remediation to prevent rust deterioration.
- Joist hanger for patio structure observed as missing a fastener at the time of the inspection. Every hole should be used in the installation of joist hangers. Recommend qualified contractor attach appropriate fastener.

rust on bolts

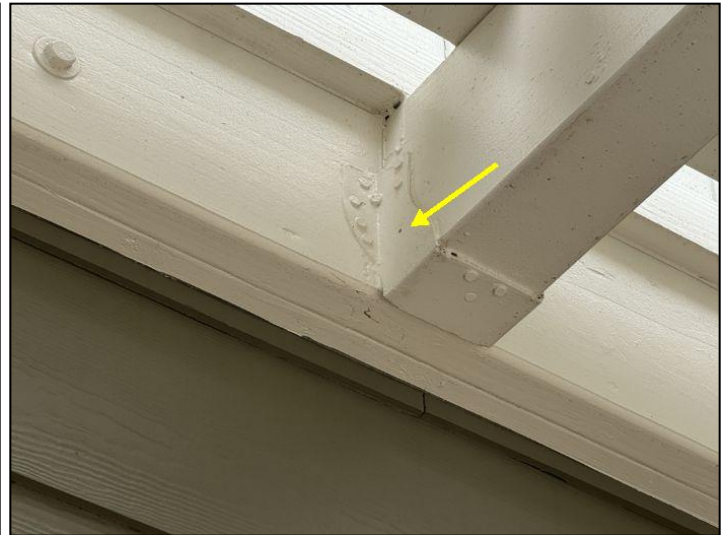
missing fastener on patio

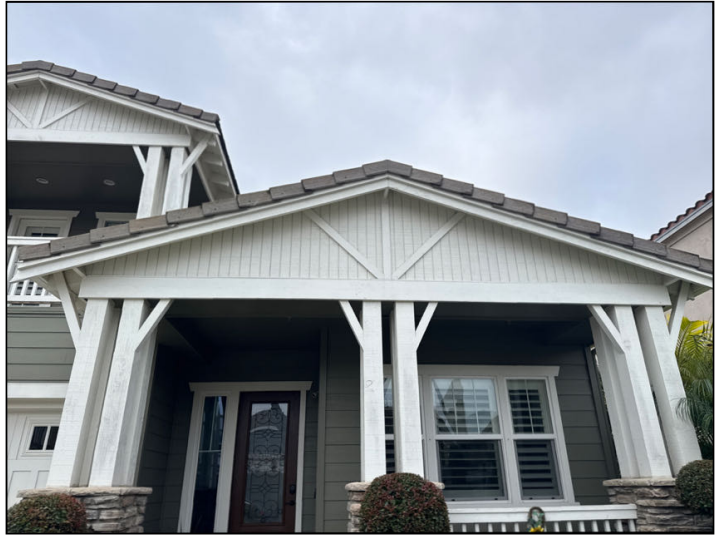
- Rusted fasteners observed on the siding at the time of the inspection. Recommend remediation qualified contractor to prevent additional rust staining and deterioration.

Rusted fastener

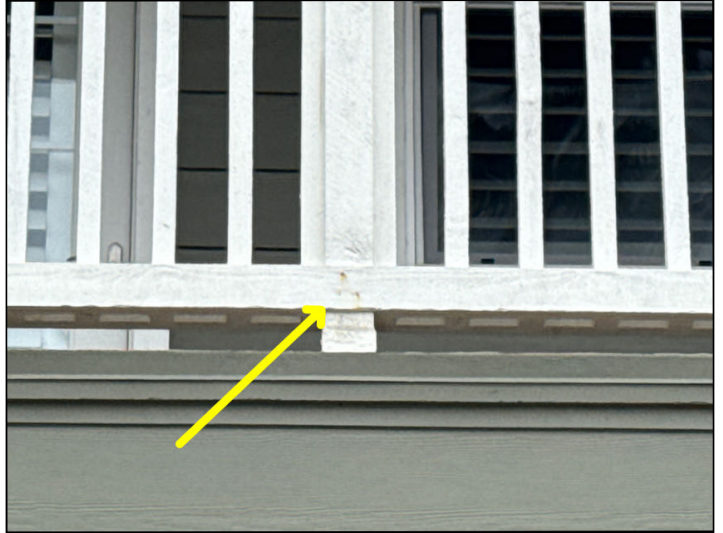
Rusted fastener

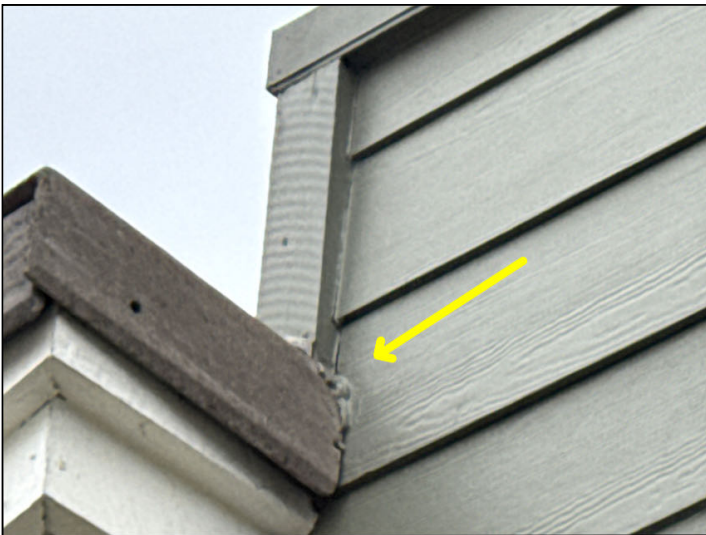
- Small cracking observed in the exterior caulking of the siding. Recommend sealing all gaps and cracks in the exterior of the structure to prevent addition moisture intrusion. Recommend qualified contractor remediate.

Seal gaps

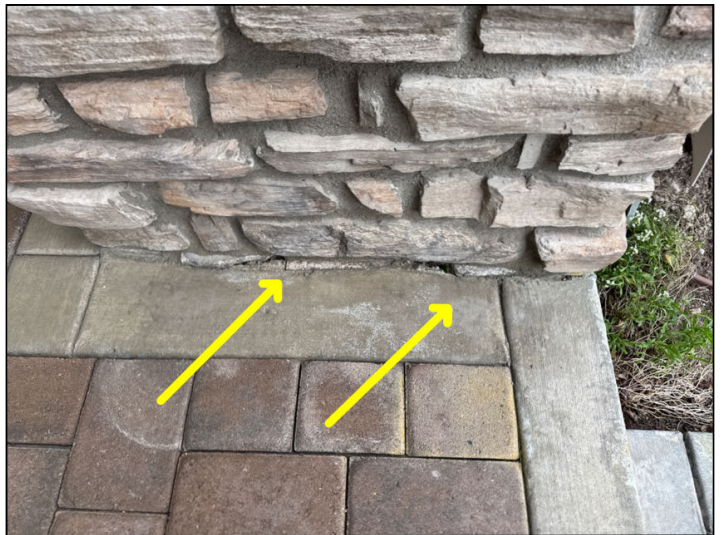
- Missing grout at porch entry. Recommend ceiling to prevent moisture intrusion and continue deterioration.
- Exposed fastener observed on siding at the time of the inspection. Recommend sealing all fasteners to prevent moisture intrusion/deterioration.

missing grout

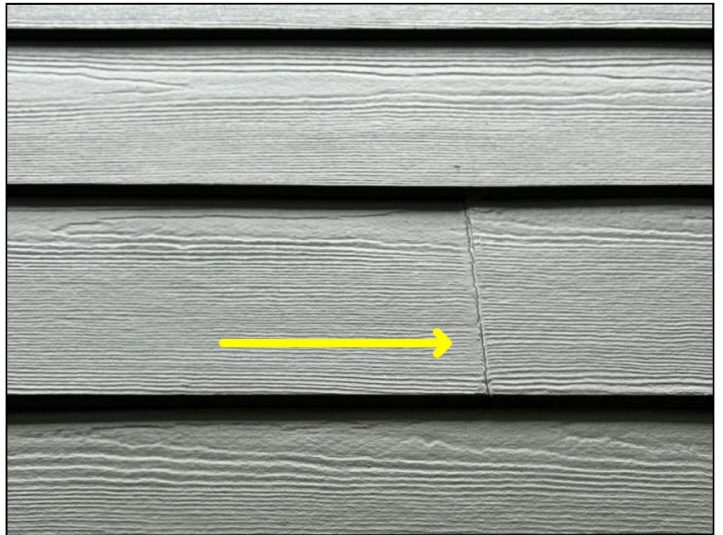
- Large horizontal siding piece, at a slant, seemed to be a cover for unknown. Cracking in connection points at the time of the inspection. Recommend reviewing disclosures regarding work. Remediate as appropriate by qualified contractor.

Seal gap - cover for unknown.

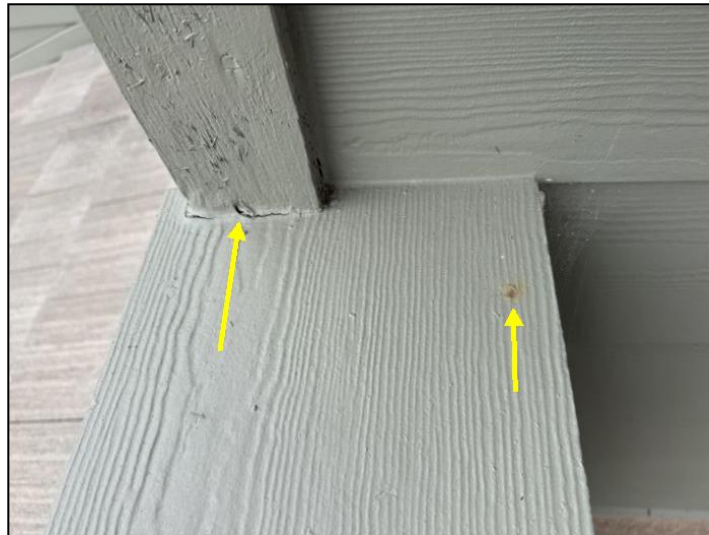
crack and rusted attachment

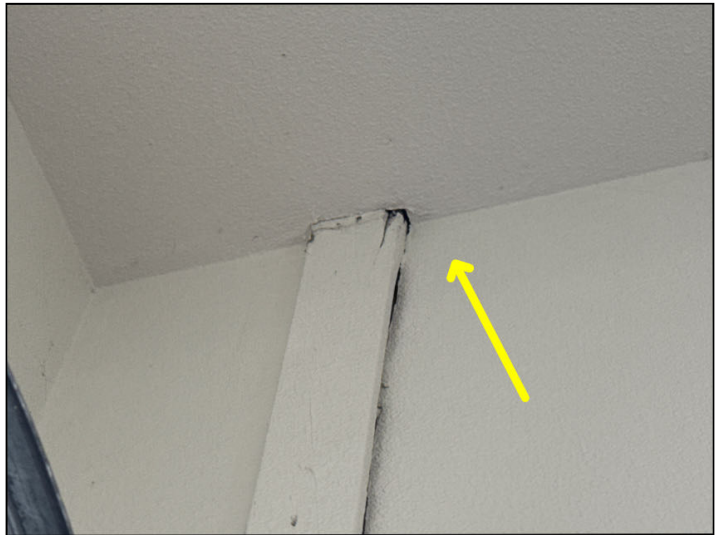
- **Break in the firewall wall at the time of the inspection. The wall and ceiling between the garage and the home is considered a firewall. Any break in a firewall could allow a garage born fire into the home and constitutes a fire hazard. Recommend remediation by licensed contractor.**

Above garage door

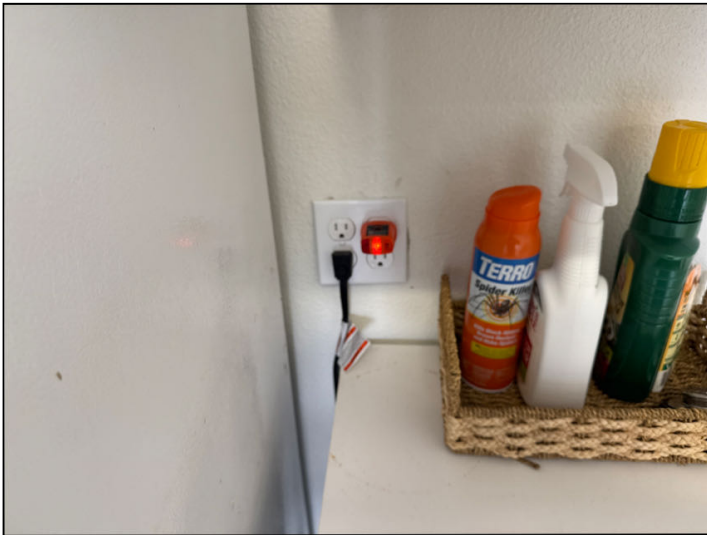
- Loose switch cover on the ceiling noted at the time of the inspection. Recommend remediation by licensed professional.
- Open ground outlet also not GFCI protected observed in the garage at the time of the inspection. This is a safety defect. Recommend electrician remediate as appropriate.

Open ground

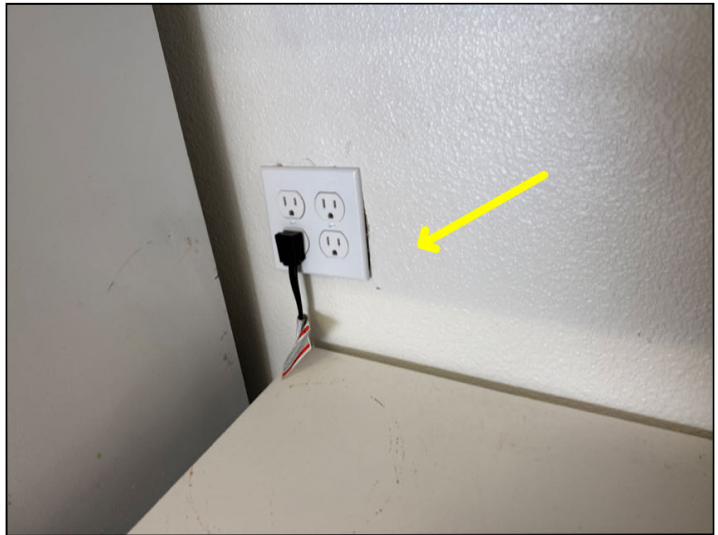
Loose cover switch

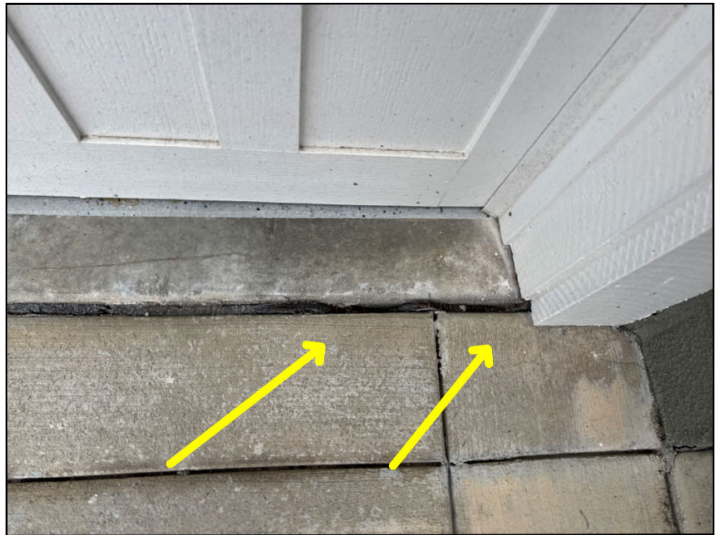
- Failing expansion gap at garage door entry at the time of the inspection... Recommend further evaluation and remediation by licensed contractor to prevent moisture settlement.

failing seal

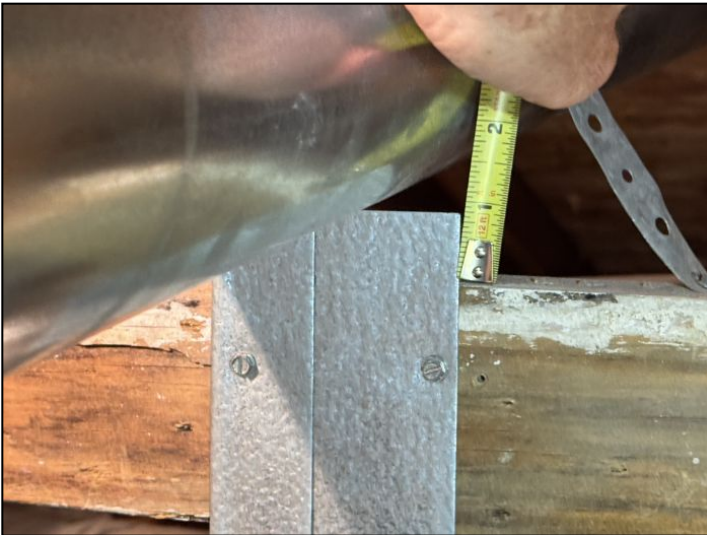
- Minimum furnace/water heater double wall B vent pipe clearance from combustible material is 1". Minimum clearance for single walled vents is 6". This is a fire hazard. Vents were observed as short of the minimum inch clearance at the time of the inspection. Recommend evaluation by HVAC contractor that vent is maintaining a 1 inch clearance from combustibles from the furnace enclosure through the roof penetration for double walled B Vent .
- An obvious attempt to establish appropriate clearance was observed but just slightly short of the mandated full inch as a MINIMUM. Recommend establishing a full inch or more by qualified HVAC contractor.

less than inch clearance

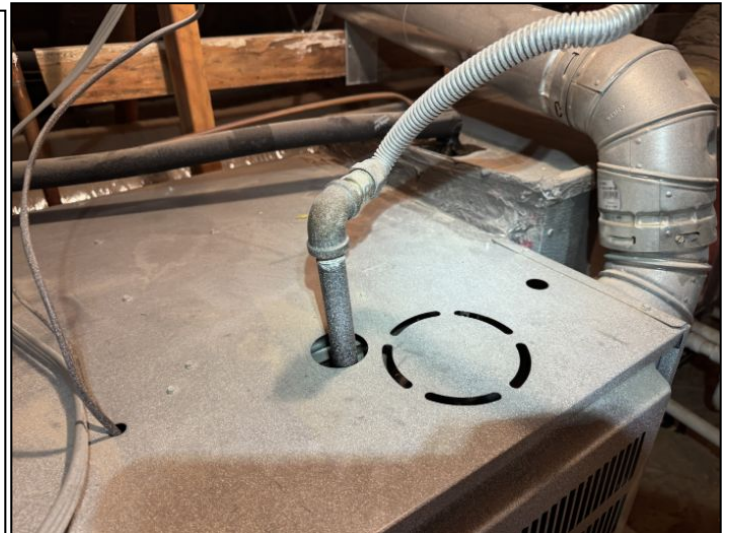
- Missing sediment traps on the furnace gas lines observed at the time of the inspection. A sediment trap collects any debris that may be trapped in the gas line before it enters the appliance and possibly cause damage. Recommend remediation by a licensed HVAC contractor.

missing sediment trap(s)

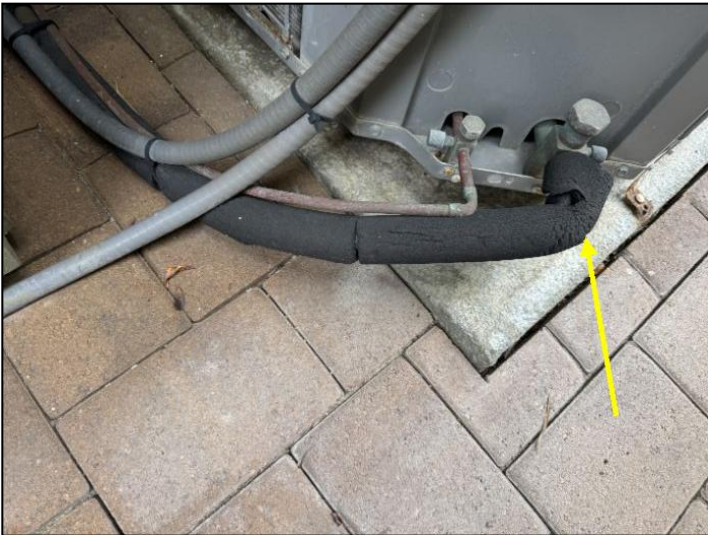
- Damage to insulation at **A/C** unit at the time of the inspection. Recommend remediation by qualified HVAC contractor.

damaged insulation

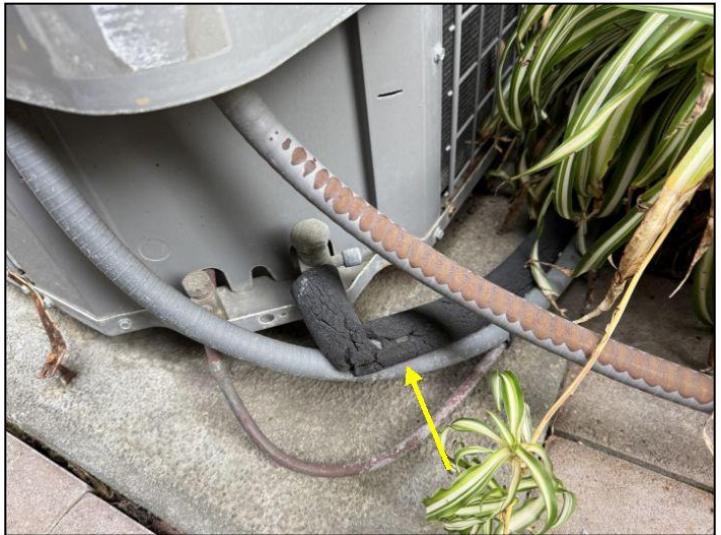
insulation damage

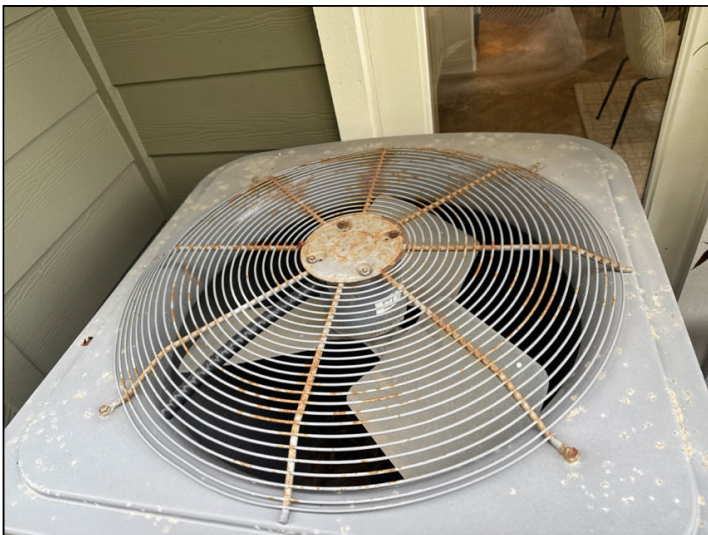
- Rust observed in unit at the time of the inspection. Recommend evaluation and servicing of unit by qualified HVAC contractor
- Air conditioner may be at or near the end of its life as evident by its use of R-22 refrigerant. Recommend evaluation by licensed HVAC contractor and budgeting for a replacement.

Rust

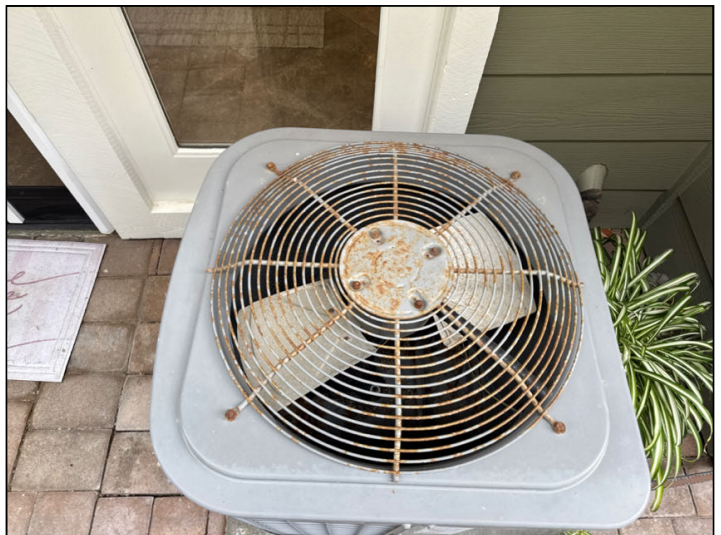
Rust

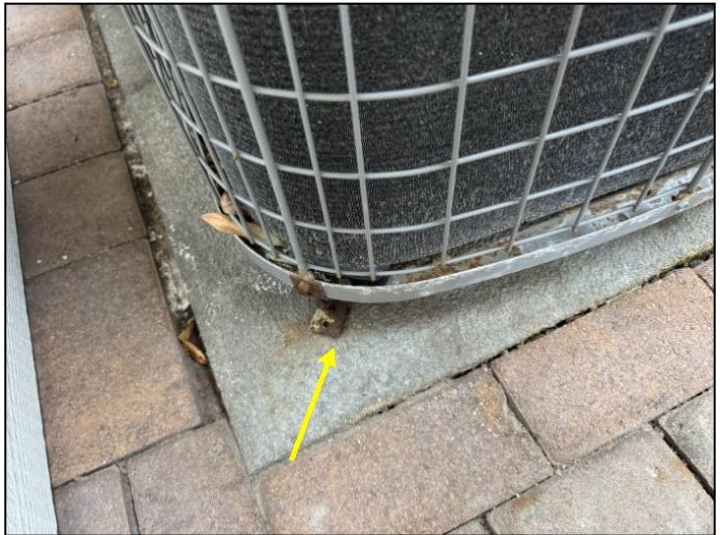
- Missing/failing attachments for the exterior AC units. Recommend addition of appropriate tie downs by licensed and insured HVAC contractor.

missing attachment

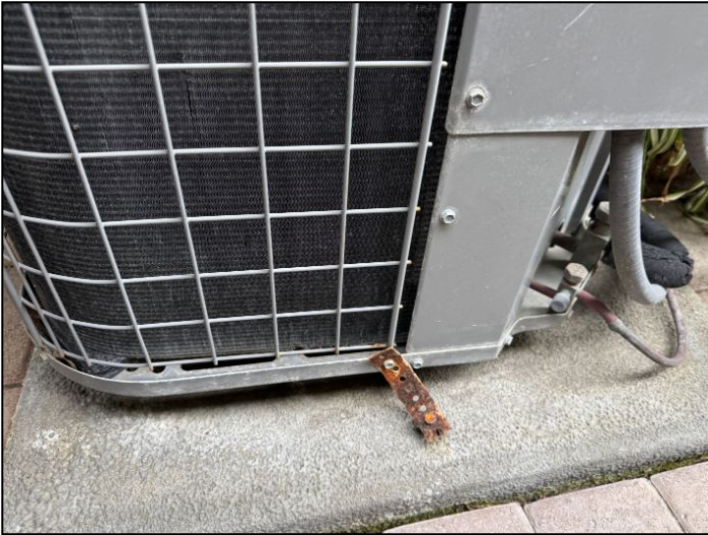
rusted

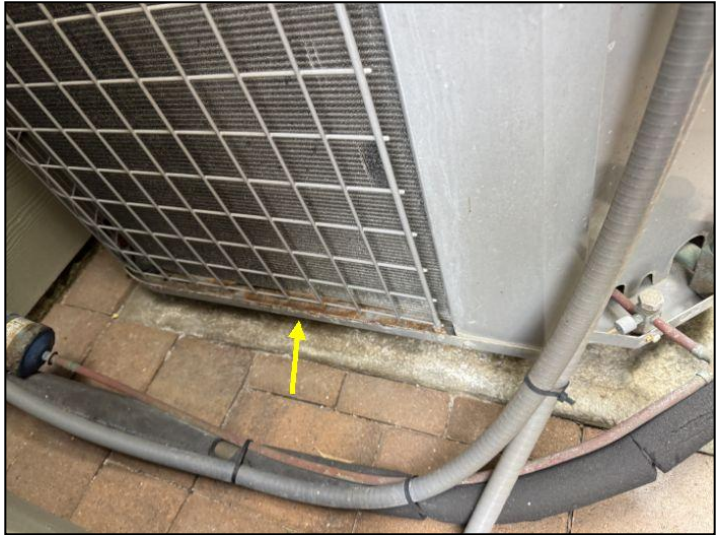
rust in unit

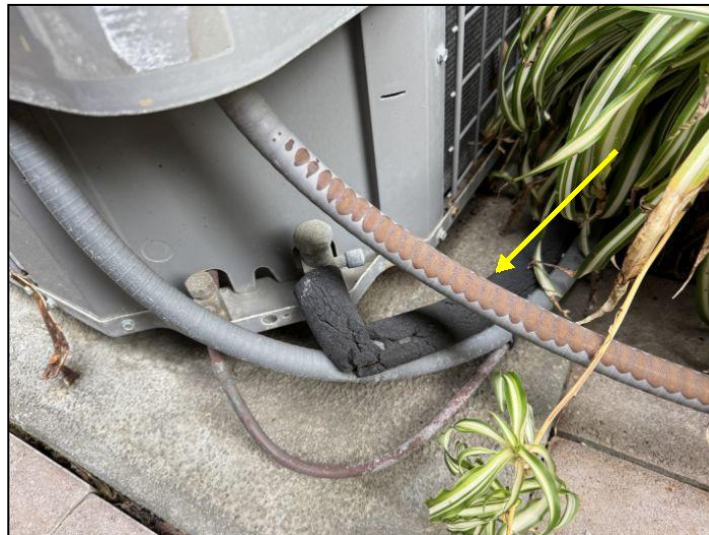
- AC Condenser - Conduit
Discoloration and staining observed on the electrical conduit entering the outdoor AC unit. This is commonly caused by condensation, UV exposure, or minor corrosion in coastal environments.
No active leaks or damage to the wiring noted. Recommend monitoring and, if discoloration worsens or spreads, evaluation by a qualified electrician or HVAC technician.

discoloration of conduit - possible exposure

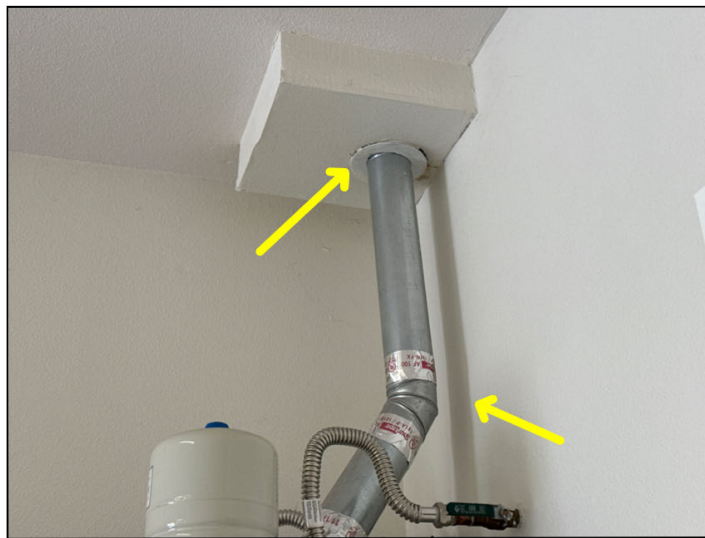
- **SAFETY CONCERN:** Gas burning water heater vent pipes had less than required minimum distance from combustible materials at the time of the inspection. This is hazard. Single walled vents need 6 inches to clearance while double typically need only one. Recommend licensed contractor remediate to establish appropriate clearance to combustibles from the top of the water heater through the roof.
- Flashing at top of water heater observed as loose against ceiling at the time of the inspection. Recommend further evaluation and remediation to establish appropriate clearance to combustibles.

Clearance to combustibles. Loose attachment point

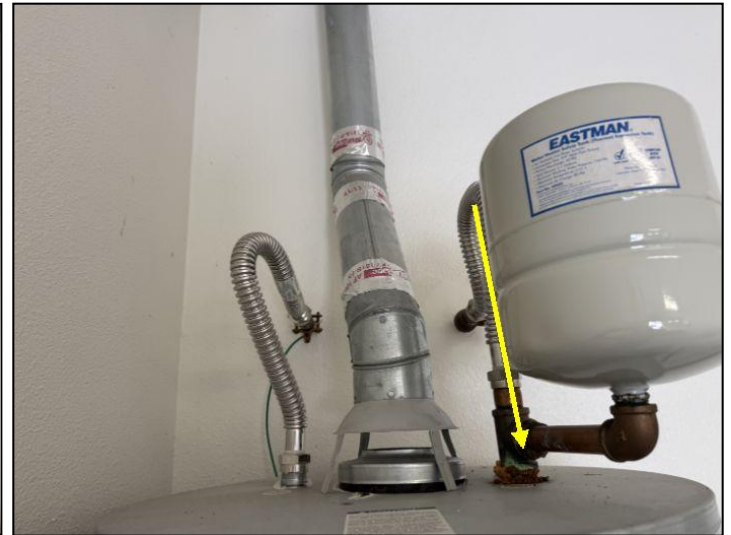
corrosion on water heater plumbing connection point

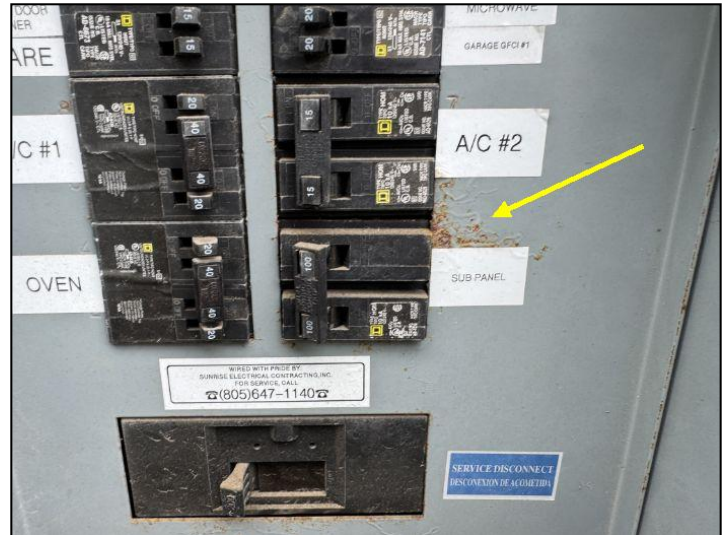
mild rust

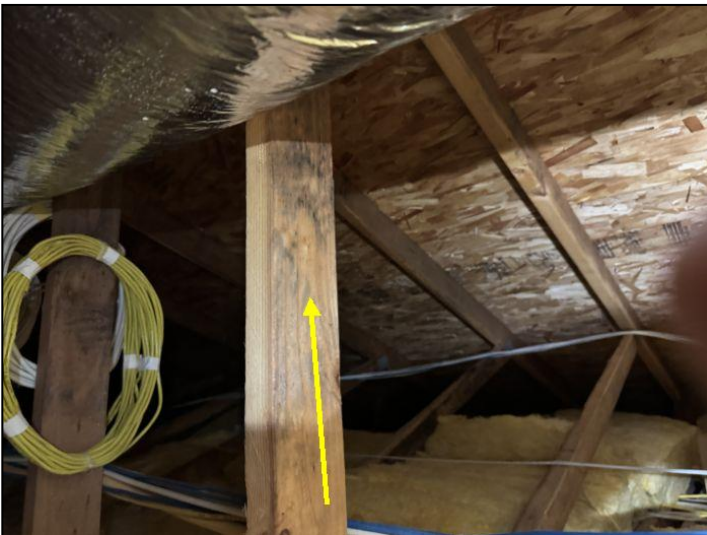
- Recommend removal of any unused products or garbage from attics.
- Dark staining on trusses at the time of the inspection. Possible microbial growth. Recommend further evaluation and remediation as appropriate by qualified contractor.

possible growth

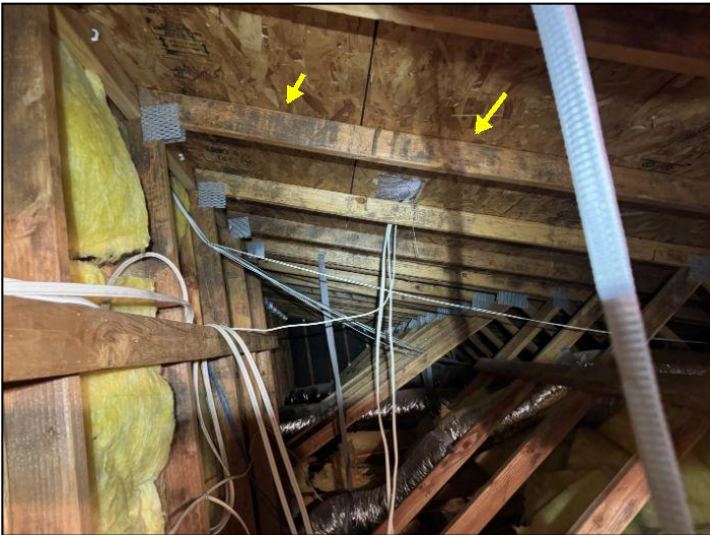
staining on trusses

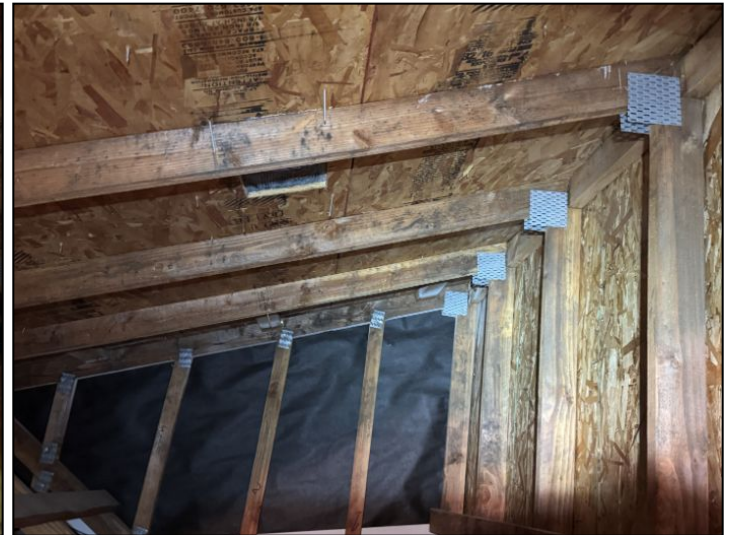
staining on trusses

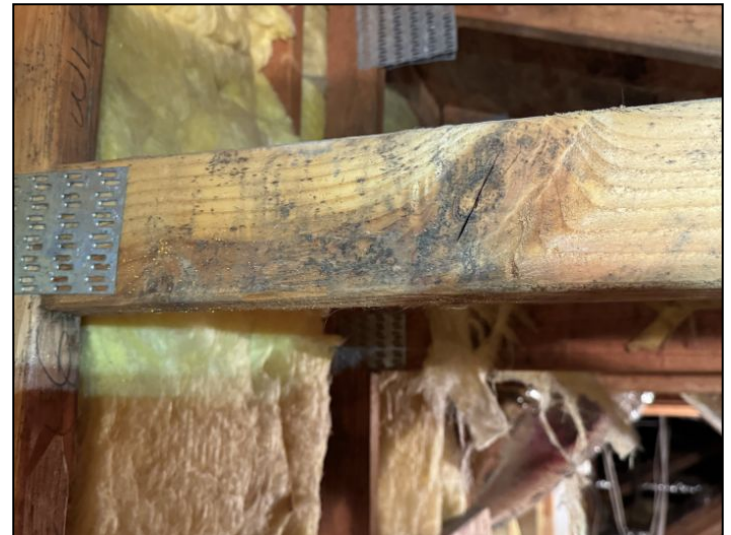
staining/possible microbial growth

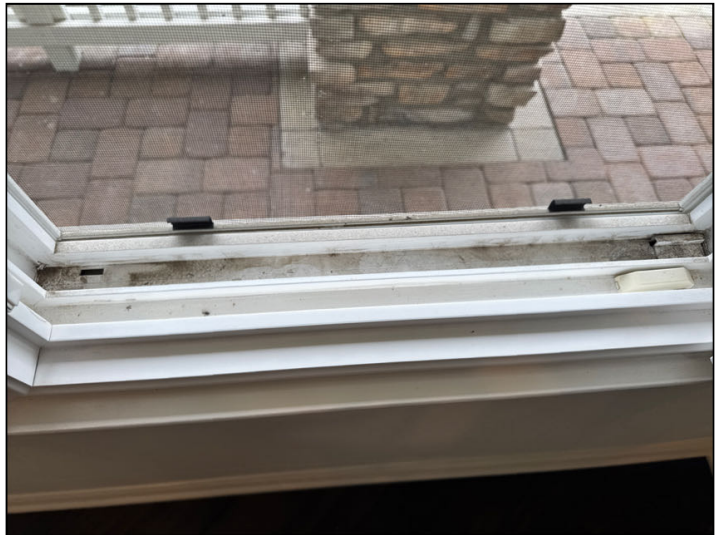
- Many of the windows were observed as slightly tight at the time of the inspection. Recommend monitoring and servicing as necessary.
- Recommend having windows cleaned and serviced for efficacy of use.
- Front window observed with difficulty closing at the time of the inspection. Recommend qualified contractor further evaluate and remediate as appropriate for ease of use
- Windows and living room observed as tight and difficult to operate at the time of the inspection. Recommend servicing windows by qualified professional for ease of use
- Window in living room on top of the stairs appears broken, unable to close at the time of the inspection. Recommend evaluation and remediation by qualified contractor.
- One or more the window blinds were non-operable or broken at the time of the inspection. Recommend repair/replacement by a licensed professional.

Difficulty closing- front window

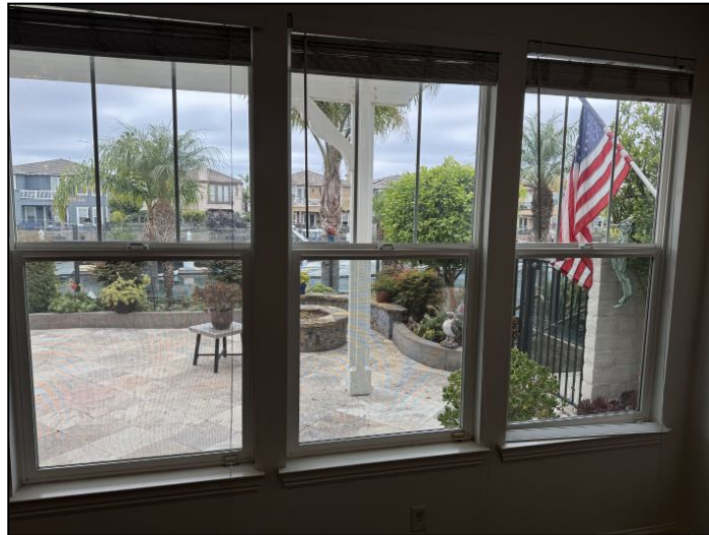
observed as tight to operate

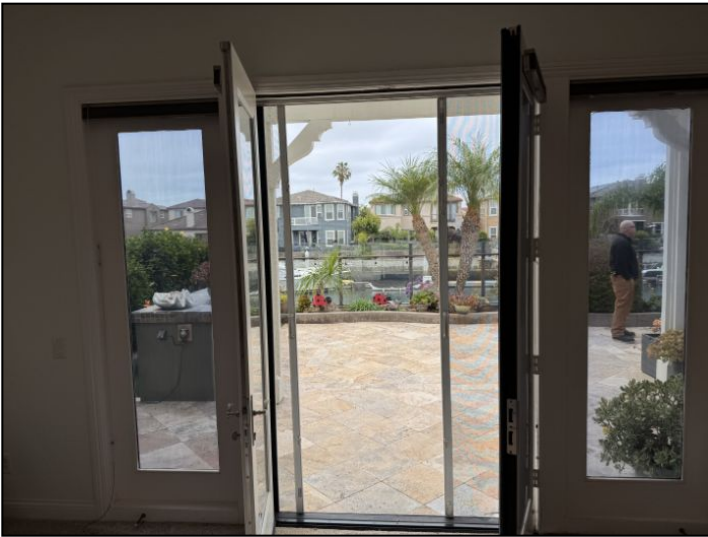
- Locking mechanism difficult to operate at the time of the inspection. Recommend servicing of doors for ease of use.
- Damage to weather stripping observed to bedroom patio doors - downstairs - at the time of the inspection. Recommend remediation as appropriate.

difficult screen doors - difficult locking mechanism

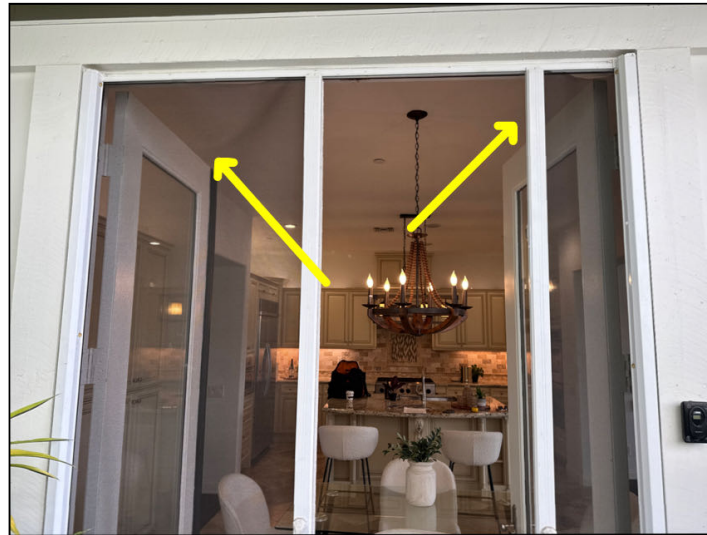
- Patio door(s) screen doors observed as difficult to function and broken at the time of the inspection. Recommend remediation by qualified contractor.

Difficult screen door

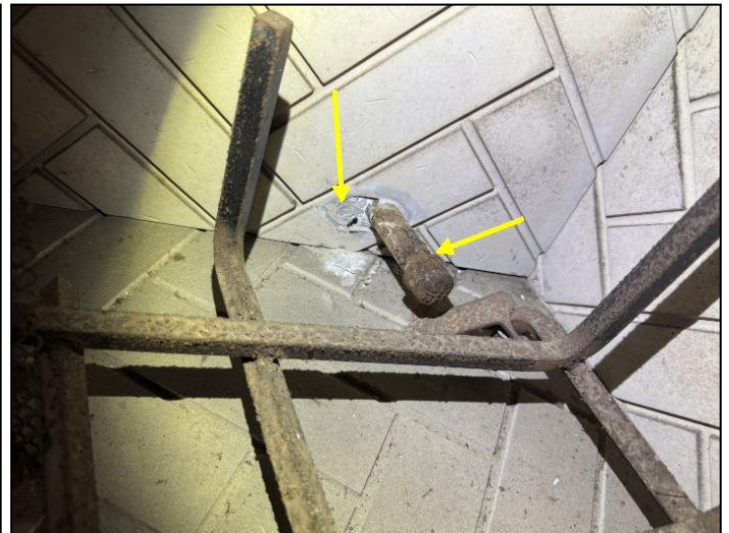
scaling rust on capped gas line. damage to connection point.

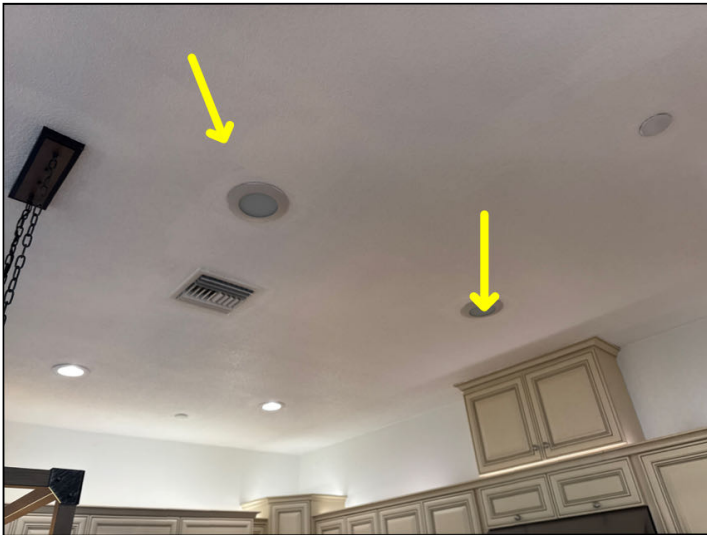
- Electrical switch under sink. Unable to determine use at the time of the inspection. Recommend review of disclosures regarding function of under sink switch.
- Two lights seemingly out in kitchen at the time of the inspection. Recommend remediation by qualified contractor.
- Electrical switch with missing screw at the time of the inspection. Recommend electrician add screw for safety of use.

missing lights

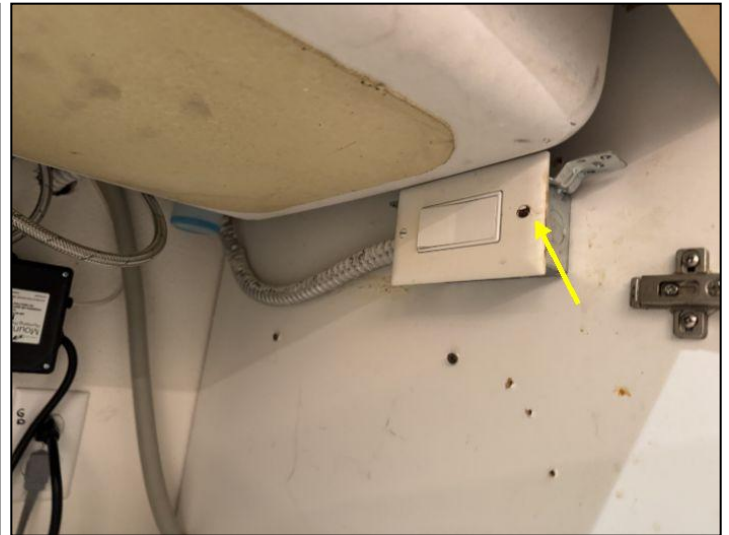
unknown function- missing screw

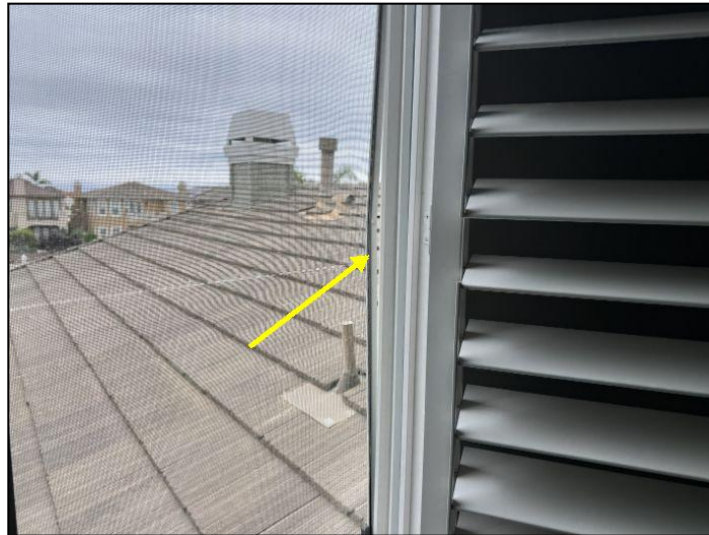
- Bent screen observed at the time of the inspection. Recommend remediation by qualified contractor.

broken screen - upstairs bedroom

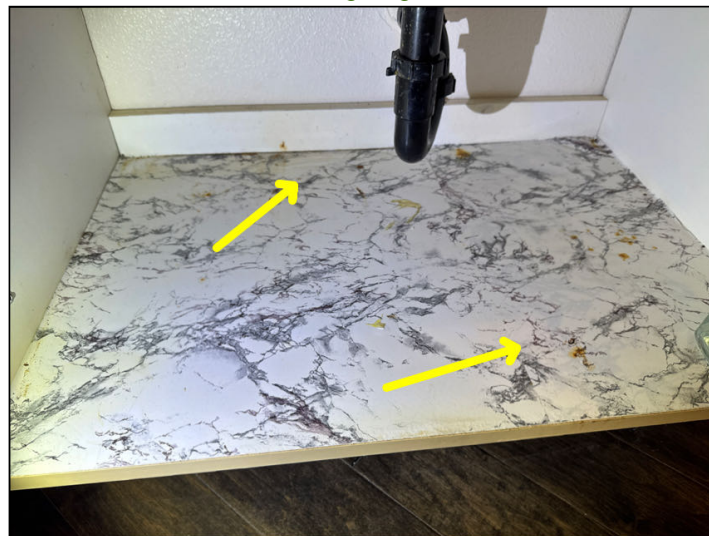
- Rust color staining observed in cabinet of restroom near garage. Recommend remediation as appropriate.

Spots

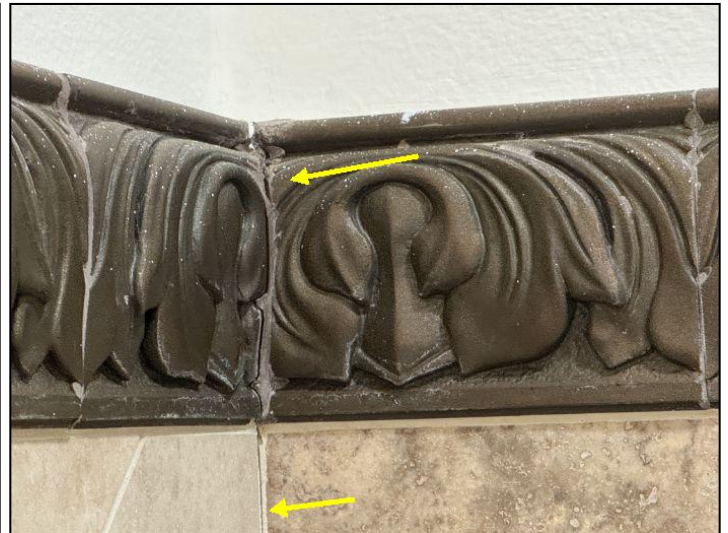
cracking

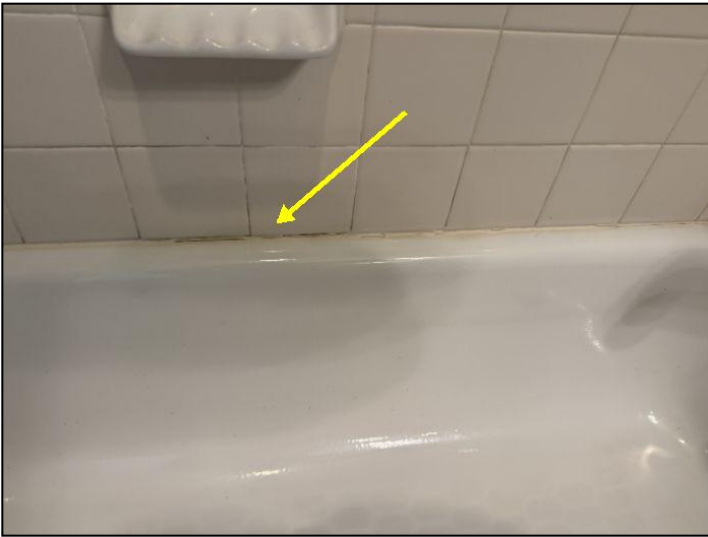
cracks

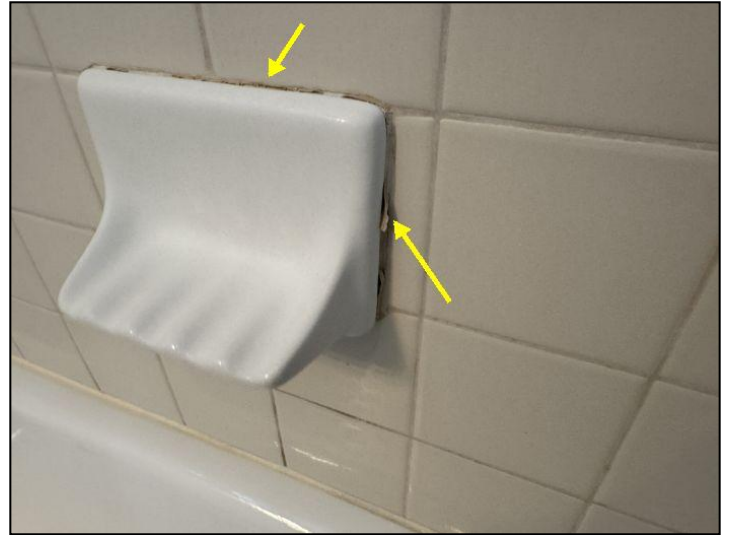
bathroom 3 - missing caulking

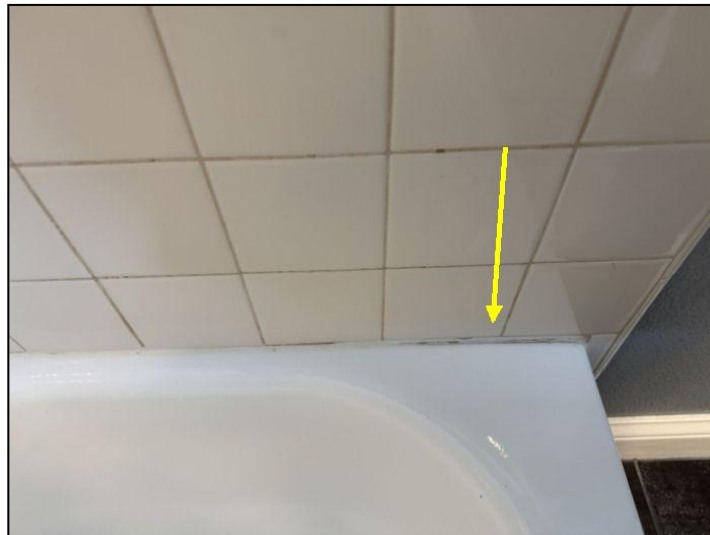
cracking

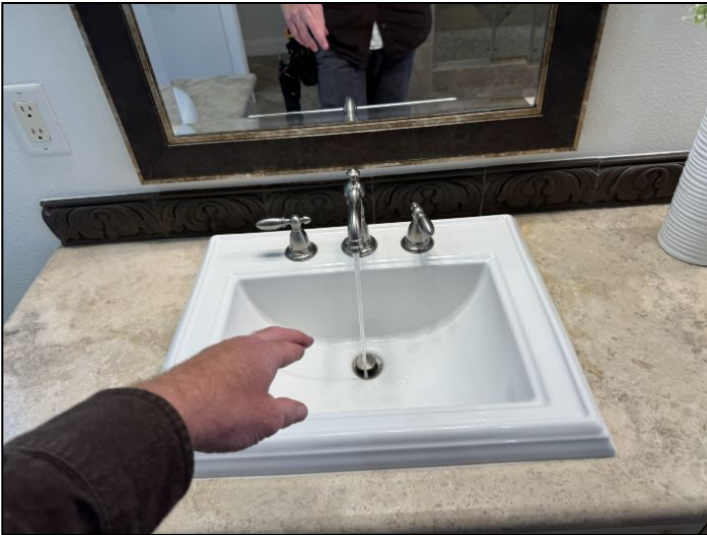
- Slow flow observed on left sink in master at the time of the inspection. Recommend further evaluation by qualified contractor for reason between differing flows at bathroom sinks.
- Active leaking plumbing below the sink at the time of the inspection. Recommend remediation by licensed plumber.

slow flow on left sink in master

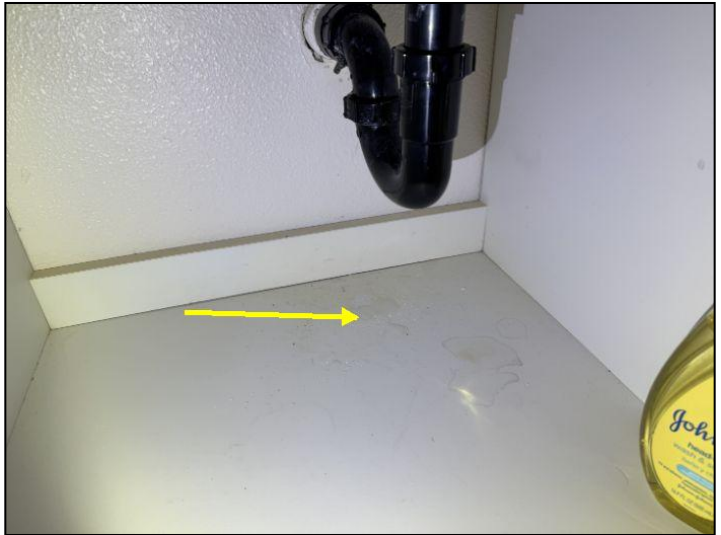
active leak - upstairs left bathroom

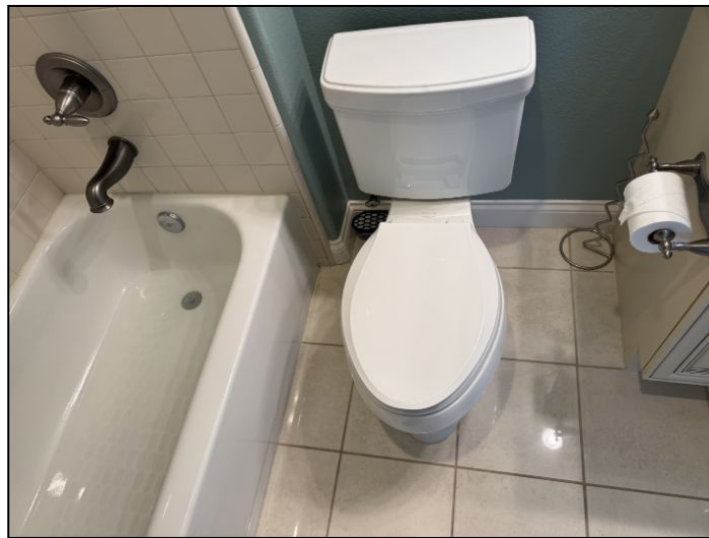
- Toilet observed is not flushing at the time of the inspection. Recommend further evaluation/remediation by qualified plumber.

did not flush

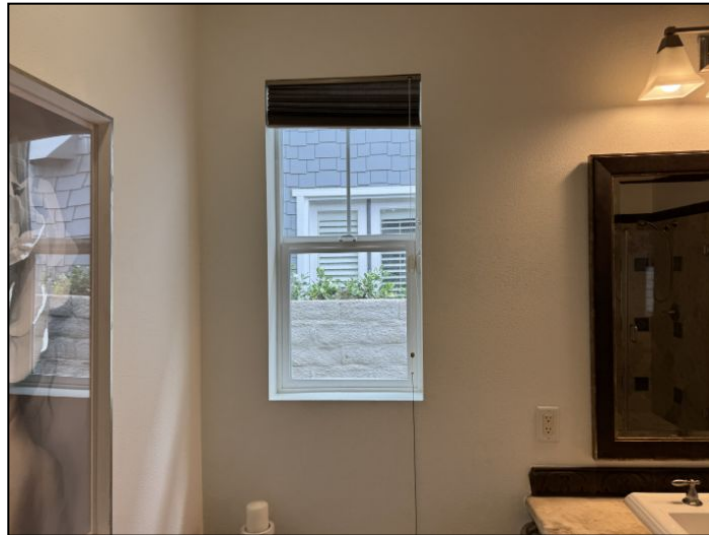
- Damaged/missing screens observed at the time of the inspection. Recommend remediation by licensed professional.

missing screen bathroom window

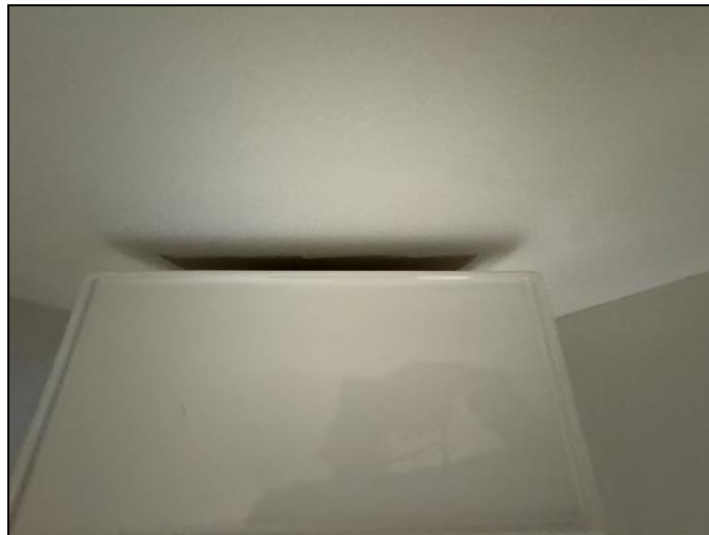
- Unfinished paint in master bathroom observed.

no paint behind toilet - master

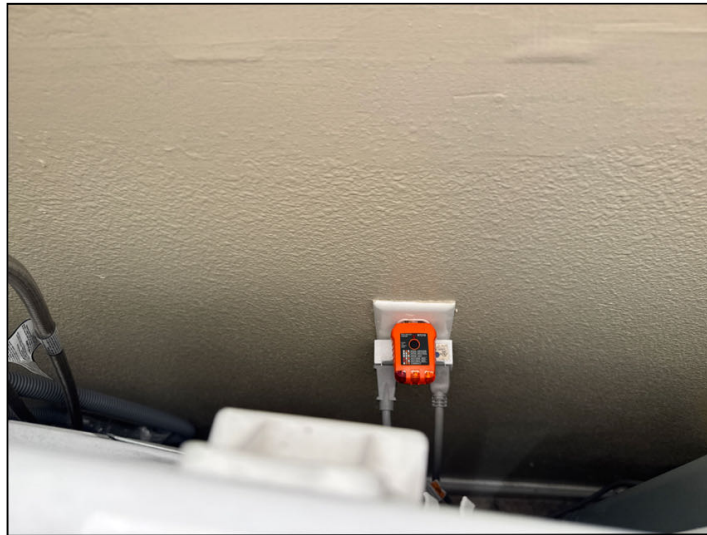
- No GFCI protection present in the laundry at the time of the inspection. We recommend upgrading all outlets in the laundry area and anywhere within 6 ft of water to GFCI protected for safety.

No gfci
