BEST COAST HOME INSPECTIONS

Confidential Inspection Report

, Oxnard , CA 93035

Date of Inspection: 5/5/2026 Time: 9am

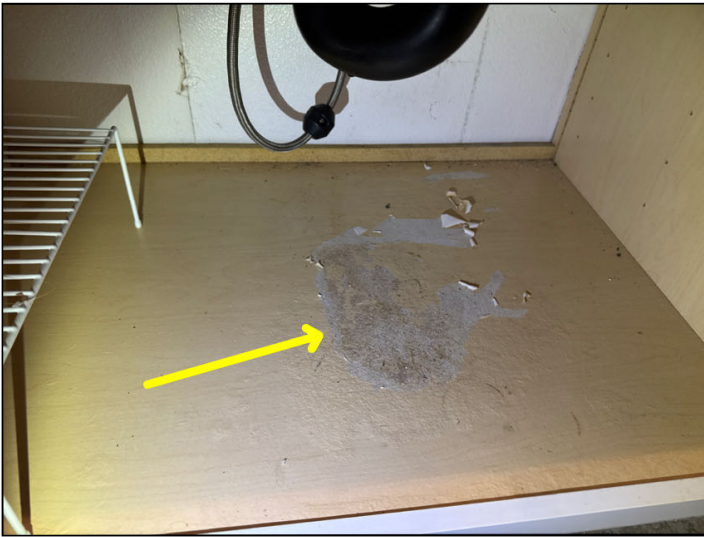
- There appears to be water damage under sink. This tested dry at the time of the inspection, but monitor for any further intrusion.

Previous leak - laundry

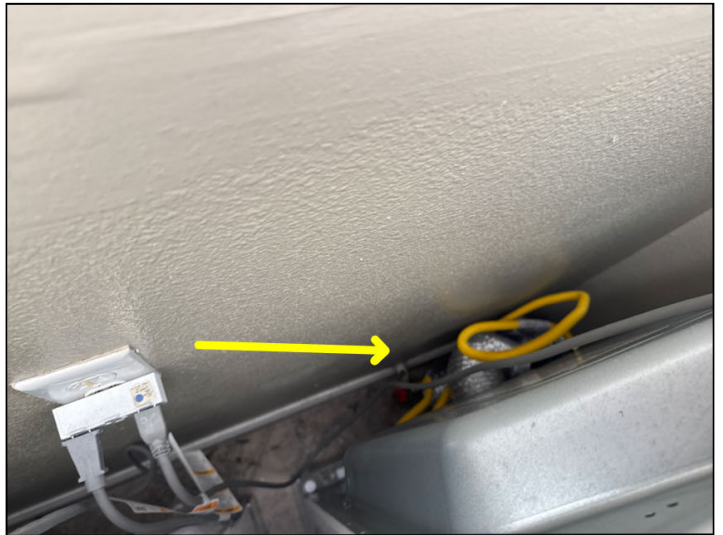
- Flexible transition dryer vent observed behind the dryer at the time of the inspection. These are allowed as transition ducts connecting the dryer to the exhaust at 8ft or less. Recommend awareness regarding the fact that flexible transition ducts can get smashed and kink when moving the dryer. A clogged or kinked dryer vent can be a fire hazard. Therefore, we recommend being aware when moving dryer and having dryer vent cleaned as appropriate to allow for proper venting. We recommend evaluating replacing flexible vent with solid to prevent any clogging/fire issues.
- Lint build up observed at vent at the time of the inspection. Recommend cleaning and maintenance of dryer vent by qualified professional.

Flex
