# BEST COAST HOME INSPECTIONS

## Confidential Inspection Report

, Santa Paula, CA 93060

Inspection prepared for: Sample Sample

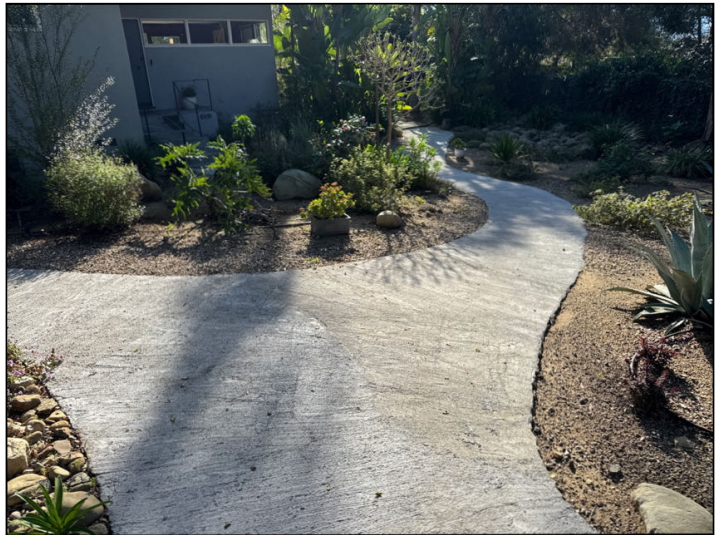
- Moderate cracks in driveway at the time of the inspection. Repair and / or monitor for expansion and development of trip hazards.

*Moderate cracks*

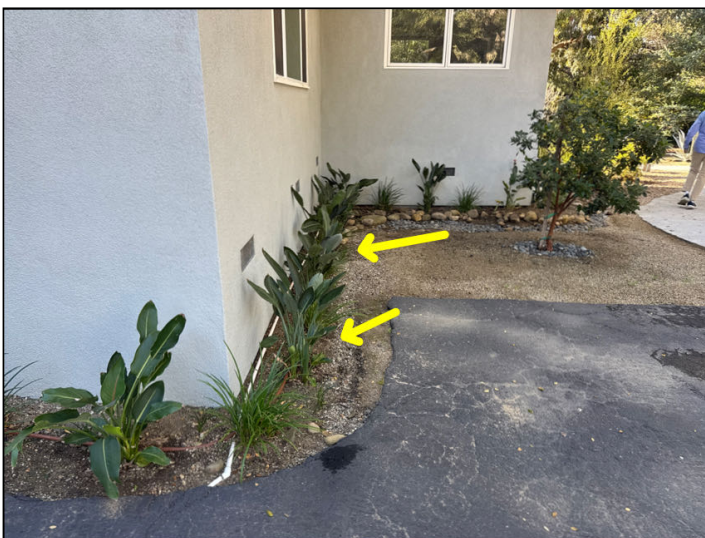
- The exterior grading was observed as improperly sloped in a couple locations around the foundation not allowing for the appropriate fall away from the home. Recommend creating the proper slope away from the foundation to allow for proper drainage and prevent moisture damage to the home. Remediation by licensed contractor recommended.

*Poor grading*

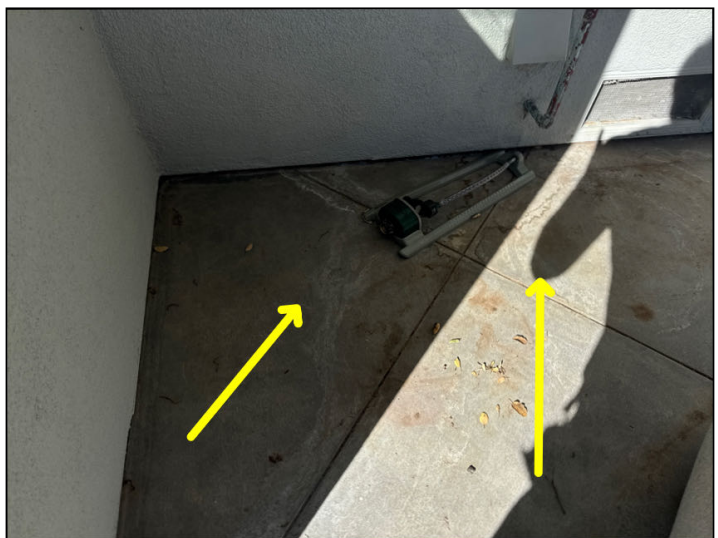
- Signs of moisture settlement noted in side yard at the time of the inspection. Recommend remediation by qualified contractor.

*signs of moisture settlement*

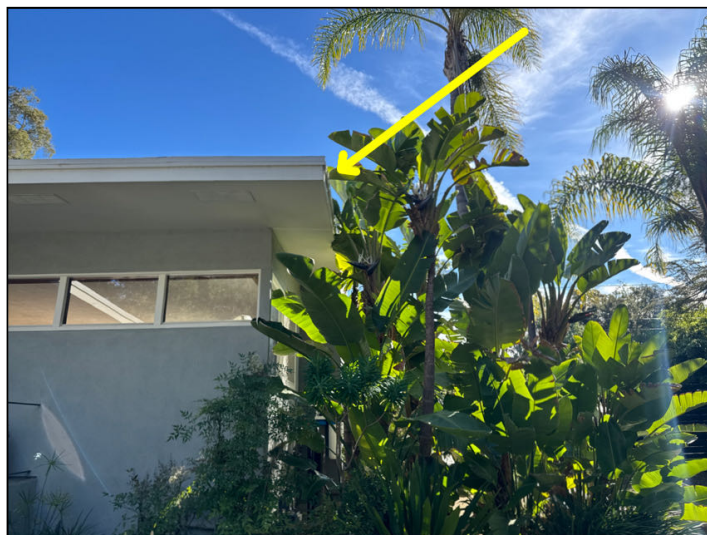
*Veg touching*

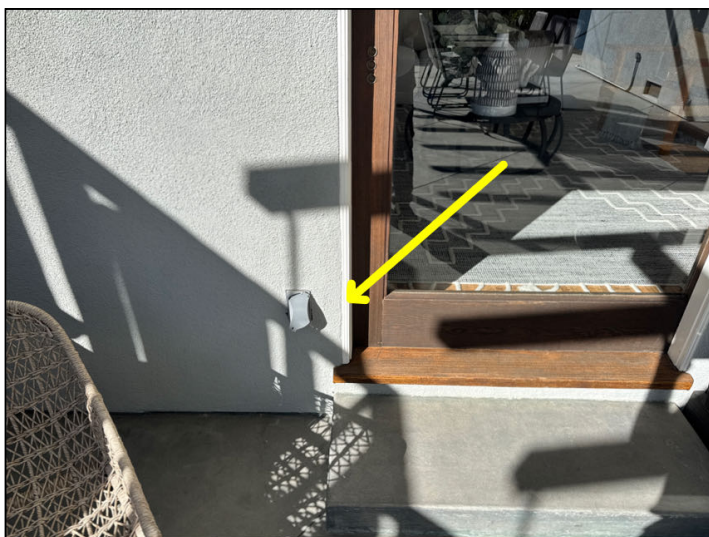
- Open ground three prong outlets present at the time of the inspection. An open ground is when you have a three prong outlet not connected to an equipment grounding conductor. The lack of an equipment grounding conductor will limit the use of certain appliances such as washing machines, computers, etc. that require a ground. Recommend electrician remediate, assess entire electrical system and add **GFCI** protection to all necessary outlets.

*Open ground*

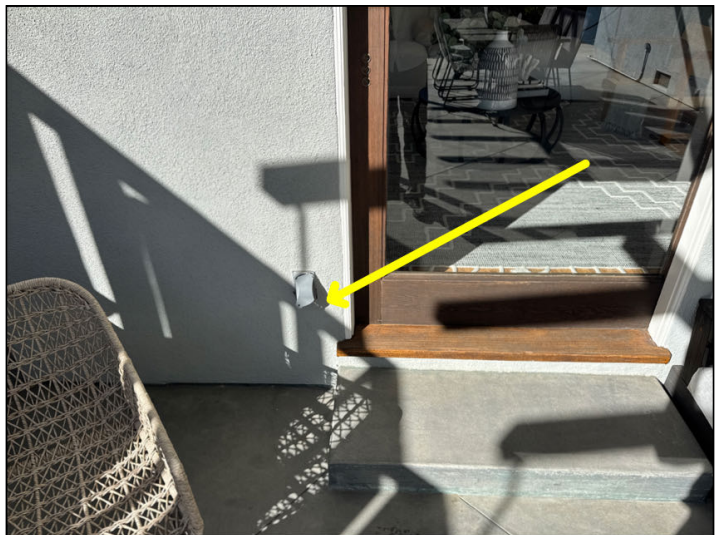
• Missing Ground Fault Circuit Interrupter (GFCI) protection in the home at the time of inspection. Although GFCI protection may not have been required at the time the home was built, for safety reasons, consider upgrading the electrical system to include GFCI protection at the following locations:

*Missing gfci*

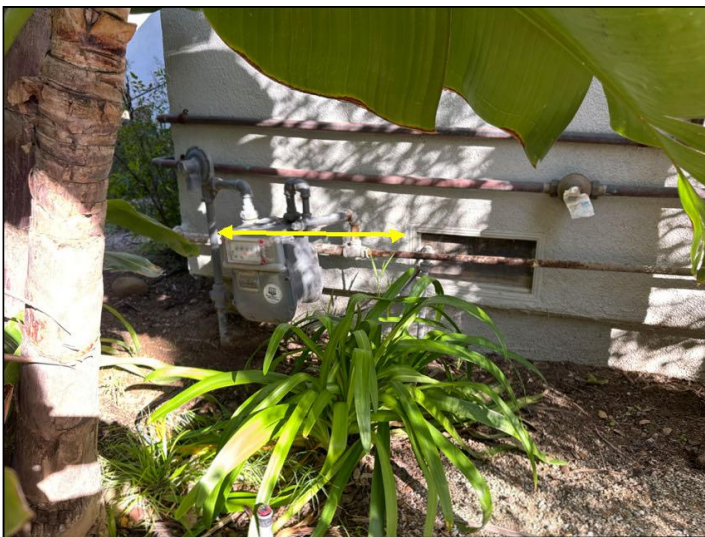
*clearance to opening*

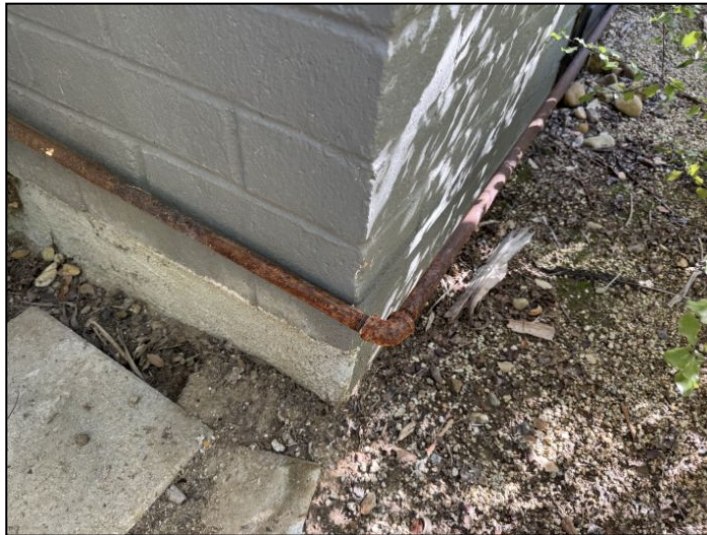
*gas line rust*

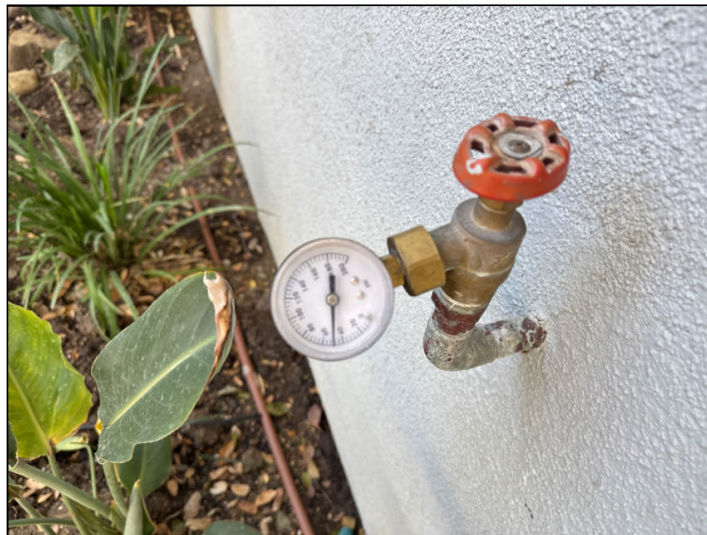
- 55 psi observed at the time of the inspection. Recommend adjusting pressure up to a max of 70psi.

*55 psi*

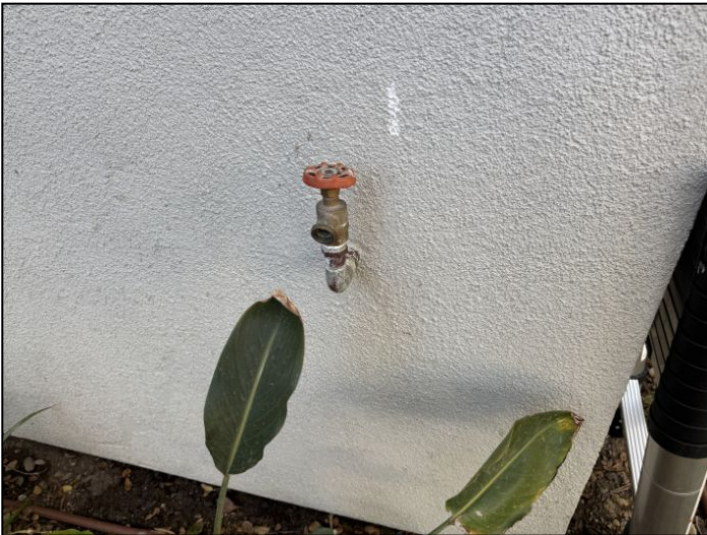
- The exterior hose bib(s) lack a visible anti-siphon device (vacuum breaker/backflow preventer). This device is intended to prevent contaminated water from being siphoned back into the homes potable water supply. Recommend licensed plumber remediate.

*no anti siphon*

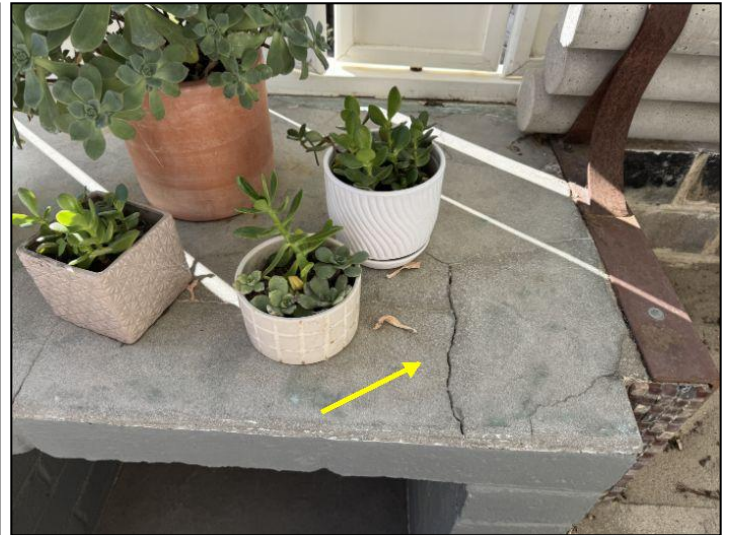
- Concrete counters observed as cracking. Recommend sealing all gaps and cracks to prevent additional deterioration.
- Start of rust observed on the patio posts at the time of the inspection. Recommend painting and sealing to prevent additional damage.

*cracking on exterior concrete*

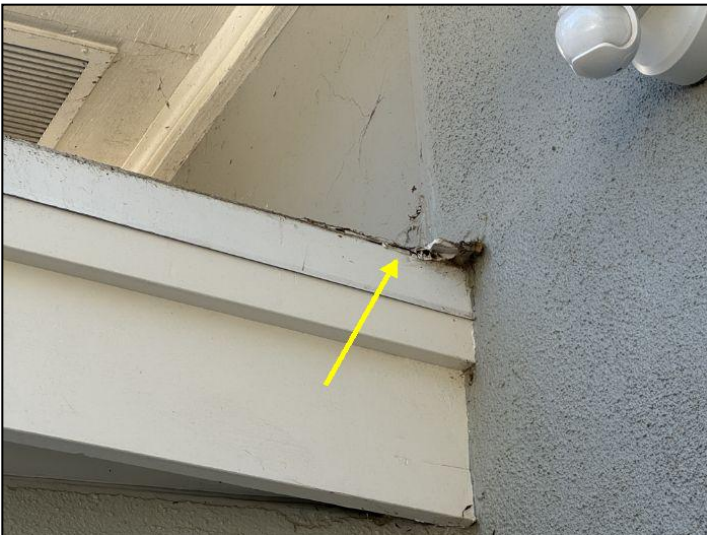
- Cracking observed in corner above roof. Recommend sealing all gaps and cracks to prevent moisture/pest intrusion.
- Low spot on roof edge allowing for moisture to pool at the time of the inspection. Recommend further evaluation and remediation by licensed roofing contractor.

*seal cracks/gaps- above garage*

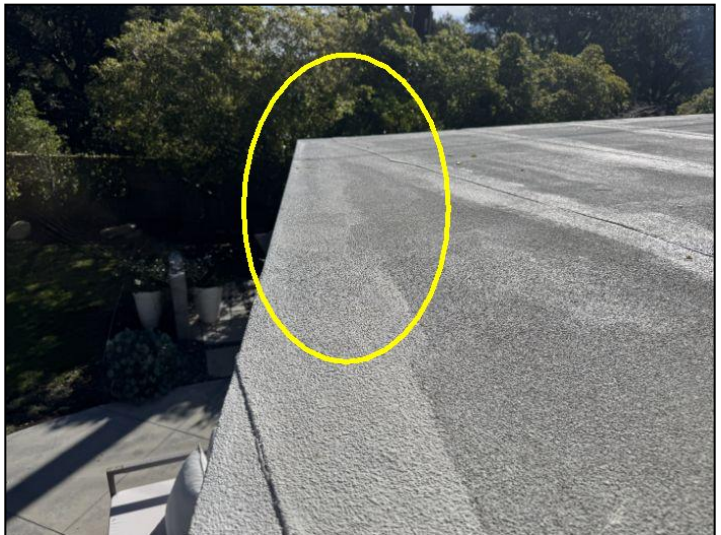
*pooling moisture*

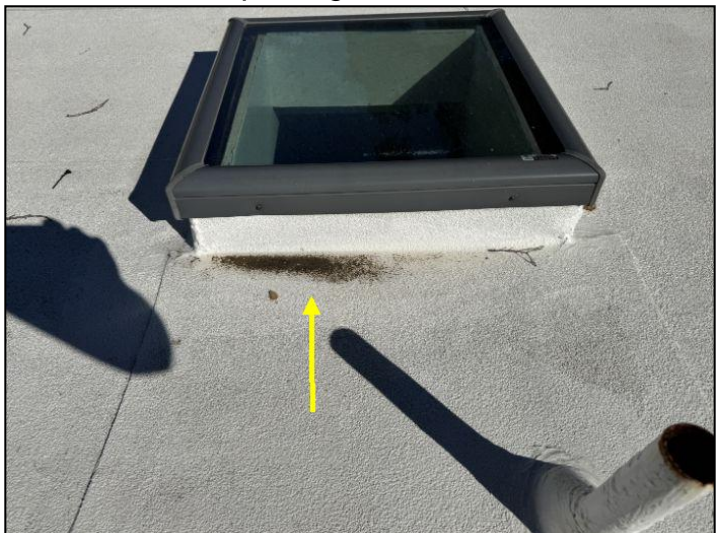
- Slight hump in roof at the time of the inspection. Recommend further evaluation and remediation by licensed roofing contractor.
- Moisture pooling behind skylight at the time of the inspection. Recommend roofing contractor further evaluate to prevent pooling and possible deterioration.

*moisture pooling and debris*

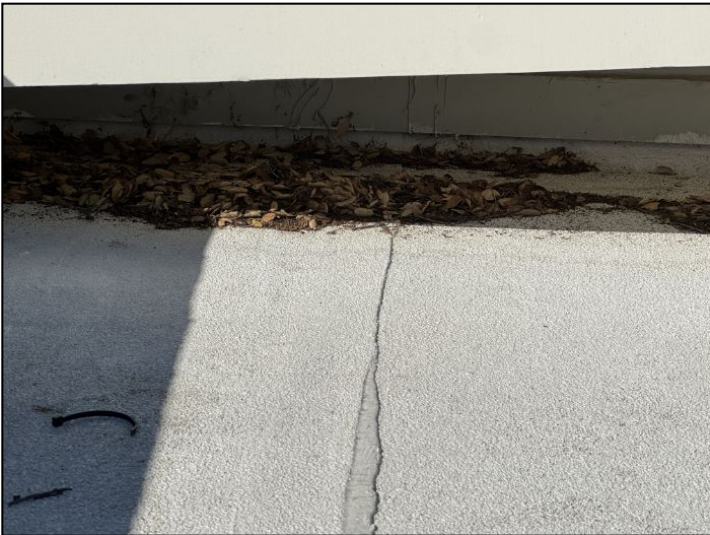
- Organic debris build up on the roof at the time of the inspection. This can harbor moisture and deteriorate the roof. Recommend further evaluation by licensed roofer and continued maintenance.

*debris*

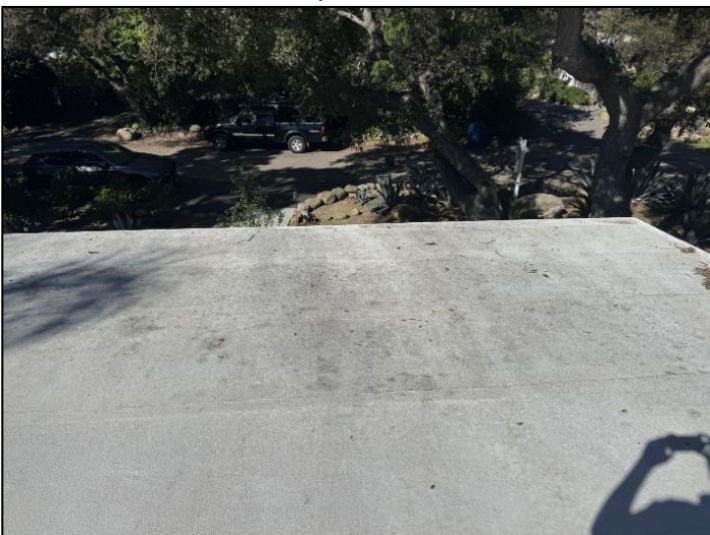
- Large oak tree dropping on roof at the time of the inspection. Recommend regular maintenance to maintain organic debris from piling on roof and causing moisture retention and deterioration.

*staining from oak*

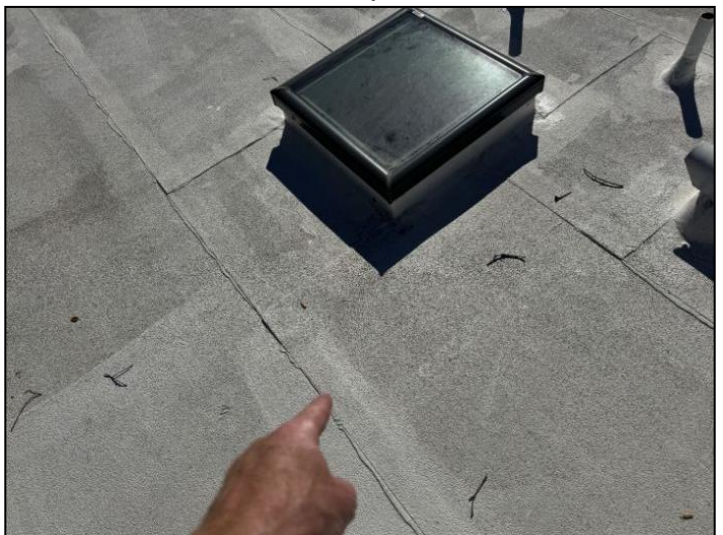
- Multiple "soft spots" observed on the roof at the time of the inspection. These soft spots may be indications of multiple different defects. Recommend further evaluation and appropriate remediation by licensed and insured roofing contractor.

*soft spot*

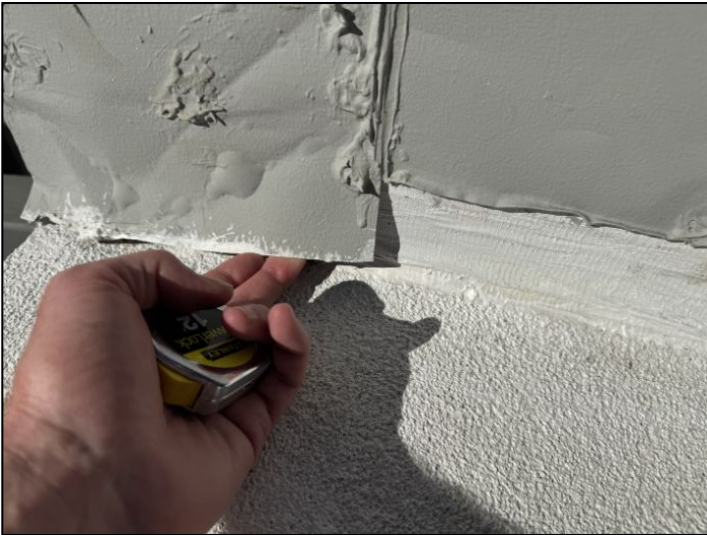
- Flashing observed as lifted allowing for moisture and pest intrusion. Recommend further evaluation and remediation by licensed roofing contractor.

*lifted flashing*

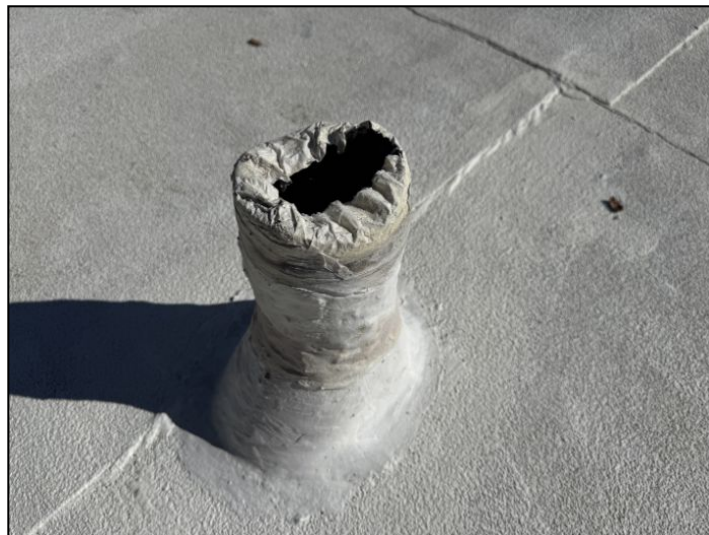
- The base and lower portion of the plumbing stack on the roof appear wrapped/sealed with a layered, fibrous material consistent with possible asbestos containing materials commonly used in pre 1980 roof penetrations. Recommend professional evaluation by a licensed professional prior to any work, repairs or modifications to avoid potential fiber release.

*roof plumbing stack - possible asbestos*

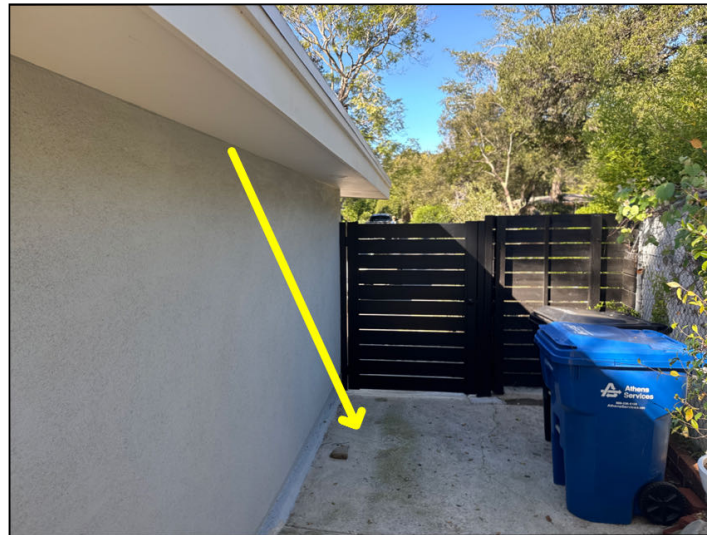
- No roof gutters at time of the inspection- Full installation recommended to keep water away from structure. Water can weaken the foundation and deteriorate the siding. Be sure to install splashblocks or extensions to carry water away. Recommend qualified contractor remediate.

Signs of moisture falling from lack of gutters

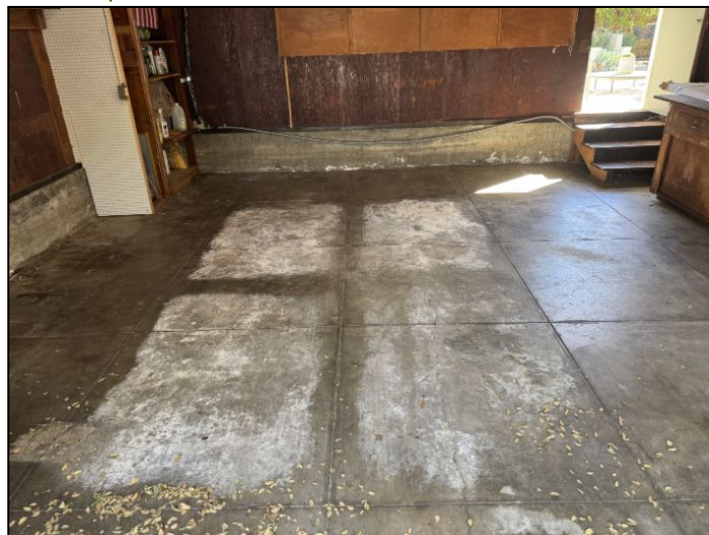
- White, powdery deposits observed on portions of the garage concrete slab, consistent with efflorescence- mineral deposits left from water. This is typical in older home slabs, especially without modern vapor barriers. Recommend monitoring for changes in extent or new moisture signs; if sealing is planned in the future, consider addressing underlying moisture sources first (improve site drainage and consult a specialist) to avoid issues with new finishes.
- Moderate cracks observed though out garage floor at the time of the inspection. These are appropriate cosmetic cracks for age of home. Monitor for separation and lift.

*signs of moisture intrusion/mild cracking*

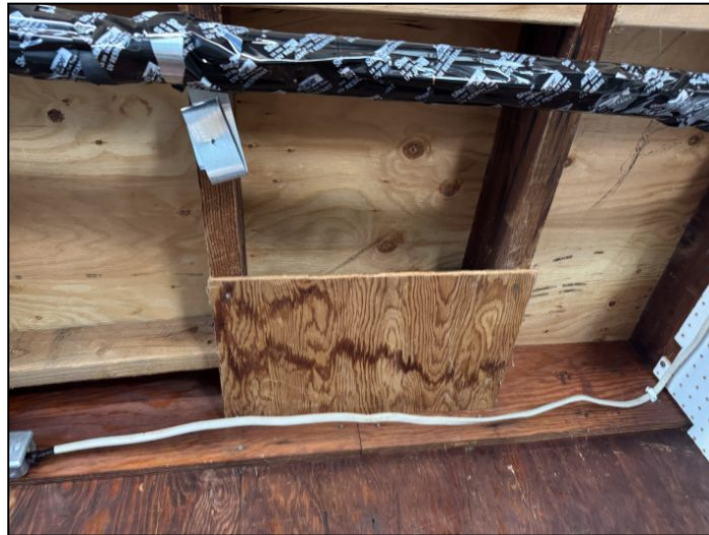
- Moisture stain observed in the ceiling of the garage at the time of the inspection. Indications of past or present leak, dry at the time of the inspection. Recommend review disclosures and further evaluation/remediation by a licensed contractor to prevent further moisture intrusion if needed.

*dry moisture staining*

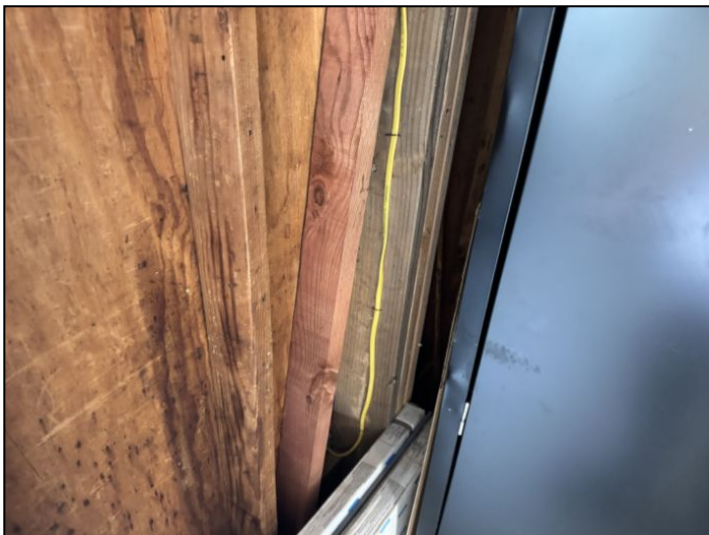
*unprotected romex*

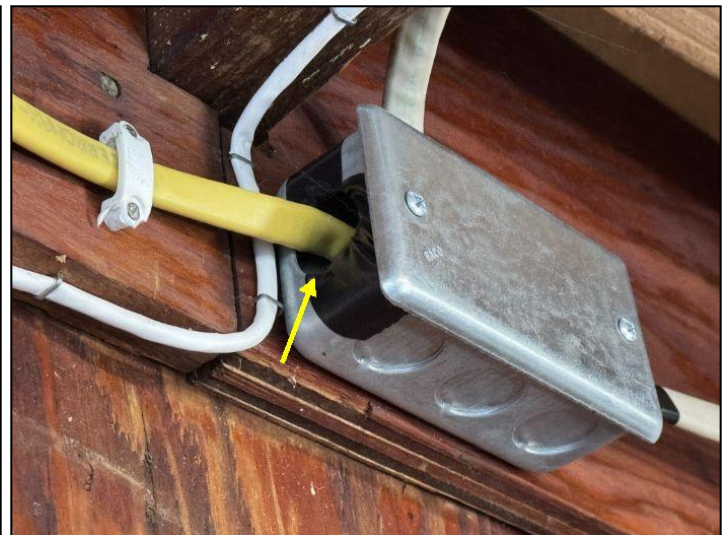
*no clamp or bushing - defect*

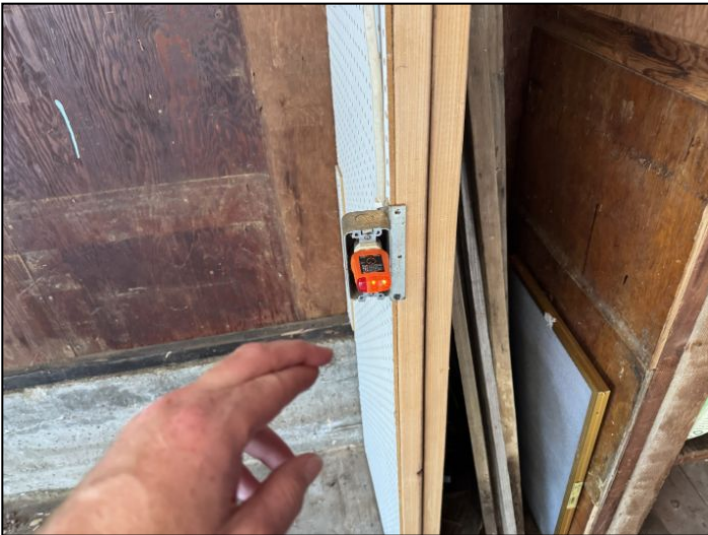
*missing GFCi and cover*

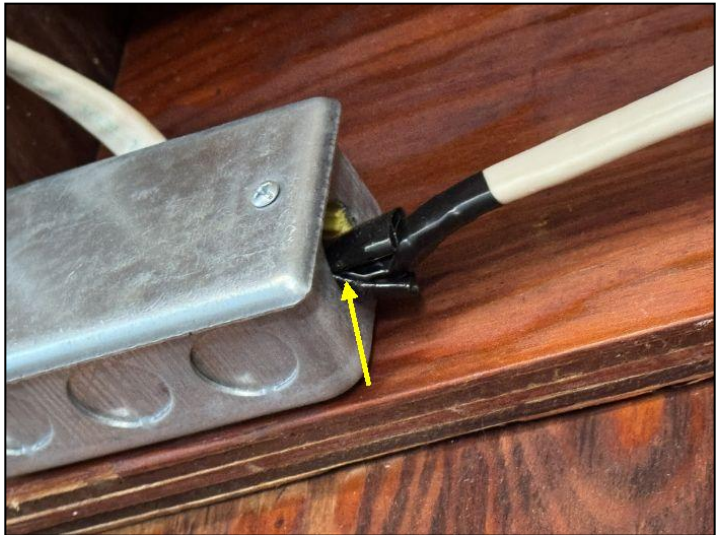
*no clamp or bushing*

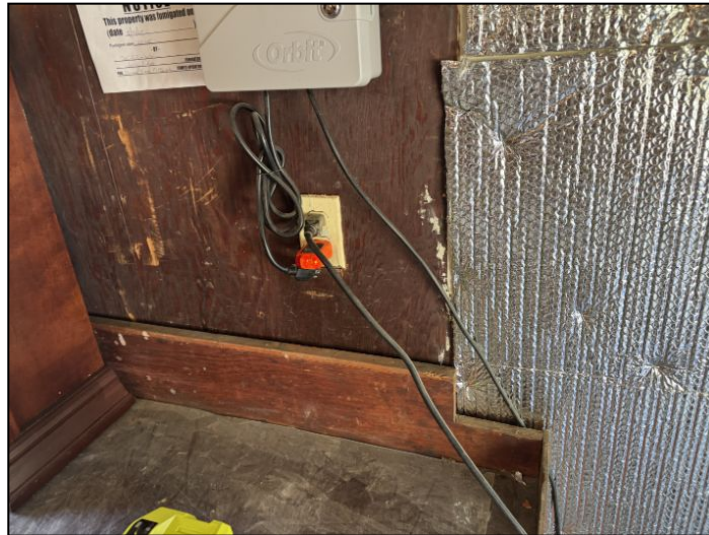
- Missing GFCI protection in the garage at the time of the inspection. Recommend remediation by qualified electrician for safety.

*no gfci*

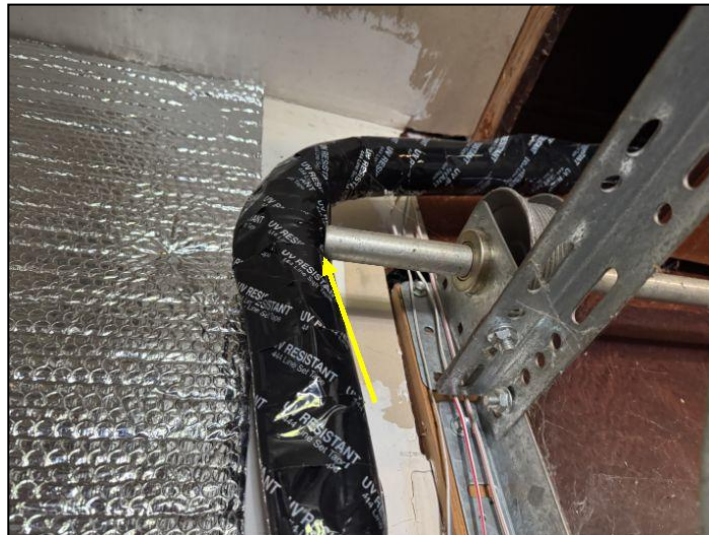
- While functional at the time of the inspection, the garage door was made significant noise when operating at the time of the inspection. Recommend servicing of garage door by qualified professional.
- Garage door only functional when holding down the open button the whole time at the inspection. Recommend remediation by qualified contractor.
- Garage door observed as rubbing heat pump lines at the time of the inspection. Recommend remediation to prevent damage.

*rubbing*

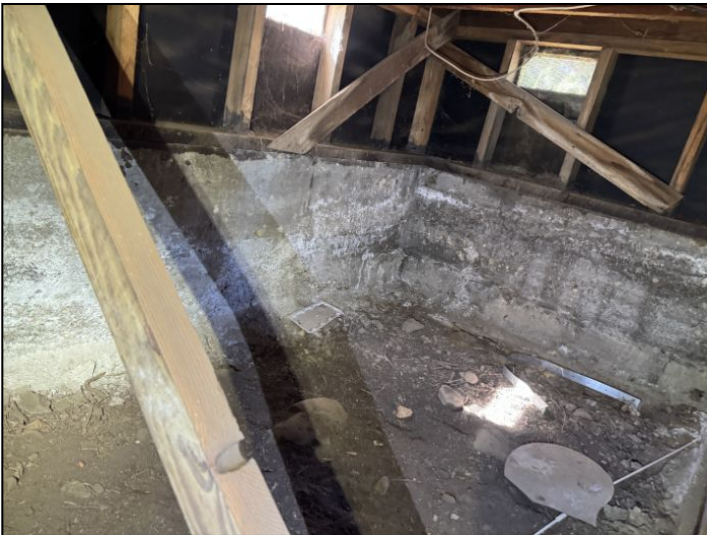
- Efflorescence noted on foundation walls- common sign of moisture passing through concrete. Recommend qualified contractor evaluate and remediate as appropriate, see "grading"
- Horizontal crack observed on the foundation at the time of the inspection. Recommend further evaluation/remediation by qualified contractor or structural engineer. Recommend remediating any drainage issues and sealing all cracks to prevent addition deterioration.

*efflorescence*

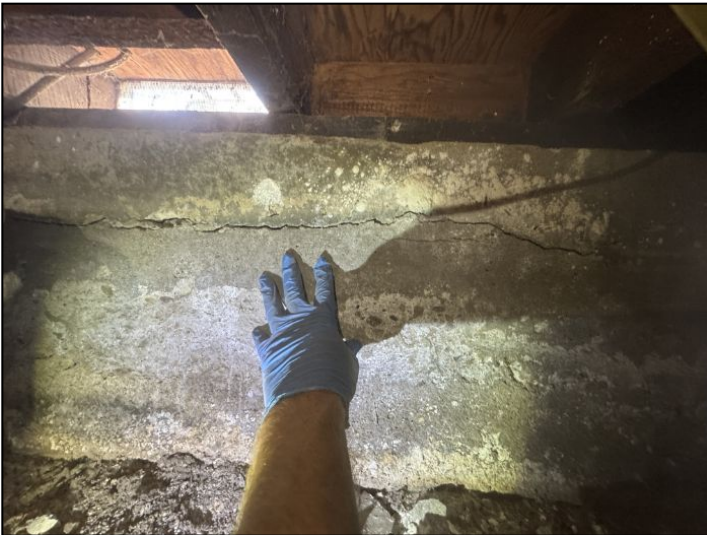
*horizontal crack*

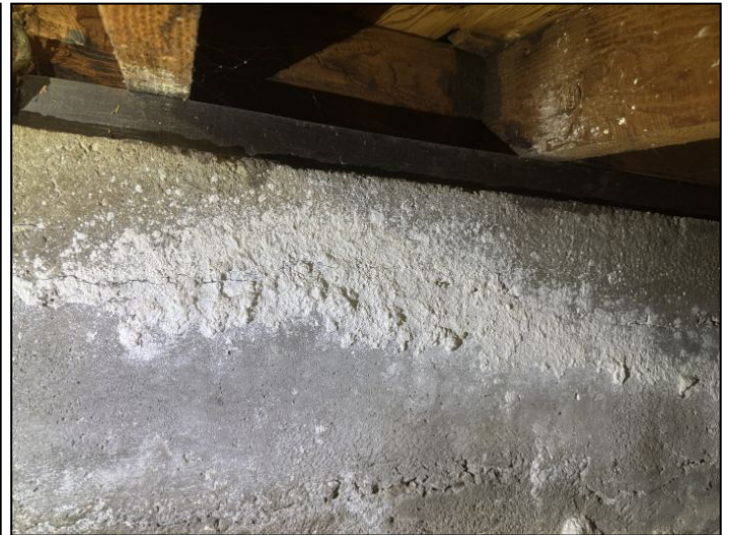
*horizontal crack with signs of moisture*

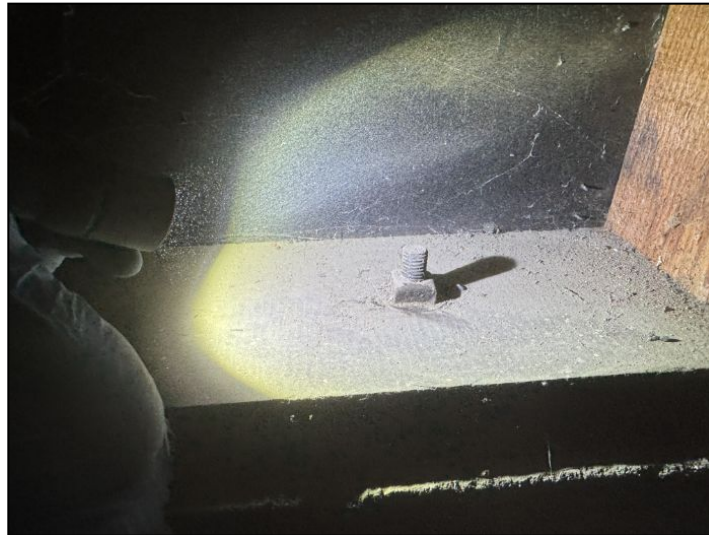
- Original anchor bolts observed with round washers at the time of the inspection. Due to the upgrades over time and the CA risk of earthquake, recommend further evaluation by qualified foundation contractor on the need to seismically upgrade the foundation.

*original foundation bolts*

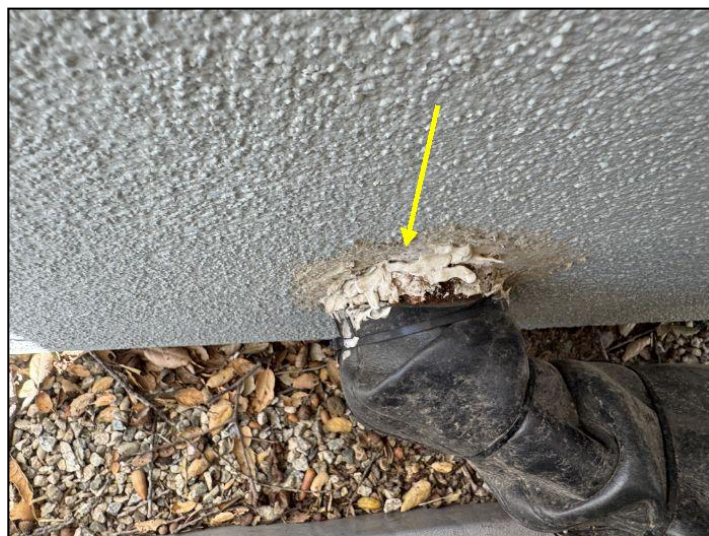
- Recommend resealing lines at the wall to prevent additional moisture and pest intrusion.

*substandard seal*

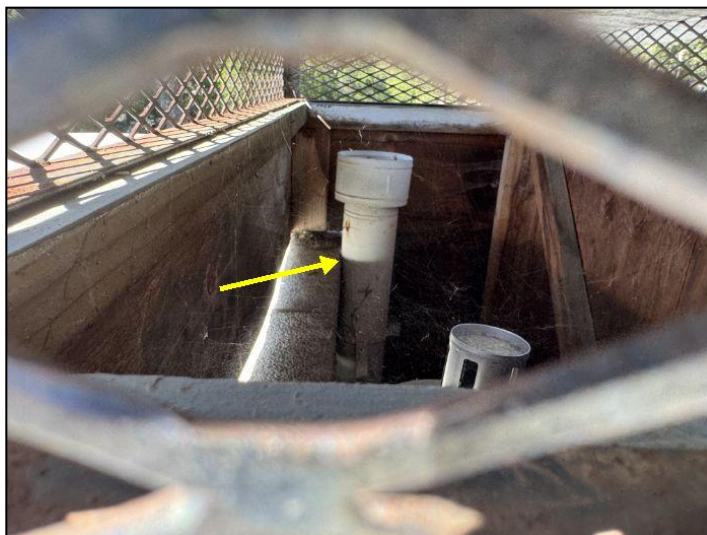
*clearance to combustible material*

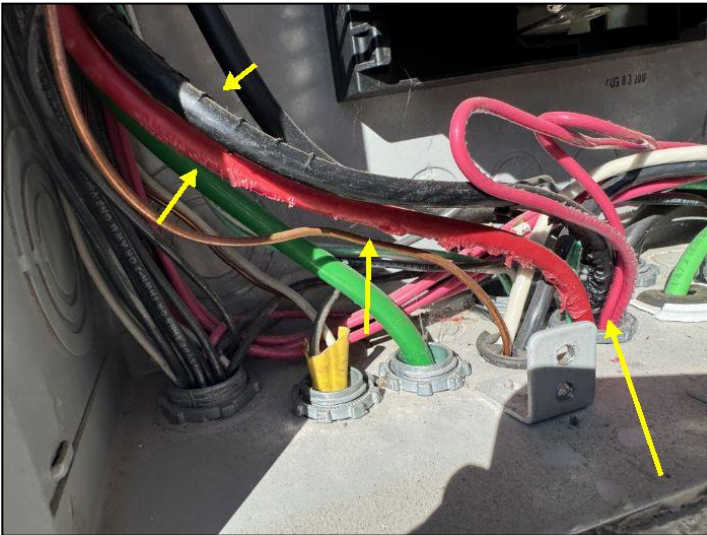
*damaged conductor insulation*

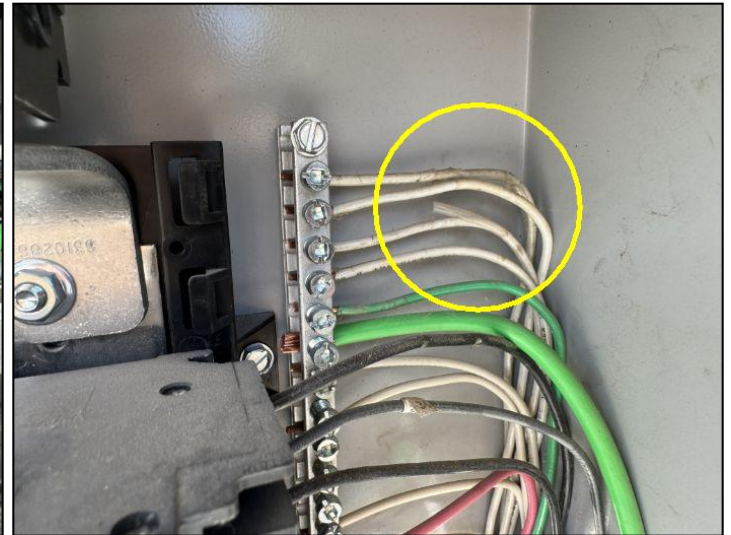
*damaged insulation*

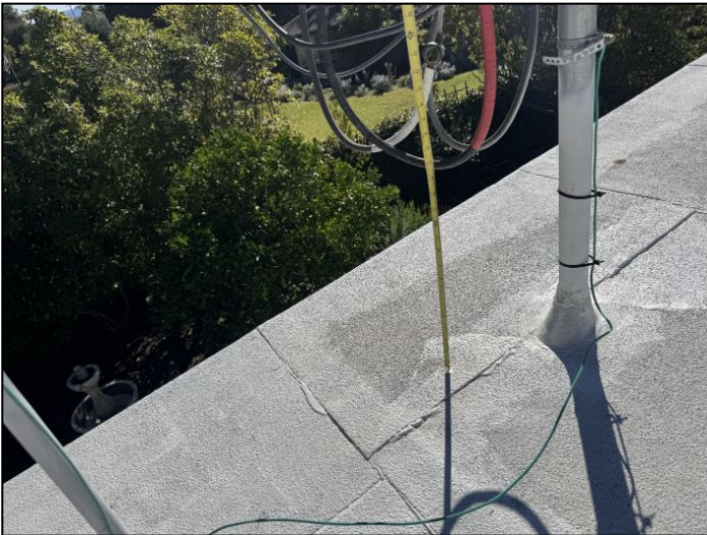
- There is an overhead service drop noted.
- The Service Entrance Cables were observed as being shorter than the allowable 18 inches from the roof and missing drip loops at the time of the inspection. Recommend qualified electrical contractor remediate.
- Damage to the service conductors above the roof observed at the time of the inspection. Recommend further evaluation/remediation by qualified electrical contractor.

2 inches shy

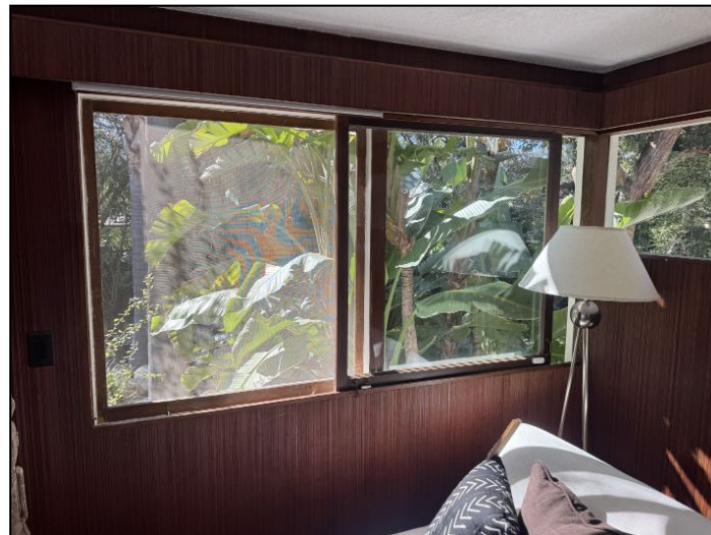
- Original wooden single pane windows and doors observed around the home. Servicing and maintenance to doors and windows will help with efficacy of use.

*original wooden windows/screens*

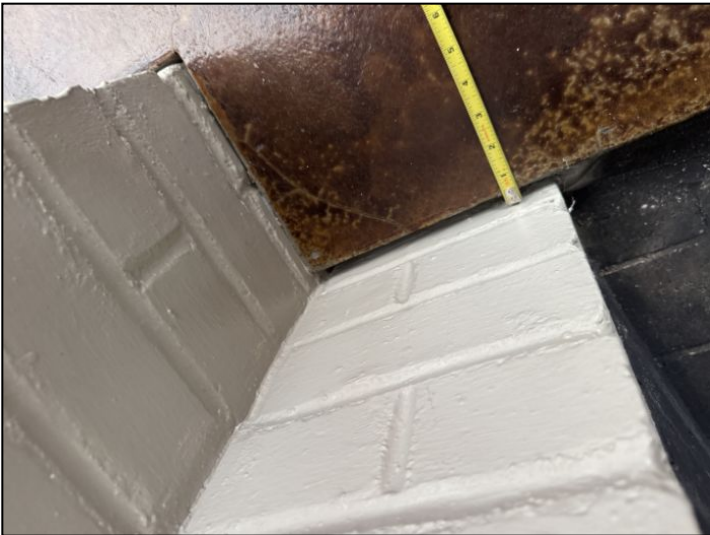
- Missing grout observed in the hearth of the fireplace at the time of the inspection. Recommend remediation by qualified fireplace professional.

*gap at hearth*

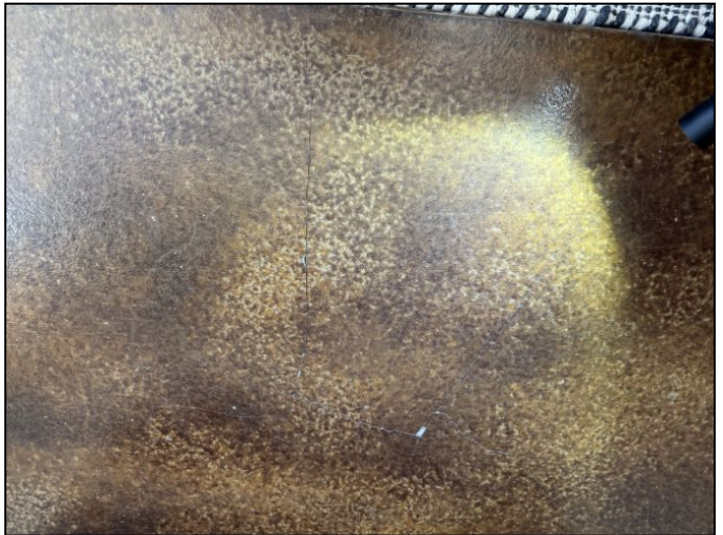
*crack in hearth*

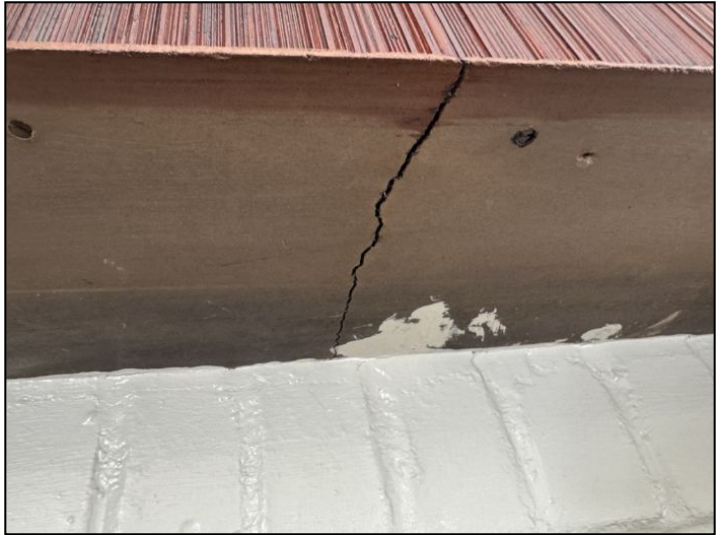
*crack in mantel*

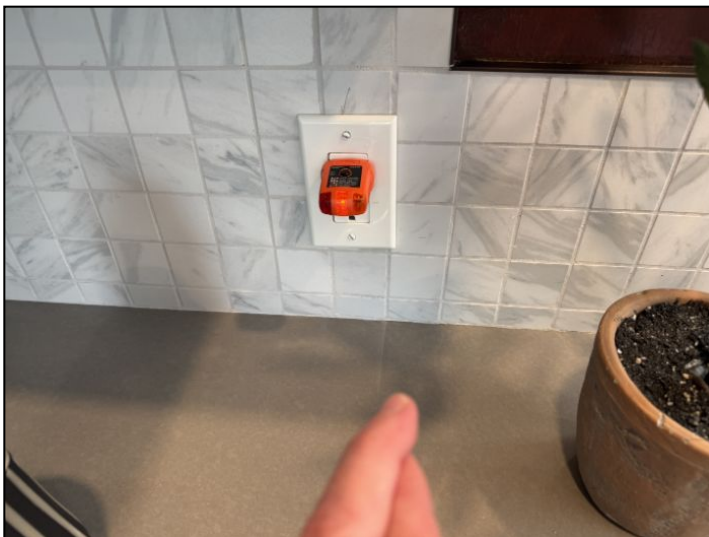
- Outlet with open ground observed in the kitchen. This is a defect. Recommend qualified electrician remediate.
- Exposed Romex electrical cable in the kitchen storage cabinets at the time of the inspection. This is defect and safety hazard. Recommend licensed electrician remediate

*open ground/no gfci*

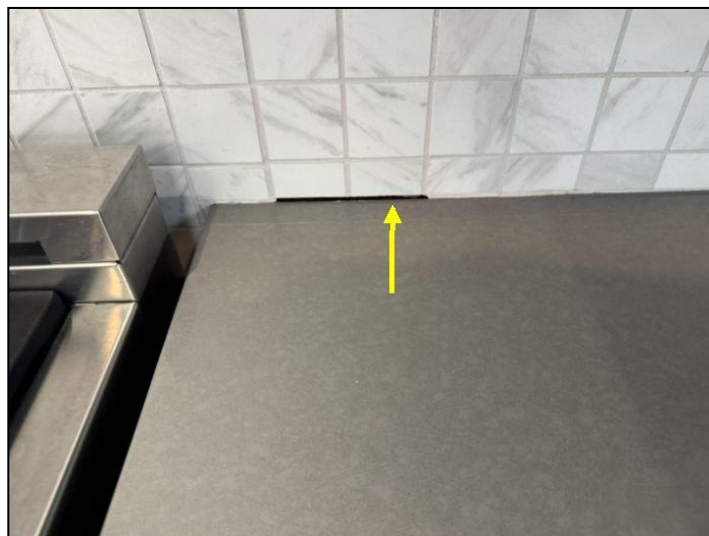
- Missing grout in back splash. Recommend remediation to prevent moisture intrusion.

*missing grout*

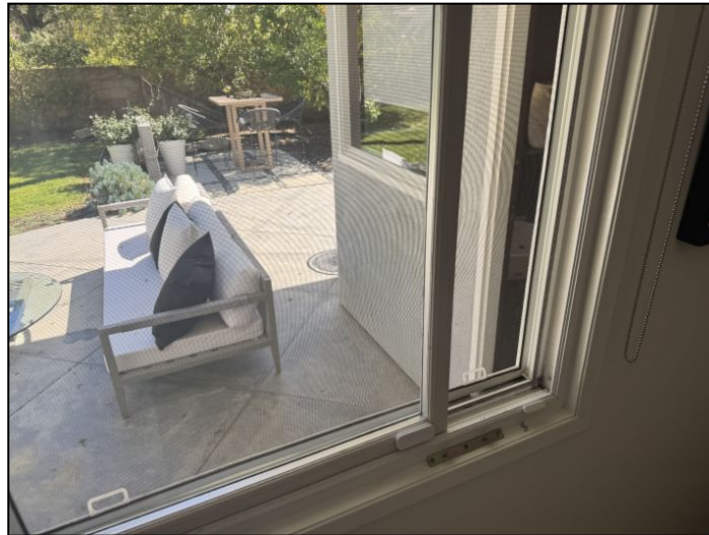
- One or more window was observed as a little tight on the day of the inspection. Recommend regular cleaning and maintenance for proper use.

*tight window, recommend maintenance*

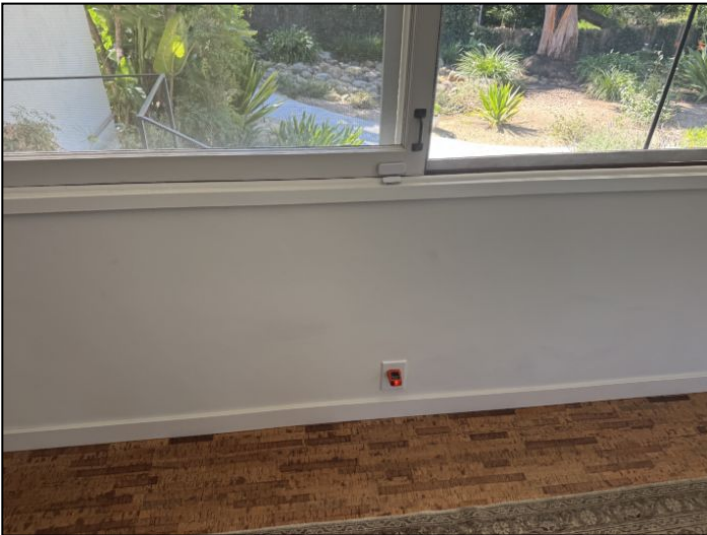
- Open ground three prong outlets noted throughout the home at the time of the inspection. This constitutes a safety hazard. Recommend full electrical evaluation. Recommend remediation by licensed Electrician.

*open grounds in all bedroom outlets*

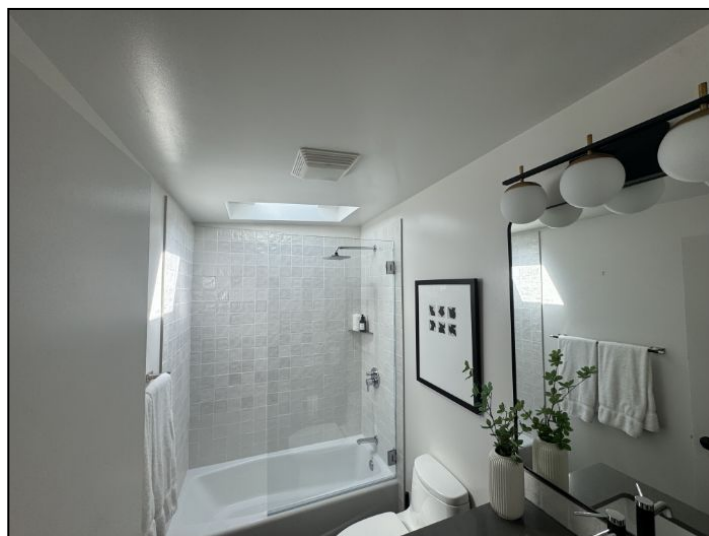
- While functional, bathroom fan(s) observed as excessively noisy at the time of the inspection. This may be a sign of age. Recommend remediation by qualified contractor.

*loud fan*

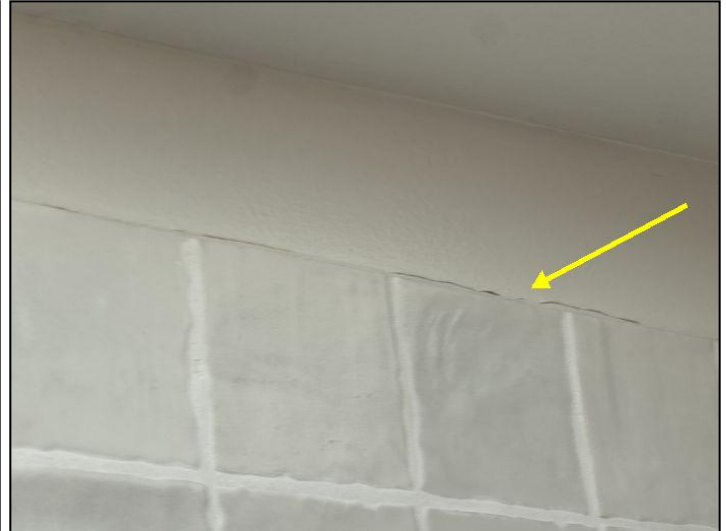
*seal gap and cracks- above shower walls*

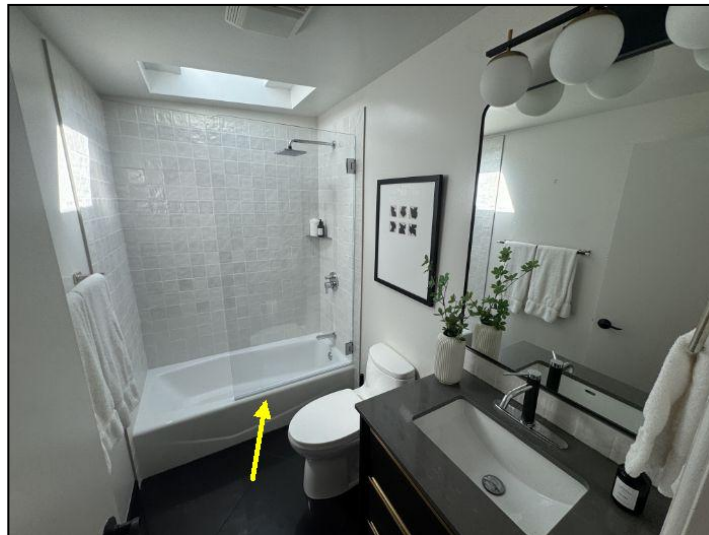
*glass panel leaking*

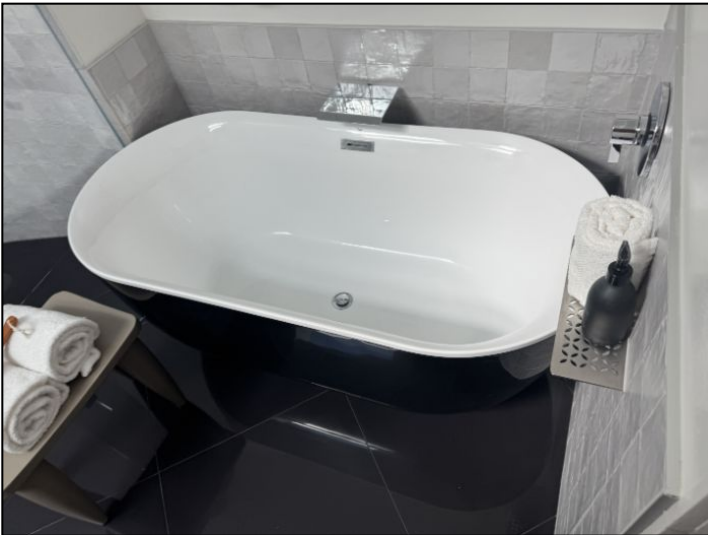
- Handle does not match the labeling. Recommend reinstallation to match hot/cold.
- The bathtub was observed as not attached to the floor and shows signs of movement. This can stress plumbing connections, cause leaks, or create instability. Recommend securing by qualified contractor or plumber.
- Exposed plumbing/wall at tub plumbing. Recommend sealing to prevent any moisture intrusion.

no secure

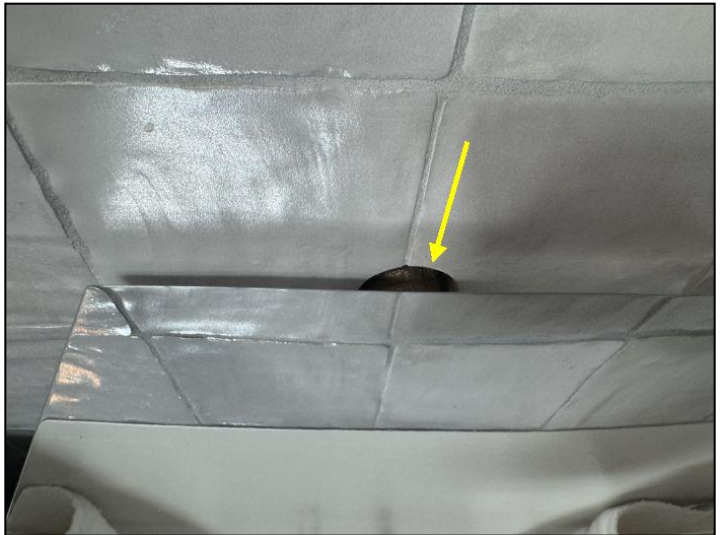
recommend sealing gap

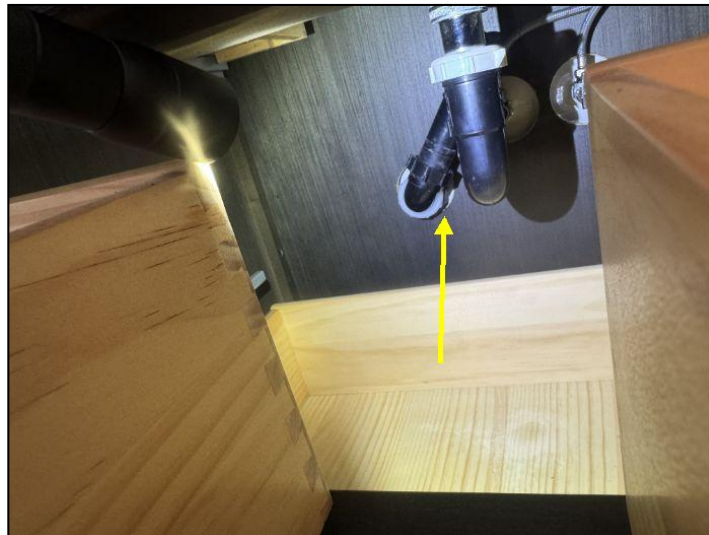
- An S-trap configuration is present beneath the bathroom sink. S-traps are prohibited in modern plumbing because they allow siphoning of the trap seal, which can release sewer gases into the home and create a health hazard. Recommend replacement with a properly vented P-trap by a licensed plumber to meet current standards and ensure safe drainage.

s-trap

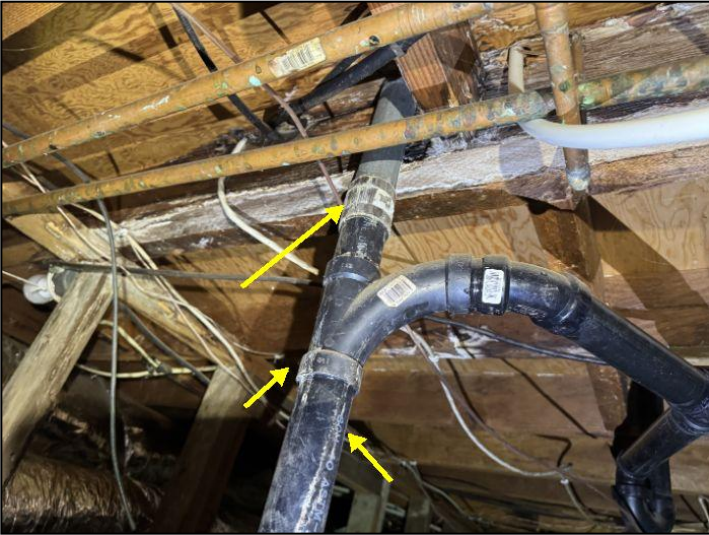
- Active leak observed at one or more drain pipe/s. Recommend review and repair by a qualified plumber.
- A manual gas shutoff valve on the black iron supply line is suspended from the crawlspace joist using twine/string. Gas valves and piping must be securely supported and mounted to prevent movement, strain on fittings, or accidental damage. Hanging via twine is improper and poses a risk of disconnection or leak over time. Recommend evaluation and proper securing (e.g., metal strap or bracket) by a licensed plumber or gas fitter.

*leaking plumbing in crawlspace*
