# BEST COAST HOME INSPECTIONS

## Confidential Inspection Report

, Santa Paula, CA 93060

Inspection prepared for: Sample Sample

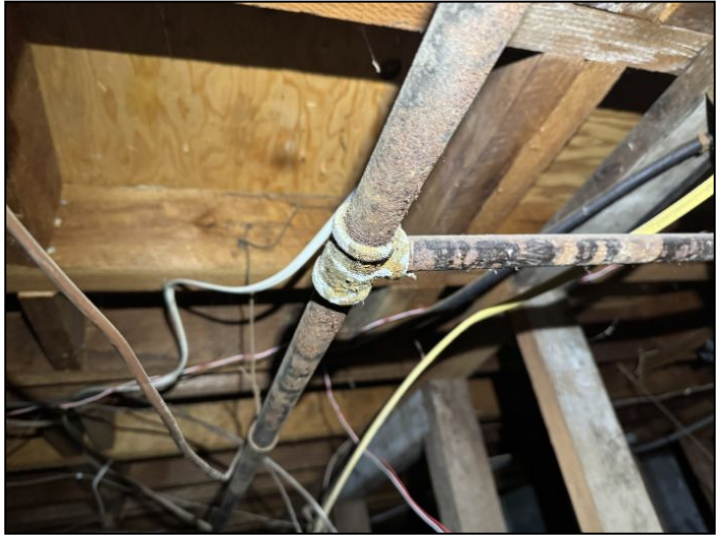
*rust on gas line*

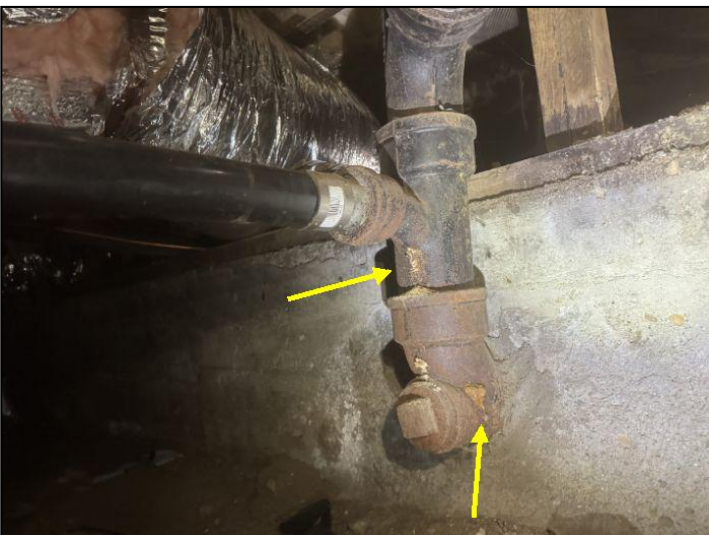
*cast iron with rust cysts*

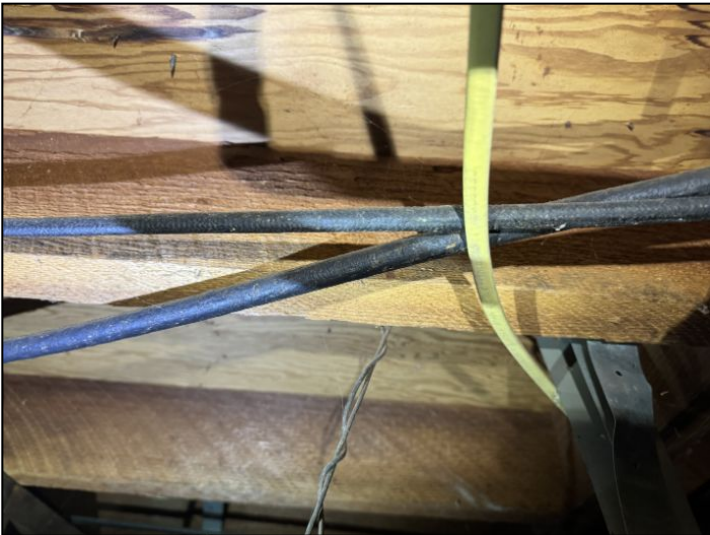
*original cloth wires*

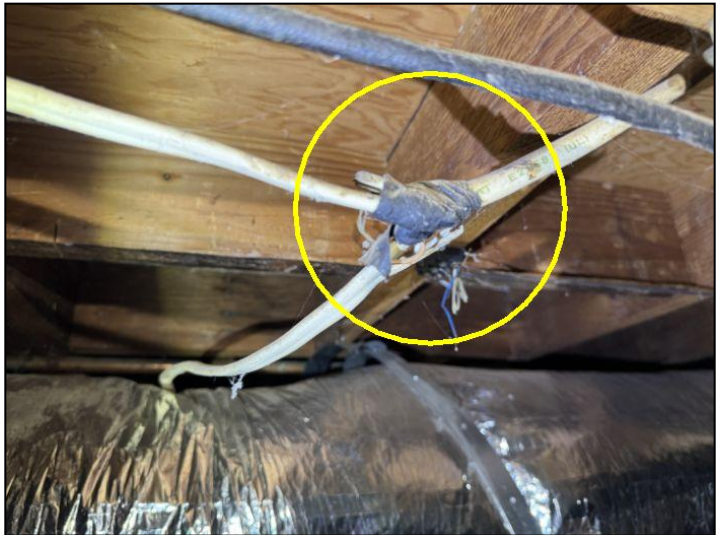
*hazard*

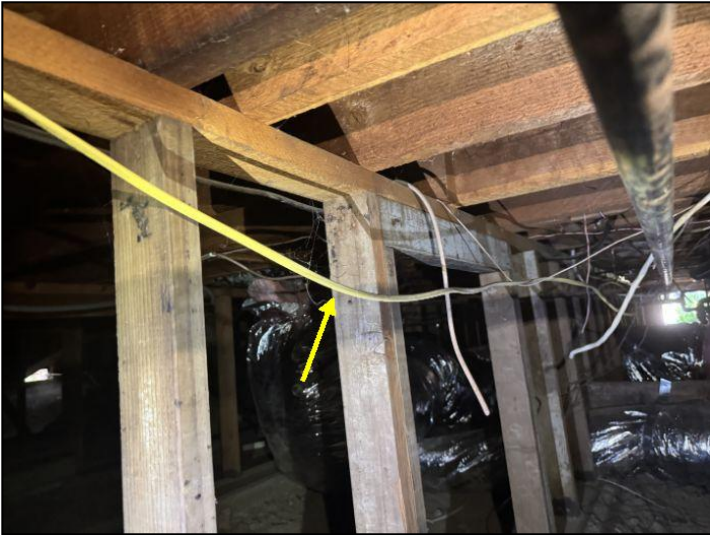
*unsupported romex*

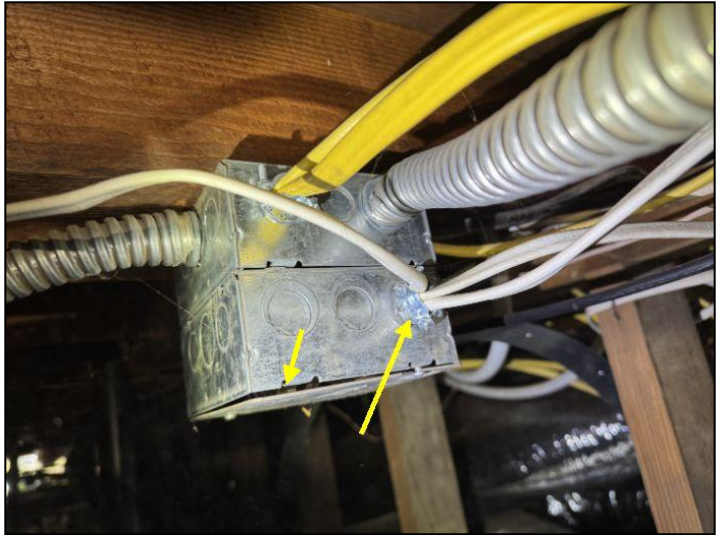
*three into one/loose connection*

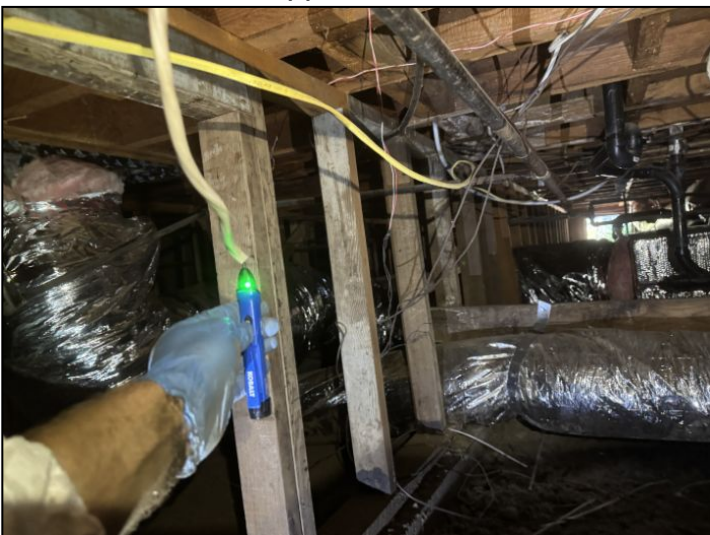
*abandoned electrical- recommend removal*

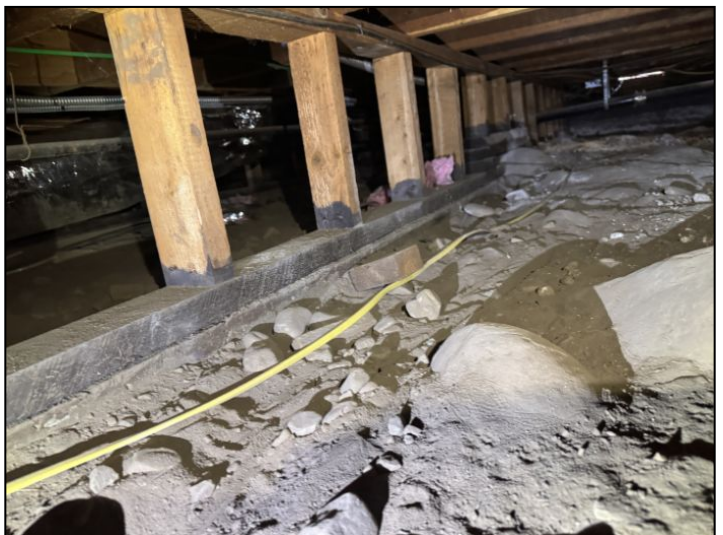
*unsupported romex - on ground*

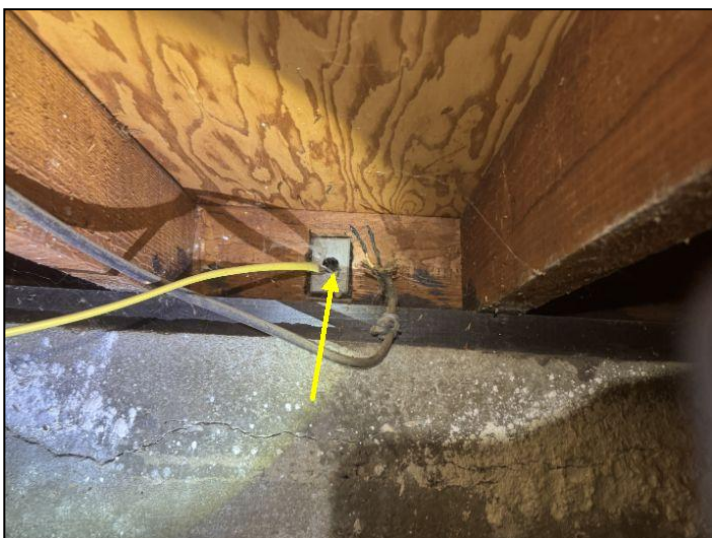
*no clamp/exposed conductors - safety defect*

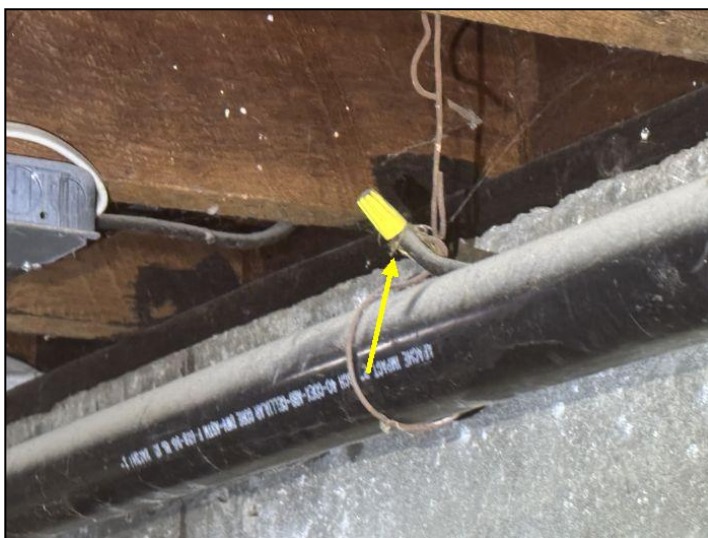
- Capped, cut live cloth wire outside a junction box. Recommend remediation by licensed electrician.
- See "garage electrical" regarding junction boxes and combining grounded and ungrounded conductors.

*capped cut cloth wire outside junction*

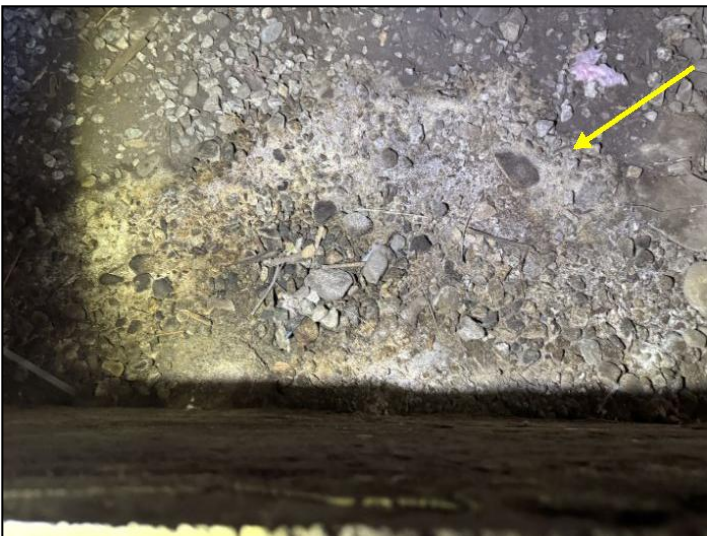
- Evidence of past moisture intrusion in the crawlspace at the time of the inspection. See "grading". Recommend monitoring moisture settlement and maintaining all moisture flow away from the foundation.
- Evidence of moisture intrusion on posts in the crawlspace. Recommend remediation to prevent moisture from entering the crawlspace to prevent addition deterioration and possible microbial growth. see "grading"

*moisture at crawlspace entrance*

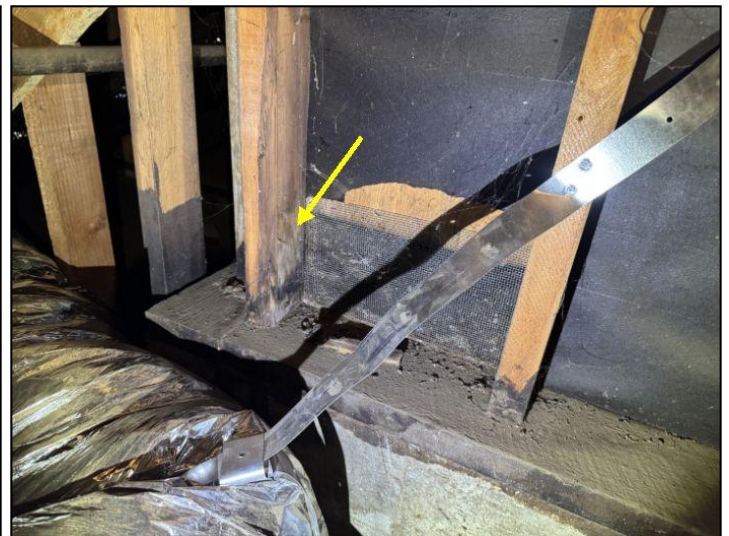
*moisture at vent*

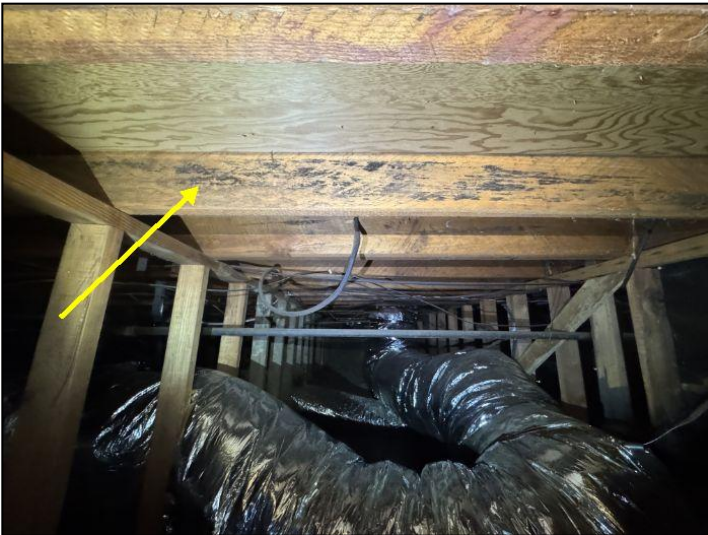
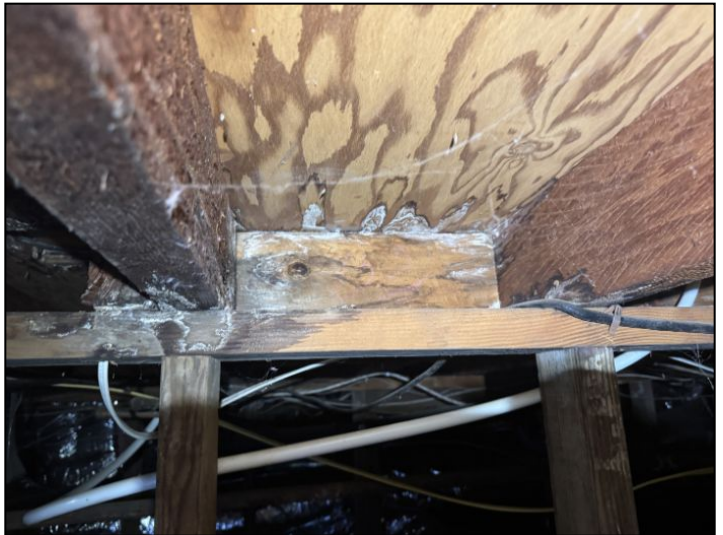
- Moisture intrusion and possible microbial growth observed on the underside of the flooring at the time of the inspection. Recommend further evaluation and remediation by qualified contractor.

*suspected microbial growth*

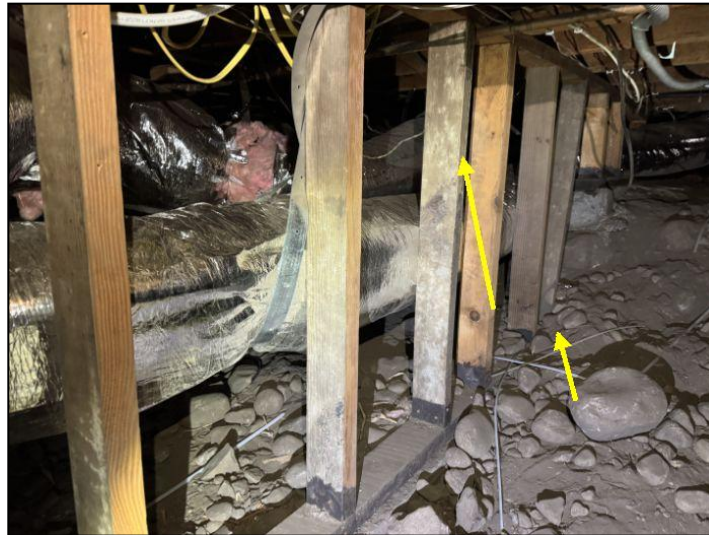
- One or more support posts have direct wood to dirt contact at the time of the inspection. This is a defect that can lead to the deterioration of the support post and needs to be evaluated and remediated by a qualified foundation contractor.

*possible growth/soil contact*

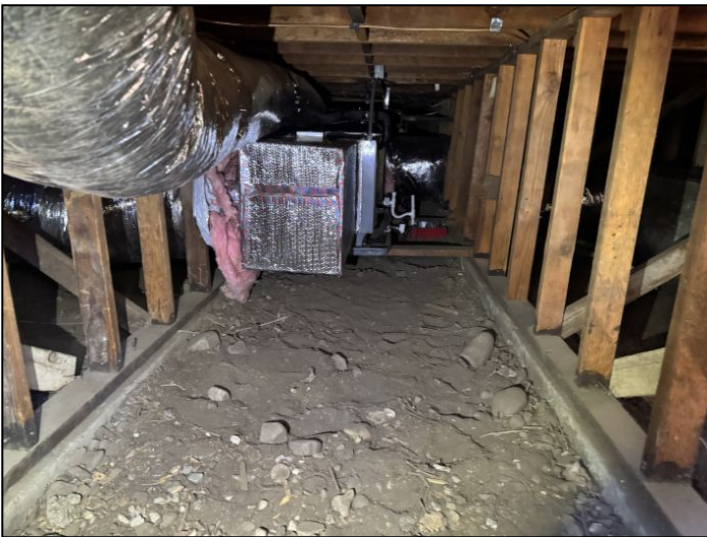
*air handler location*

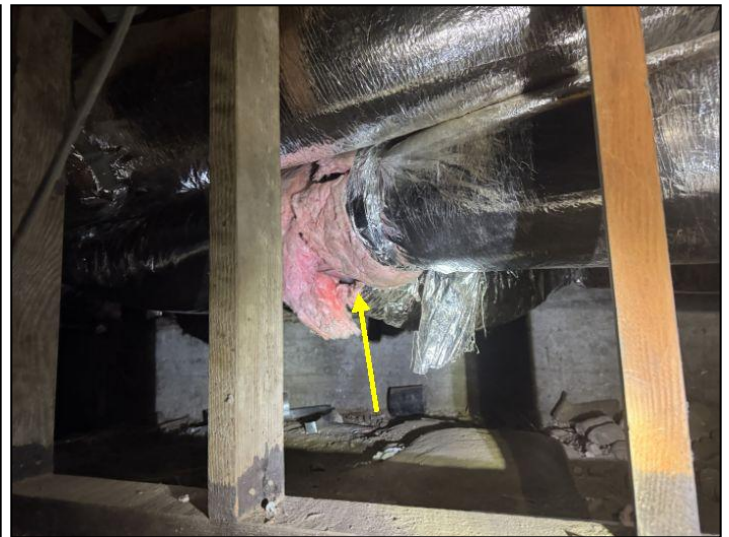
- Due to the location of the air handler, we recommend having the unit serviced and filter changed before moving in.
- Damage to duct work insulation observed in crawlspace. Recommend sealing up failed seams for efficiency of use. Recommend qualified contractor.

*damaged insulation to ducts*
