# SAMPLE INSPECTION

## Confidential Inspection Report

Sample St. , Camarillo, CA 93010

Date of Inspection: 2/14/2025 Time: 1015

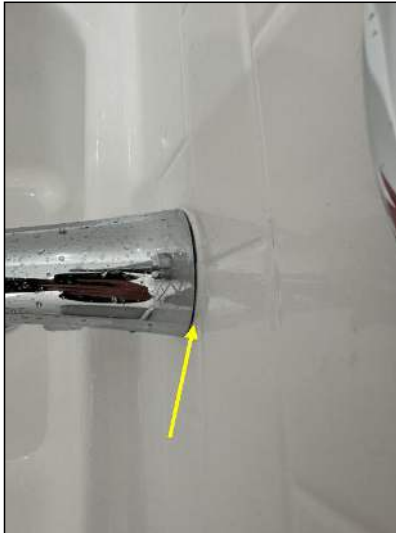
*gap at shower faucet-upstairs hallway*
