Confidential Inspection Report

, Oxnard , CA

Date of Inspection: 9/1/2025 Time: 10am

***BEST COAST
HOME INSPECTIONS***

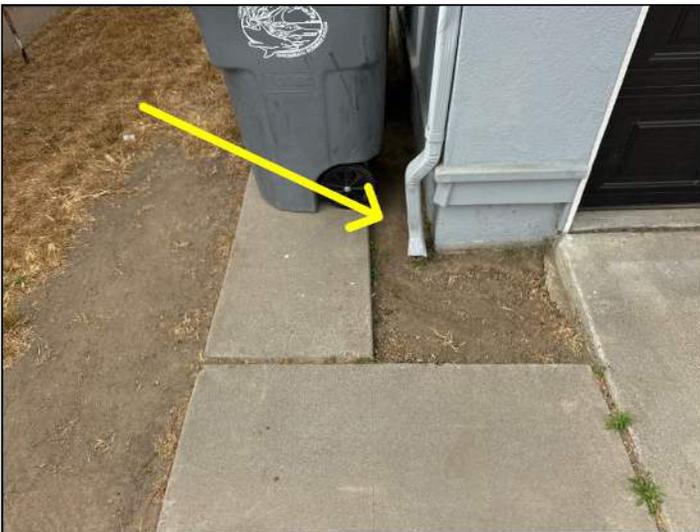
- Gutter downspout observed as draining right next to the foundation wall with signs of moisture settlement at the time of the inspection. Recommend hiring qualified contractor to extend downspout to avoid moisture settlement near foundation

Poor drainage

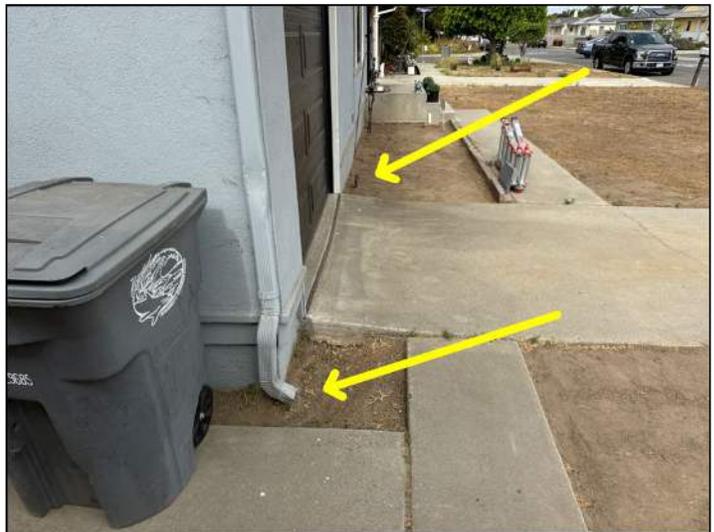
- The exterior grading was observed as improperly sloped in a couple locations around the foundation not allowing for the appropriate fall away from the home. Recommend creating the proper slope away from the foundation to allow for proper drainage and prevent moisture damage to the home. Remediation by licensed contractor recommended.

Poor grading

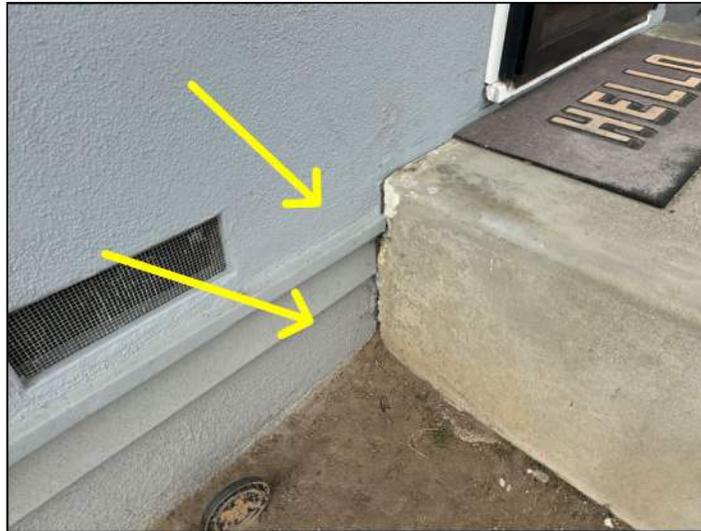
- Separation between the home and the porch landing observed at the time of the inspection. Recommend further evaluation/remediation by qualified contractor to prevent continue deterioration.

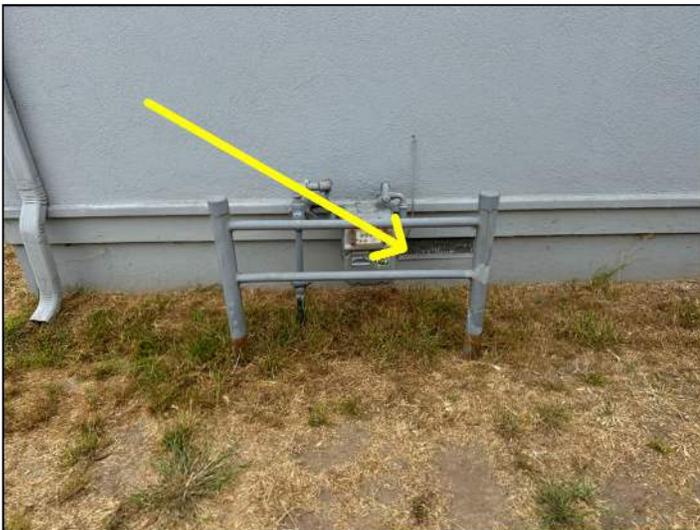
- Main gas meter was located within 36 inches of door and electrical at the time of the inspection. The main gas meter regulator vent terminations should not be within 36 inches of an ignition source, electrical equipment and openings to the building. This clearance extends ten feet above and 36 inches below the regulator vent terminations. Recommend contacting utility company for further evaluation and remediation of gas valve clearances. Please see diagram.
- Rust observed on the main gas valve at the time of the inspection. Recommend gas company remediate to prevent further rust/deterioration.

Too close to opening

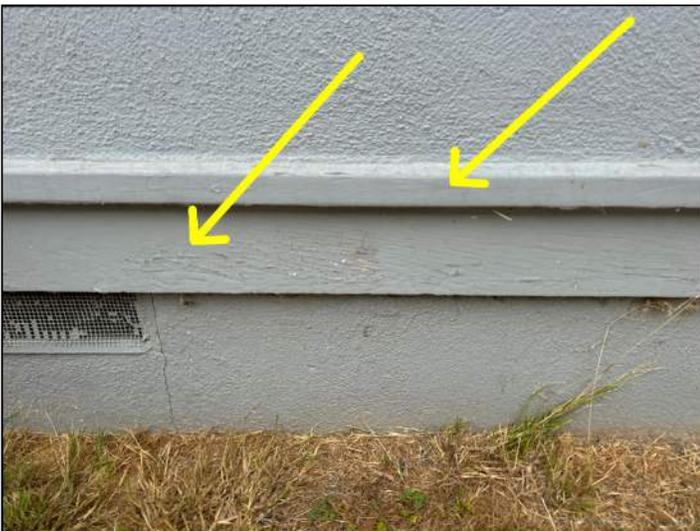
- Peeling paint observed on the siding at the time of the inspection recommend for the evaluation/remediation by qualified contractor
- Wood siding above the roof observed with age and possible moisture intrusion. Recommend further evaluation of siding by qualified contractor for the addition of counter flashing to prevent addition moisture intrusion.

Peeling paint

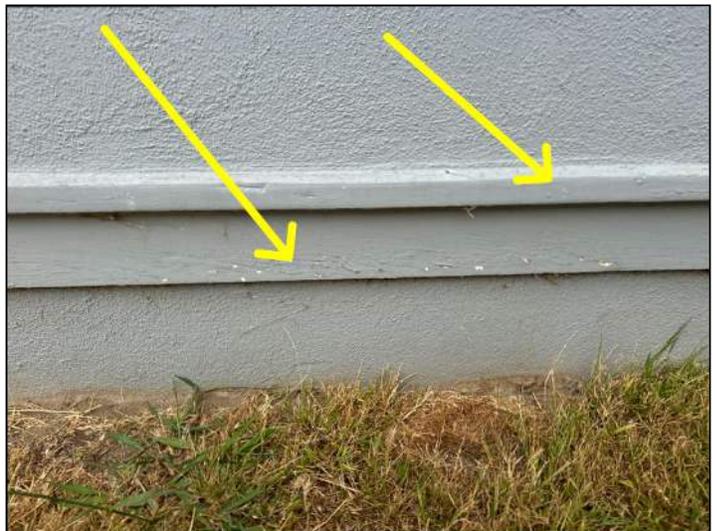
Peeling paint

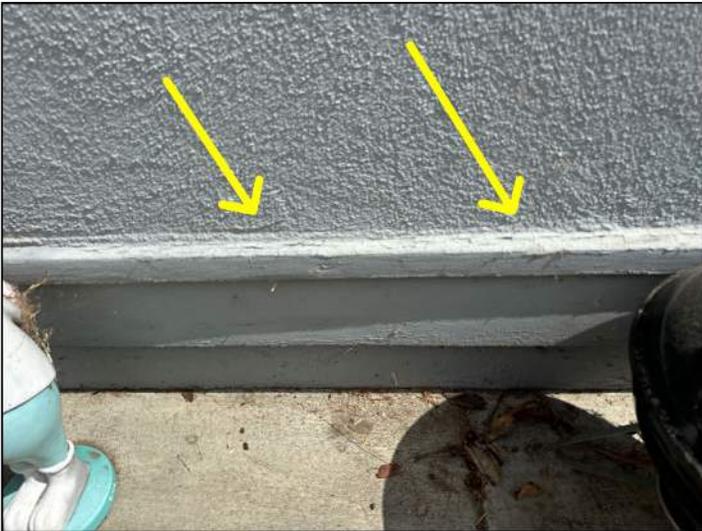
Cracked paint

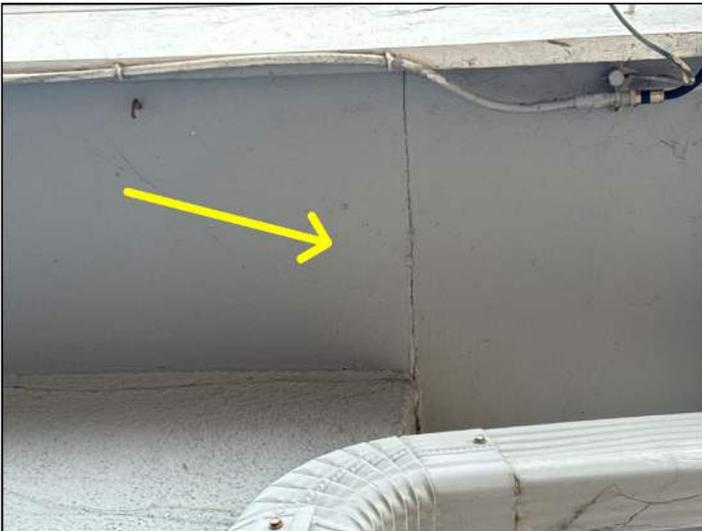
- Small crack observed in the eave board at the time of the inspection. Recommend monitoring and sealing all gaps in the building's envelope to prevent moisture and pest intrusion and maintain the efficacy of the HVAC systems.

Seal cracks

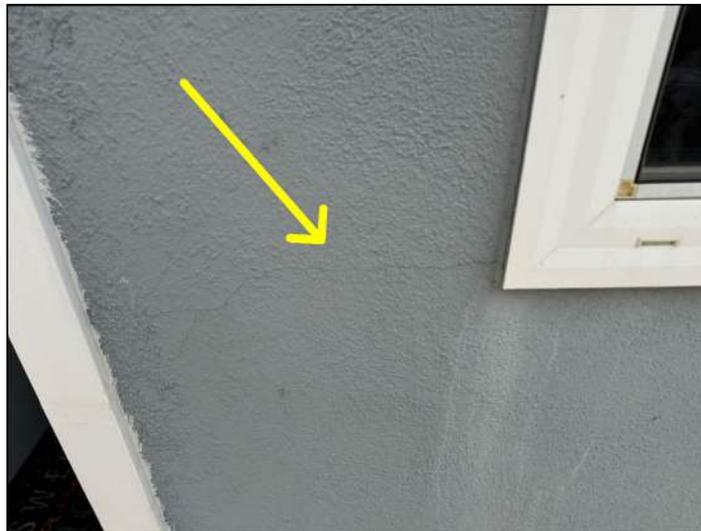
- Small settlement cracks in the stucco observed at the time of the inspection. Less than 1/16 inch are considered normal stucco settlement. Despite this, we recommend monitoring cracks for any change. We recommend monitoring and sealing holes & gaps in the stucco to keep water intrusion from causing damage.

minor settlement crack

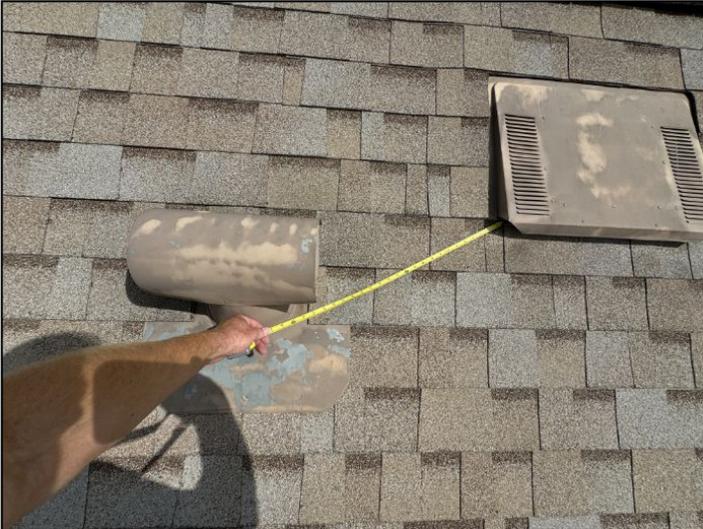
- Kitchen exhaust vent observed as only 2 ft from the passive attic vent at the time of the inspection. This is a potential defect as a minimum of three feet is recommended to prevent exhaust re-entry which could cause possible microbial growth or air quality issues. Recommend further evaluation by a licensed and insured HVAC professional for the need to relocate vent.

kitchen exhaust next to attic vent

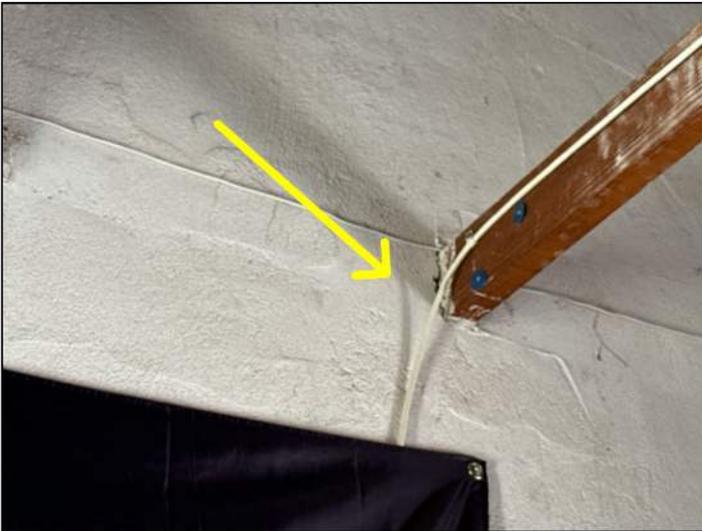
- Break in the firewall wall at the time of the inspection. The wall and ceiling between the garage and the home is considered a firewall. Any break in a firewall could allow a garage born fire into the home and constitutes a fire hazard. Recommend remediation by licensed contractor.
- Damage to drywall observed at the time of the inspection. Recommend further evaluation/remediation by qualified contractor to maintain firewall.
- Garage top place observed as notched over 50 percent to make room for the laundry vent at the time of the inspection. Recommend remediation by qualified contractor for the addition of a metal plate for reinforcement.
- Evidence of wood destroying pest in the framing in the back of the garage at the time of the inspection. Recommend further evaluation and remediation by licensed pest control company.

Seal crack in firewall

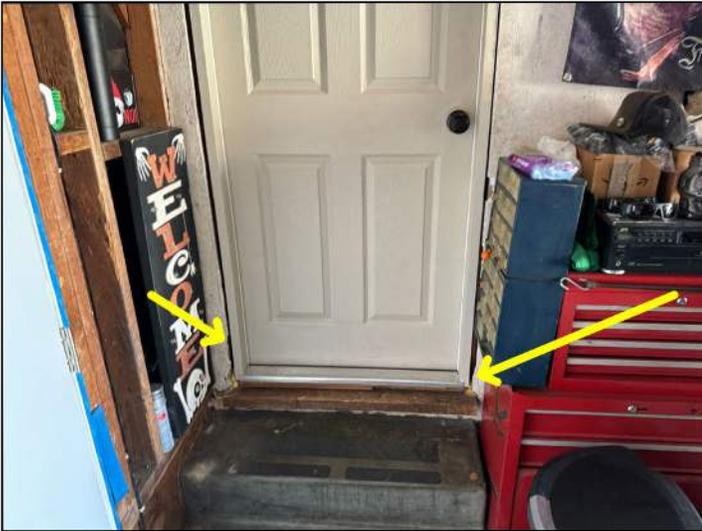
break in firewall

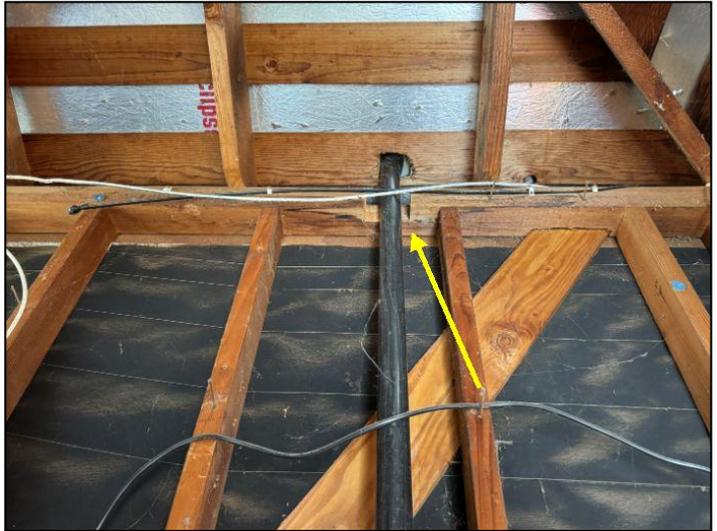
notched top plate

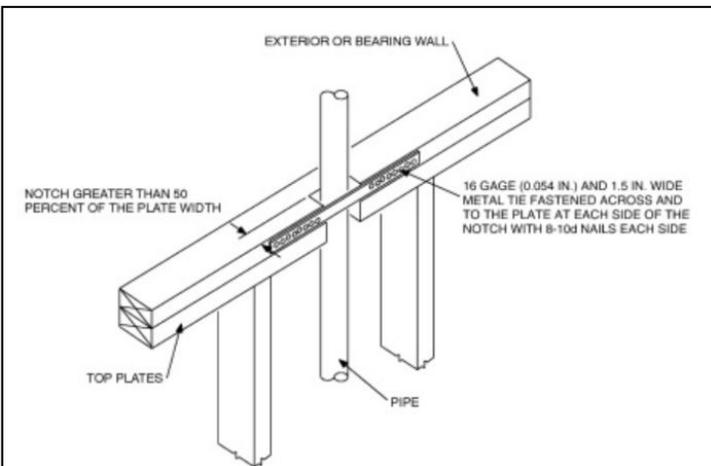
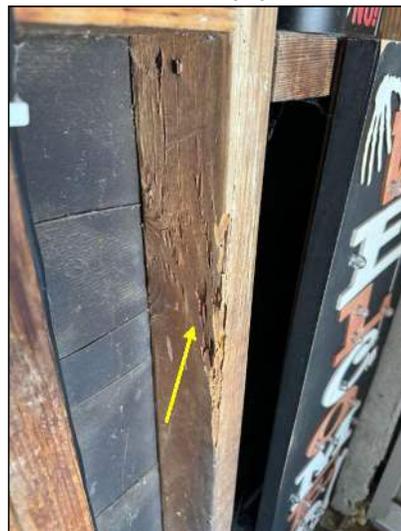
possibe pest damage

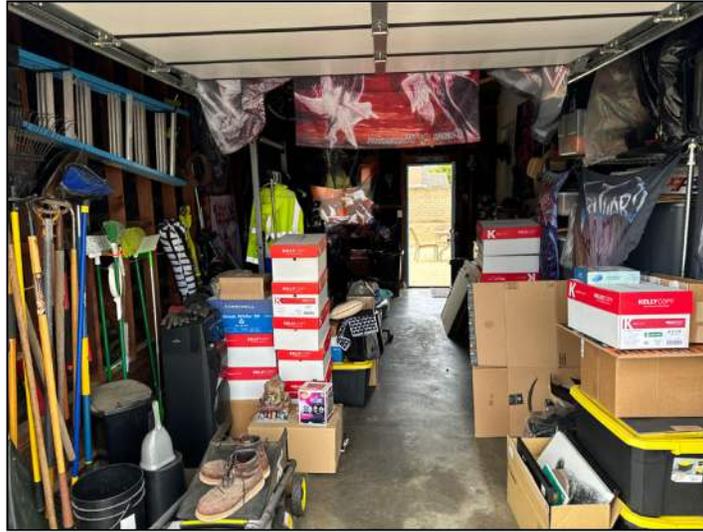
- Personal belongings in the garage at the time of the inspection limited the scope the inspection.

Personal belongings

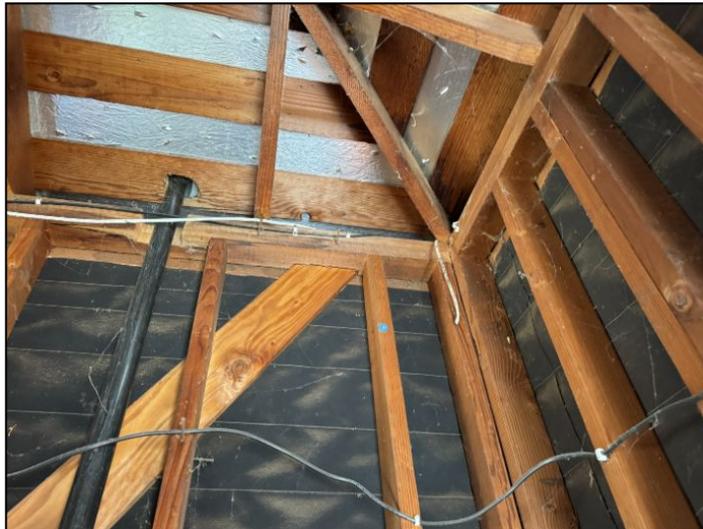
- Moisture stain observed in the ceiling of the garage at the time of the inspection. Indications of past or present leak, dry at the time of the inspection. Recommend further evaluation/remediation by a licensed contractor to prevent further moisture intrusion.

moisture staining/dry at the time of the inspection.

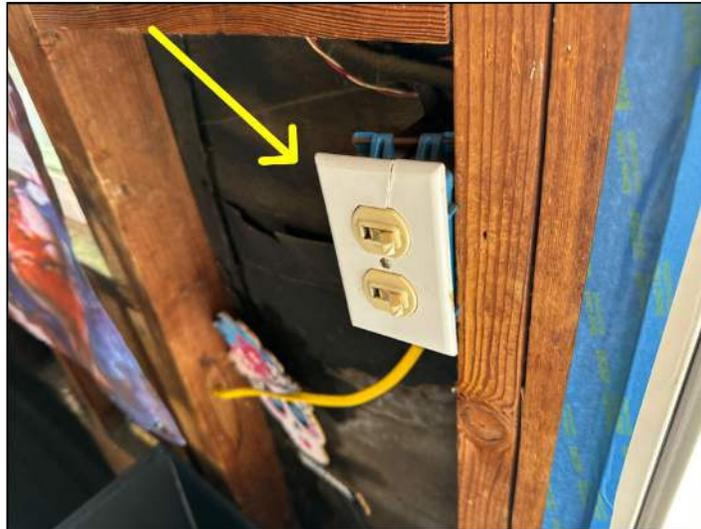
- Crack in switch cover observed at the time of the inspection. Recommend replacing cover by licensed electrician.
- Exposed Romex (electrical conductor) within reach in the garage at the time of the inspection. This is a safety defect as a child could pull of the live conductor in the garage. Recommend licensed and insured electrician further evaluate the need to protect said Romex in the garage and prevent electrical safety issue.

crack cover/ exposed conductors

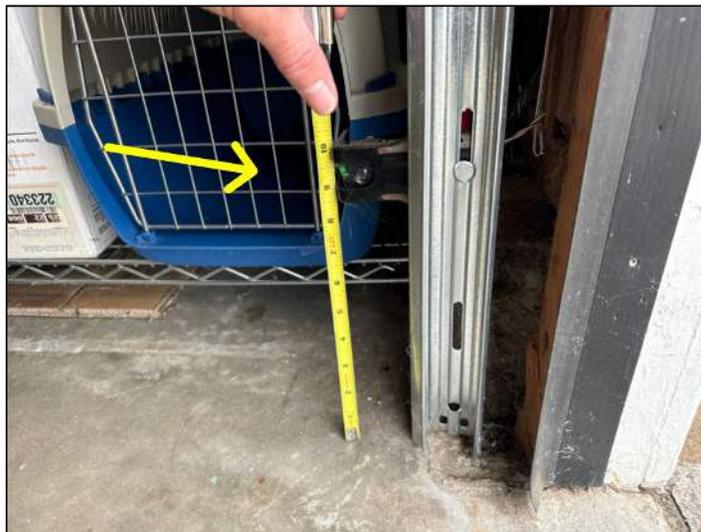
- Pressure sensor non functional in reversing garage door at the time of the inspection. Recommend further evaluation by licensed professional.
- Garage door reverse eye sensor too high at the time of the inspection. Recommend qualified contractor lower height to 4-6 inches from the ground to prevent any garage door accidents.

Too high

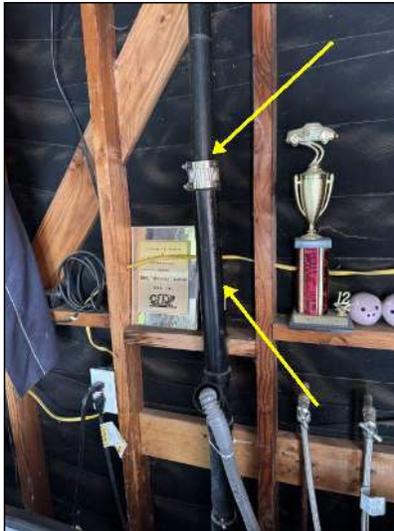
- Laundry drain and vent loose and unattached at the time of the inspection. Recommend further evaluation and remediation by licensed and insured plumber.

loosely attached drain/vent

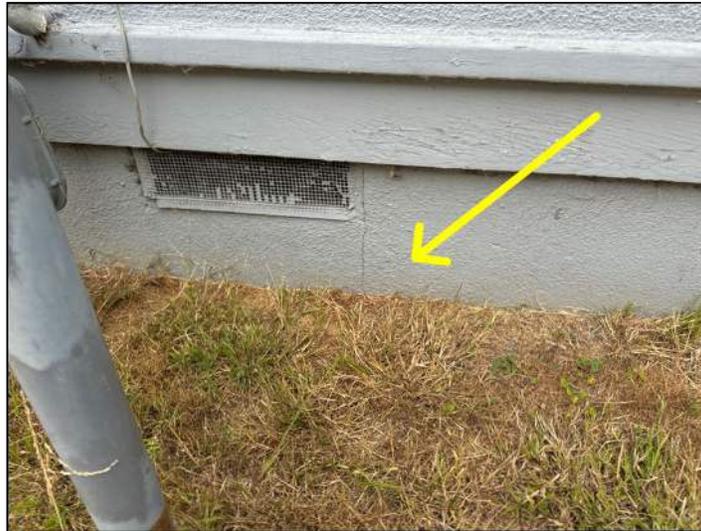
- Vertical crack observed at the time of the inspection less than 1/4 inch. Recommend qualified contractor patch and monitor for movement.
- See "Basement/crawlspace" walls for foundation cracking.

Seal crack

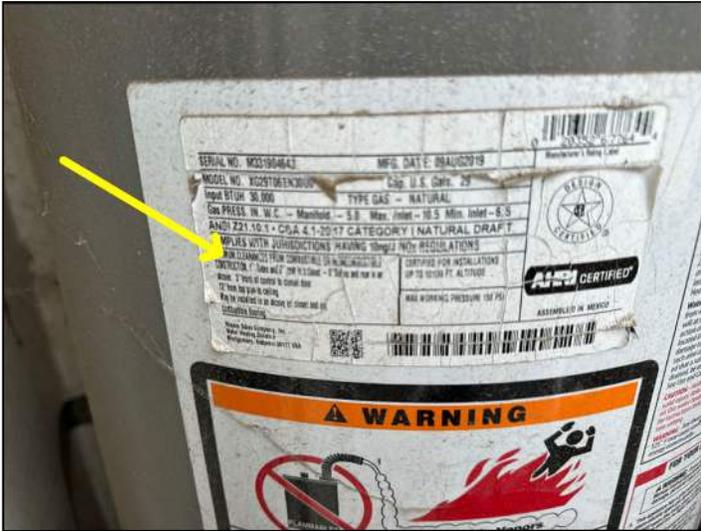
- Water heater body observed as within the recommended 3 inches of clearance on front of the unit at the time of the inspection. This clearance recommendation is subject to manufacturers installation instructions. We recommend review of water heater installation instructions and confirmation heater is within allowable clearance. Remediation by licensed and insured plumber.
- Suspected microbial growth around the water heater at the garage at the time in the inspection. Recommend further evaluation by qualified contractor.
- Deterioration of the water heater closet observed at the time of the inspection. Recommend remediation by licensed contractor.

clearances

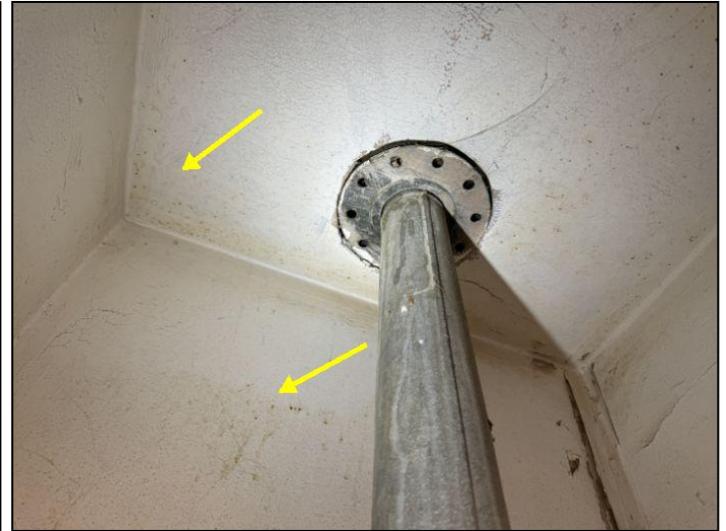
possible microbial growth

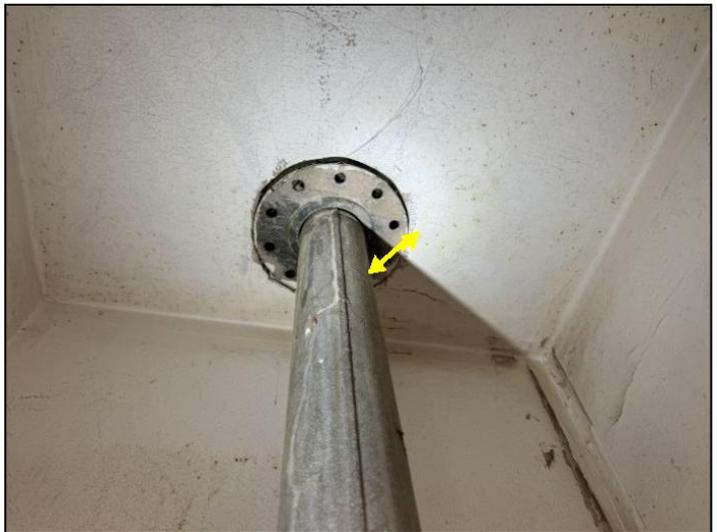
single walled less than 6 inches to combustibles

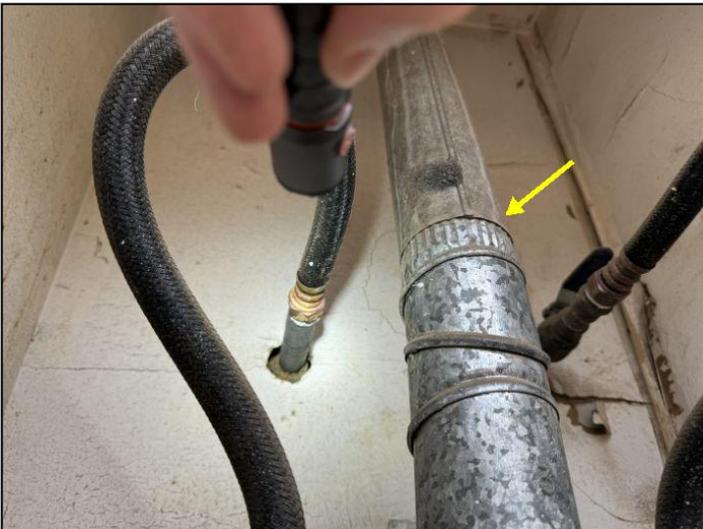
lacking attachments

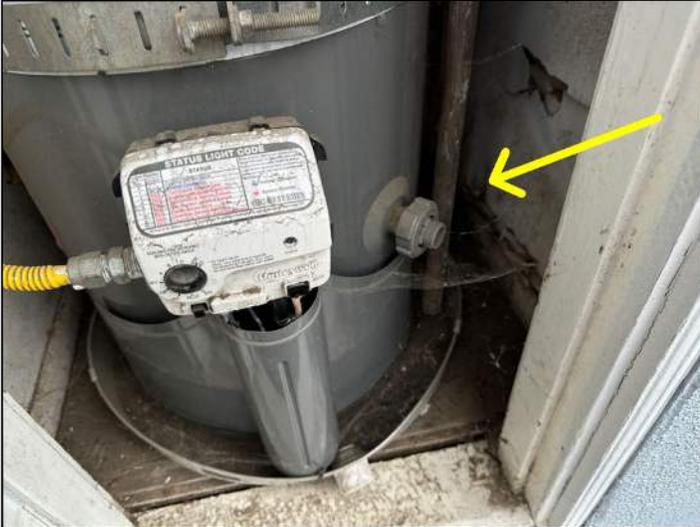
- **TPR valve** observed as terminating into the drain pan at the time of the inspection. This is defect as the TPR drainage piping must run independently from other drainage piping. Recommend licensed professional remediate.

TPR into drain pan

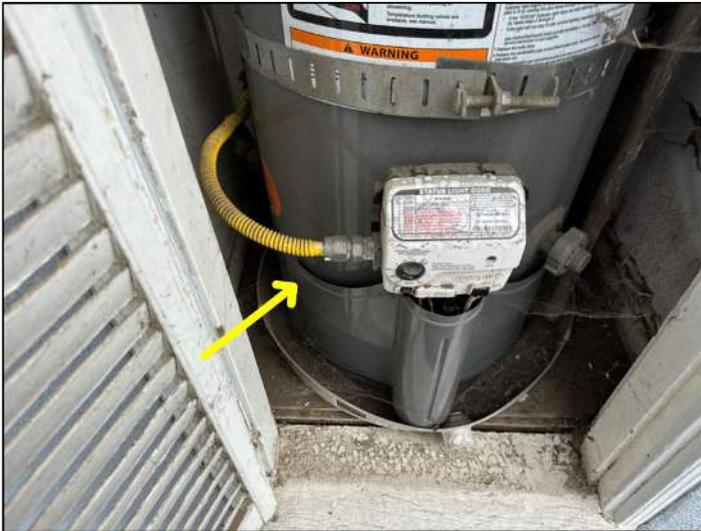
- Missing sediment trap on the gas line at the time of the inspection. Sediment traps installed at gas appliances are used to help catch any sediment or debris that may be present in the gas line and prevent it from entering the appliance and possibly damaging it. Recommend licensed plumber to remediate.

no sediment trap

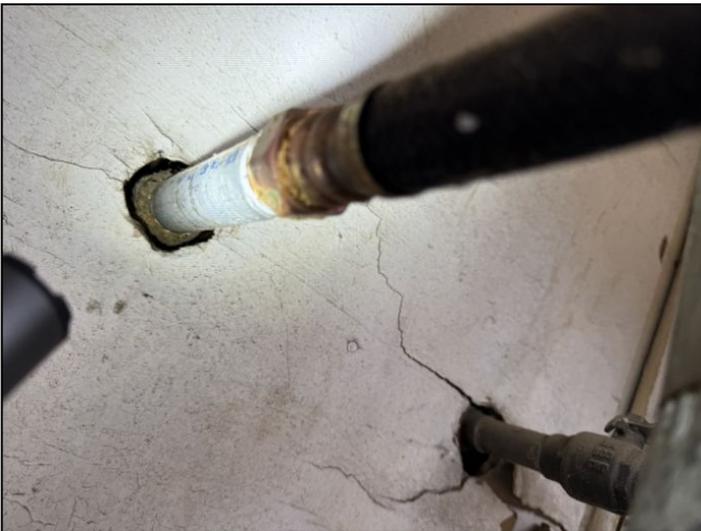
- Corrosion observed on water line connection on the top of the water heater between the copper and galvanized connection at the time of the inspection. Recommend hiring licensed and insured plumber to remediate to prevent further corrosion.

galvanized waterline

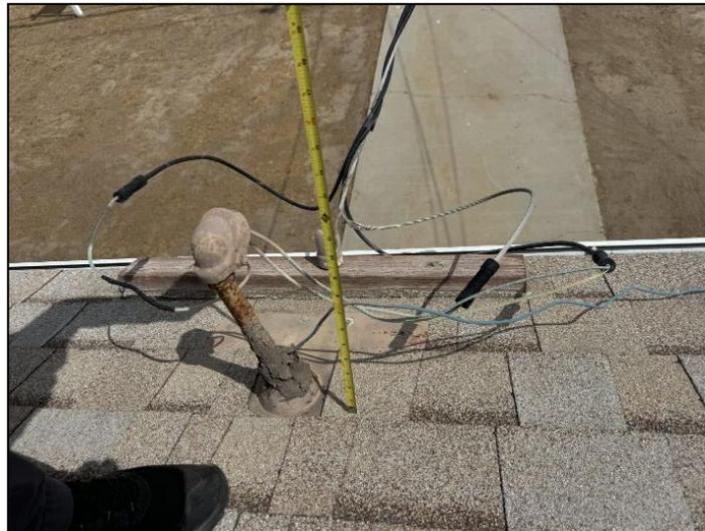
too short

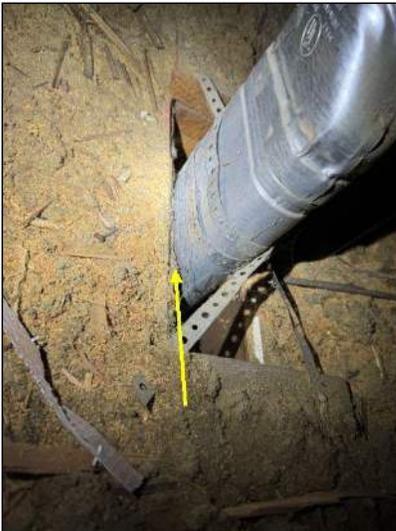
- Combustible vent for water heater observed as not having the clearance necessary to combustible materials at the time of the inspection. This is a defect and fire hazard. Recommend remediation by licensed contractor to establish appropriate clearance to combustibles for all combustion appliances.

clearance to combustibles- furnace

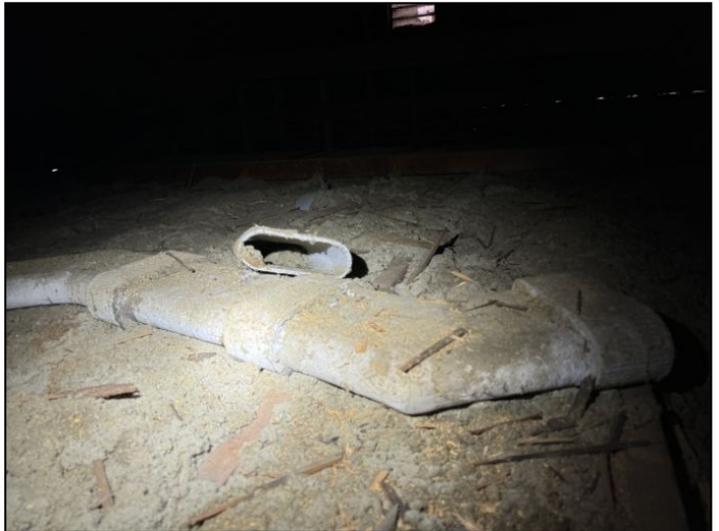
- Transite vent observed in the attic at the time of the inspection. This pipe is comprised of a solid, cement-like material that is known to contain asbestos fibers. Admittedly, these fibers could not easily escape from within the material, but the majority of heat vents and certainly those that pass through attics, are required to be double-walled, or Type-B. While functional at the time of the inspection, an imperceptible crack in a single walled vent pipe could result in a fire, and we recommend that the transite pipe be replaced with a modern double-walled steel type.

abandoned transite asbestors

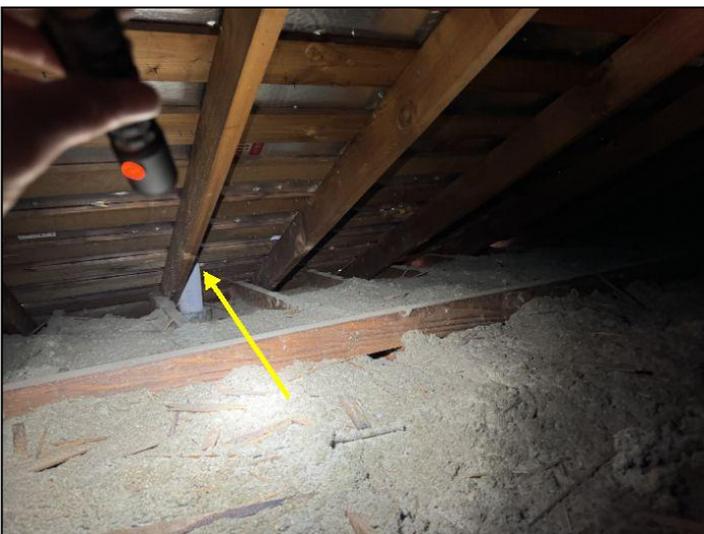
transite asbestos pipe/too close to combustibles

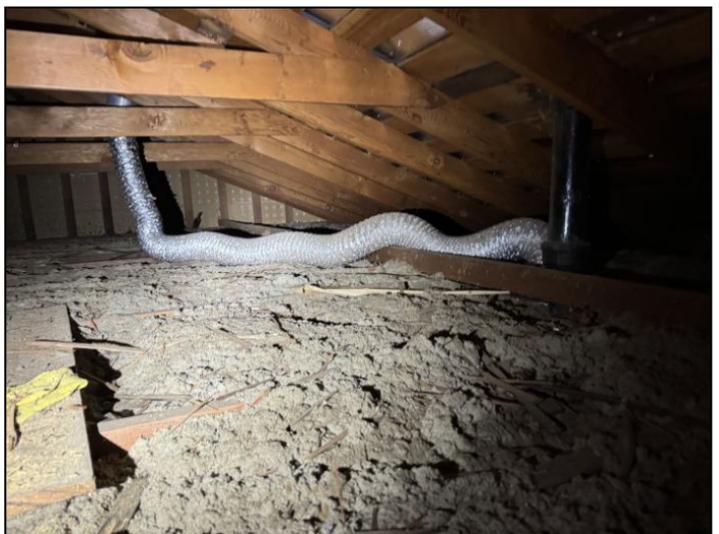
no flex vent for kitchen

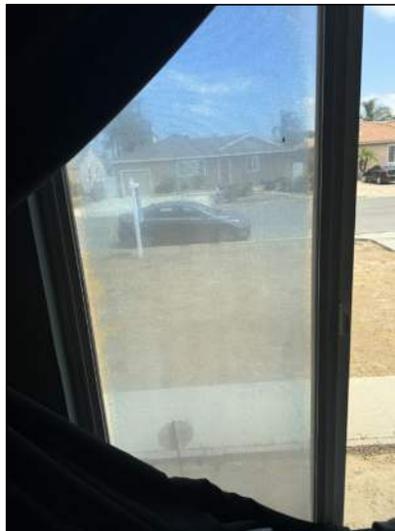
- One or more of the windows were dirty at the time of the inspection making the distinction between loss of seal and dirty window difficult. Recommend cleaning/servicing for efficient use.
- Majority of windows observed as loose on the track, dirty, with damaged screens. Recommend qualified contractor service windows for efficiency of use.
- Possible microbial growth observed on the window at the time of the inspection. Recommend remediation by a qualified contractor.
- Staining noted in on or more windows at the time of the inspection. This is an indication that the seal on the window has failed and it is no longer performing in the same capacity. Recommend hiring a licensed contractor to repair or replace all damaged windows to provide energy savings and prevent hazed window from limiting view out of window.

loss of seal

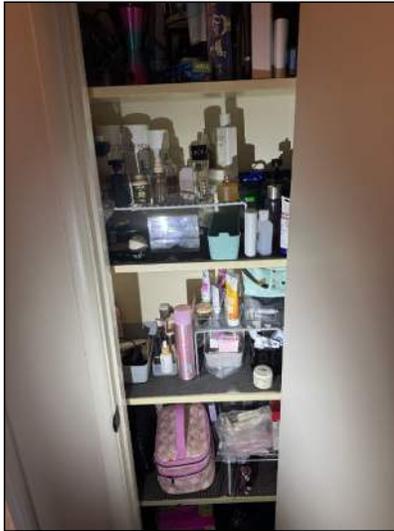
personal belongings

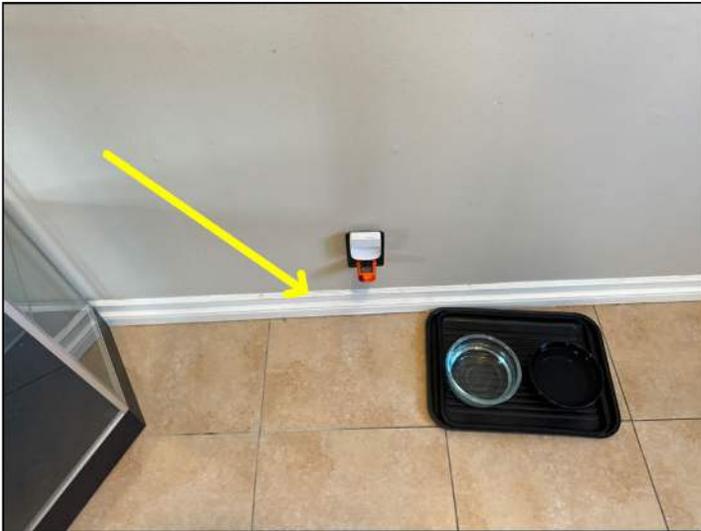
- Open ground (or 2-wire) outlets present at the time of the inspection. This means that the 3rd (round) part of an appliance plug is not getting ground protection. This is a defect and a concern with items such as computers and electronic devices. Recommend further evaluation/remediation by qualified electrical contractor.
- Open ground GFCI outlets in kitchen not labeled open ground. Recommend further evaluation and remediation of open ground outlets by licensed and insured electrician.
- Outlet next to exhaust observed as having no cover at the time of the inspection. Recommend remediation by licensed electrician.

Open Ground outlet

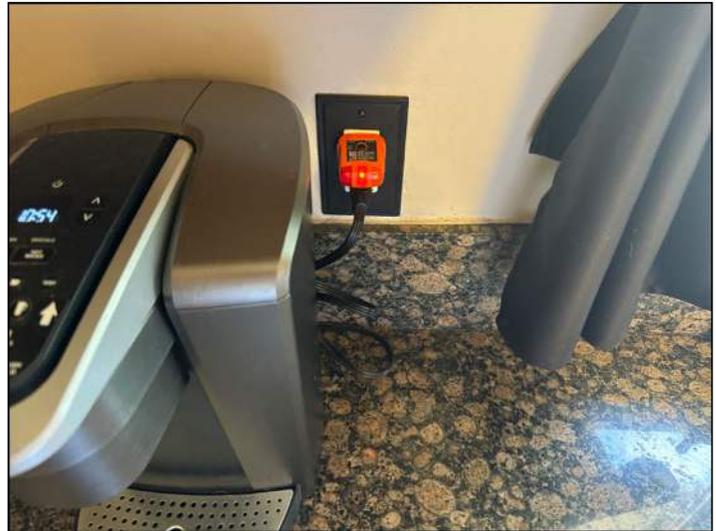
open ground gfc

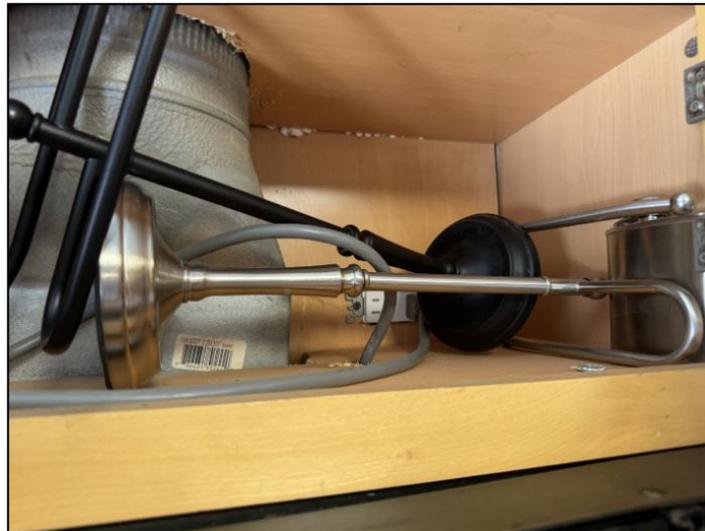
no cover

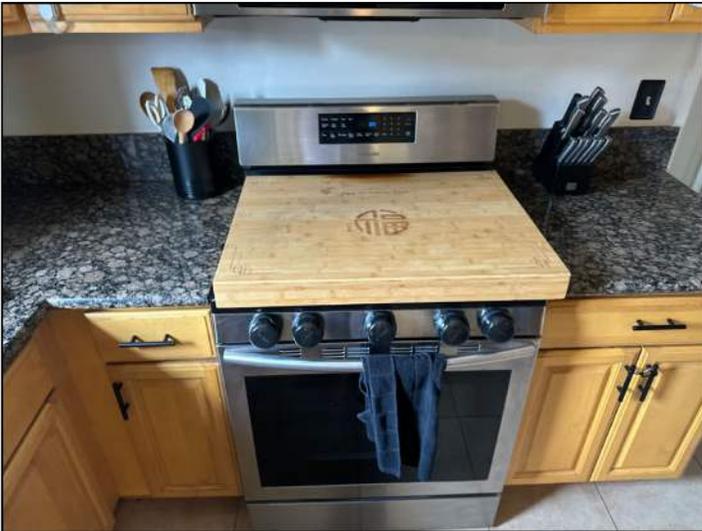
- Did not operate the oven at the time of the inspection as the owners personal belongings were being stored in the oven. Recommend confirming proper operation prior to close.
- Oven observed as missing anti-tip bracket and was not fastened to the floor at the time of the inspection. This is a safety defect. All free standing, slide in ranges include an anti-tip device essential for safety of use. Recommend a qualified contractor secure range so it cannot tip over.

No anti tip

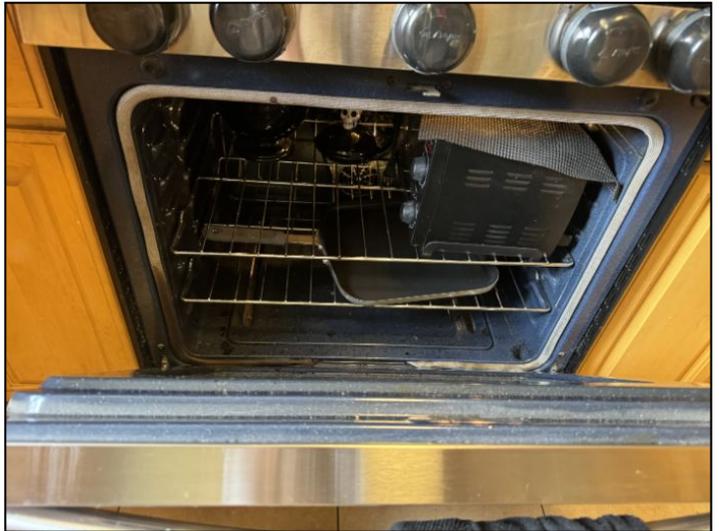
personal belongings

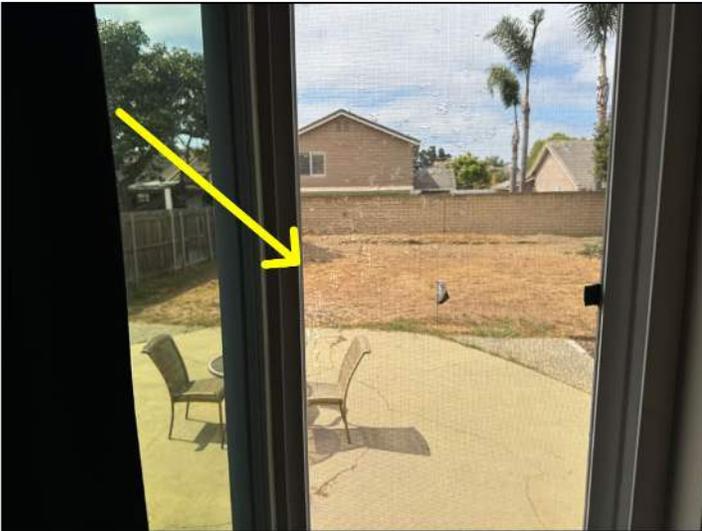
- Damaged screens observed.
- Window observe, loose on tracks at the time of the inspection recommend servicing of windows by qualified contractor
- Broken glass observed in kitchen window at the time of the inspection. Recommend mediation by qualified contractor.

Broken glass

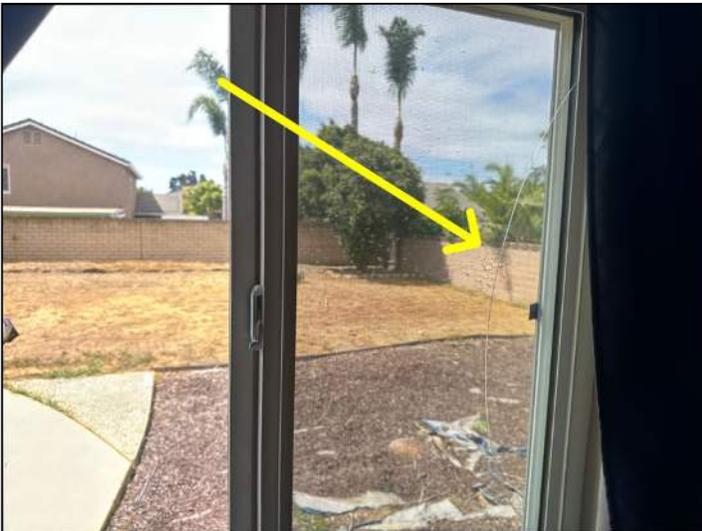
Damage the screen

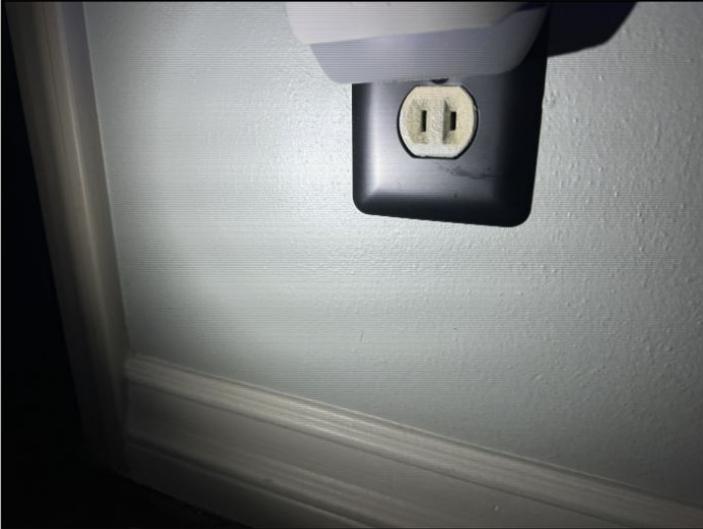
The home contained outdated, ungrounded 2-prong electrical outlets at the time of the inspection. Although this condition may have been commonly considered safe or acceptable at the time the home was originally constructed, as general knowledge of safe building practices has improved with the passage of time, building standards have changed to reflect current understanding. Consider updating the existing condition to meet generally-accepted current safety standards. Recommend licensed and insured electrician remediate.

2 prong open ground

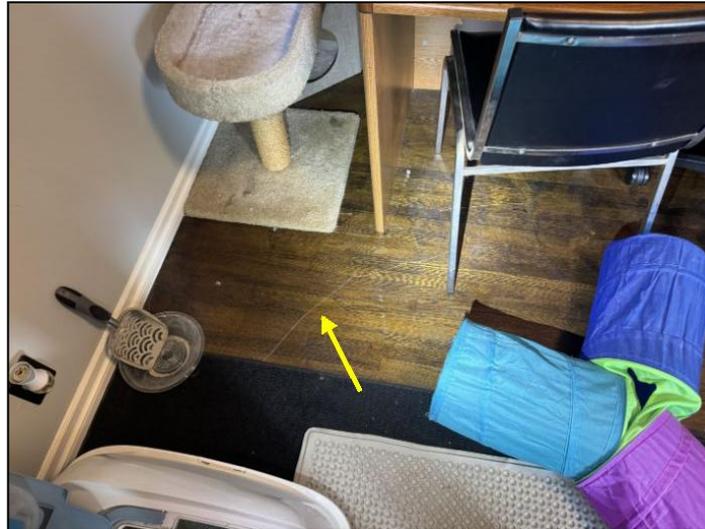
- Scratching to bedroom floor observed at the time of the inspection. Recommend remediation by qualified contractor.

scratch

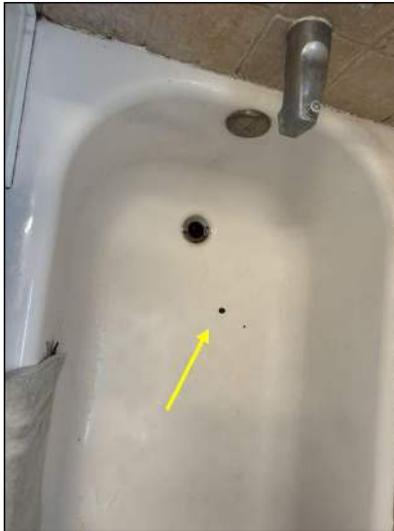
- Crack on bath tub observed at the time of the inspection. Recommend remediation by qualified contractor.

crack in tub

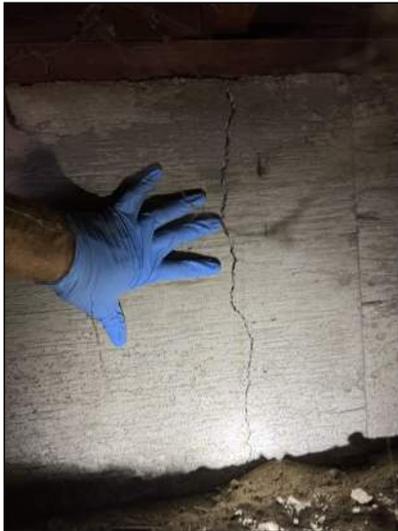
- Vertical cracking less than a 1/4 inch observed in crawlspace at the time of the inspection. Recommend qualified contractor further evaluate and remediate as appropriate to prevent moisture intrusion and further deterioration.

vertical crack

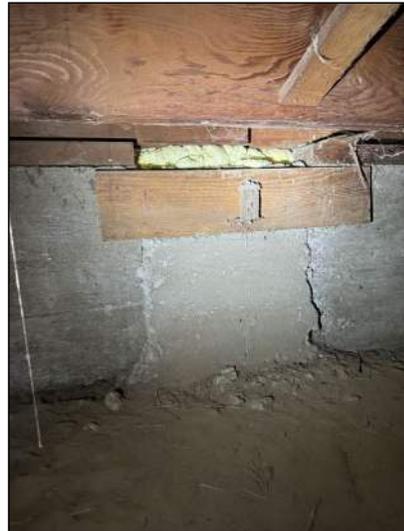
previous patch work

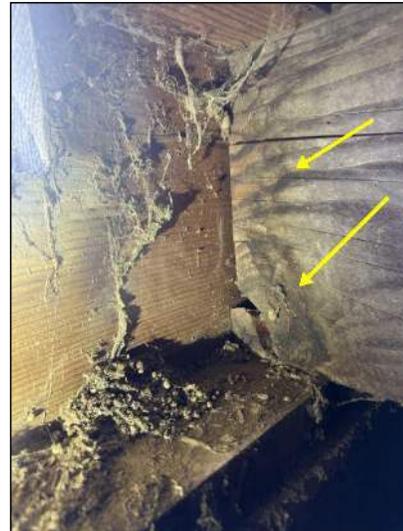
- At front of house, floor joist observed as water stained with corner cracked off at the time of the inspection. Recommend further evaluation and remediation as appropriate by qualified contractor.

front of house- moisture damage and cracking of floor joist at connection

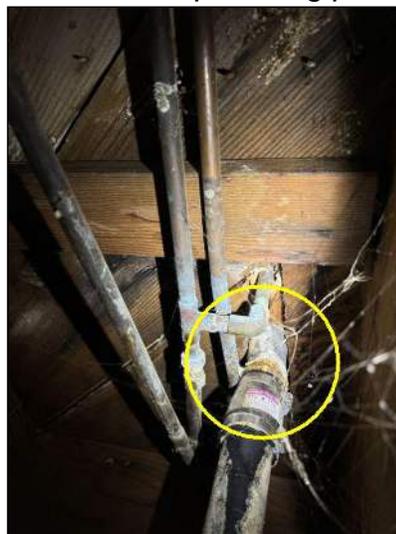
corrosion

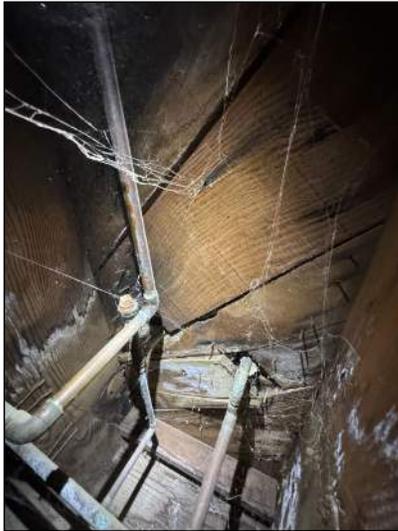
moisture intrusion
