BEST COAST HOME INSPECTIONS

Confidential Inspection Report

VENTURA CONDO , Ventura , CA 930003

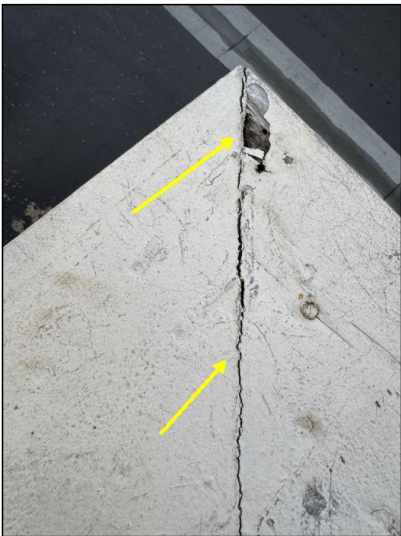
- Damage to exterior of structure observed at the time of the inspection. Cracking/gaps and possible signs of wood destroying insects observed. Recommend contacting HOA regarding all exterior damages and maintenance.
- Possible organic growth observed on patio at the time of the inspection. Recommend remediation by qualified contractor.

damage to exterior-patio

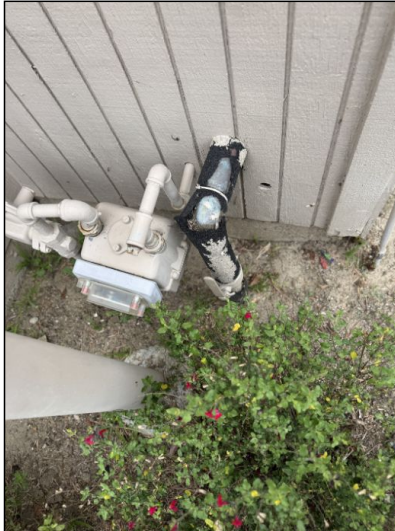
- Damage to water line insulation at the time of the inspection. Recommend remediation by qualified professional.

damage to insulation on exterior water line

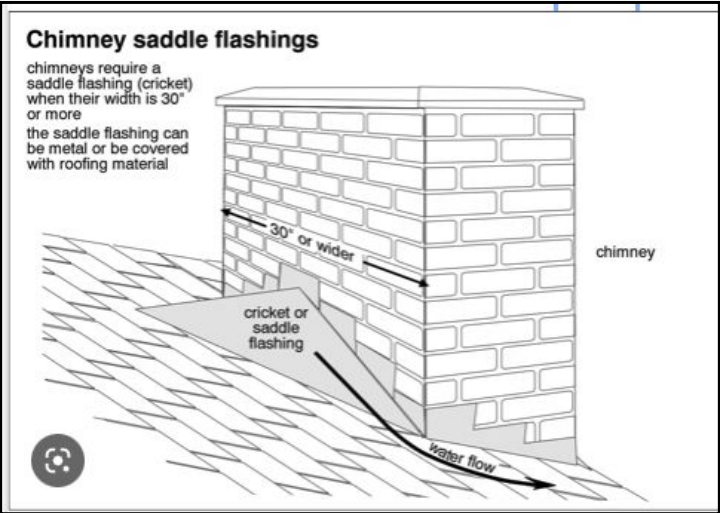
- The chimney was observed as being without the application of a cricket flashing at the time of the inspection. A cricket is designed to keep runoff from pooling on the uphill side of the chimney. Recommend evaluation by a licensed roofing contractor for the addition of a cricket at the chimney.
- Flashing at base of chimney was observed as having some small gaps and holes at the time of the inspection. Recommend licensed and insured roofing contractor remediate to ensure a continued waterproof seal.

damage to flashing behind chimney-cricket recommended

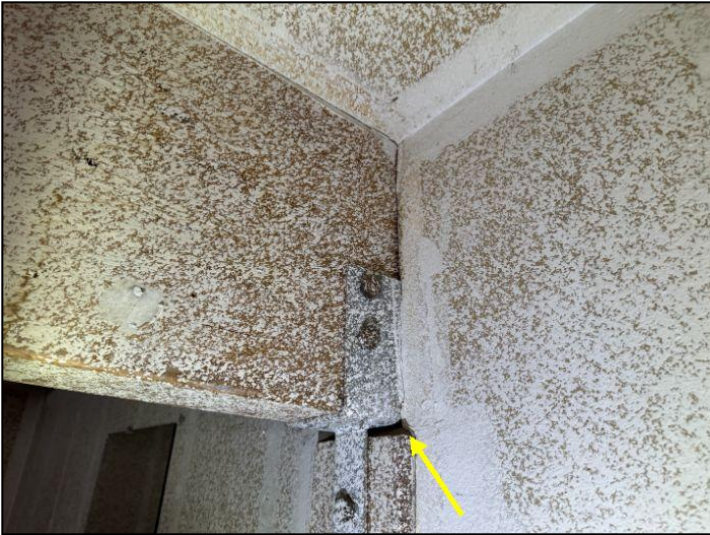
- The common wall between the garage and home has damage or improperly covered areas at the time of the inspection. This is a defect. Fire potential to the home is at a greater risk as most home fires originate in the garage. Recommend further evaluation and remediation by repairing all gaps, cracks and openings to insure a proper firewall between to home and the garage. Recommend qualified contractor remediate.

gaps in walls

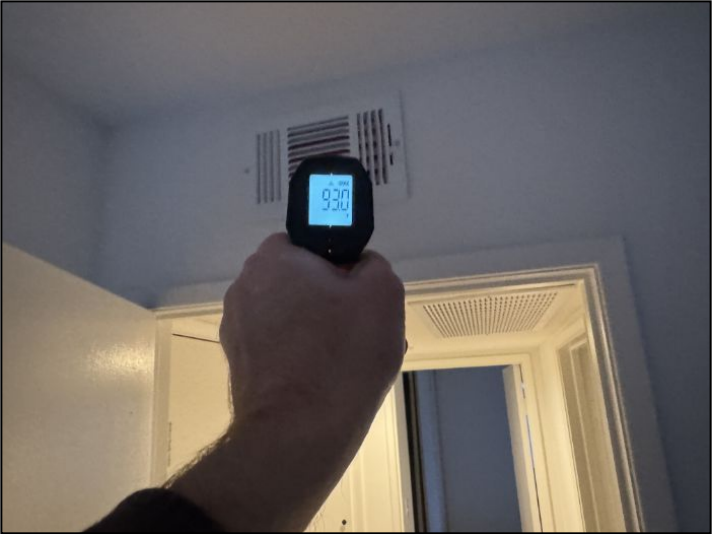
- Functional under normal operating controls at the time of the inspection.
- As indicated by the serial number, the furnace was manufactured in 2017.
- Electrical conduit feeding the roof top unit observed with damaged insulation/cover at the time of the inspection. Recommend remediation by licensed and insured contractor.

functional

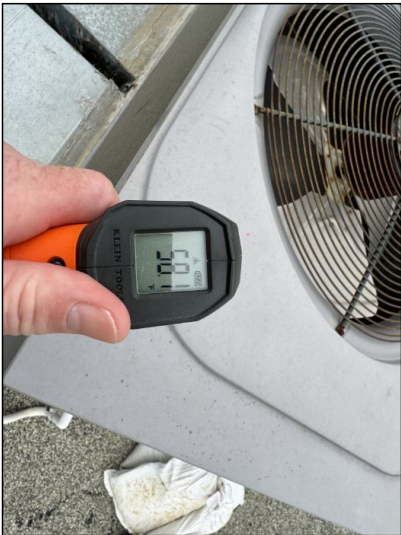
- Air conditioner not run on the day of the inspection as the temperature outside was less than 60 degrees. Recommend running cooling cycle under normal operating controls when weather permits before the end of escrow.
- Rooftop HVAC unit observed without a shut off nearby. Recommend the addition of a shut off for safely servicing the unit for maintenance. Recommend qualified contractor.
- Do to the number of defects and condition of the roof top package unit, we recommend having an HVAC contractor assess the unit as whole and service it for safety and function.
- Sealant on duct work observed as weathered and cracking at the time of the inspection. Recommend further review and remediation as appropriate by licensed HVAC contractor.
- Damage to the exterior of the unit observed at the time of the inspection. Recommend HVAC contractor evaluate/remediate.

58 degrees did not run cooling cycle

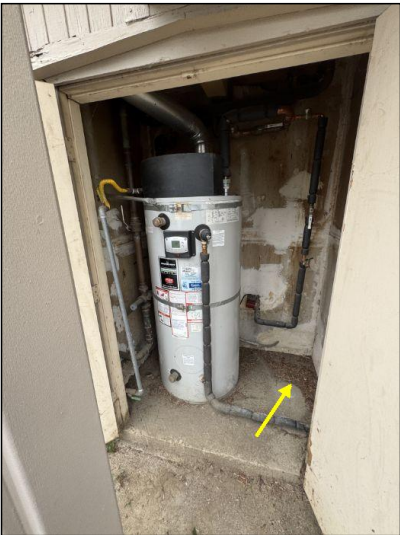
remove debris

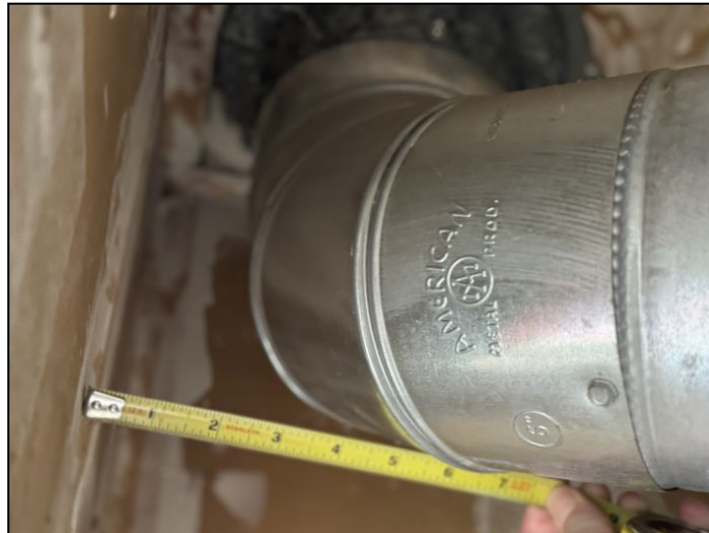
clearance to combustibles single walled flue

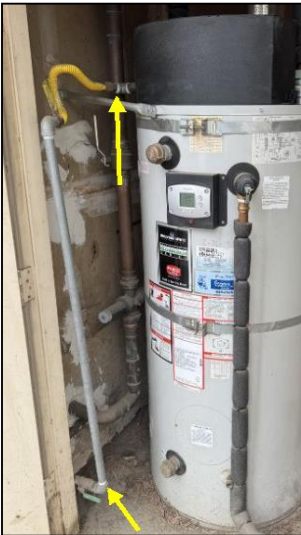
- Missing sediment trap on the gas line at the time of the inspection. Sediment traps installed at gas appliances are used to help catch any sediment or debris that may be present in the gas line and prevent it from entering the appliance and possibly damaging it. Recommend licensed plumber to remediate.
- The threaded gas line connection to the water heater uses white teflon tape. Industry standard and manufacturer recommendations call for yellow (gas rated-high density) tape for an approved pipe thread compound on natural gas piping. White tape is typically for water pipe and may not be approved for gas line installation. Recommend verification by qualified plumber that sealant is listed/approved for natural gas use and correction as needed.

no sediment trap/use of white teflon tape

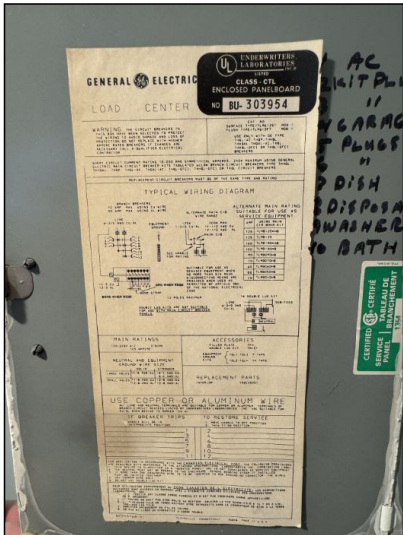
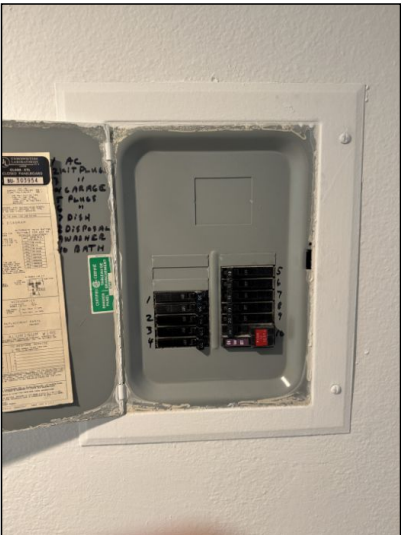
- Multi-Wire branch circuit observed in the panel at the time of the inspection. When two separate breakers share a neutral is it necessary to tie the breaker handles together. Recommend further evaluation and remediation by qualified electrical contractor.
- White neutral conductor re identified with green at the time of the inspection. This is defect as green can only be used for ground. Recommend licensed electrician label the now green conductor with red or black and additionally on the AC unit side.
- Debris observed in the electrical panel at the time of the inspection. Recommend licensed electrician clean panel of all contaminates.
- Loose attachment screw for dead front cover for electrical panel observed at the time of the inspection. Recommend remediation by licensed electrician for securing panel cover.

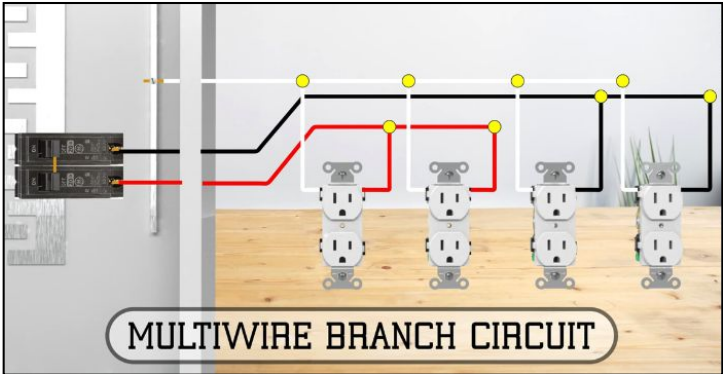
MULTIWIRE BRANCH CIRCUIT

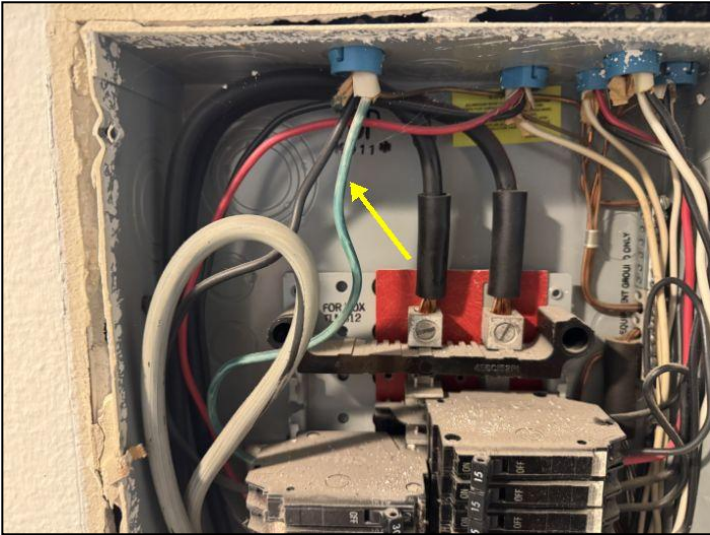
incorrect green

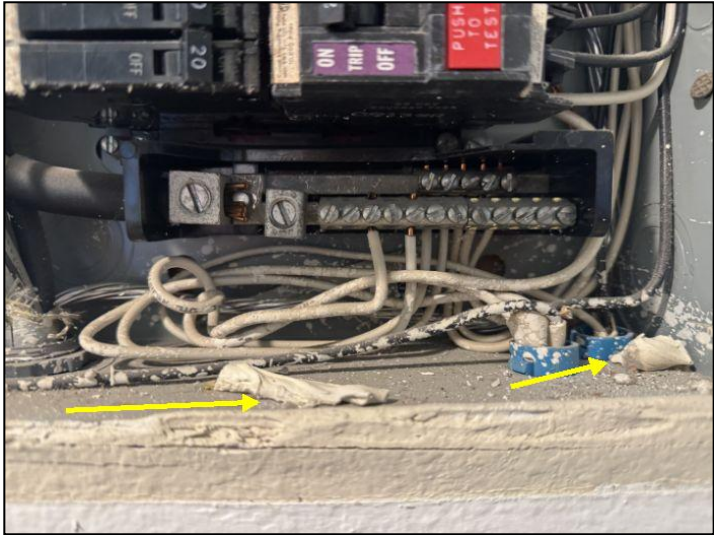
debris

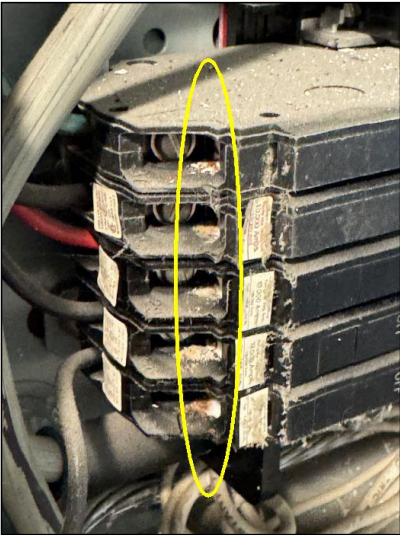
- Observations:
- Rust and or corrosion observed on breaker(s) at the time of the inspection. Recommend licensed and insured electrician further evaluate and remediate as appropriate.

corrosion on breakers

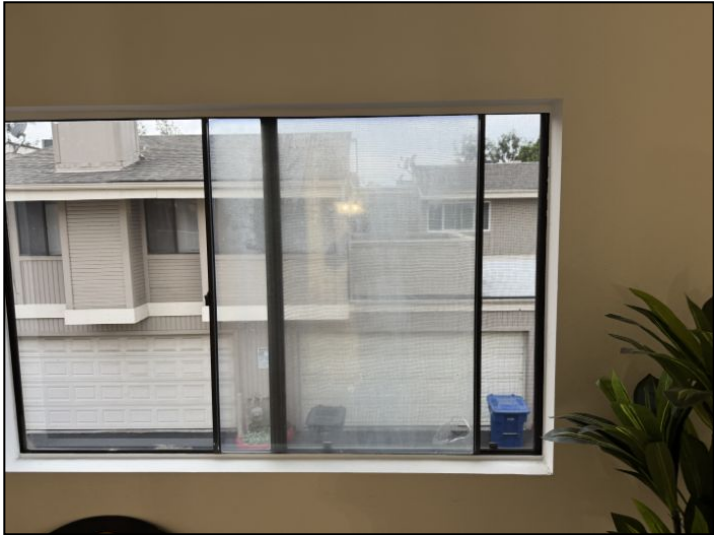
damged film on window

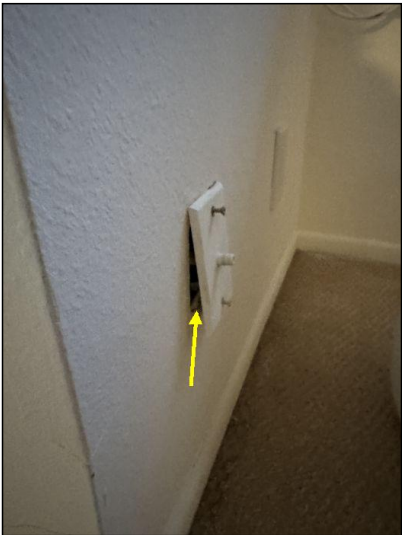
- Loose outlet cover observed at the time of the inspection. Recommend having all outlet covers tight against the wall. Recommend remediation by licensed electrician.
- One or more outlet covers observed as installed with slight gaps. Recommend installation of covers and outlets without any gaps. Recommend licensed electrician remediate.

loose outlet cover - fireplace room

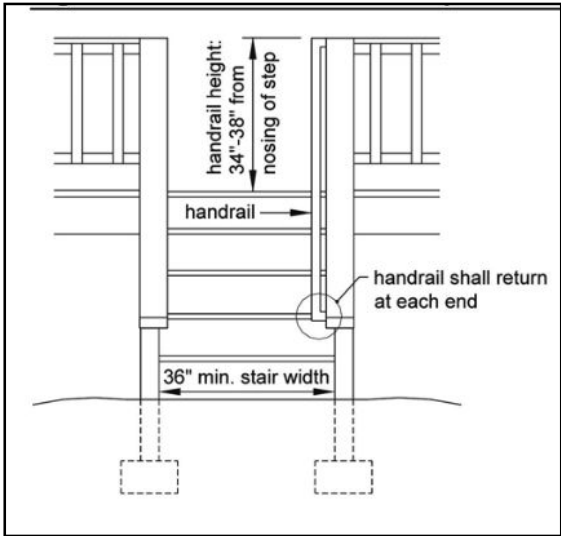
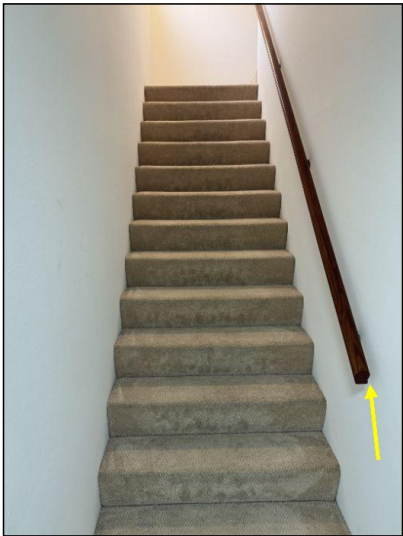
- Handrail observed as not returning to the wall at the end of the rail at the time of the inspection.

no return

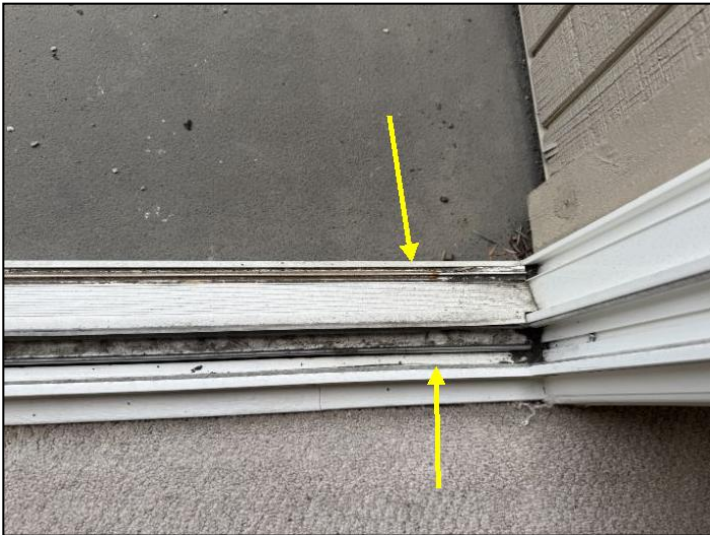
- Sliding door tracks were dirty, making the door difficult to operate at the time of the inspection. Recommend cleaning the tracks out for smooth door use.

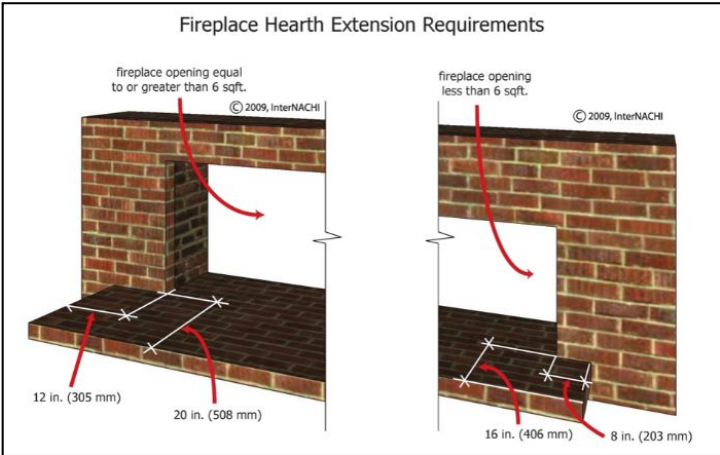
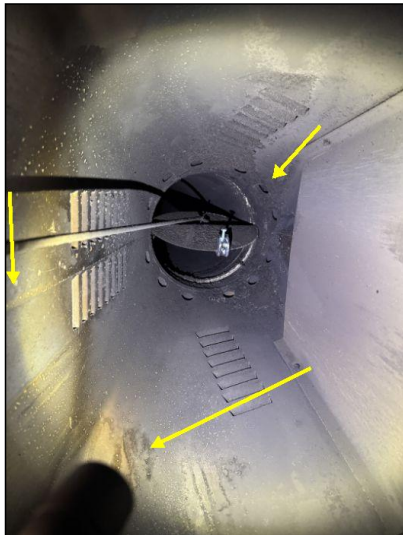
- Signs of possible moisture intrusion in fireplace at the time of the inspection. Recommend evaluation and remediation by qualified fireplace professional.

- Bend in metal wall of fireplace observed at the time of the inspection. Recommend review and remediation as appropriate by licensed professional.

soot build up and moisture staining observed.

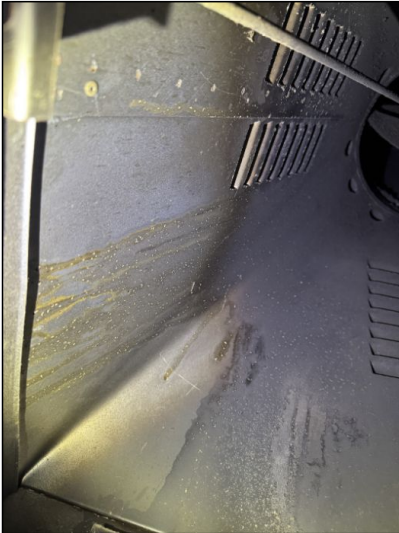
moisture staining

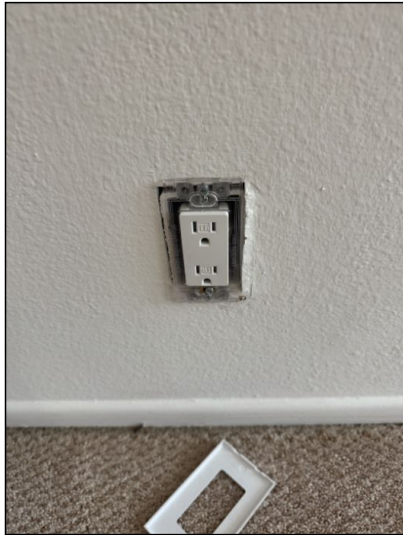
missing cover

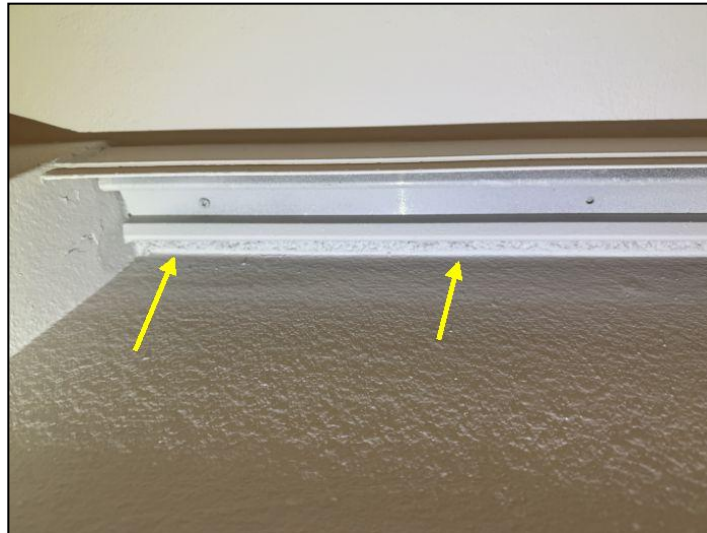
- Observations:
- Line of acoustic ceiling observed in the bedroom closet. Due to the age of the home, it may contain asbestos. Asbestos can be dangerous when disrupted or in friable form. If removed/disturbed, recommend licensed professional.

bedroom closet acoustic ceiling

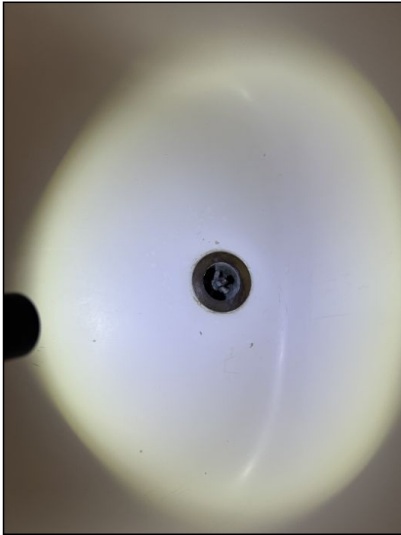
no drain stopper
