BEST COAST HOME INSPECTIONS

Confidential Inspection Report

, Oxnard , CA 93035

Date of Inspection: 5/5/2026 Time: 9am

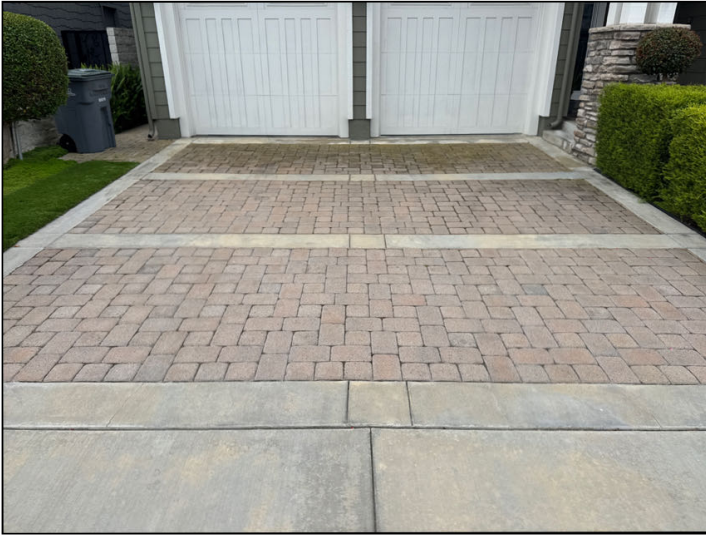
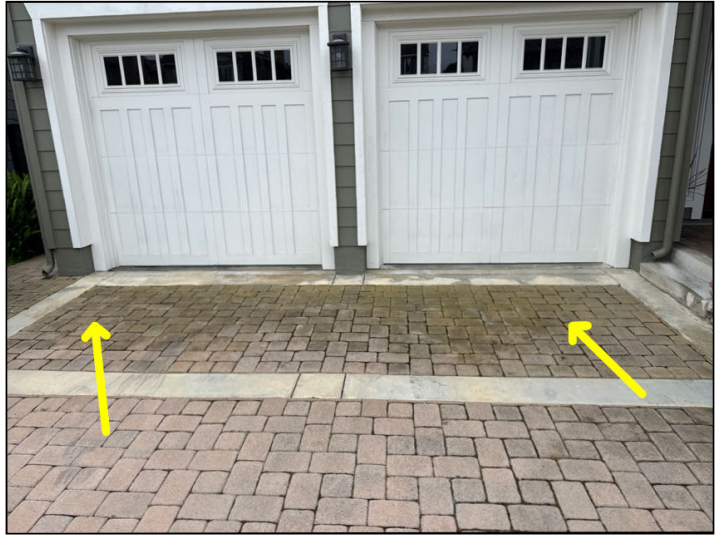
- Minor settlement, or "hairline" cracks in driveways and walkways, are normal for properties of any age. They should, however, be monitored for expansion and sealed as necessary.
- Moss from roof runoff and drainage on driveway observed at the time of the inspection. Recommend cleaning up and monitoring for appropriate drainage.

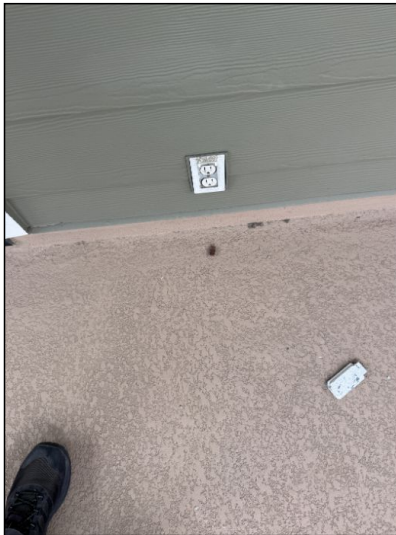
- Missing Ground Fault Circuit Interrupter (**GFCI**) protection in the home at the time of inspection. Although GFCI protection may not have been required at the time the home was built, for safety reasons, consider upgrading the electrical system to include GFCI protection at the following locations:
 - Bathrooms
 - All exterior
 - Garages
 - Crawlspace (at or below grade)
 - Kitchens
 - Laundry rooms
 - Within 6 feet of water
- Exterior outlet observed as missing cover at the time of the inspection. We recommend electrician to install covers on all outdoor outlets.
- Exterior deck, GFCI non-functional at the time of the inspection. Recommend evaluation/remediation by qualified electrician.

non functinal GFCI and broken cover - patio

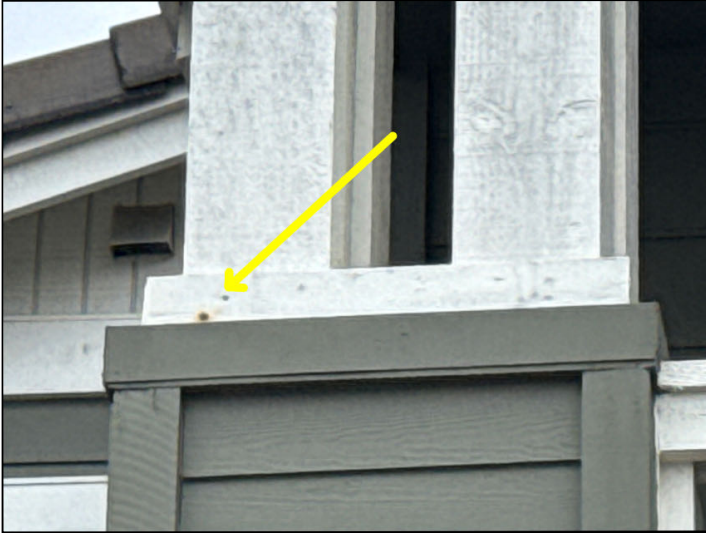
- Rusted fasteners observed on the siding at the time of the inspection. Recommend remediation qualified contractor to prevent additional rust staining and deterioration.

Rusted fastener

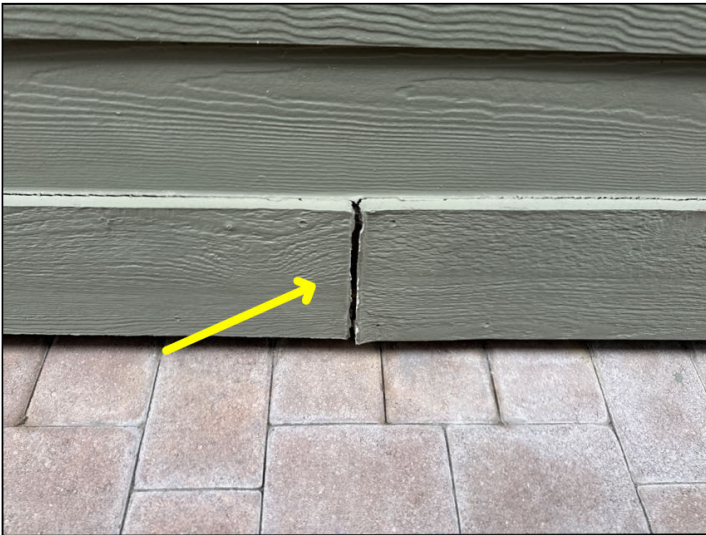
- Large horizontal siding piece, at a slant, seemed to be a cover for unknown. Cracking in connection points at the time of the inspection. Recommend reviewing disclosures regarding work. Remediate as appropriate by qualified contractor.

Seal gap - cover for unknown.

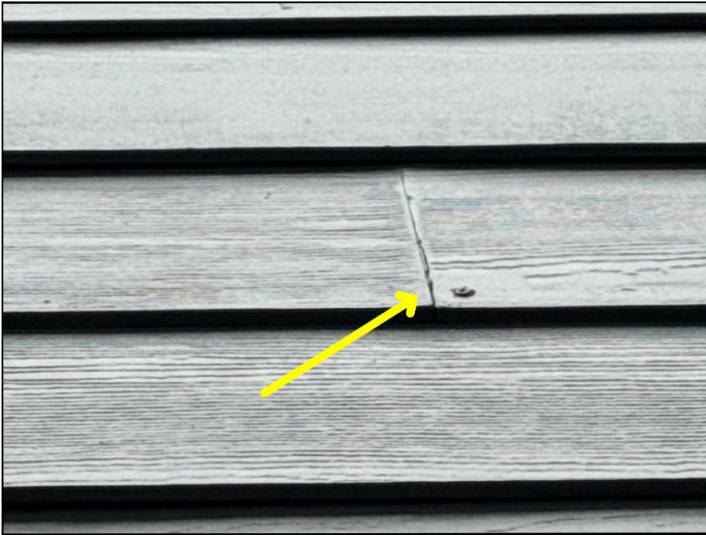
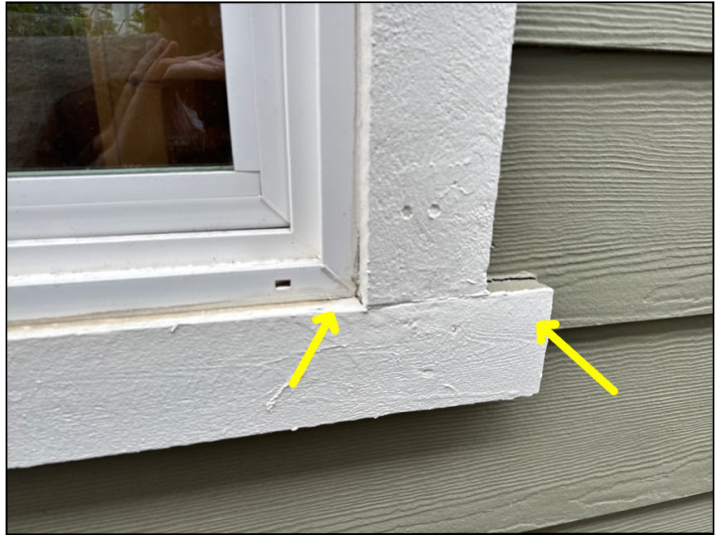
- Small cracking observed in the exterior caulking of the siding. Recommend sealing all gaps and cracks in the exterior of the structure to prevent addition moisture intrusion. Recommend qualified contractor remediate.

Seal gaps

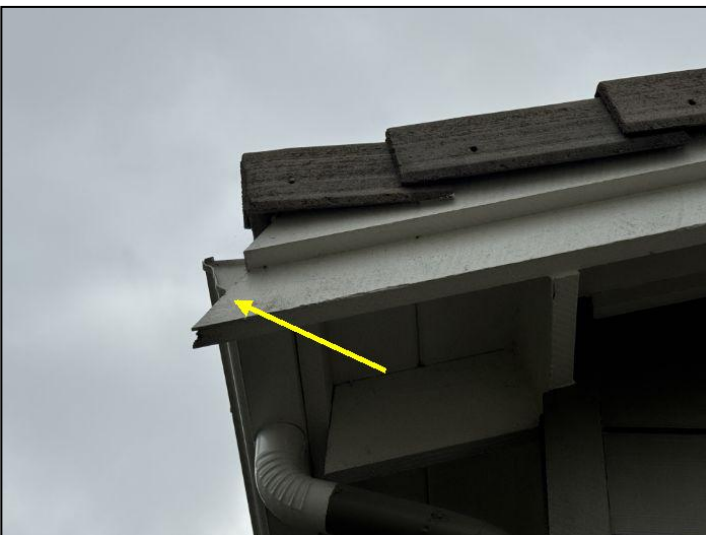
- Pointed wood extensions on eaves are a design feature. It allows for the wooden ends to eventually be damaged by moisture/weather. Recommend monitoring and maintaining these areas to prevent additional deterioration.

unprotected decorative extension

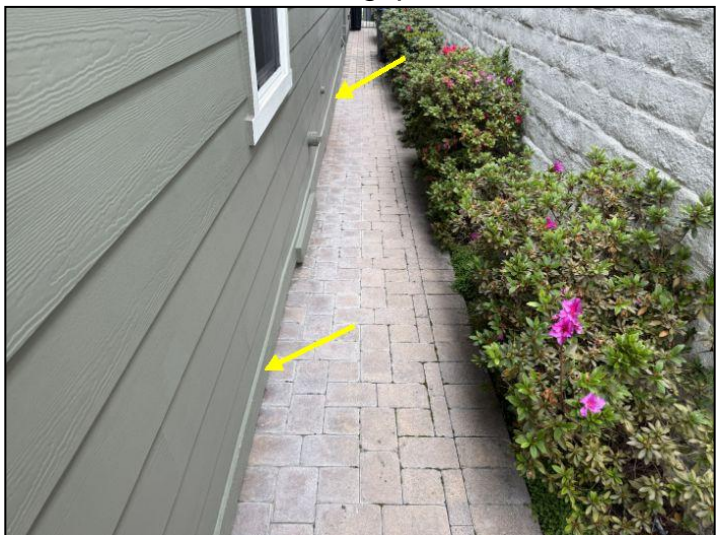
unknown installation- review disclosures

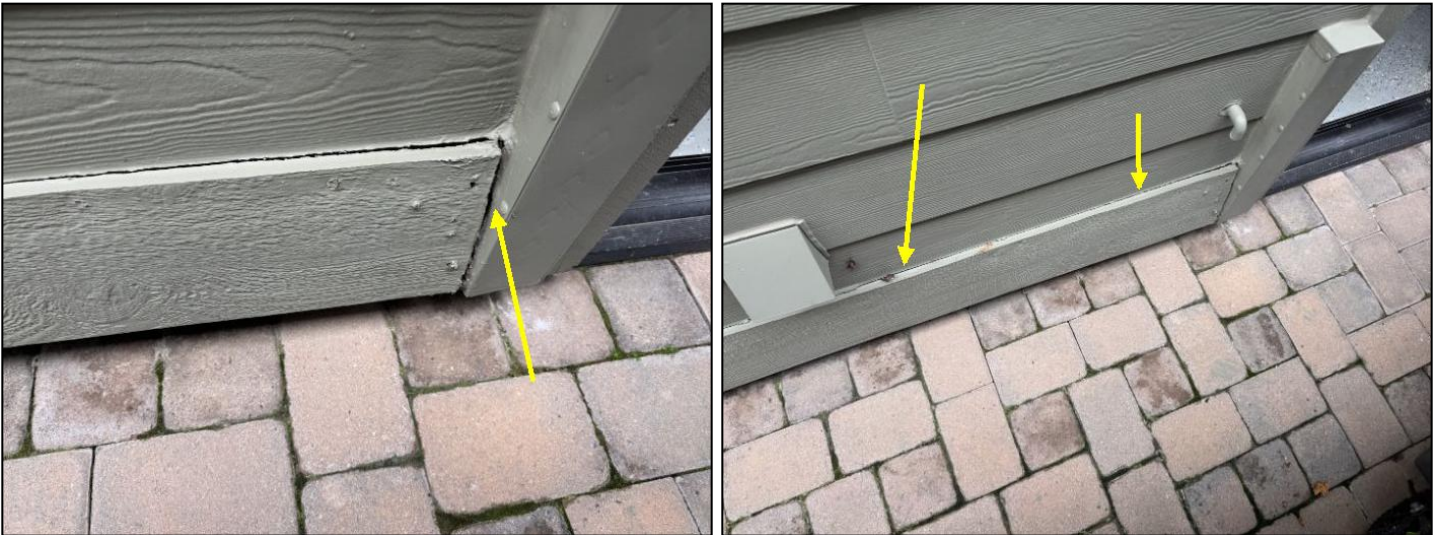
gaps

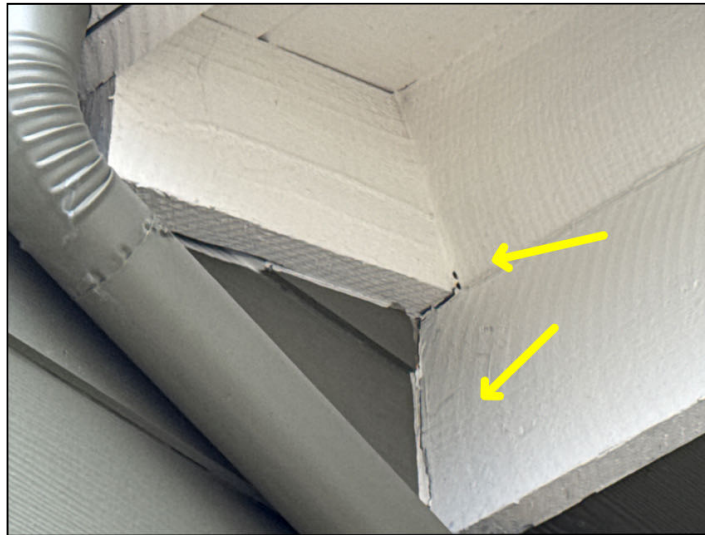
- Small separations observed in eaves at the time of the inspection. Recommend sealing all gaps and cracks in exterior of structure by qualified contractor to prevent moisture and pest intrusion.

Seal gaps

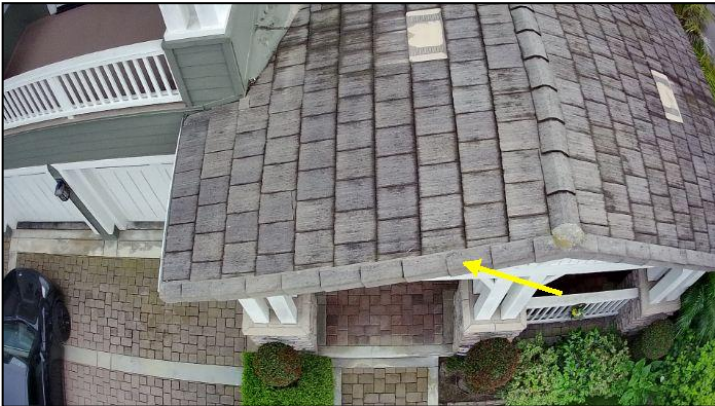
- Slight discoloration and staining observed on the roof at the time of the inspection. Recommend cleaning of roof by qualified contractor.
- Numerous tile cracks observed on the roof at the time of the inspection. Recommend hiring licensed and insured roofer to fully evaluate roof as a whole and remediate cracked/chipped tiles as appropriate.

chip tile

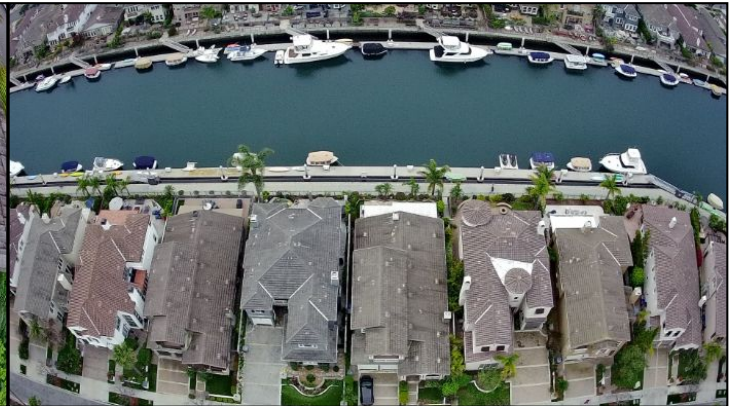
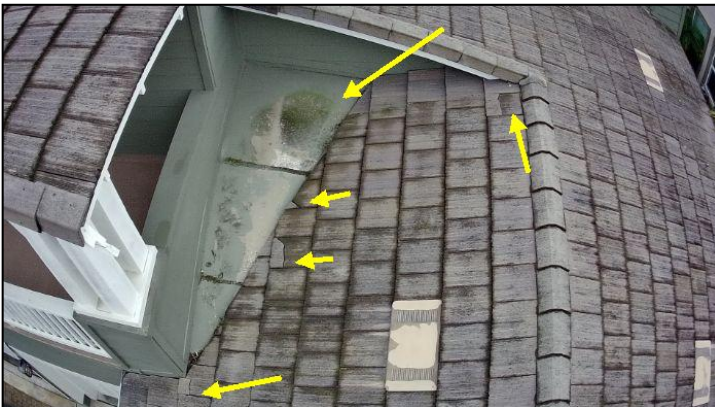
moss build up and cracked tiles

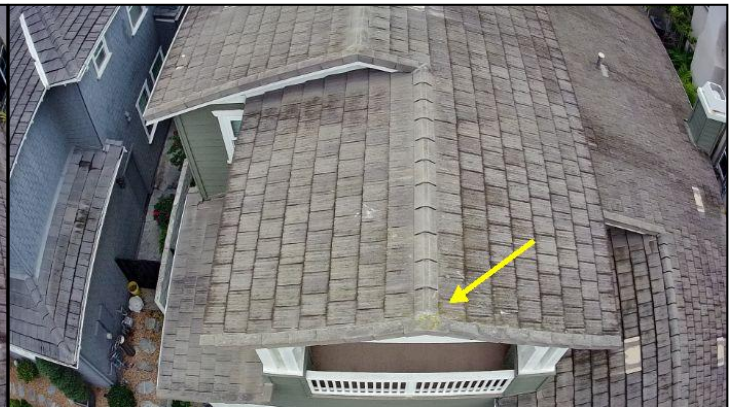
slight moss growth

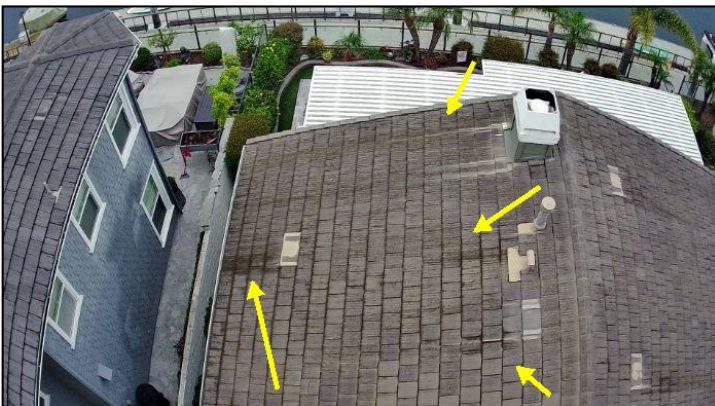
cleaning staining

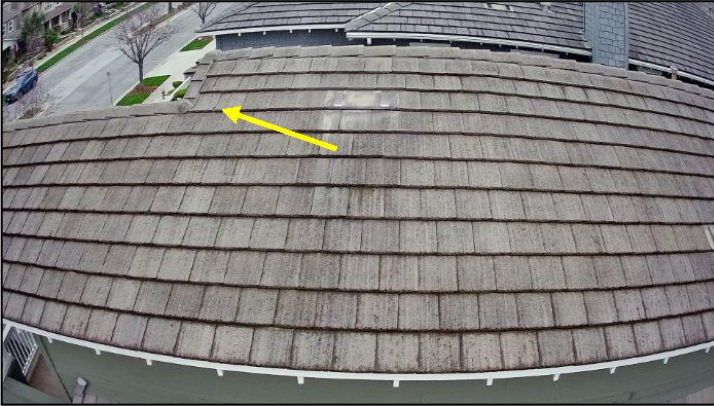
chip in tile

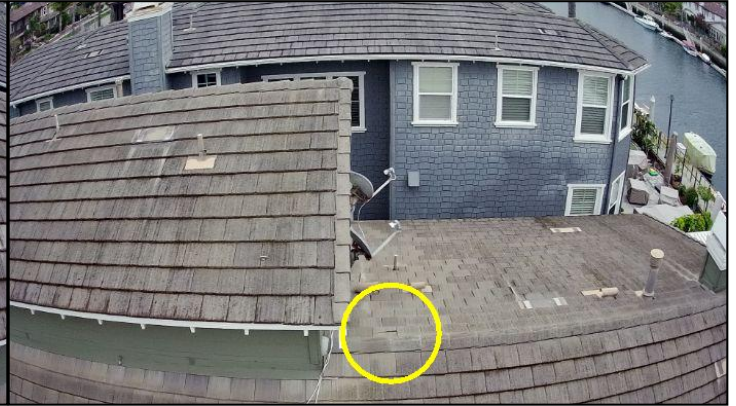
cracked tile

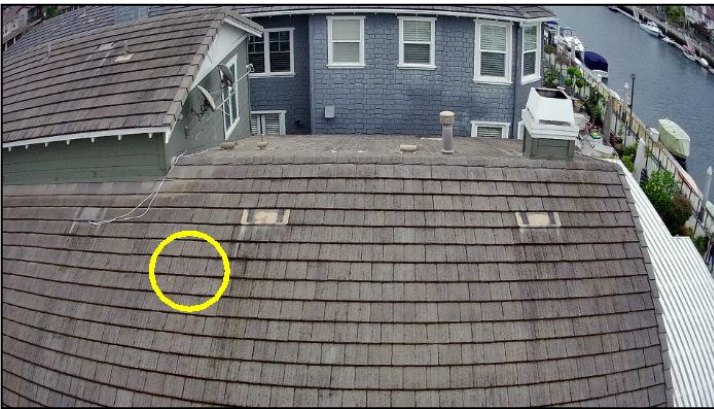
crack in tile

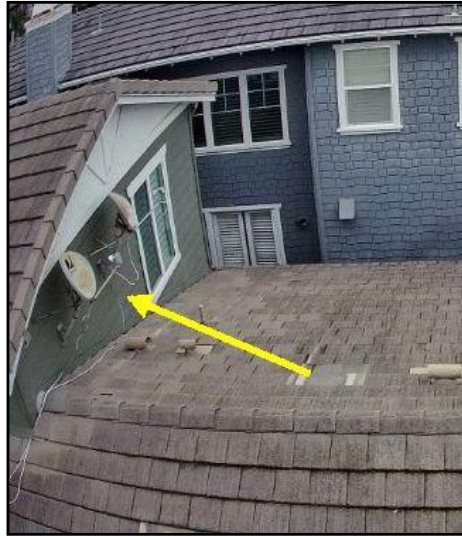
Satellite dish is strapped directly to the siding above the roof. This non-standard mounting method can create penetrations that allow moisture intrusion behind the siding and may stress the siding in high winds.

Recommend evaluation by a qualified roofing or satellite installer and consideration of relocating to a wall or pole mount to prevent potential damage. No active leaks or damage observed at this time.

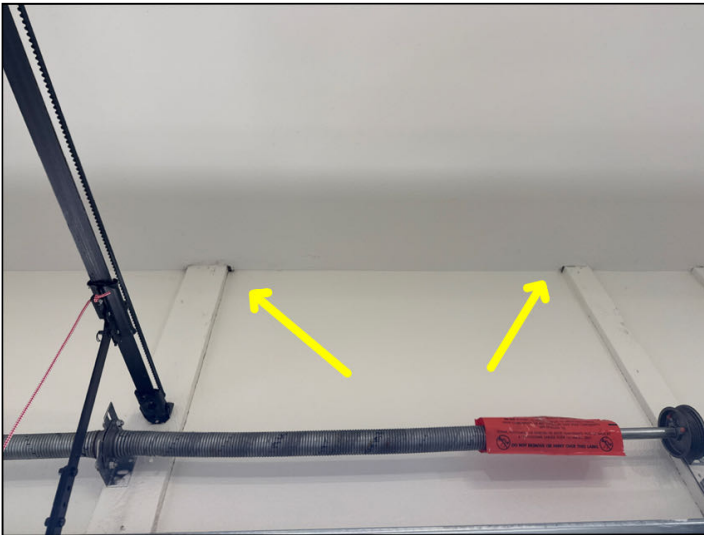
Above garage door

- **Break in the firewall wall at the time of the inspection. The wall and ceiling between the garage and the home is considered a firewall. Any break in a firewall could allow a garage born fire into the home and constitutes a fire hazard. Recommend remediation by licensed contractor.**

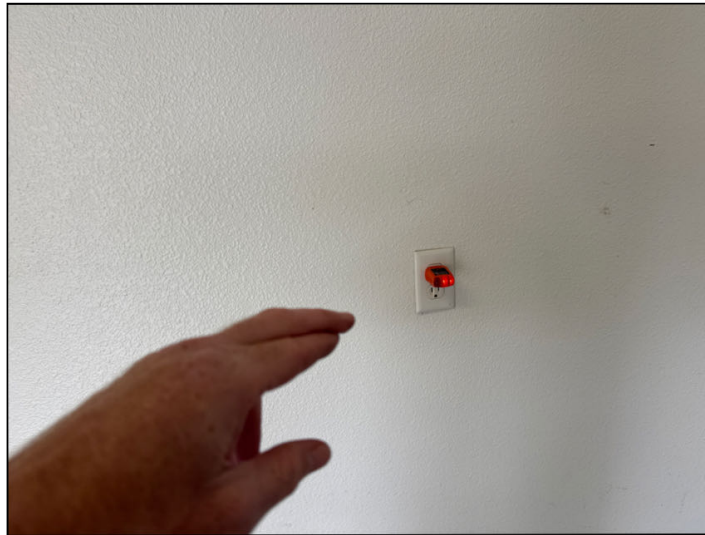
- Missing GFCI protection in the garage at the time of the inspection. Recommend remediation by qualified electrician for safety.

Missing gfci protection

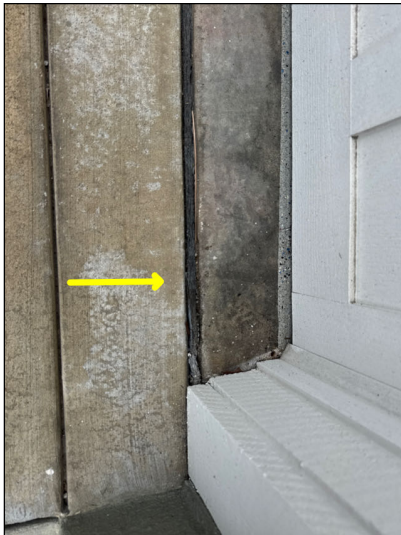
- Failing expansion gap at garage door entry at the time of the inspection... Recommend further evaluation and remediation by licensed contractor to prevent moisture settlement.

Failing

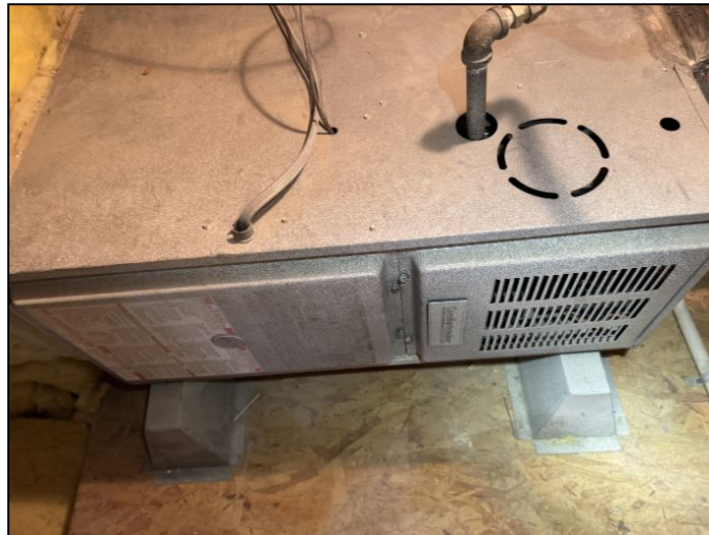
- Functional under normal operating controls at the time of the inspection.
- Paint over spray observed in attic and on furnace at the time of the inspection. Furnace was functional under normal operating controls. Client may elect to have unit serviced to rule out any possible paint related issues.

overspray on furnace

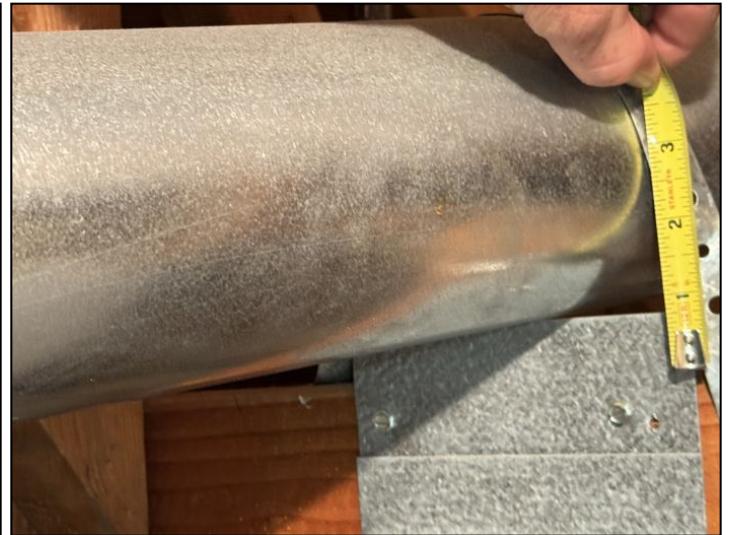
less than inch clearance

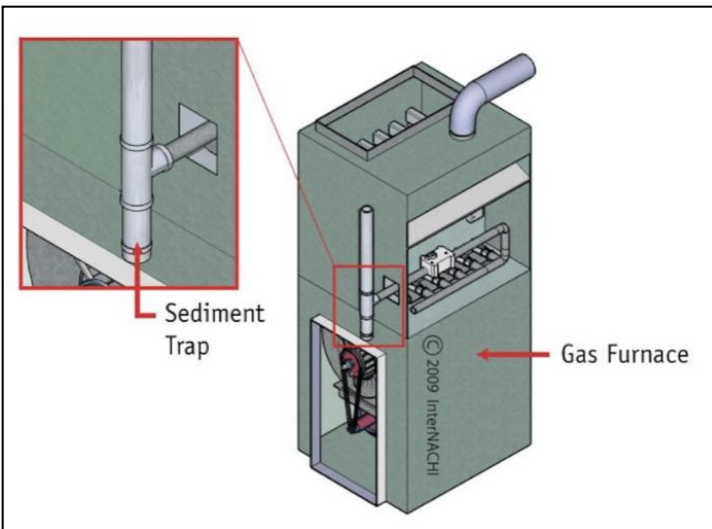
- Missing sediment traps on the furnace gas lines observed at the time of the inspection. A sediment trap collects any debris that may be trapped in the gas line before it enters the appliance and possibly cause damage. Recommend remediation by a licensed HVAC contractor.

missing sediment trap(s)

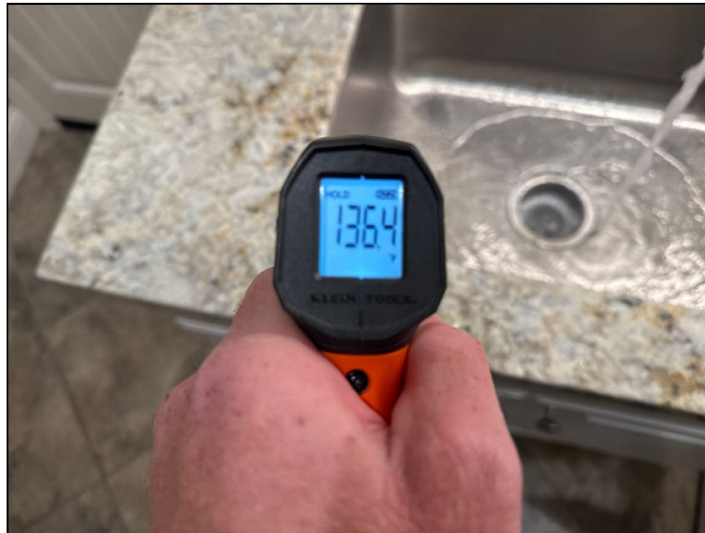
- Water temperature measured at 136 which is a scalding hazard. Recommend reduction of temperature to 120 to prevent scalding.

136

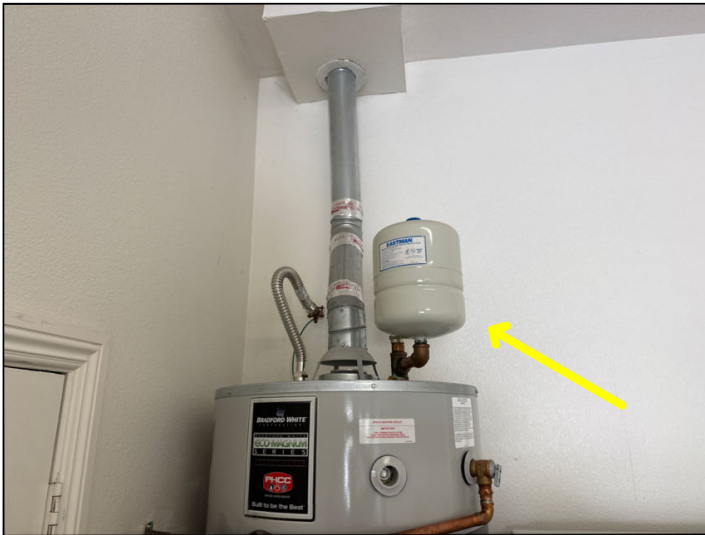
Expansion tank observed mounted above the water heater without proper support or strapping. This can lead to stress on piping and potential leaks over time.

No support

Recommend securing the tank with appropriate strapping by a qualified plumber. No active leaks noted at this time.

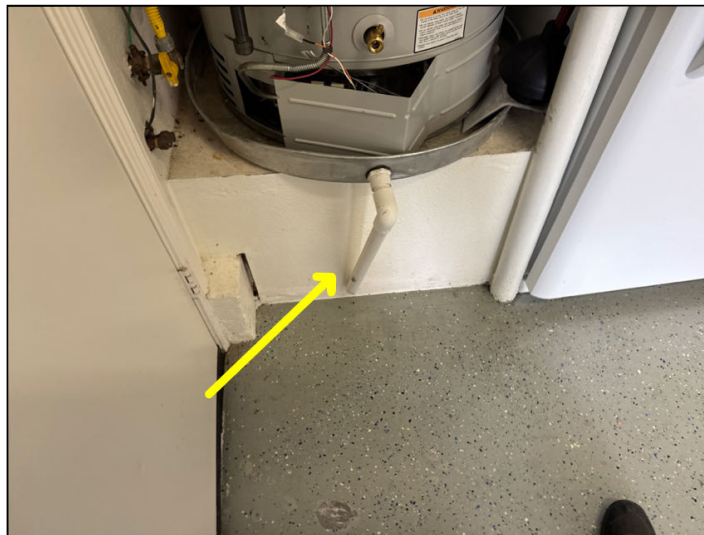
- Overflow line observed as emptying directly to garage floor at the time of the inspection. We recommend that the line extend to the exterior of the enclosure. In the event of its use, extending the line to the outside will prevent water damage to anything of value stored in the garage.

Discharge tube

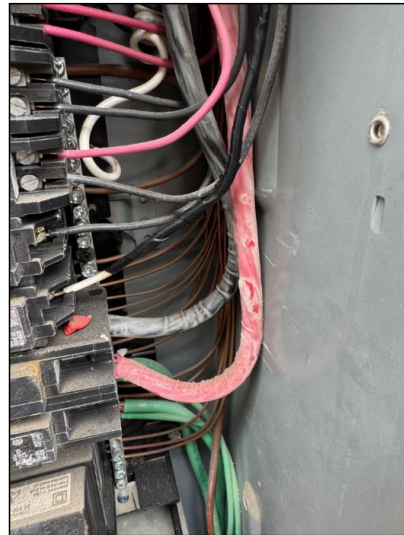
- Outer thin layer of live conductor observed slightly damaged at the time of the inspection. No damage to colored insulation and no observable exposed live wires. Recommend having electrician fixing gfci and other electrical issues confirm conductor as safe for use.

slight damage to insulation

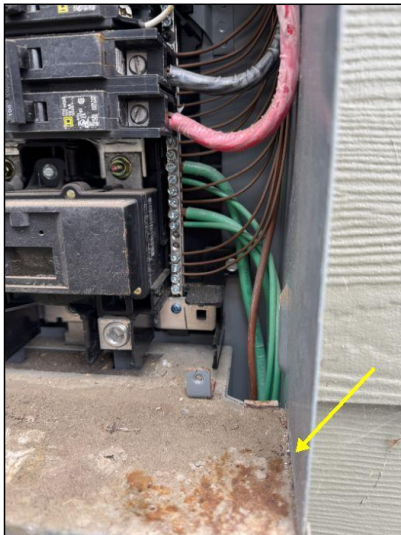
- Main panel observed as having "dirt"/ mild rust in the bottom of the panel. Recommend further evaluation/cleaning of panel of all debris by qualified electrician. Monitoring for rust expansion.

mild rust

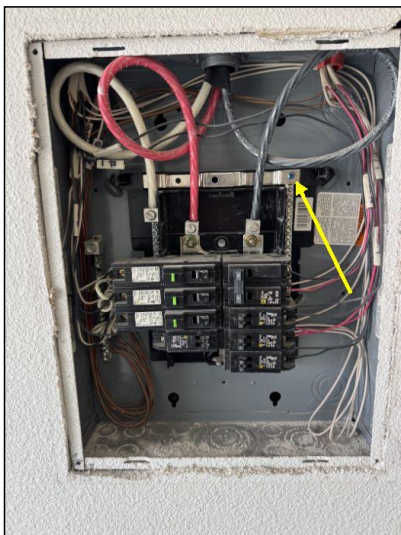
- Neutral observed as incorrectly bonded to the sub panel neutral bus bar with green screw at the time of the inspection. The neutrals and grounds should only be bonded at the first means of disconnect. Recommend further evaluation, removal of bond by licensed electrician.

bonding screw still installed in sub panel- defect

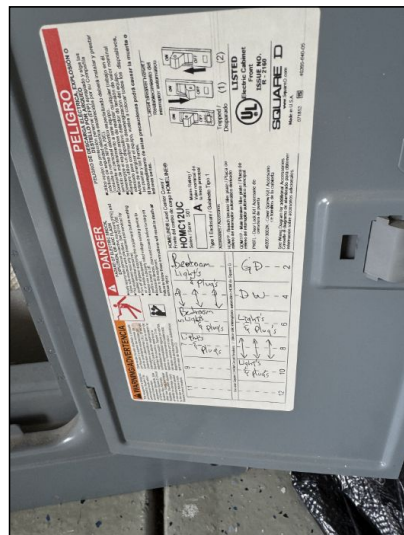
- Insufficient labeling observed on the electrical panels at the time of the inspection. Recommend licensed electrician troubleshoot to label in a fashion that anyone would be able to tell what the breaker feeds.

labeling

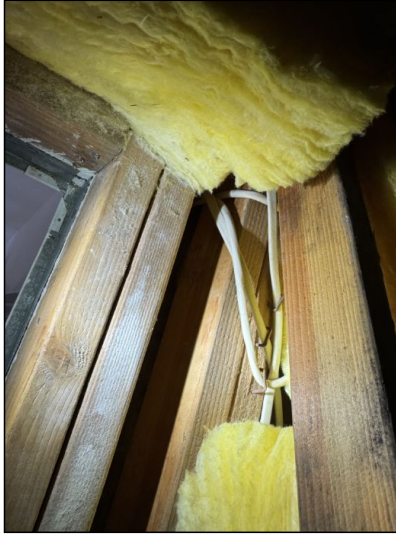
- Inspection of attic area limited to the accessible areas/platforms in/above the access points
- Conductors observed as right next to the access points of the attic at the time of the inspection. Any conductors within 6 ft of an attic access need to be protected with guard strips and secured at intervals not to exceed 54" to prevent any damage to the conductor when accessing the attic. Recommend licensed electrician remediate.

conductors next to access

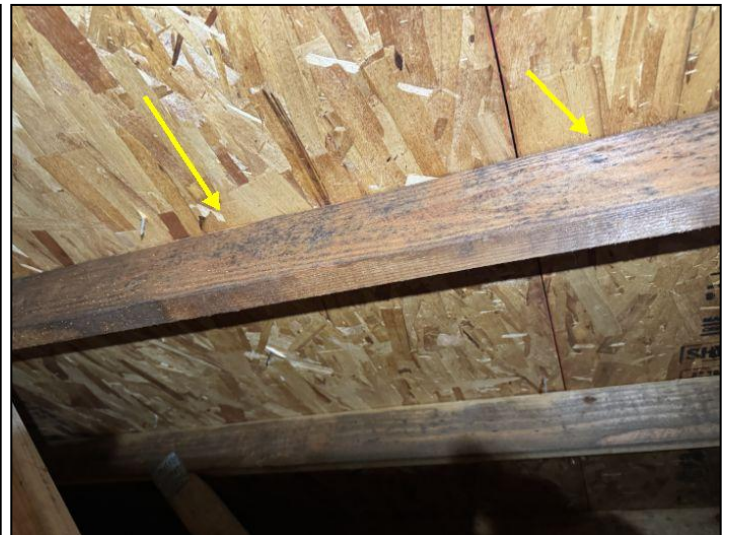
- Recommend removal of any unused products or garbage from attics.
- Dark staining on trusses at the time of the inspection. Possible microbial growth. Recommend further evaluation and remediation as appropriate by qualified contractor.

possible growth

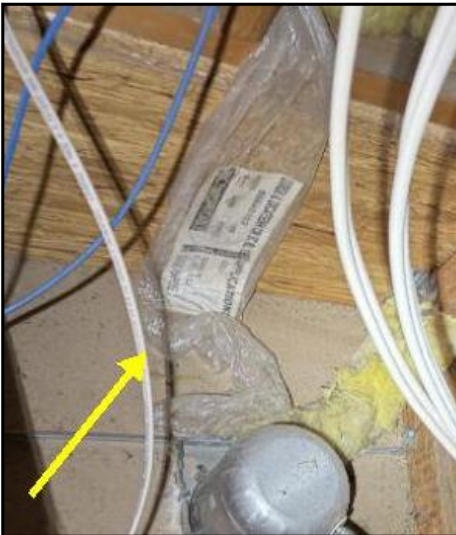
trash in attic - recommend removal

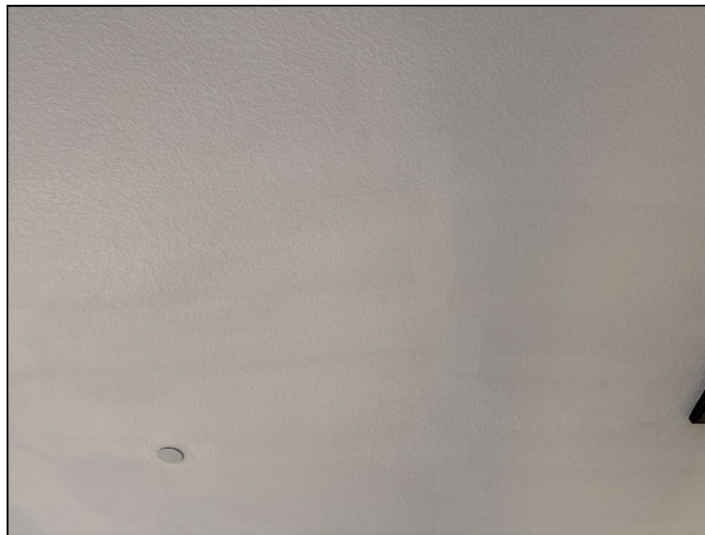
- Incomplete paint job observed throughout the house at the time of the inspection. Recommend further evaluation and remediation as appropriate by qualified contractor.

Differing shades

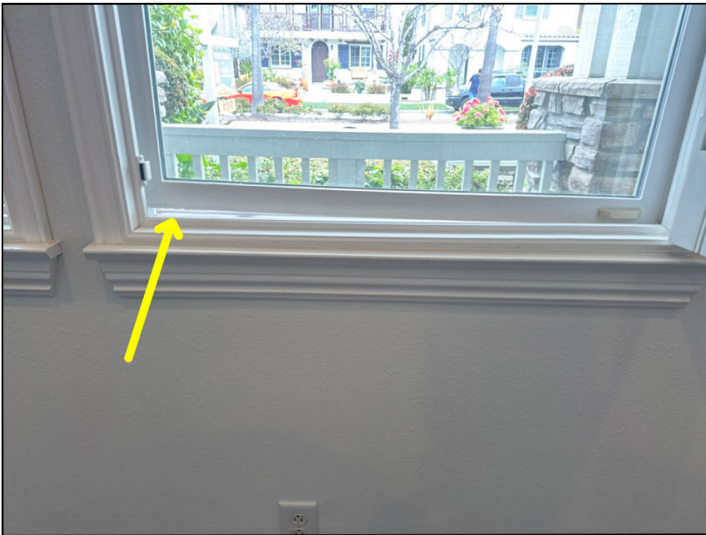
- Many of the windows were observed as slightly tight at the time of the inspection. Recommend monitoring and servicing as necessary.
- Recommend having windows cleaned and serviced for efficacy of use.
- Front window observed with difficulty closing at the time of the inspection. Recommend qualified contractor further evaluate and remediate as appropriate for ease of use
- Windows and living room observed as tight and difficult to operate at the time of the inspection. Recommend servicing windows by qualified professional for ease of use
- Window in living room on top of the stairs appears broken, unable to close at the time of the inspection. Recommend evaluation and remediation by qualified contractor.
- One or more the window blinds were non-operable or broken at the time of the inspection. Recommend repair/replacement by a licensed professional.

Difficulty closing- front window

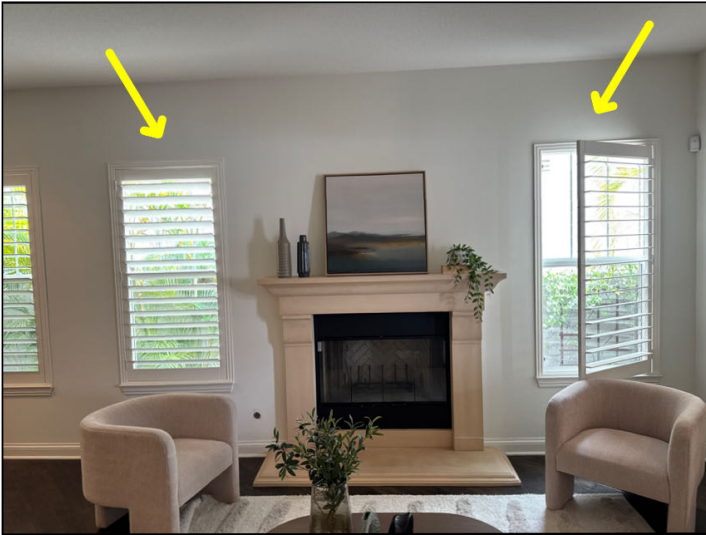
Tight

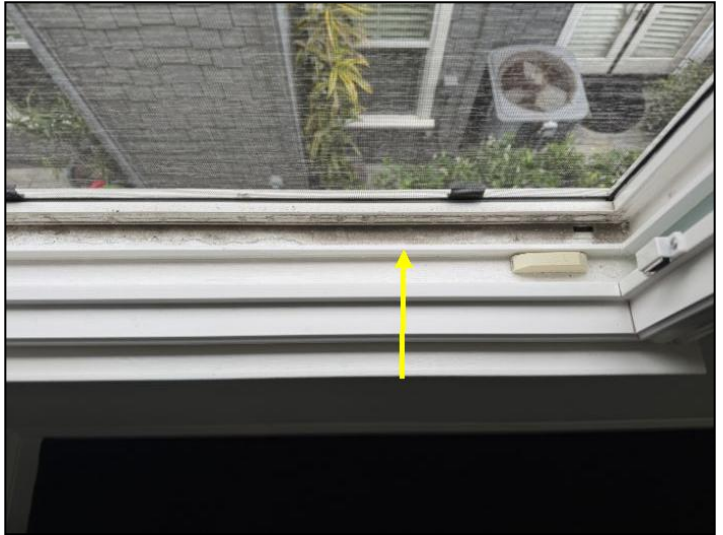
dirt on window sills

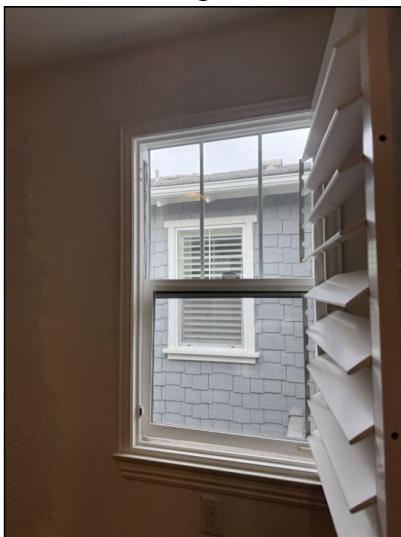
right window top of stairs - broken

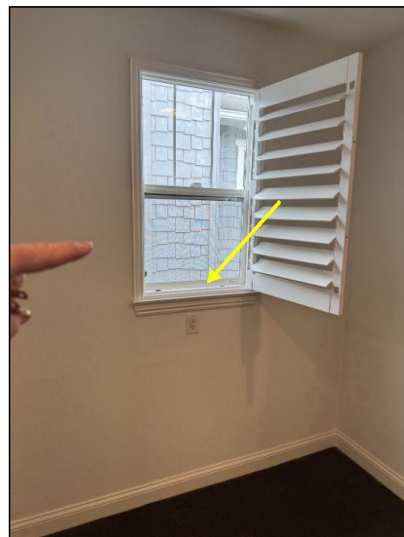
would not close

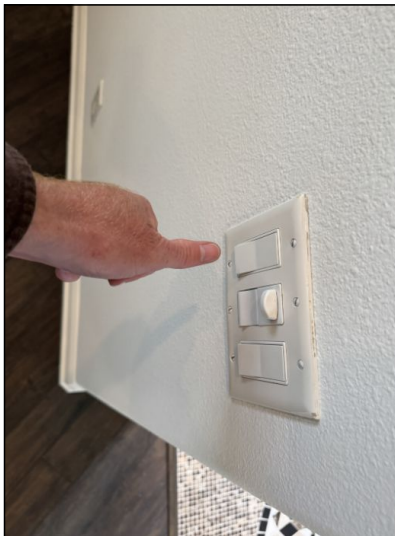
- One or more wall switches in the home observed as having no function at the time of the inspection. Recommend licensed and insured electrician for further evaluation.

front room left switch unknown

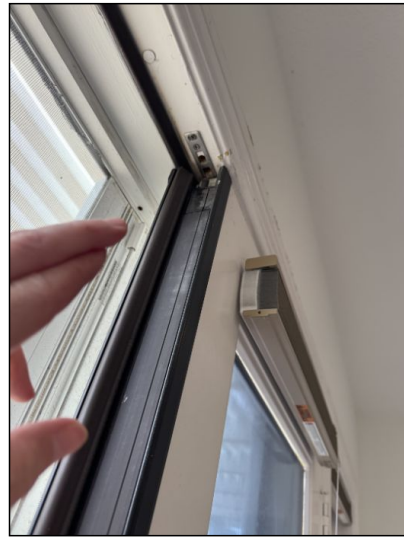
difficult lock patio door bedroom

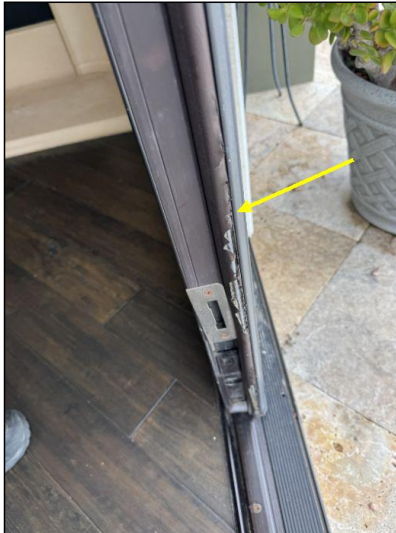
damage to weather stripping

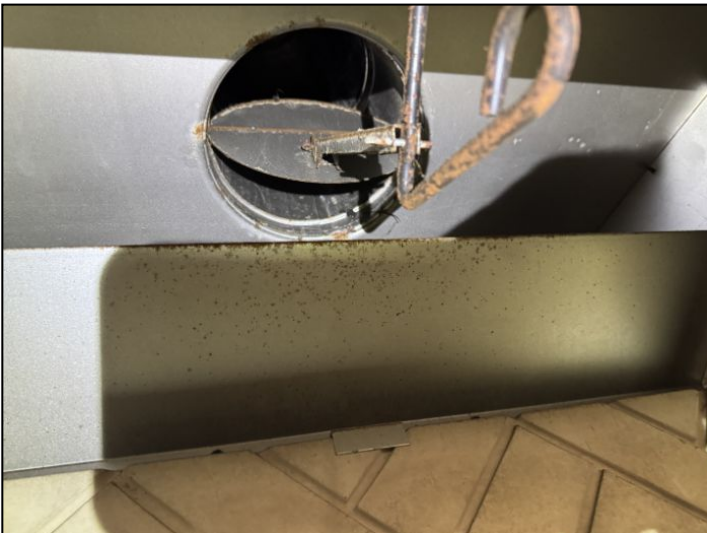
- No damper clamp observed in the back patio room fireplace. If in use, having the clamp to maintain the damper in the open position is a prudent recommendation.

Patio room - slight rust - no damper clamp

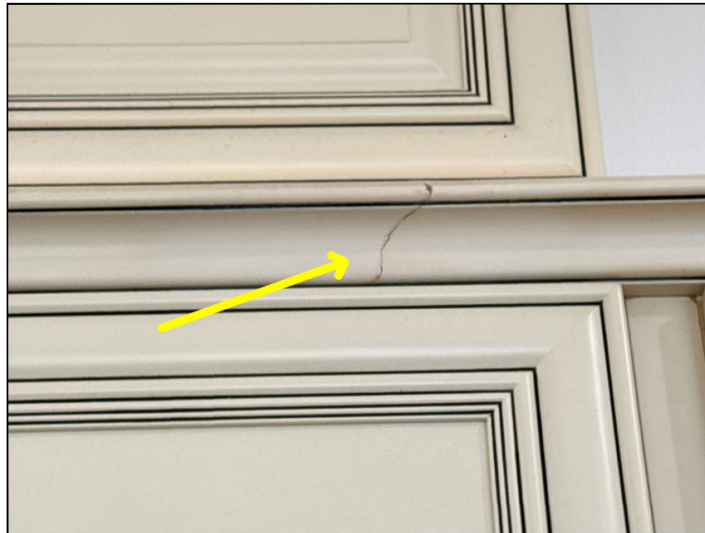
- Crack in cabinet observed in the kitchen at the time of the inspection.

crack

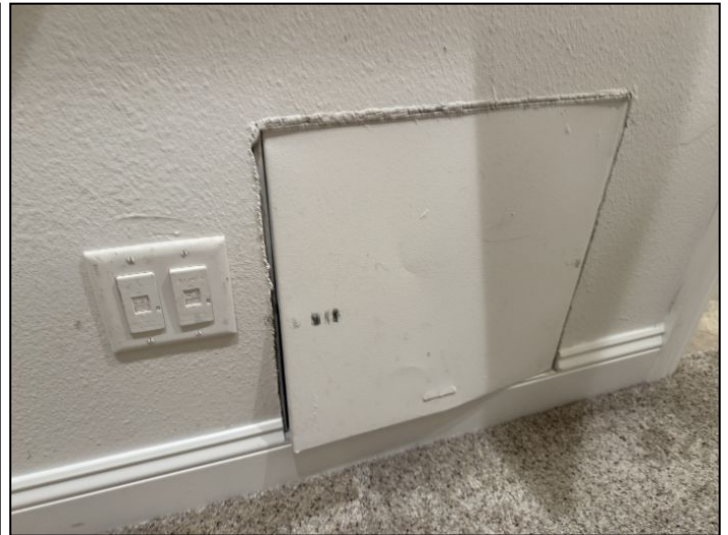
access stuck open

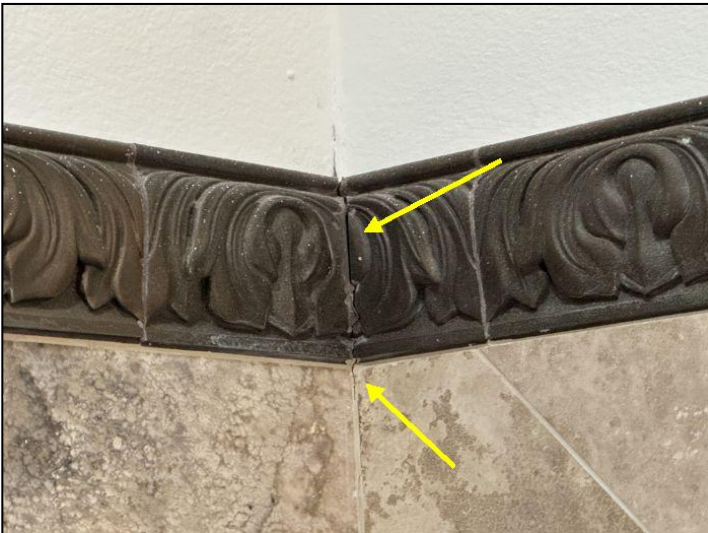
- Cracking in the grout noted at the time of the inspection. Recommend sealing of all grout to prevent additional moisture intrusion.
- Cracking in caulking observed at the time of the inspection. Recommend cleaning and replacing all cracked caulking to prevent moisture intrusion. Recommend remediation by qualified contractor.
- Gap at shower faucet allowing moisture penetration. Recommend remediation to prevent continued moisture intrusion.

seal cracks

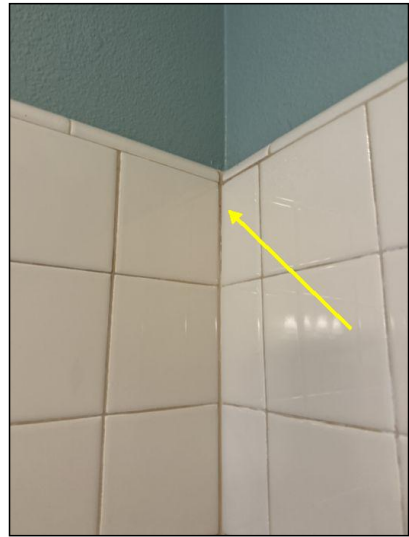
cracks

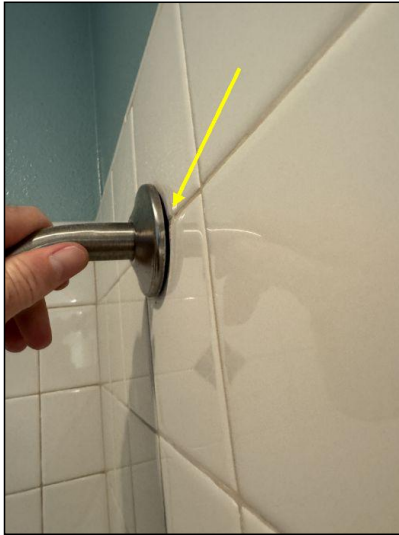
seal gap

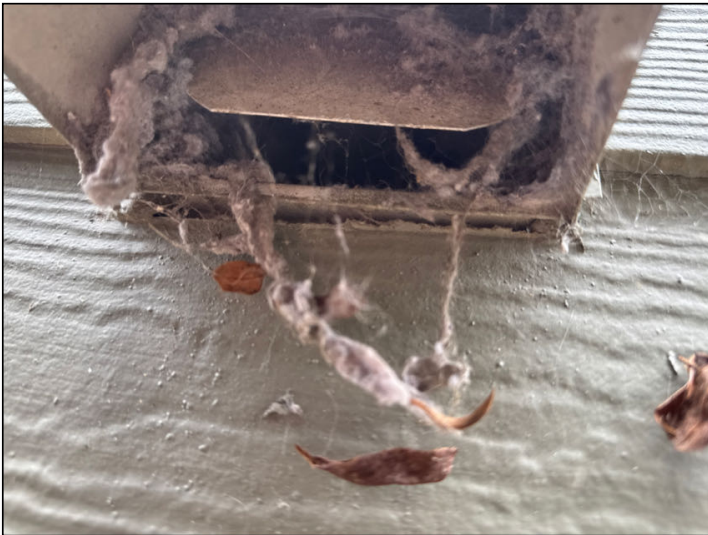
- Flexible transition dryer vent observed behind the dryer at the time of the inspection. These are allowed as transition ducts connecting the dryer to the exhaust at 8ft or less. Recommend awareness regarding the fact that flexible transition ducts can get smashed and kink when moving the dryer. A clogged or kinked dryer vent can be a fire hazard. Therefore, we recommend being aware when moving dryer and having dryer vent cleaned as appropriate to allow for proper venting. We recommend evaluating replacing flexible vent with solid to prevent any clogging/fire issues.
- Lint build up observed at vent at the time of the inspection. Recommend cleaning and maintenance of dryer vent by qualified professional.

Clean

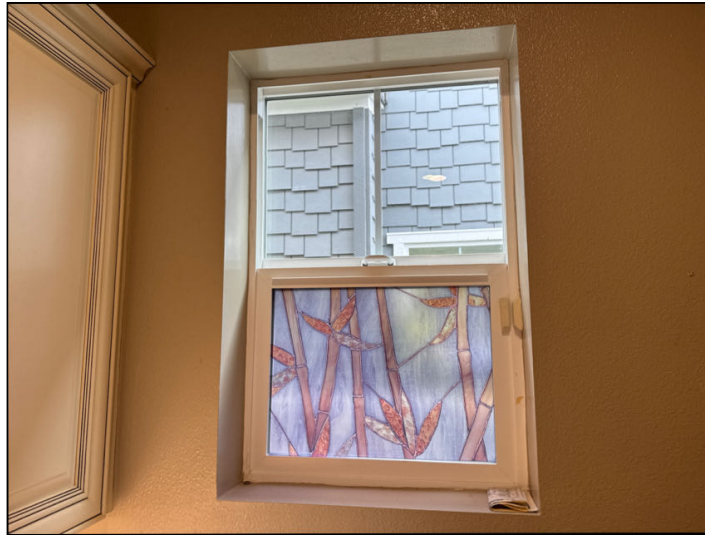
- Window and laundry room reserved to be loose during use recommend servicing window for ease of use.

Loose window
