# BEST COAST HOME INSPECTIONS

## Confidential Inspection Report

, Santa Paula, CA 93060

Inspection prepared for: Sample Sample

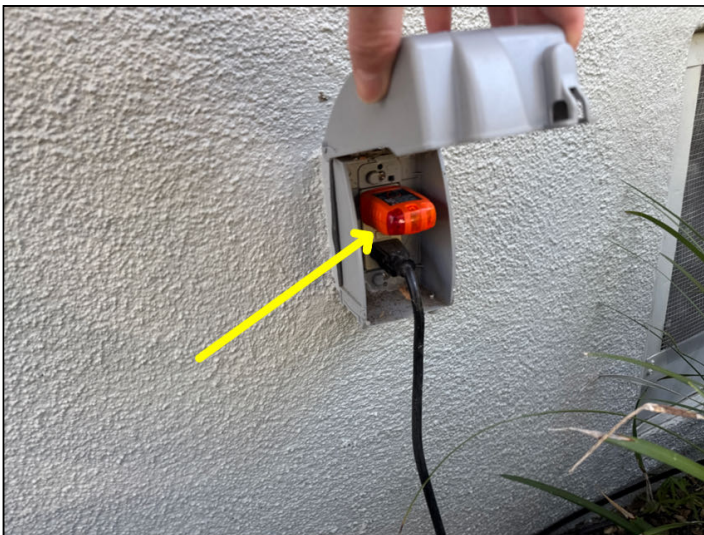
• Missing Ground Fault Circuit Interrupter (GFCI) protection in the home at the time of inspection. Although GFCI protection may not have been required at the time the home was built, for safety reasons, consider upgrading the electrical system to include GFCI protection at the following locations:

*Missing gfci front of house*

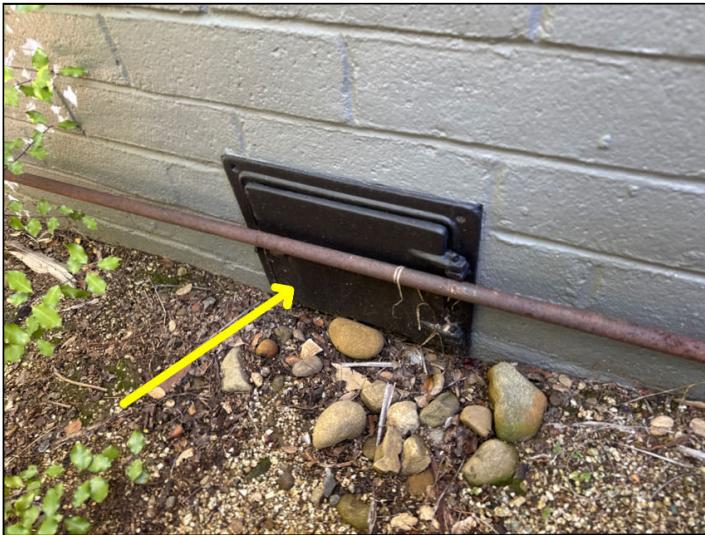
- Chimney clean out, observed as blocked by gas line at the time of the inspection. Recommend further review of gas line by licensed plumber to relocate in order to allow proper use of chimney clean out.

*Clean out blocked*

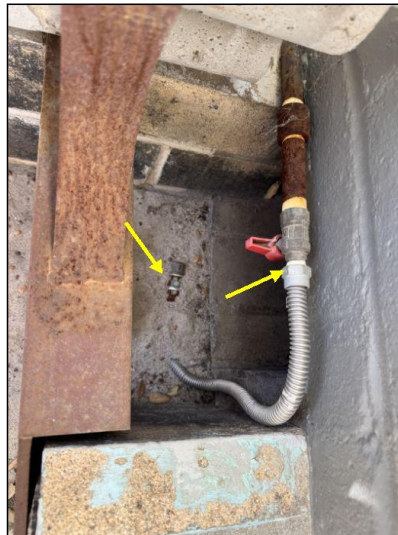
- White PTFE thread tape observed on gas line at the time of the inspection. While no gas leaks were observed at the time of the inspection, yellow PTFE tape (or approved tape compound) is the standard material specified for natural gas piping due to its higher density and compatibility with fuel gases, white tape is typically for water lines and may not provide long term reliability on gas threads. Recommend verification from licensed plumber to confirm the tape is an approved high-density type suitable for gas use. If not correction is advised to meet industry standards and best practices.

*white tape on exterior gas line*

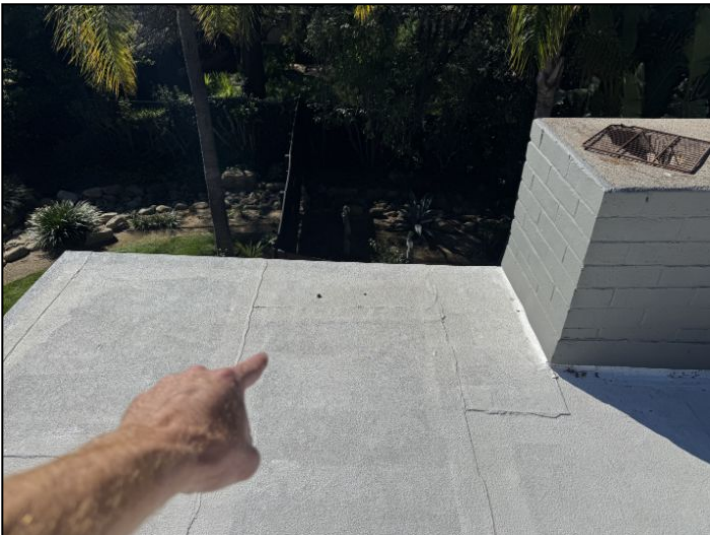
*soft spot on roof*

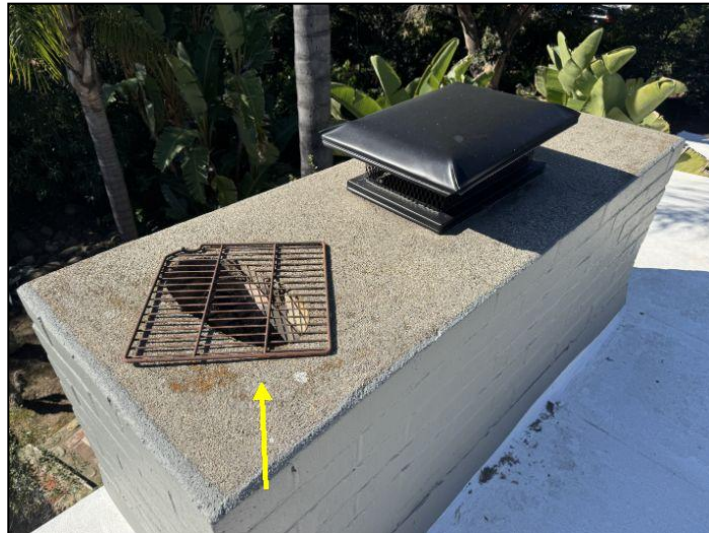
- No chimney cap/spark arrestor visible at the time of the inspection. Recommend installation to prevent premature weathering, water intrusion, and nesting of wildlife.

*missing spark arrestor and rain shield*

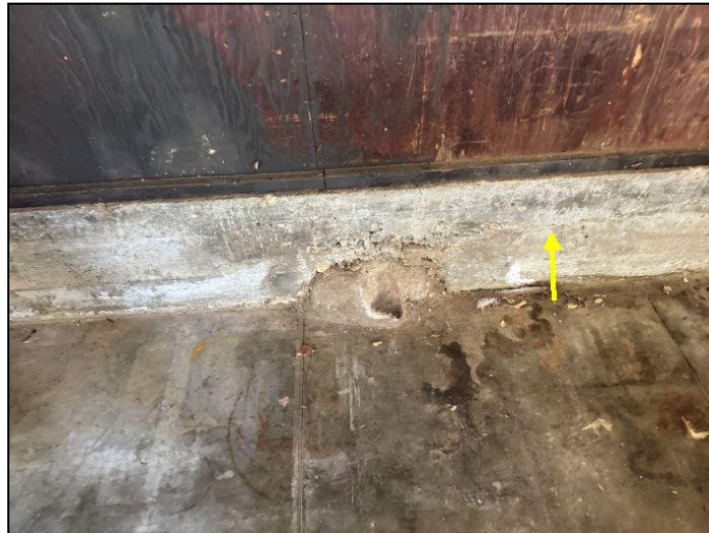
- Crack extending from rock built into foundation wall. Recommend qualified contractor seal all cracking to prevent additional deterioration.

*seal cracking from rock*

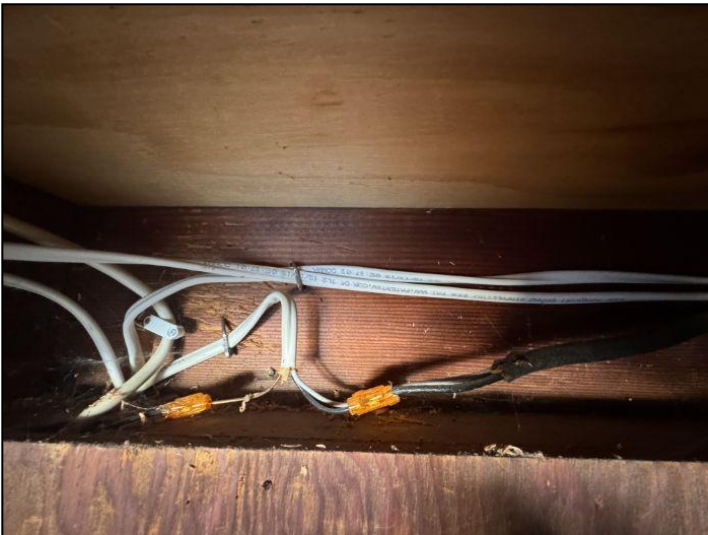
*exposed connection in garage*

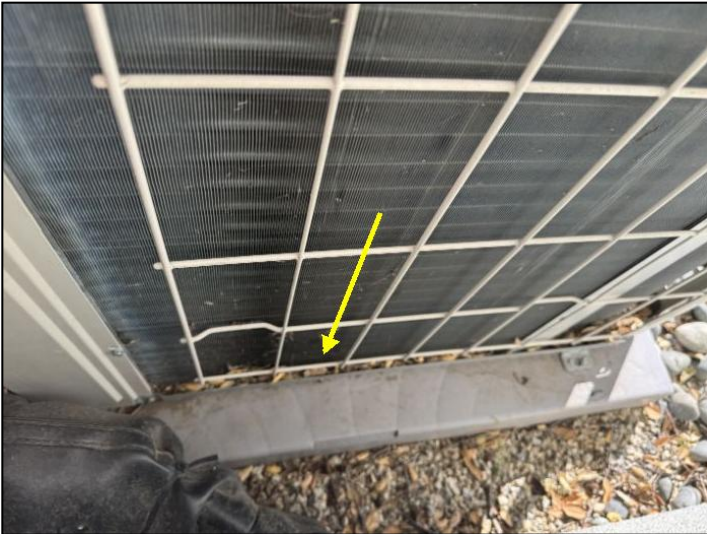
- Recommend clearing debris at unit.
- Heat pump unit functional under normal operating controls at the time of the inspection.

*clean debris from unit*

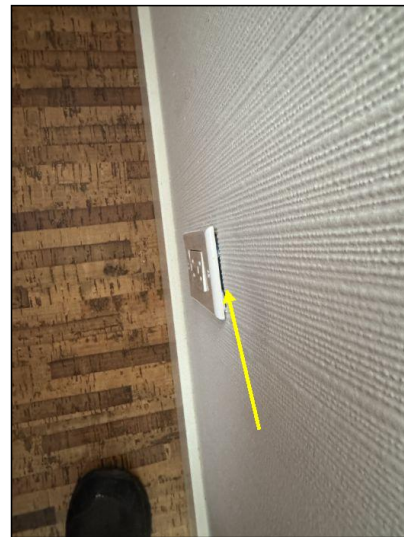
*seal gaps around electrical*

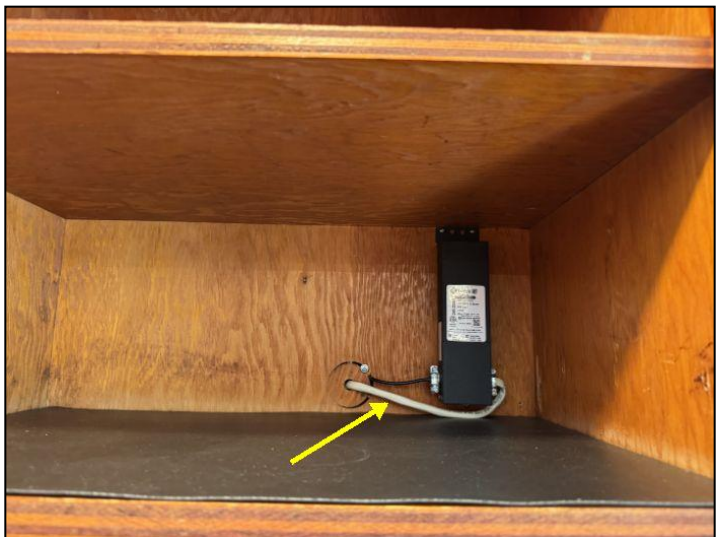
- Outlet with open ground observed in the kitchen. This is a defect. Recommend qualified electrician remediate.
- Exposed Romex electrical cable in the kitchen storage cabinets at the time of the inspection. This is defect and safety hazard. Recommend licensed electrician remediate

*exposed romex in cabinet*

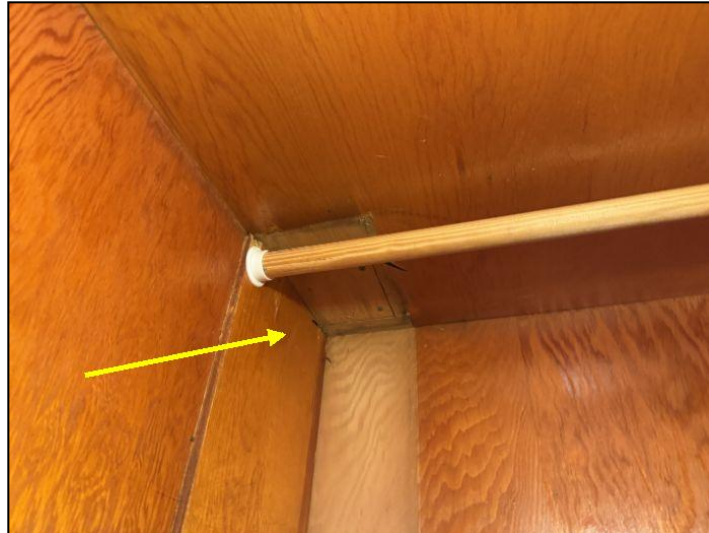
*patching of closet ceiling*

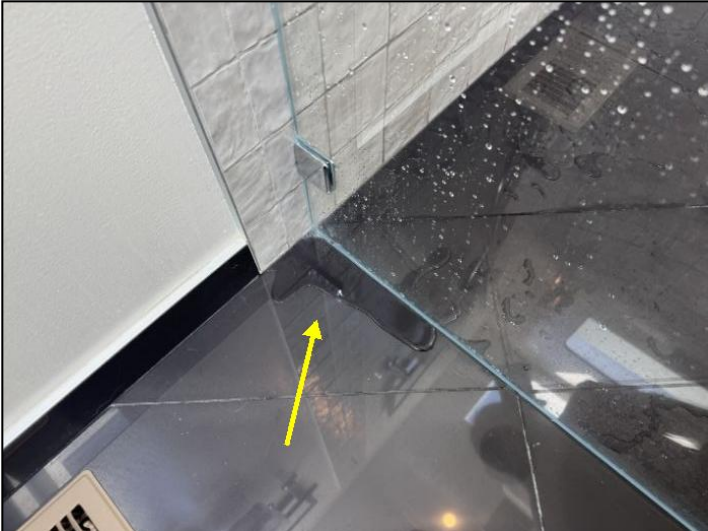
- Showers missing doors at the time of the inspection. Recommend monitor for the need of installation.
- Glass shower walls observed as leaking at the time of the inspection. Recommend remediation by qualified contractor to prevent additional moisture intrusion.
- Cracking in caulking observed at the time of the inspection. Recommend cleaning and replacing all cracked caulking to prevent moisture intrusion. Recommend remediation by qualified contractor.

*leaking shower wall*

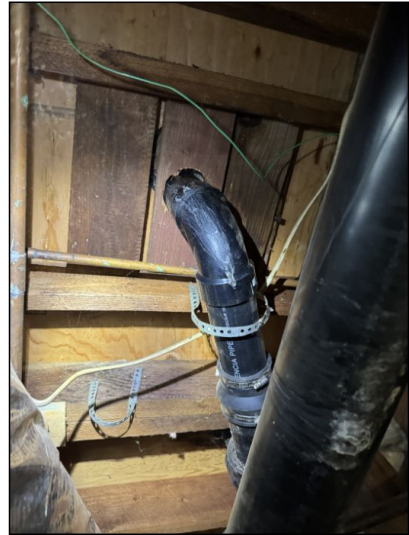
*location of active leak*

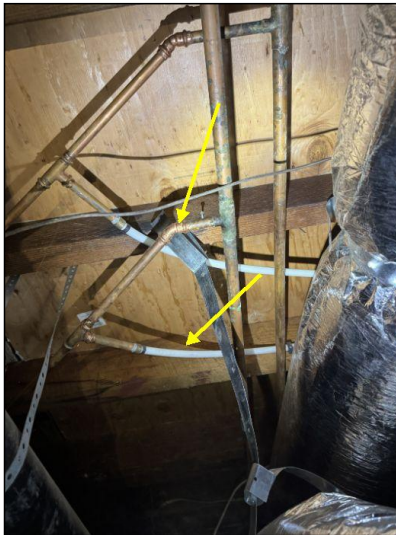
*plastic piping patch*
