# SAMPLE INSPECTION

## Confidential Inspection Report

Sample St. , Camarillo, CA 93010

Date of Inspection: 2/14/2025 Time: 1015

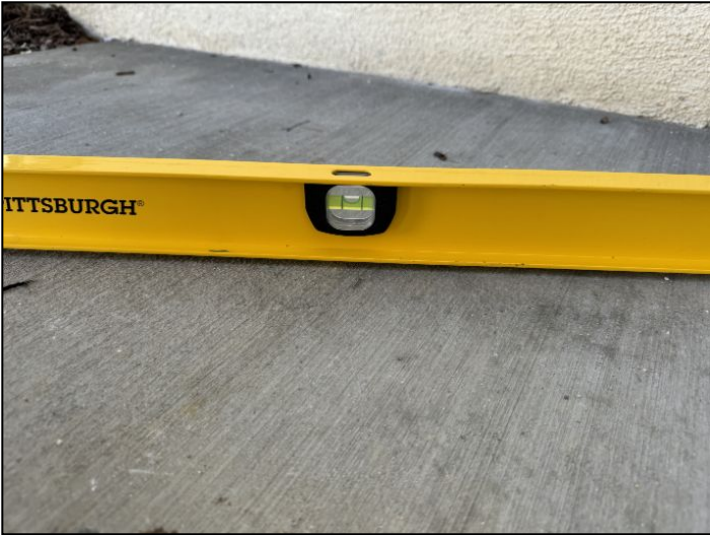
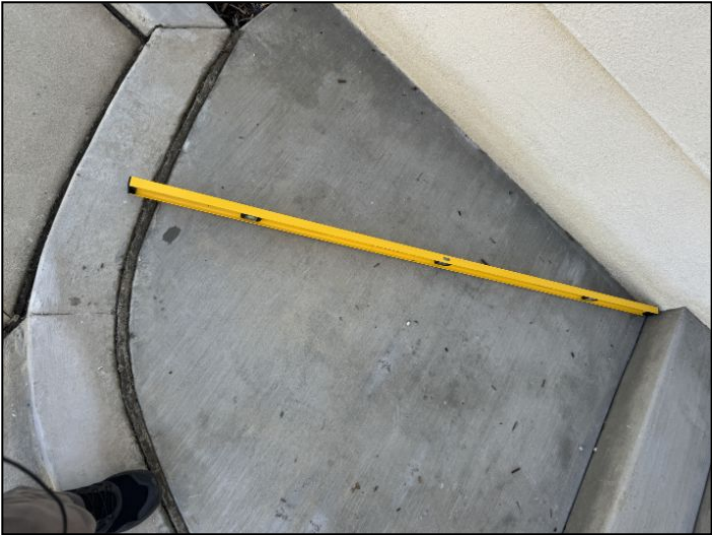
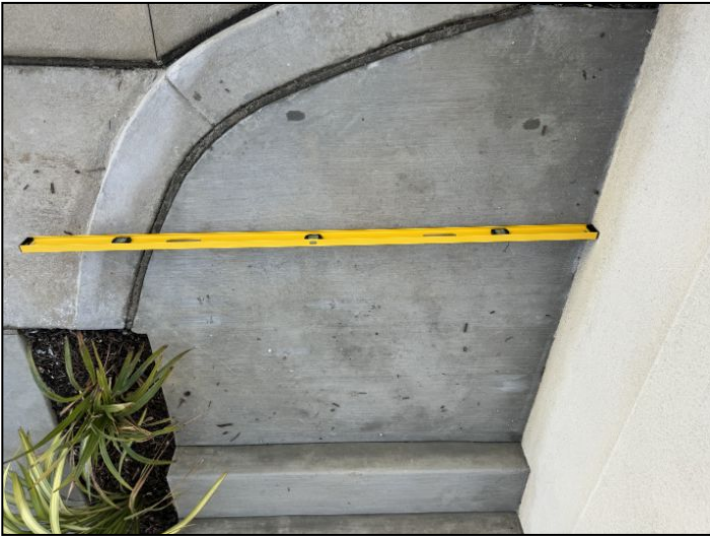
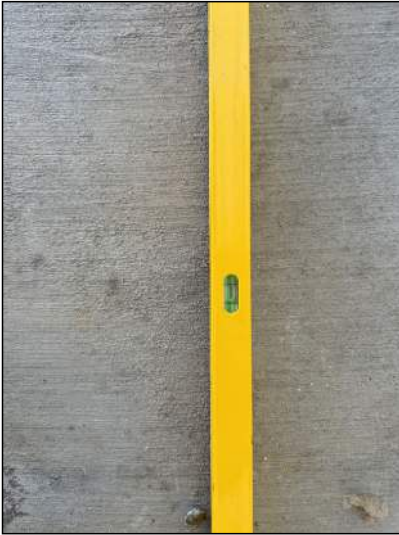
- Signs of possible moisture settlement against foundation wall in front of the house at the time of the inspection. Measured with large level, fall is very slight and level in multiple locations. Recommend monitoring walkway for moisture settlement, further evaluation by qualified contractor and remediation as appropriate.

*level*

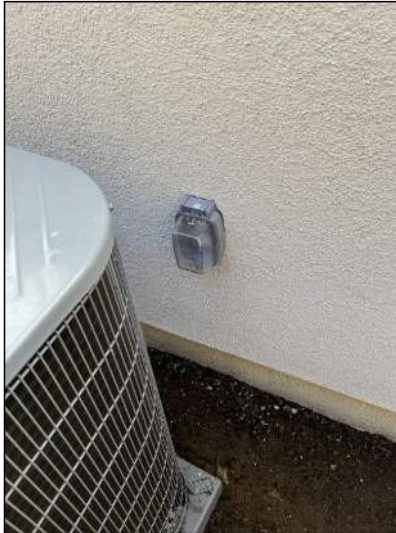
- Exterior **GFCI** reset observed on outlet adjacent to front door.

*reset at front door*

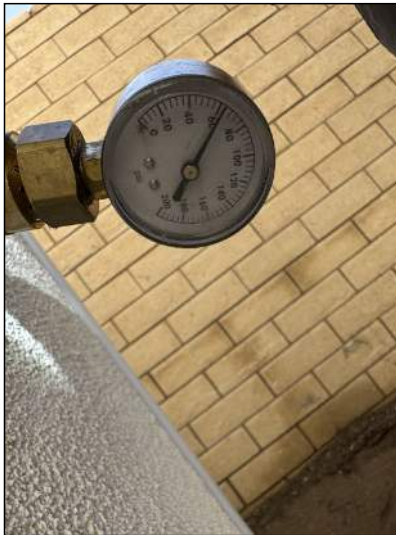
- 60psi

*above 60*

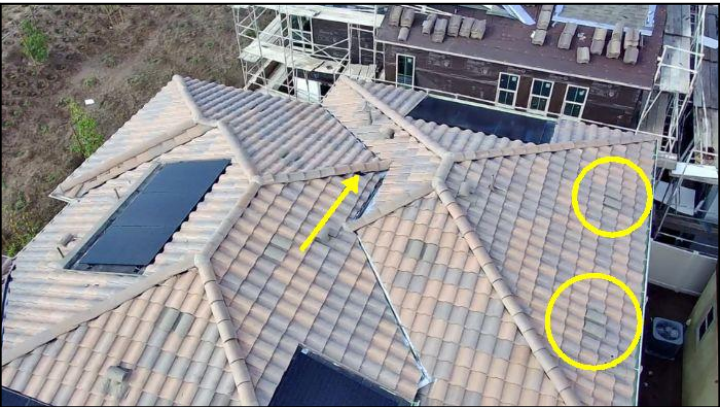
*tile slid down*

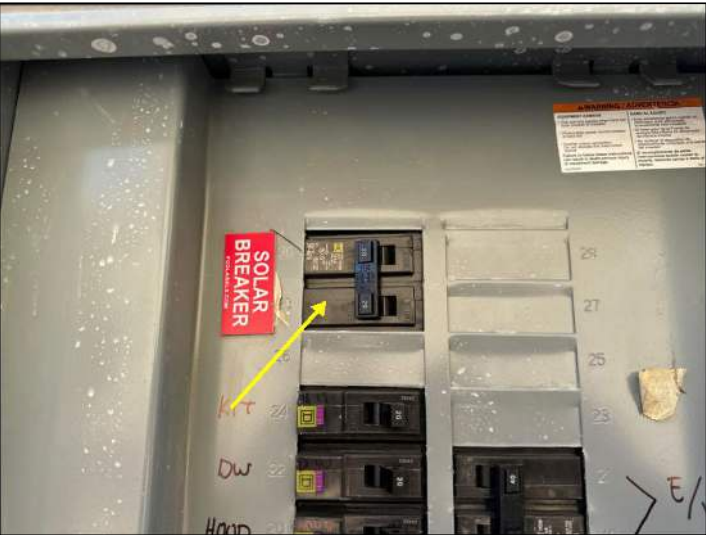
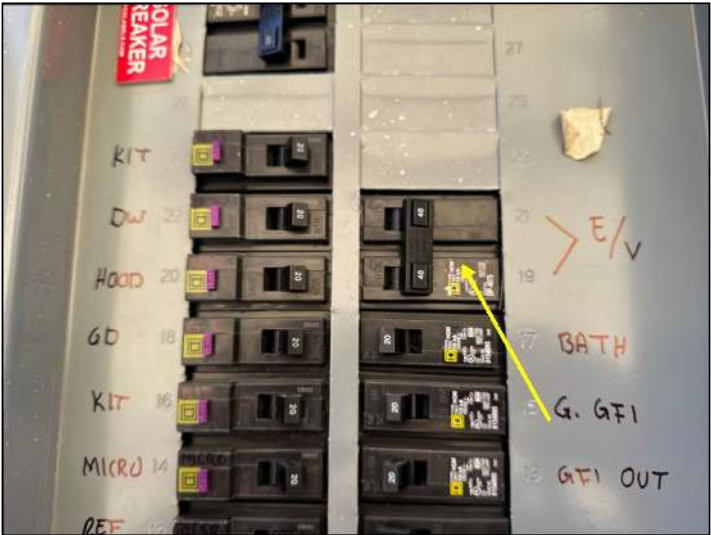
- 2

Off

off

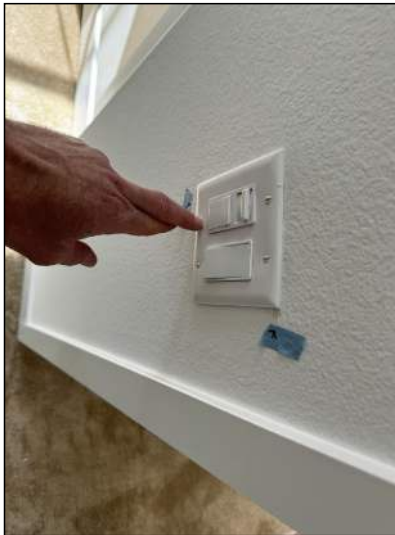
- All bedrooms observed with lamp switch and no functional switch most likely wired to ceiling outlet cover at the time of the inspection.

*lamp and ceiling switch*
