SAMPLE REPORT

Confidential Inspection Report

Inspection prepared for: SAMPLE

Date of Inspection: 1/2/2025 Time: 9am

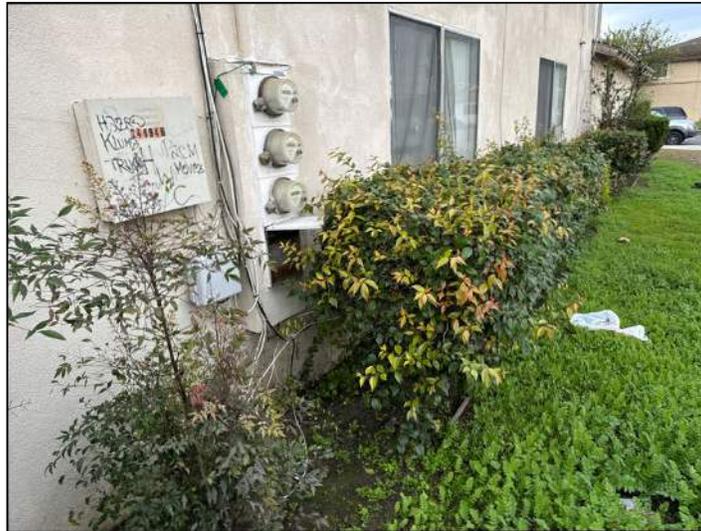
- Maintenance Tip: When landscaping, keep plants, even at full growth, at least a foot (preferably 18 inches) from house siding and windows. Keep trees away from foundation and roof. Plants in contact or proximity to home can provide pathways for wood destroying insects, as well as abrade and damage siding, screens and roofs.
- Vegetation observed as resting against the house at the time of the inspection. This may lead to damage of siding or moisture entry. Recommend evaluating the need to trim back vegetation.
- Signs of excess moisture in the garden area lining the front of the home at the time of the inspection. Recommend monitoring sprinklers and water pooling to prevent excess moisture from pooling next to the homes foundation.

Vegetation against home

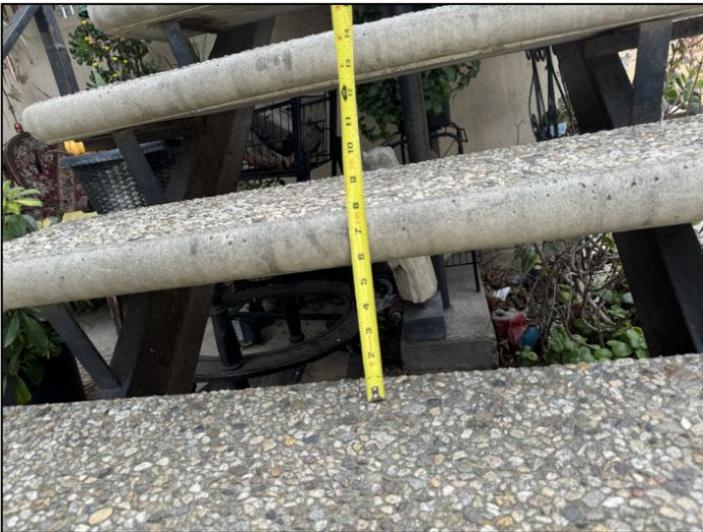
- Open stair risers exceeded the 4 inches allowable for child safety standards observed at the time of the inspection. Recommend remediation by licensed professional.
- The spacing between the stairs and the handrail was observed as larger than the allowable 6 inches at the time of the inspection. Recommend remediation by a licensed professional to prevent small children falling hazards.
- Significant rust/spalling observed on the stairs and balcony at the time of the inspection. This may increase chances of failure. Recommend remediation by licensed and insured contractor to prevent additional deterioration and prevent any failure of a safety guard.
- Observed possible microbial growth on the stairs/balcony at the time of the inspection. Recommend remediation by licensed professional.

larger than 4 inch gap

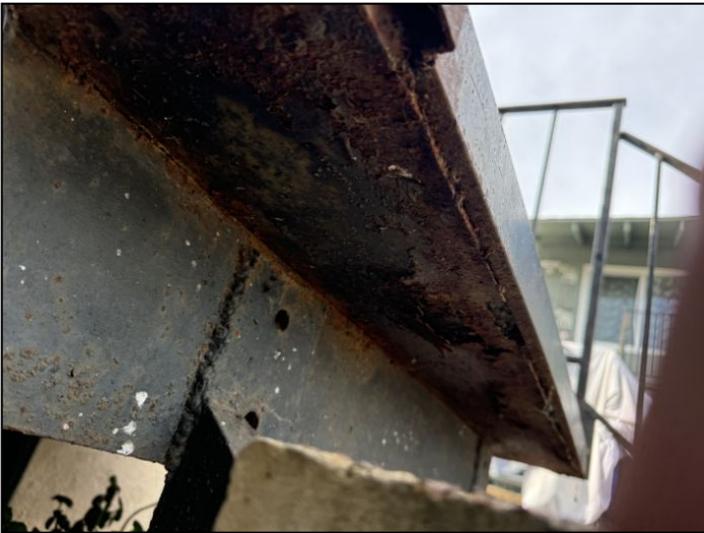
rust on stairs/balcony

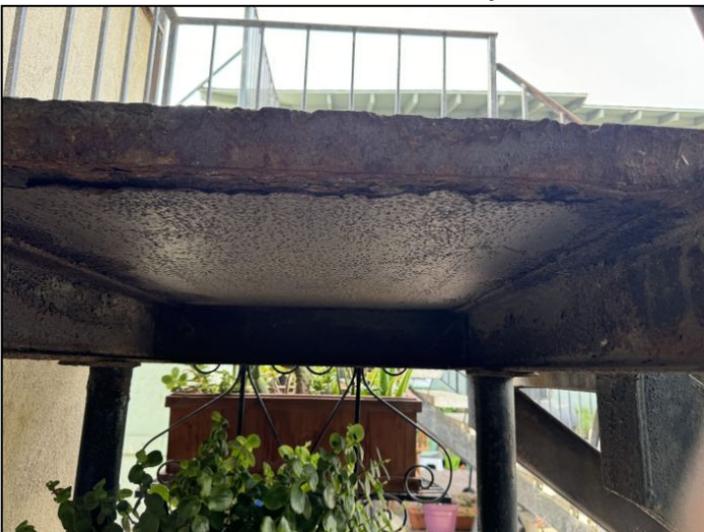
rust

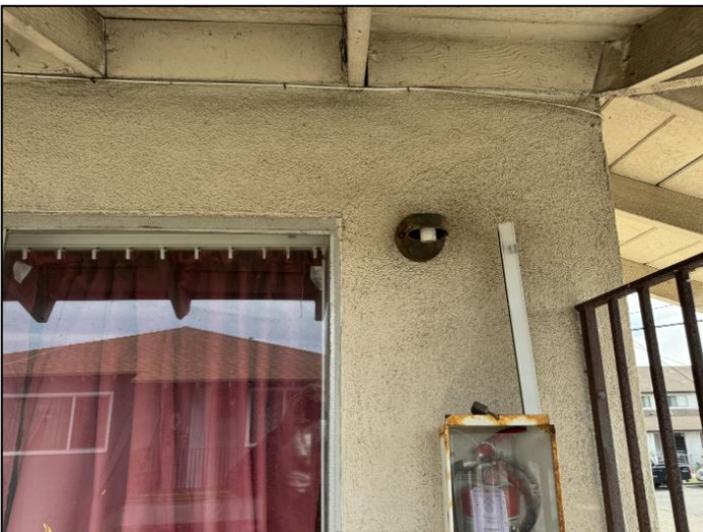
no light - apt 3

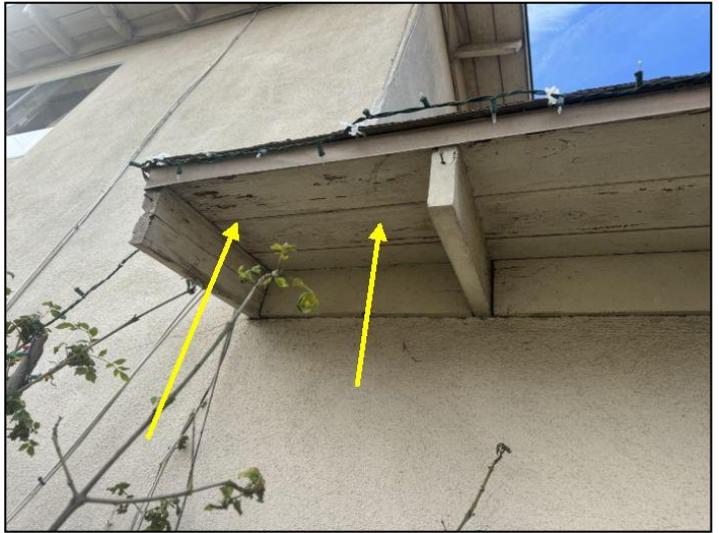
- Gap observed in eaves at the time of the inspection. Recommend sealing all gaps and cracks in exterior of structure by qualified contractor.
- Signs of possible wood destroying pests around the exterior of the home at the time of the inspection. Recommend for the evaluation by qualified contractor.

pests

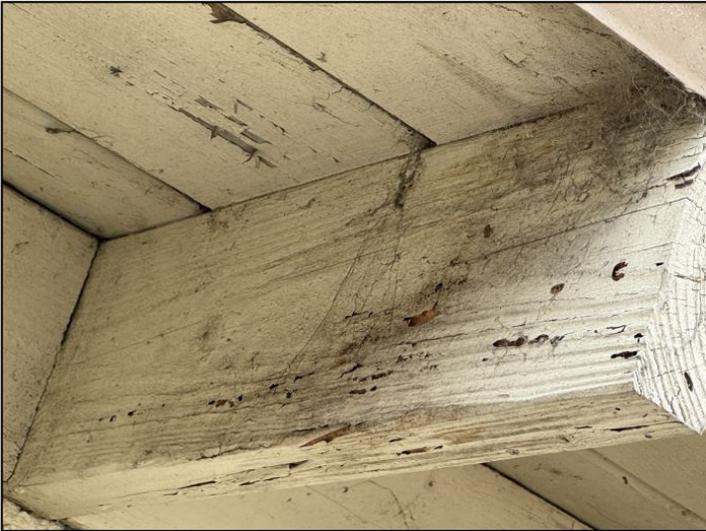
suspected wood destroying pests

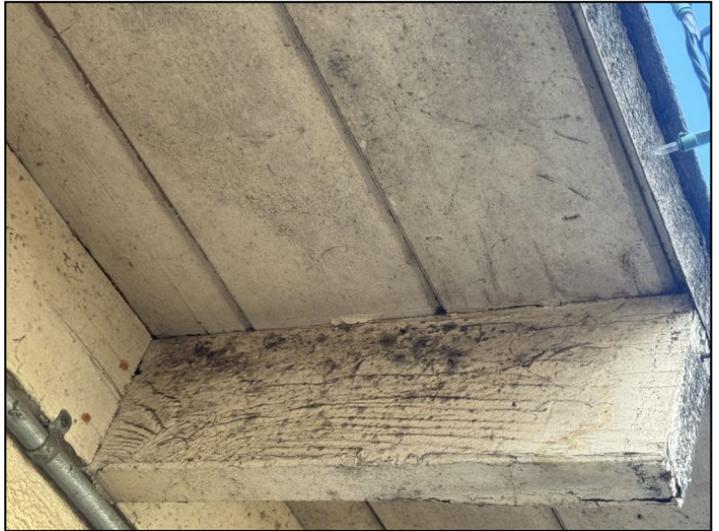
- Signs of dirt and possible microbial growth under the eaves observed at the time of the inspection. Recommend cleaning. Recommend remediation by a licensed professional.

suspected growth

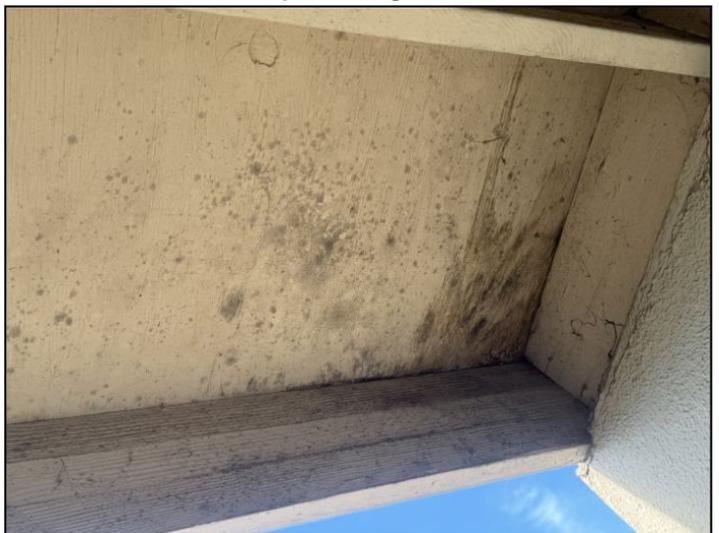
suspected growth

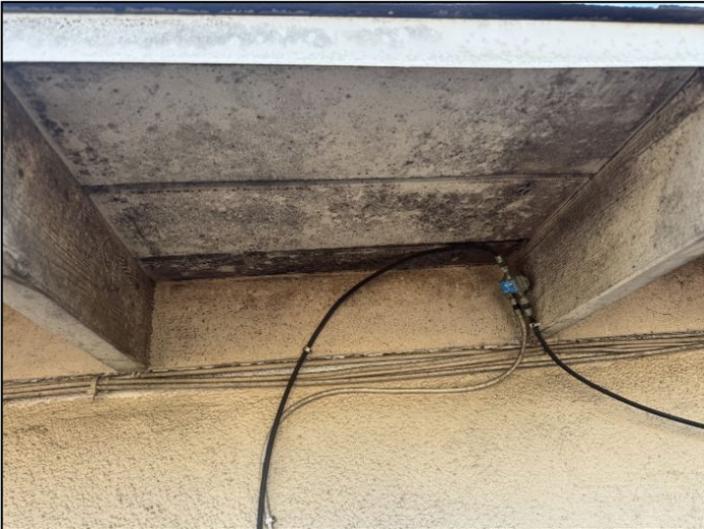
second story eaves - suspected growth

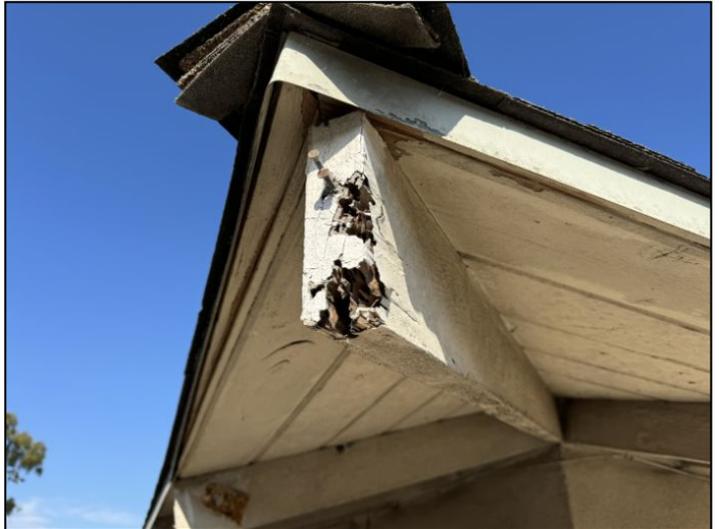
suspected pests

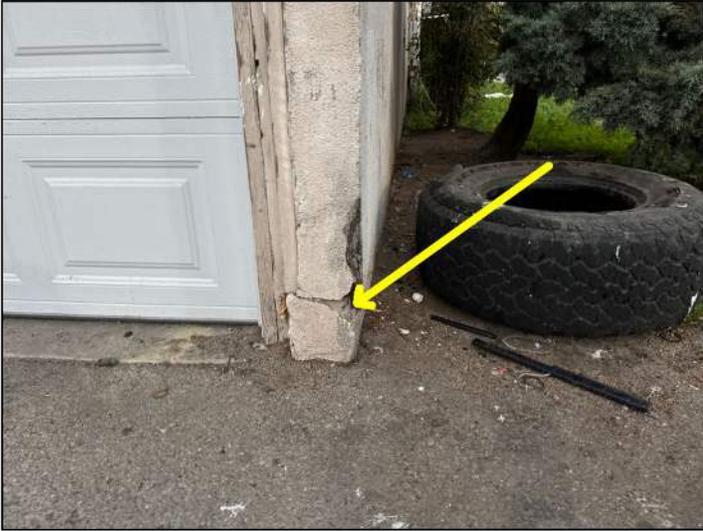
- Cracks in stucco extending from window at the time of the inspection. There is stucco missing in areas of the exterior. Recommend having a qualified exterior finish contractor evaluate and correct the issue.

Large crack, exposed stucco

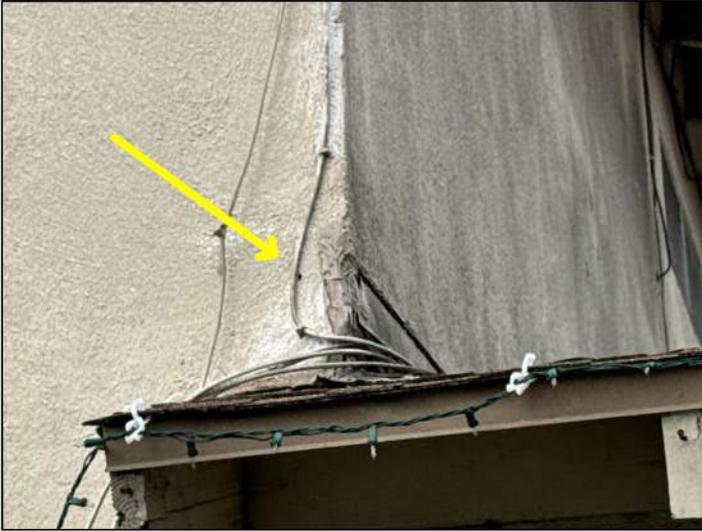
damage

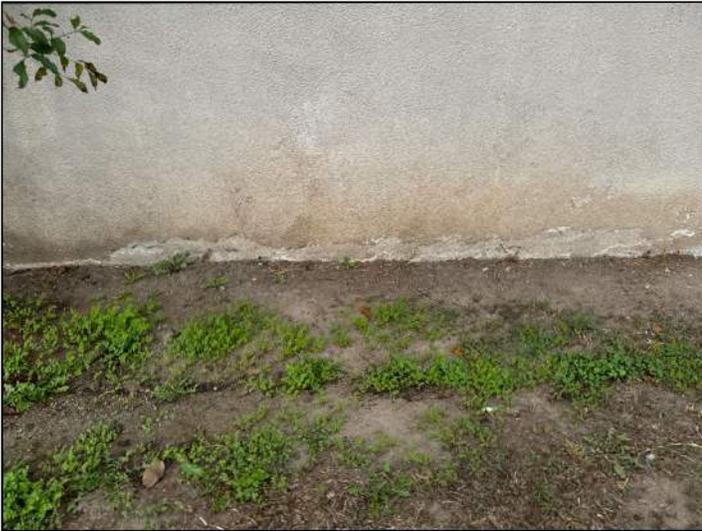
- The exterior grading was observed as improperly sloped in a couple locations around the foundation not allowing for the appropriate fall away from the home. Recommend creating the proper slope away from the foundation to allow for proper drainage and prevent moisture damage to the home. Remediation by licensed contractor recommended.

moisture damage- see "grading"

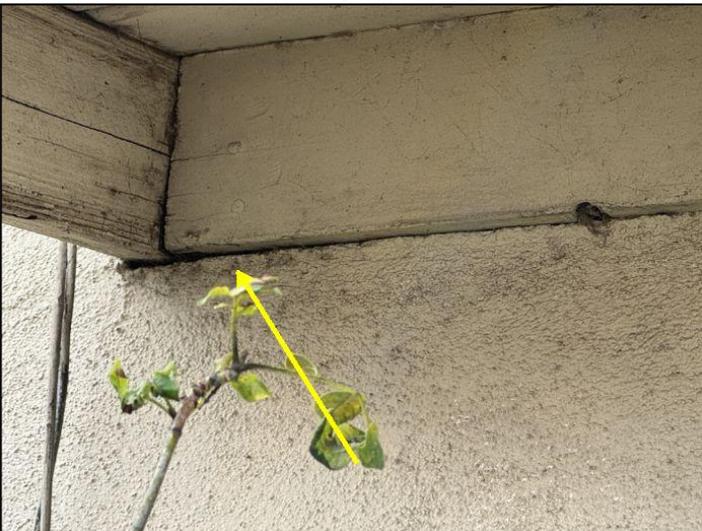
- Deterioration of stucco under balcony at the time of the inspection. Recommend remediation by qualified contractor.
- Cracks and gaps observed in stucco around exterior of structure at the time of the inspection. Recommend filling all cracks and gaps to prevent moisture and pest intrusion.

seal gaps

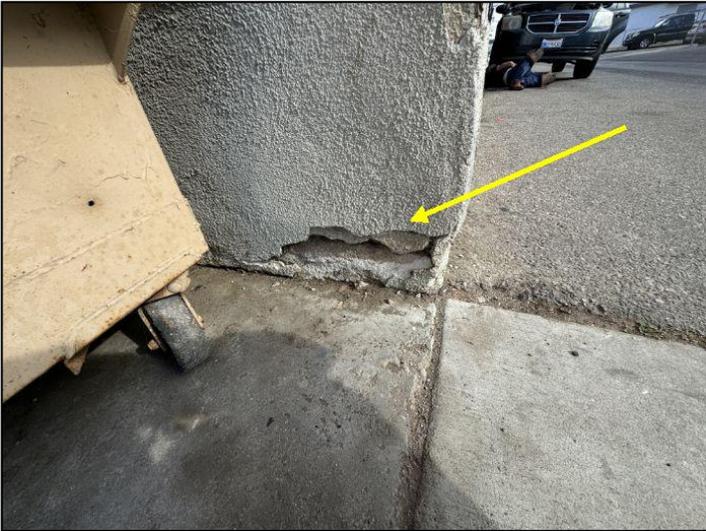
large crack

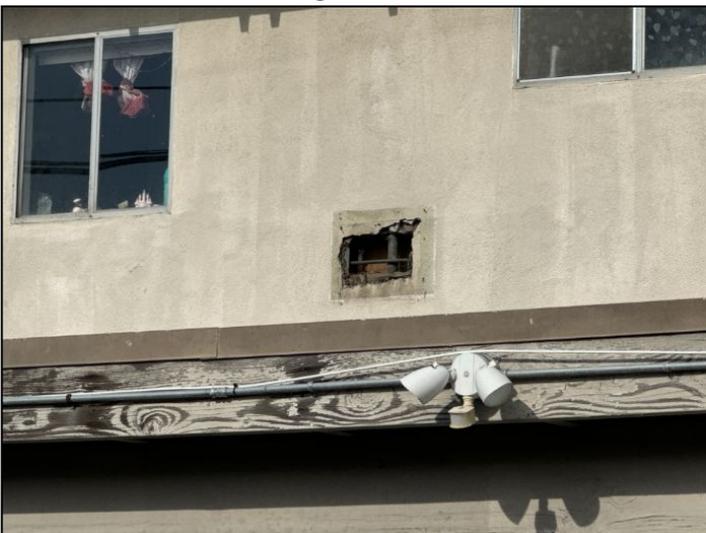
hole in wall

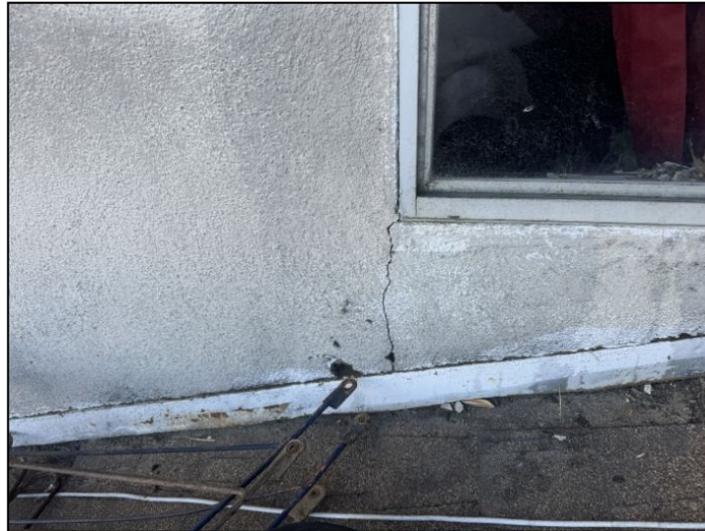
- Small settlement cracks in the stucco observed at the time of the inspection. We recommend monitoring and sealing holes & gaps in the stucco to keep water infiltration from causing further damage.

settlement crack

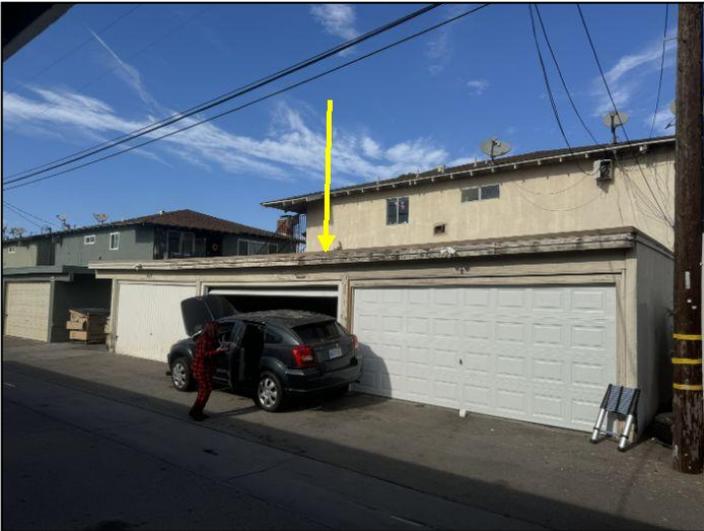
- Garage roof observed as slightly sagging in the middle at the time of the inspection. Recommend further evaluation and remediation by licensed and insured contractor.
- Moisture observed as settling in multiple spots on the drainage plane of the roof at the time of the inspection. Possible microbial growth/moss observed, Recommend license and insured roofer evaluate for remediation.
- Exposed fasteners on the ridge line of the roof at the time of the inspection. Recommend remediation by licensed contractor.
- Shingles worn down exposing the fiberglass observed at the time of the inspection. This is a sign the roof is at or near the end of its functional life. Recommend evaluation and remediation by licensed and insured roofing company.
- Shingles observed as split on the ridge line at the time of the inspection. Recommend qualified roofer remediate.

Appears to sag above garage

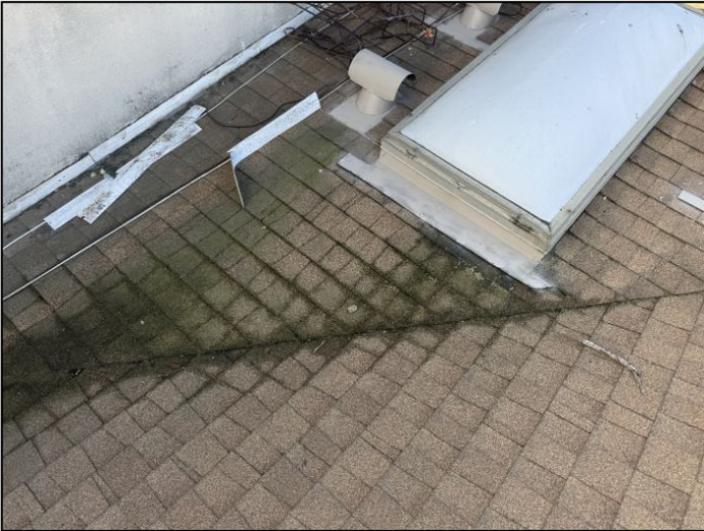
moisture settlement/suspected growth

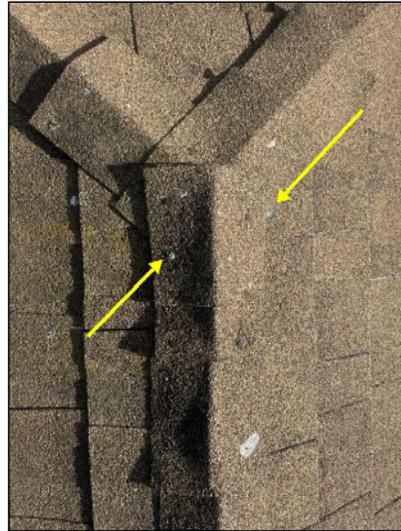
exposed fasteners

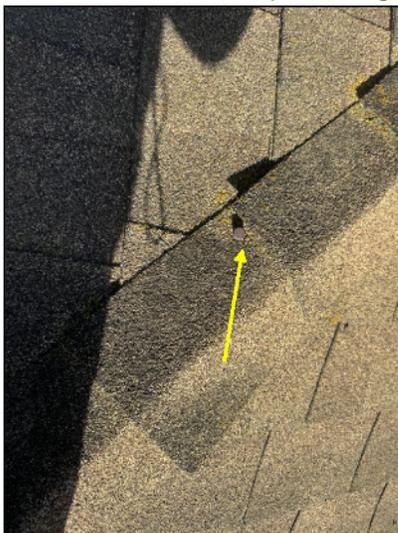
exposed fastener

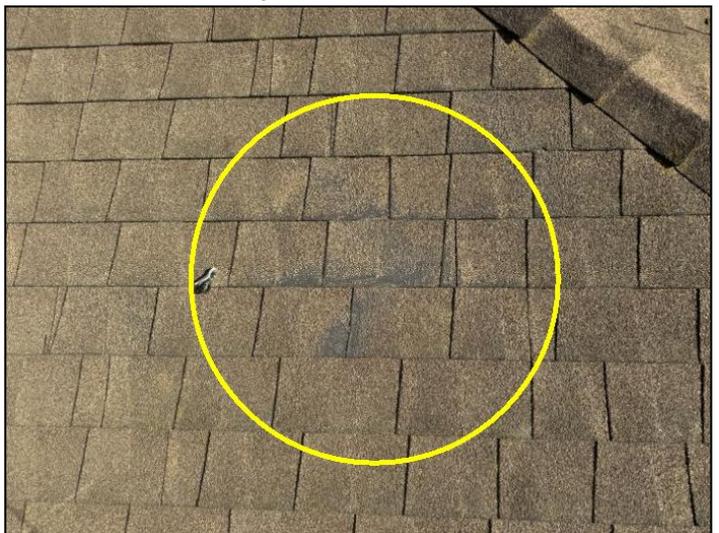
exposed fiberglass

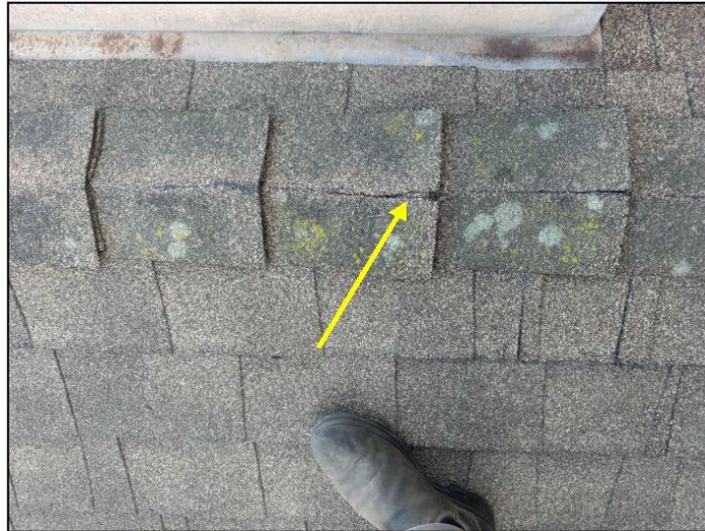
cracks in ridge line

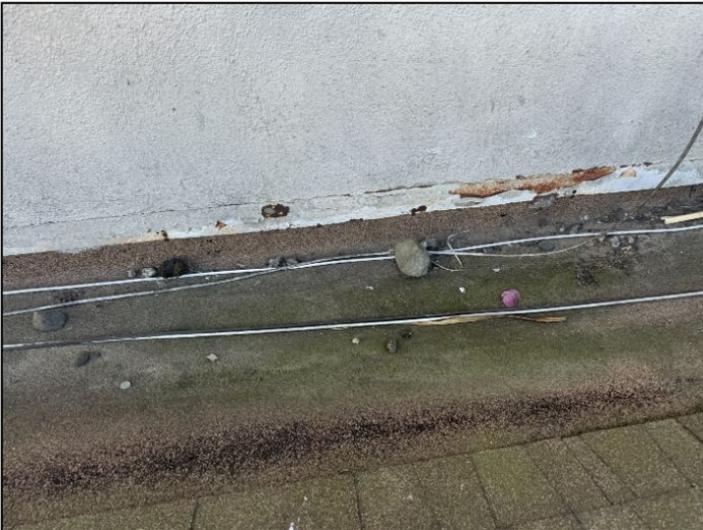
- Rusted flashing observed with peeling paint at the time of the inspection. Recommend remediation by licensed and insured roofer.
- Previous repairs to the flashing where the roof meets the wall were observed at the time of the inspection. Recommend hiring licensed contractor to seal all gaps and cracks in the flashing/stucco to prevent moisture or pest intrusion.

rusted flashing/peeling paint

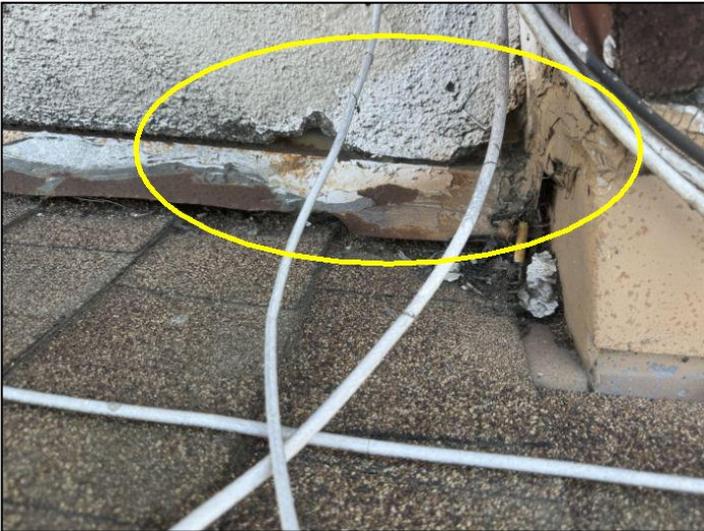
- Multiple areas of the flashing observed as damaged at the time of the inspection. Recommend replacement of all damaged flashing to insure the prevention of moisture intrusion.

failing flashing

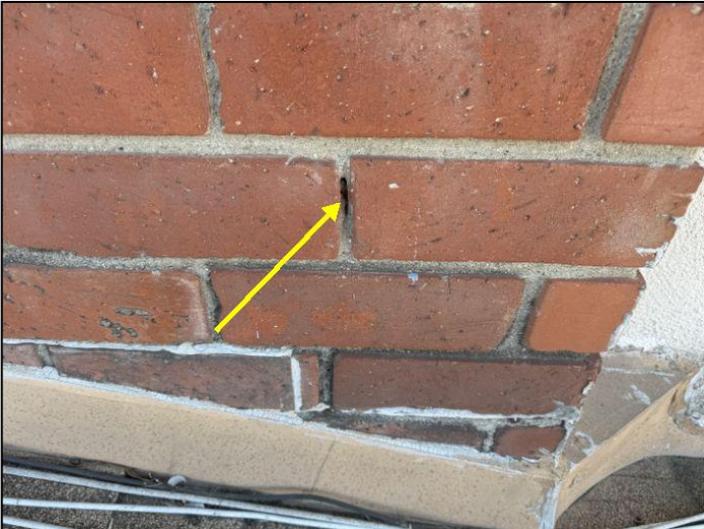
missing grout

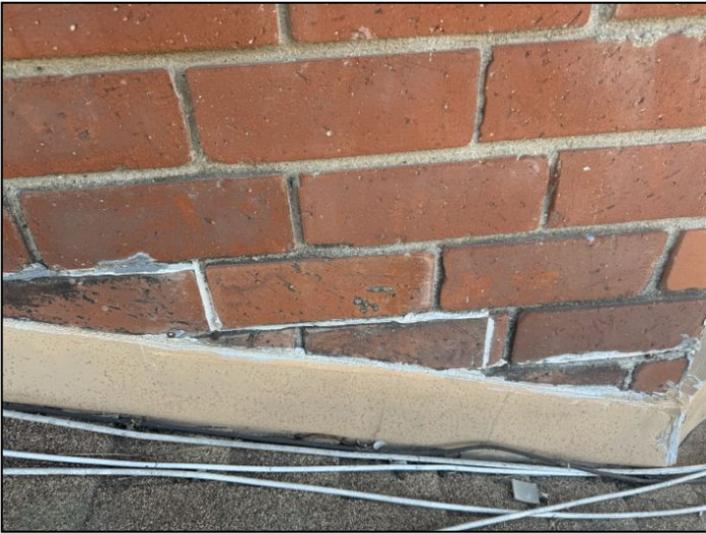
- Previous waterproof patching observed around chimney at the time of the inspection. Recommend review of disclosure regarding timing and reason.
- The chimney was observed as being without the application of a cricket flashing at the time of the inspection. A cricket is designed to keep runoff from pooling on the uphill side of the chimney. Recommend evaluation by a licensed roofing contractor for the addition of a cricket at the chimney.
- Cracking observed on the exterior of the chimney at the time of the inspection. Recommend full inspection and remediation of masonry chimney by qualified contractor for safety of use including inspection of flue and clearance to combustibles.

patch work

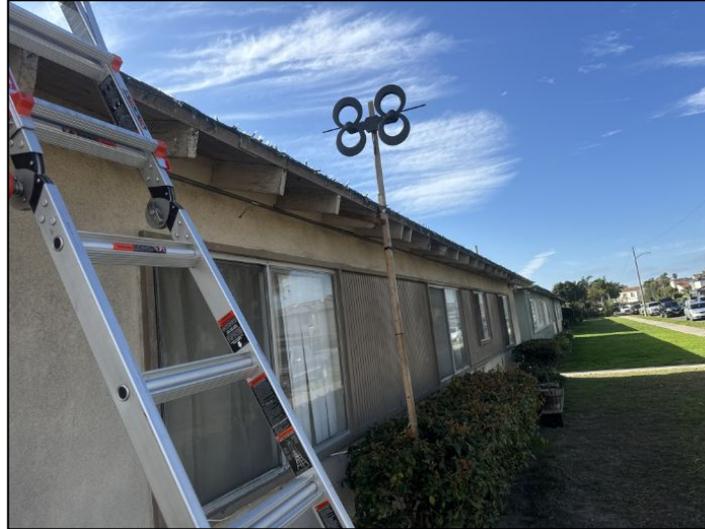
no cricket

- Missing gutters observed at the time of the inspection. Full installation recommended to keep water away from structure. Water can weaken the foundation and deteriorate the siding. Be sure to install splashblocks or extensions to carry water away, and keep water from areas such as driveways or walkway. Recommend qualified contractor for remediation.

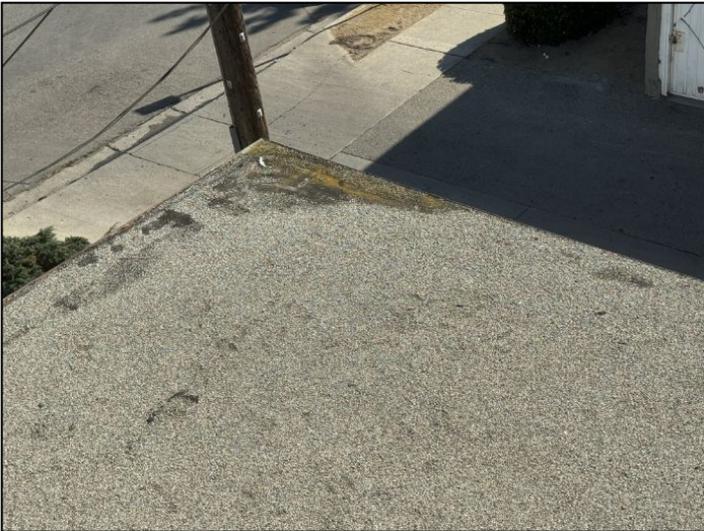
- Garage roof observed as sagging and missing granules, allowing for moisture intrusion at the time of the inspection. Recommend licensed and insured roofing contractor evaluate roof for remediation.
- Observed deterioration of garage roof from runoff at the time of the inspection. Recommend licensed roofer for remediation.

missing granules

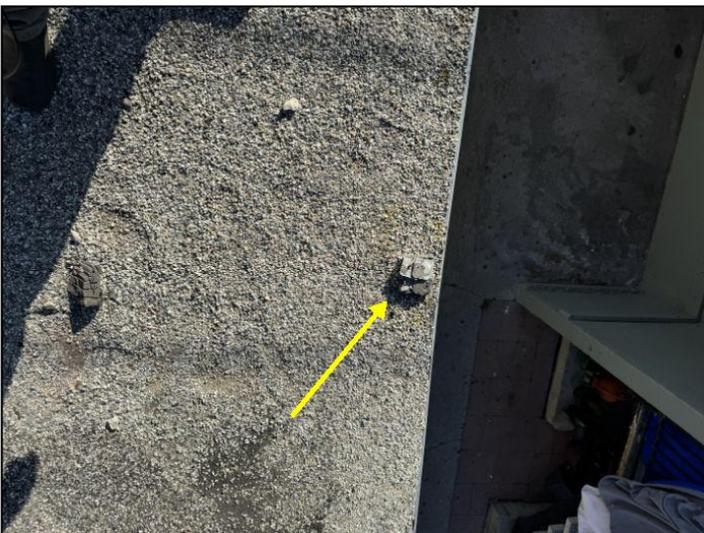
garage roof

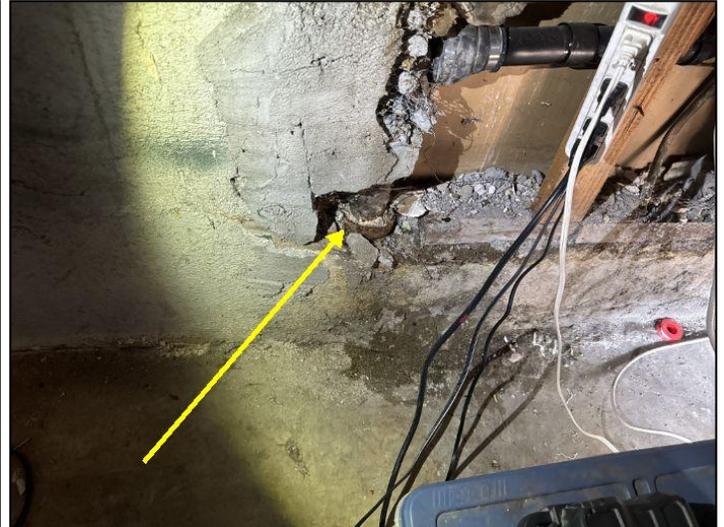
- Large hole in back of garage 2 observed at the time of the inspection. Disclosed by tenant it is in mid construction as current owner is in the middle of fixing. Recommend review of disclosures regarding all work and reason for said work. Recommend licensed and insured contractors for all work.
- Rusty cast iron drain line observed in wall in garage at the time of the inspection. Cast iron has a limited life expectancy. Recommend review of disclosures regarding any cast iron failures and qualified plumber for remediation.

cast iron drain line

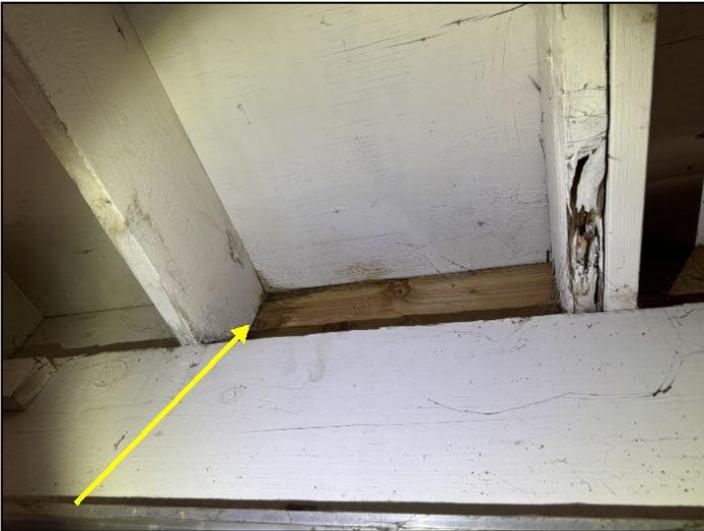
- Signs of suspected past or present pest activity in rafters at the time of the inspection. Recommend further evaluation by qualified contractor.
- Moisture intrusion and possible microbial growth observed in the garage at the time of the inspection. Recommend remediation by qualified contractor.
- Moisture stain observed in the ceiling of the garage at the time of the inspection. Indications of past or present leak, dry at the time of inspection. Recommend remediation by a licensed contractor to prevent further deterioration.
- Dark staining observed in garage ceiling at the time of the inspection. 15 year tenant expressed it had always been that way. Recommend further evaluation of garage roof to prevent any additional moisture damage.

moisture intrusion

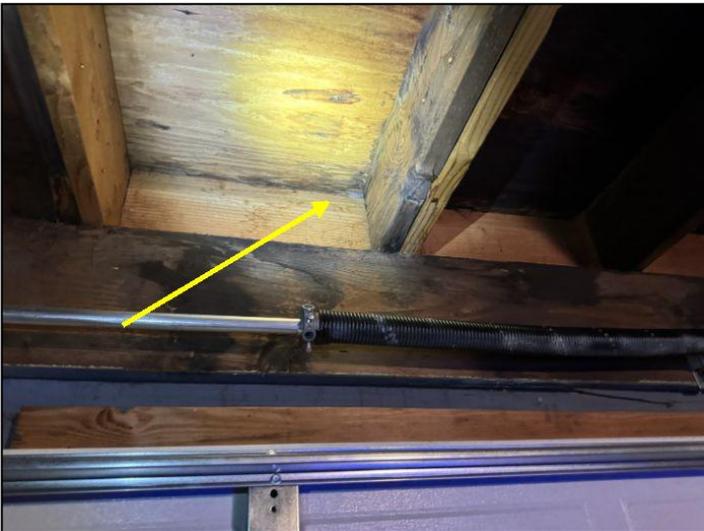
moisture intrusion

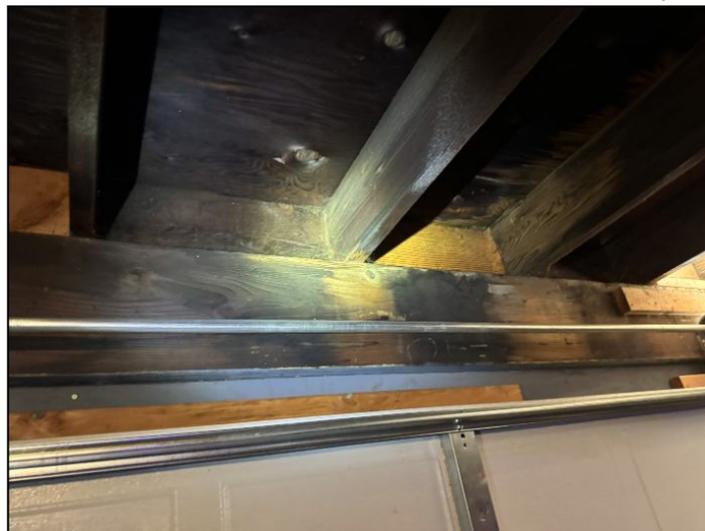
dark staining

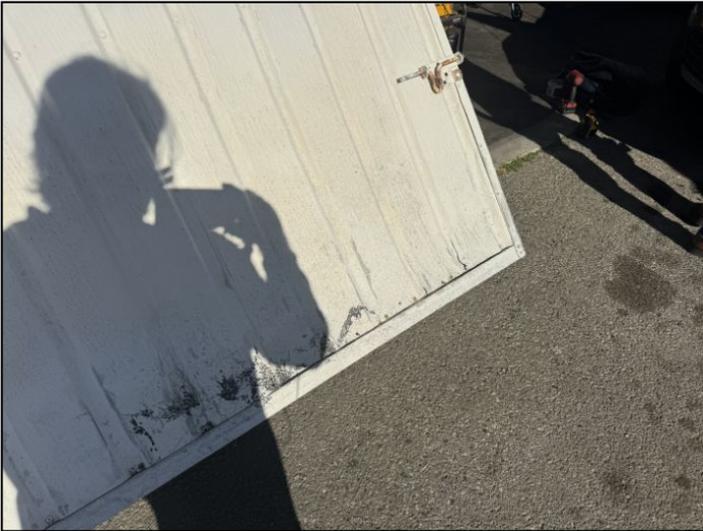
- Garage door and reverse eye sensors both noted as functional at the time of the inspection. (middle garage door)
- Both sides of the main garage door had deteriorated trim near the bottom at the time of the inspection. Open holes to the outside offer the opportunity for pest and moisture to enter the building's envelope. Recommend remediation by license professional.
- Third garage was observed as locked at the time of the inspection. Inspector unable to access garage and garage not included in the inspection report.

swing door with damage

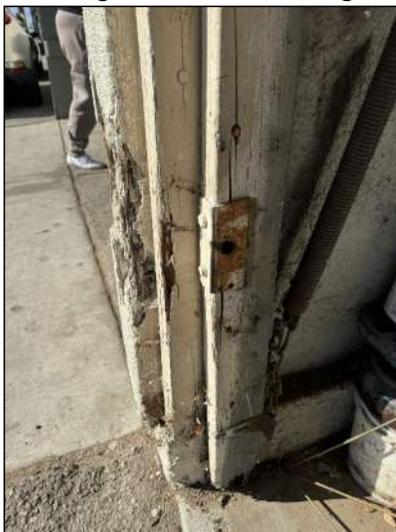
suspected pest

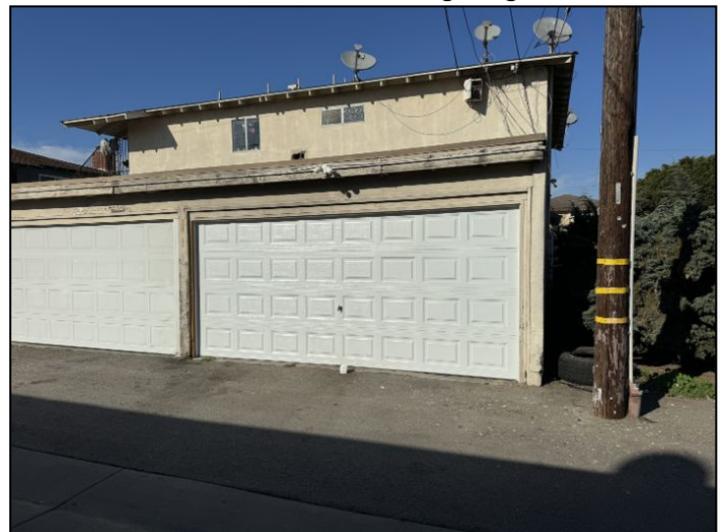
locked at the time of the inspection.

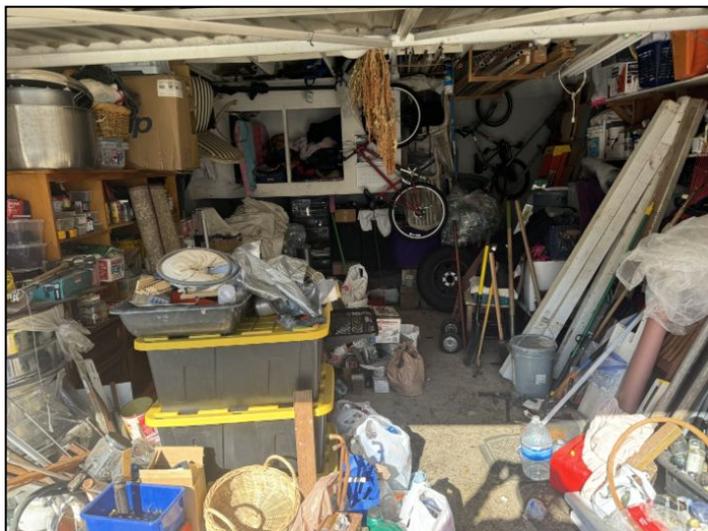
- Personal belongings stored in the garage limited the scope of the visual inspection of the garage.

belongings

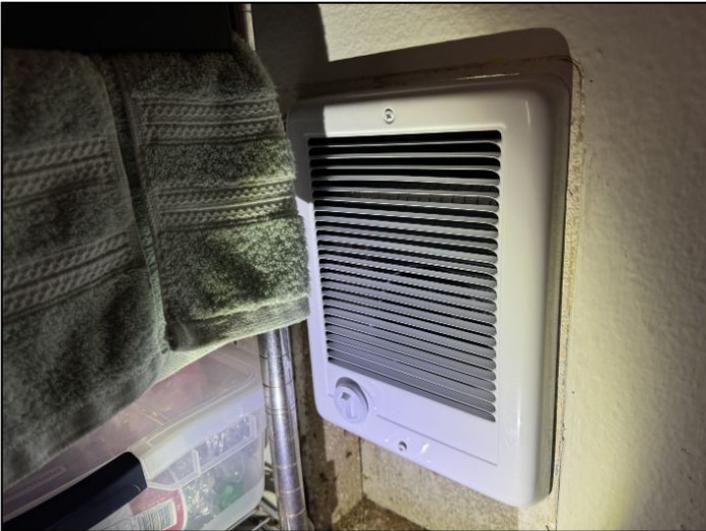
- Small wall heaters observed as too close to combustibles in all apartments at the time of the inspection. Recommend maintaining appropriate distance to combustibles when running wall heaters to prevent fire hazard.
- Exposed cloth wiring observed below wall heaters at the time of the inspection. This is a defect. Recommend further evaluation by licensed electrician to prevent damage to exposed electrical conductor.
- Observed signs of possible wood destroying pests under wall heater at the time of the inspection. Recommend remediation by licensed and insured pest contractor.
- Living room wall heater in unit two was blowing only cold air at the time of the inspection. Recommend remediation by qualified professional.

too close to combustibles

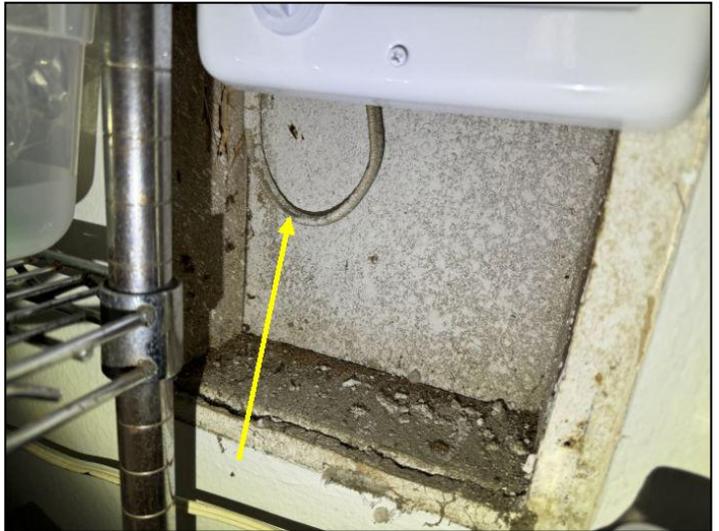
exposed cloth wiring under wall heaters - multiple heaters

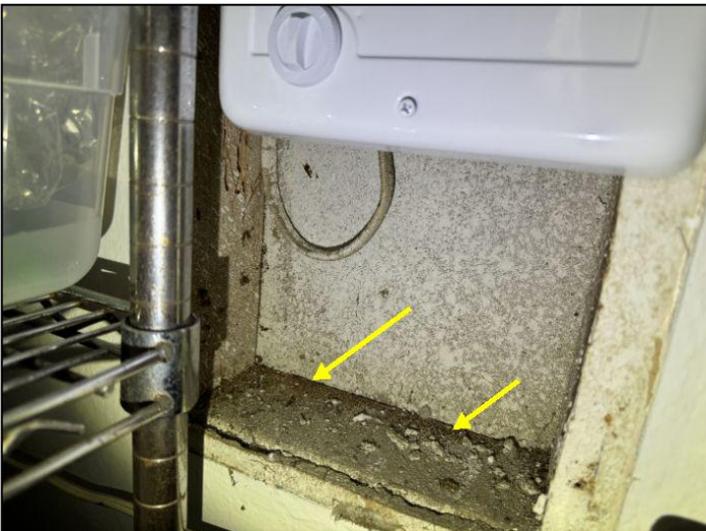
possible wood destroying pests.

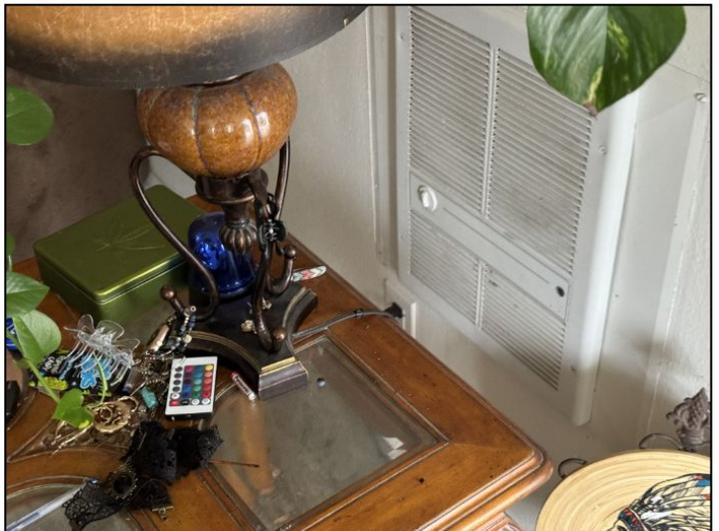
apt 2 heater non functional

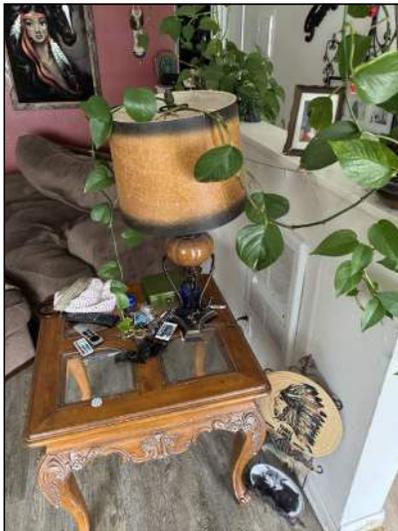
close to combustibles -apt 2

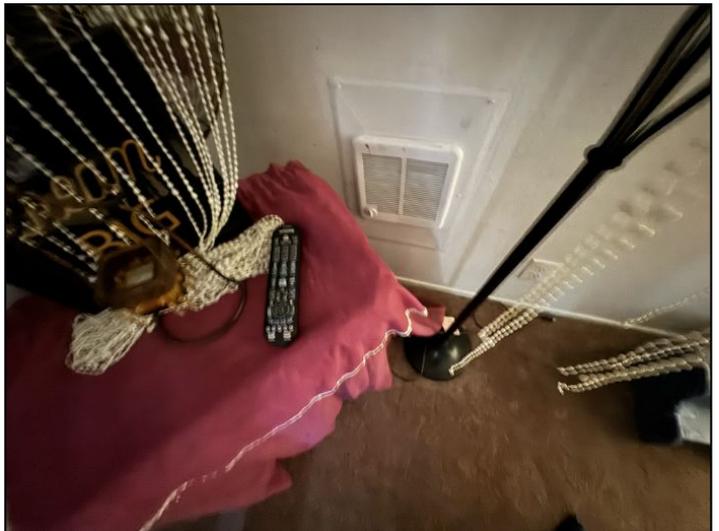
combustibles - apt 2

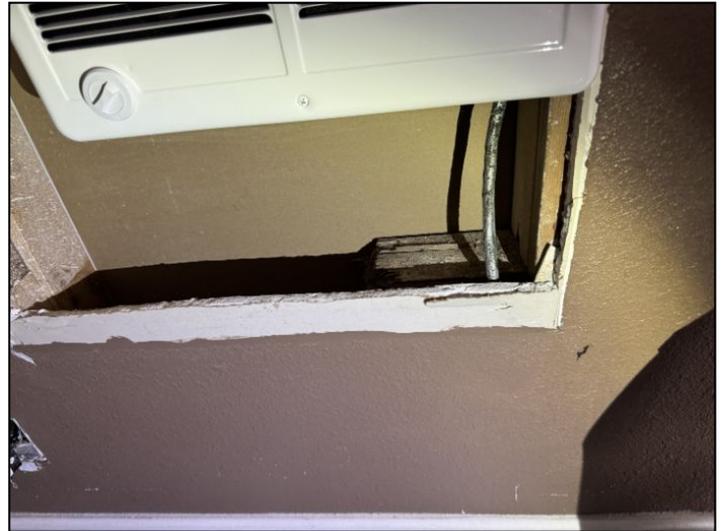
exposed electrical cloth conductor - apt 3

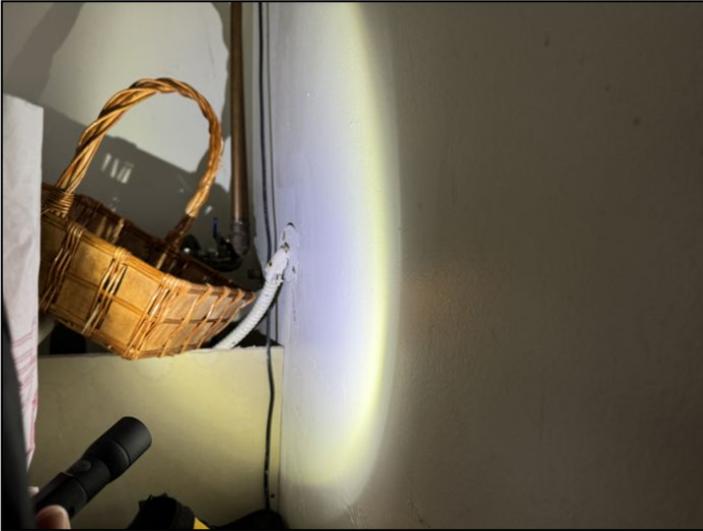
- Water heaters observed as located in the back of clothing closets at the time of the inspection. Observed combustible material on and around water heaters at the time of the inspection. Recommend licensed and insured plumber evaluate and remediate all water heaters for function and safety.

water heater hiding in closet -apt1

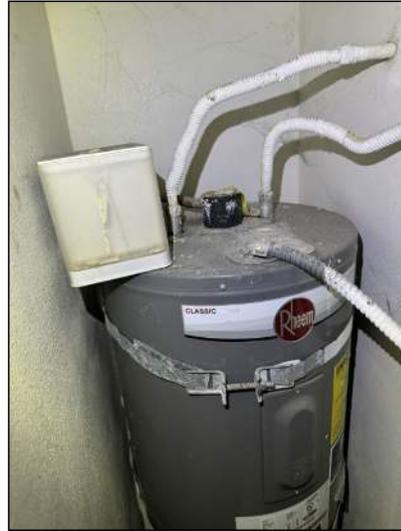
remove items from around and on top of water heater

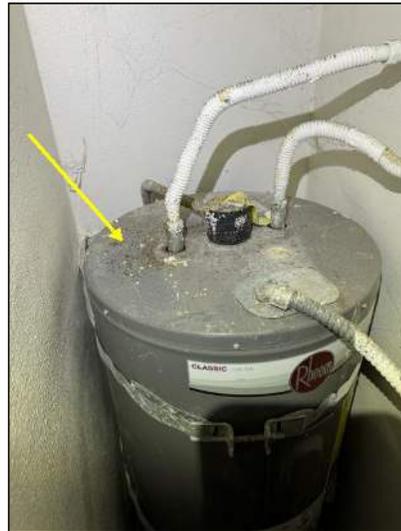
- Signs of suspected wood destroying pests at the time of the inspection. Recommend qualified professional.

signs of wood destroying pest

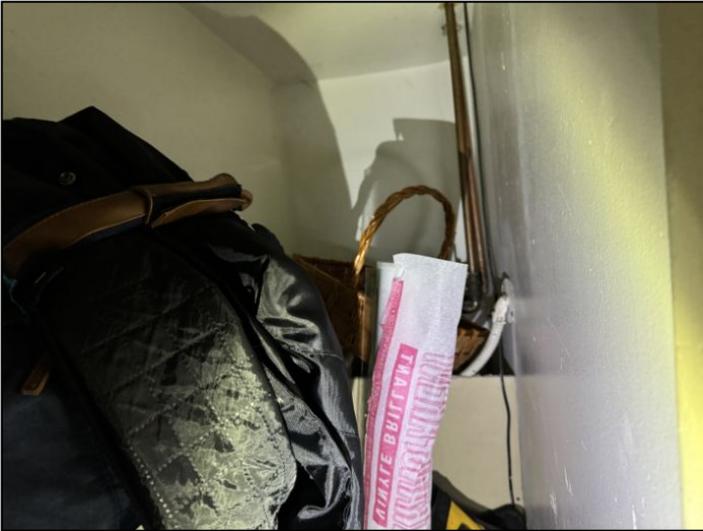
- Electric water heaters (all three) missing shut off in the same room as the heaters at the time of the inspection. Recommend remediation by licensed and insured plumber so heaters can be safely serviced/maintained.
- Moisture staining observed on the top of the heater at the time of the inspection. Recommend licensed and insured plumber evaluate and remediate as necessary.
- Multiple defects observed at the water heaters at the time of the inspection. Recommend licensed and insured plumber assess all water heating units for updated safety precautions and the need for remediation.
- Loose cover observed at the time of the inspection. Recommend licensed and insured plumber remediate.

missing electrical shut off-apt 1

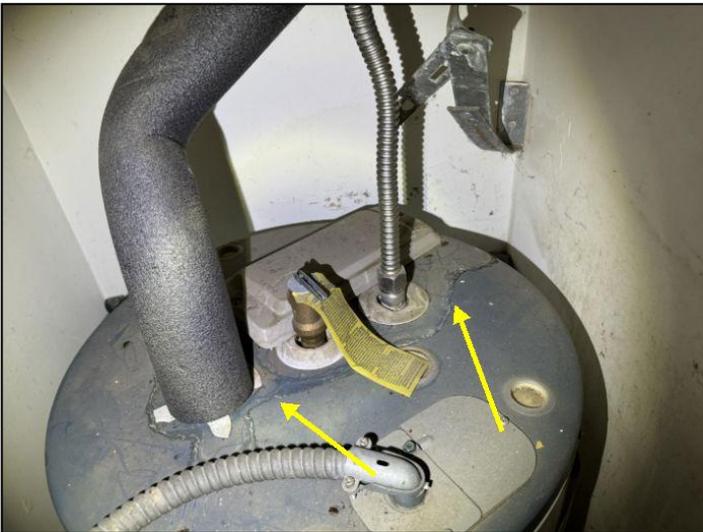
moisture staining- apt 1

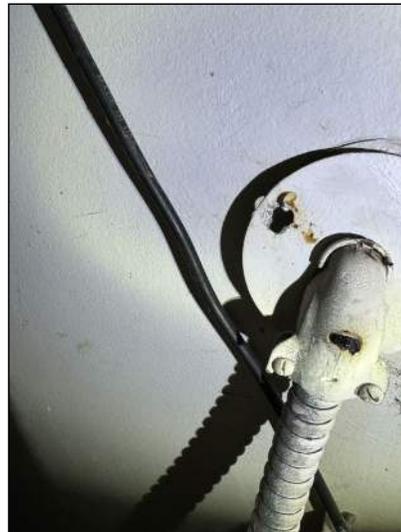
loose electrical connection-apt 1

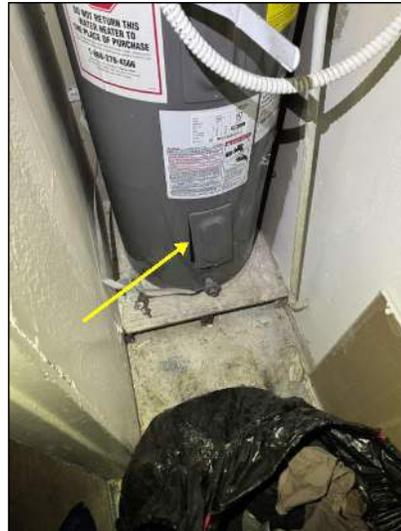
loose cover - apt 2

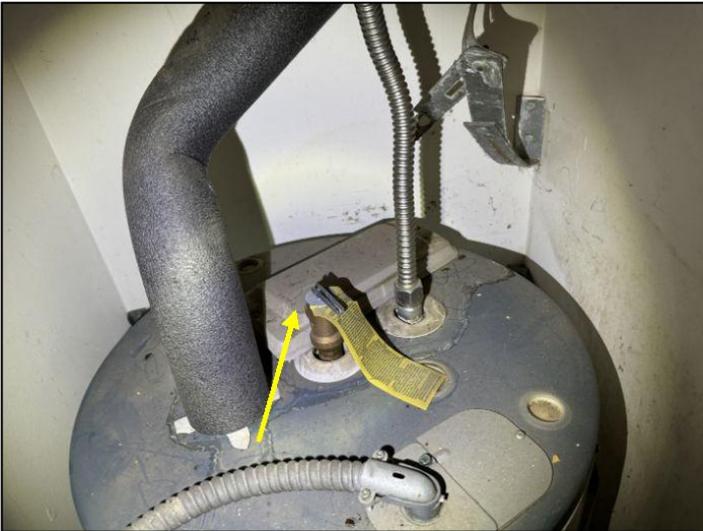
- There is no **LPR valve** extension pipe present on the water heaters at the time of the inspection. This is a safety concern and needs to be corrected at once. We recommend contacting a licensed plumber to install a proper valve pipe and safety evaluation of water heaters.

Missing TPR apt 1

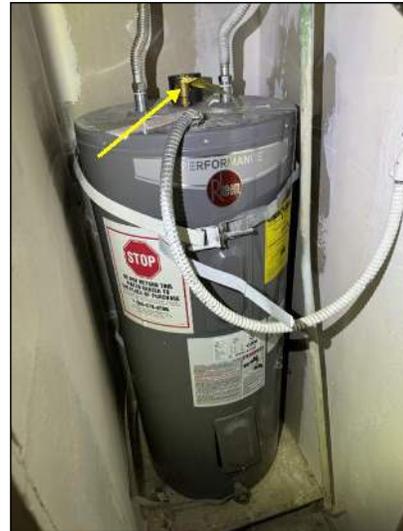
apt 2- missing tpr

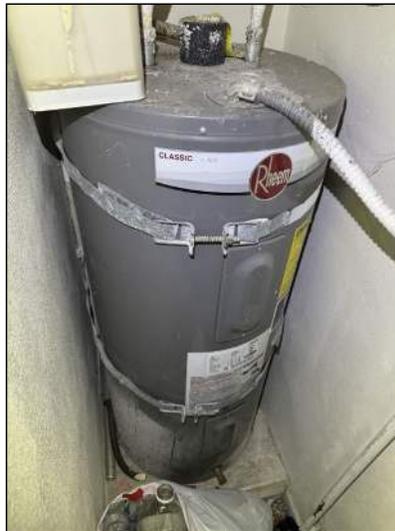
apt 3 - cannot confirm tpr downspout

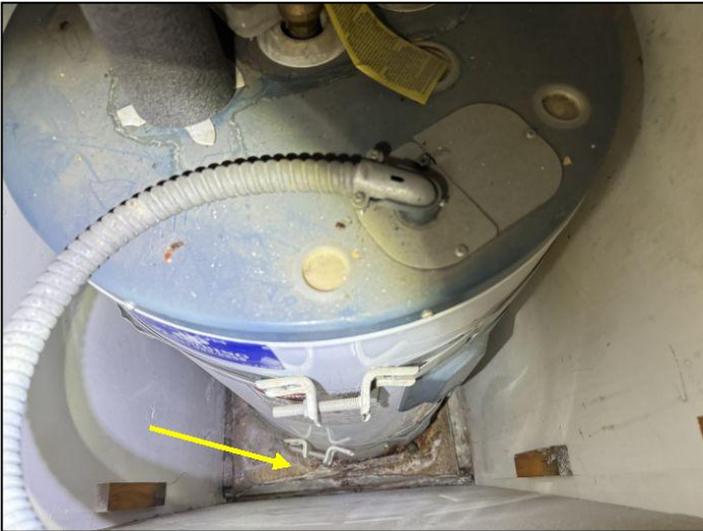
pan with rust-apt1
