SAMPLE REPORT

Confidential Inspection Report

Inspection prepared for: SAMPLE

Date of Inspection: 1/2/2025 Time: 9am

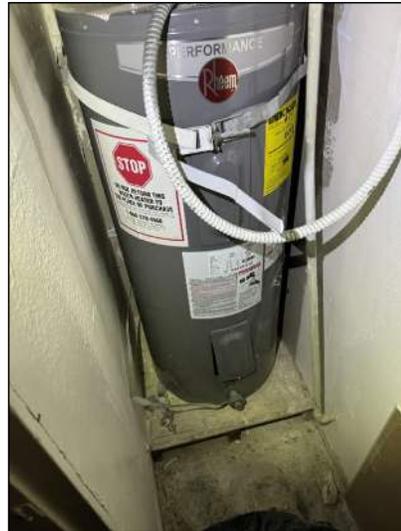
apt 2 -missing pan and extension

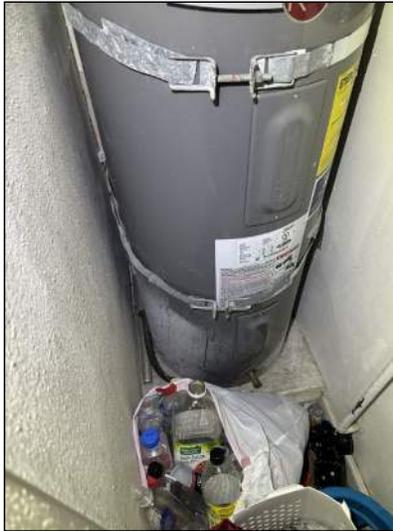
no pan - apt 3

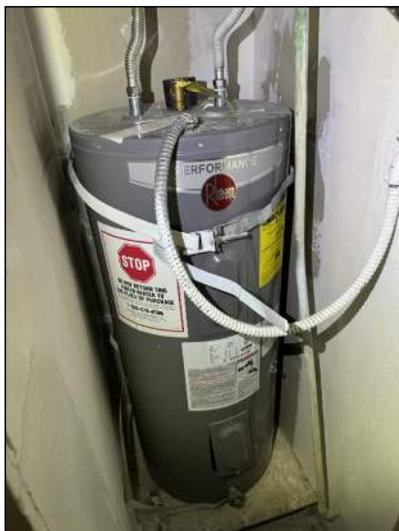
- Loose strapping and missing wood blocking at the time of the inspection. Safety concern. Recommend remediation by licensed plumber to validate safety of water heater.

apt 2 - inadequate strapping

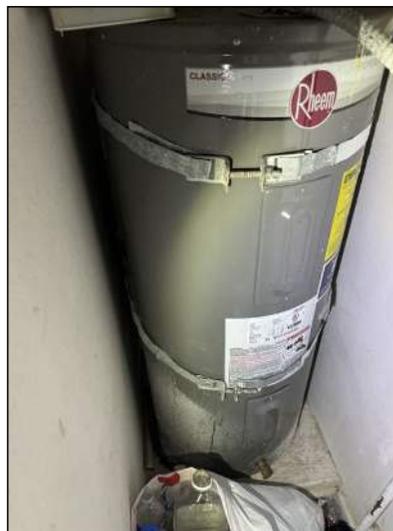
inadequate strapping - apt 3

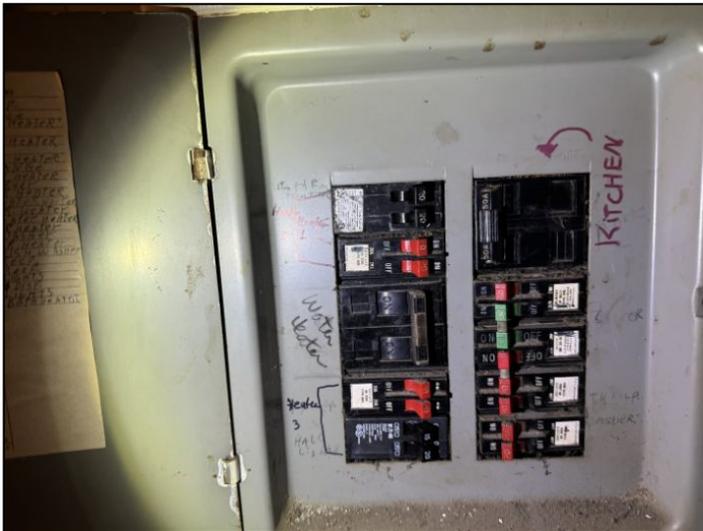
- Insufficient labeling observed on the electrical panels at the time of the inspection. Recommend licensed electrician troubleshoot to label in a fashion that anyone would be able to tell what the breaker feeds.

apt 1- insufficient labeling

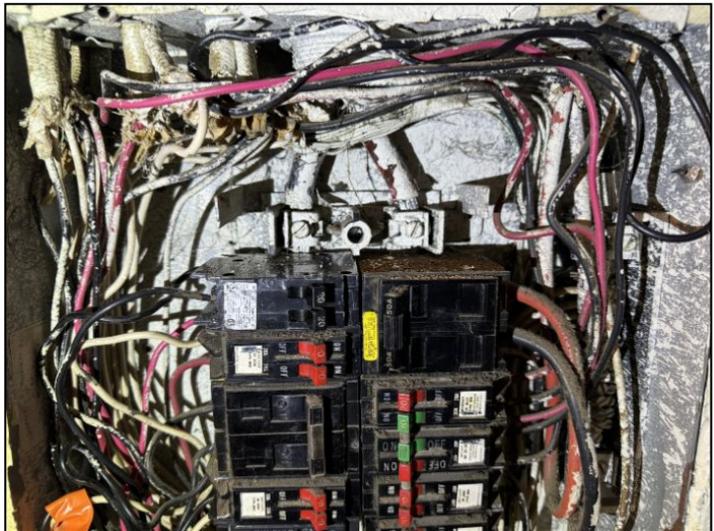
- Significant paint/texture overspray observed in the electrical panels at the time of the inspection. Electrical panel should to be free from contaminants. Recommend further evaluation/remediation by licensed and insured electrician.

- Cloth wiring observed as entering sub panels without the addition of protective bushings at the time of the inspection. Recommend further evaluation/remediation by licensed and insured electrician.

Cloth wiring/overspray

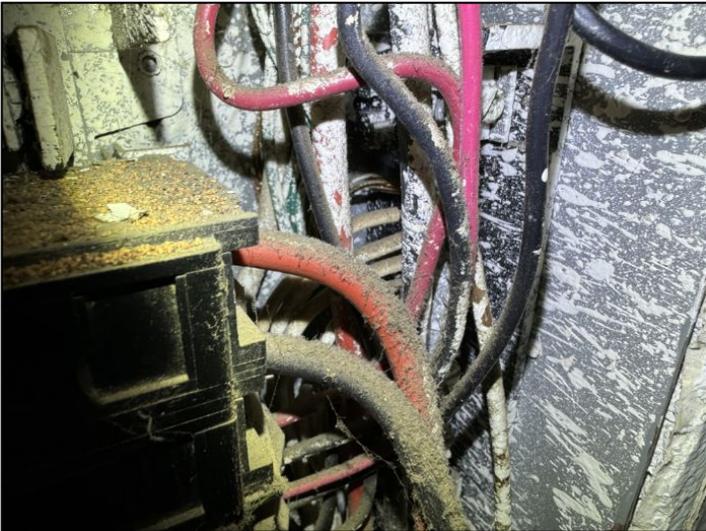
- Equipment grounds and neutrals observed as sharing a busbar at the time of the inspection. Grounds and neutrals should be kept separate in a subpanel, recommend further evaluation by licensed and insured electrician.

grounds and neutrals sharing bus bar

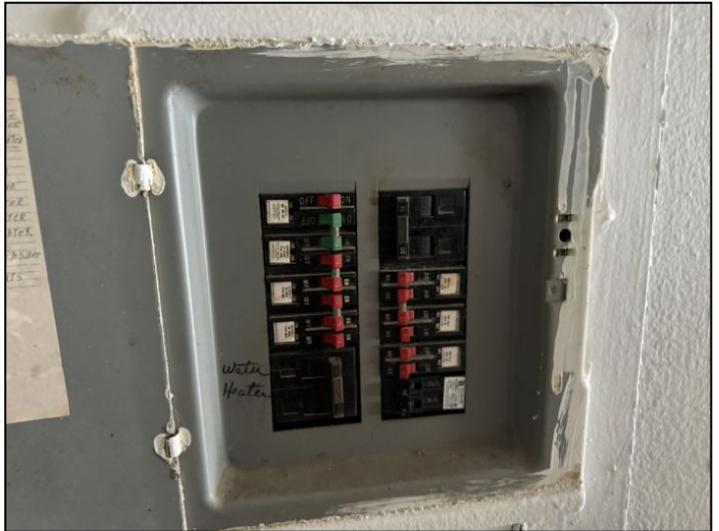
- Subpanels observed as having insufficient labeling at the time of the inspection. Recommend licensed electrician further evaluate and label in a way that can be easily determined by someone not living in the home.

apt 2- insufficient labeling

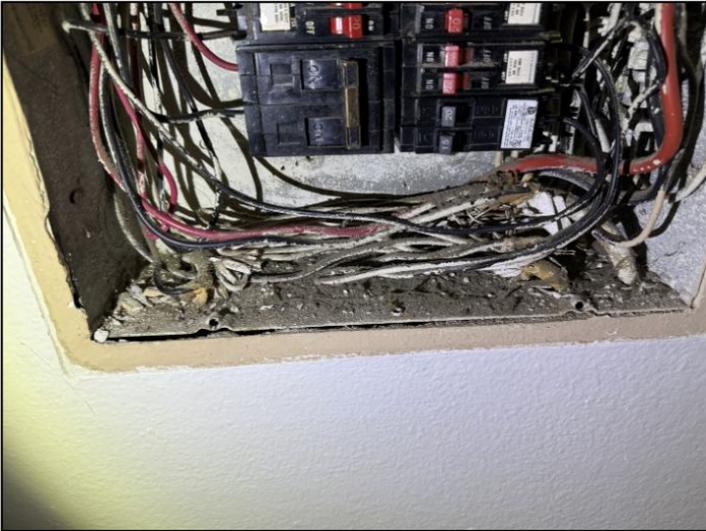
- Debris and possible pest droppings observed in the electrical panels at the time of the inspection. Recommend licensed electrician clean panels of all contaminates.

dirt and grime/recommend cleaning out contaminants-apt 2

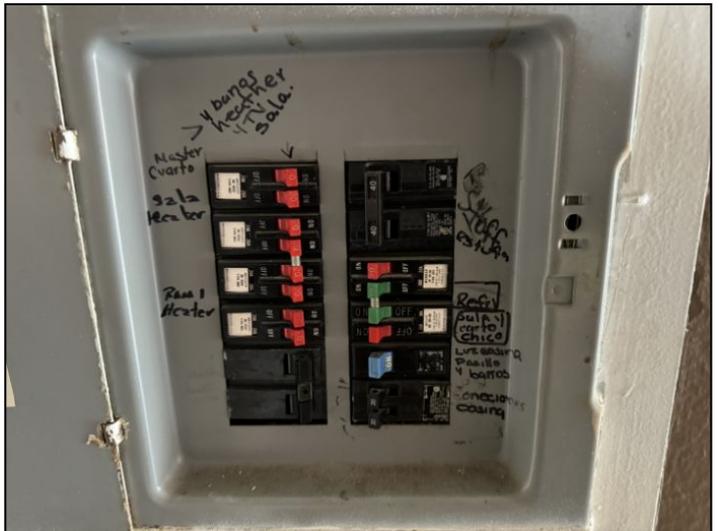
apt 3 - labeling

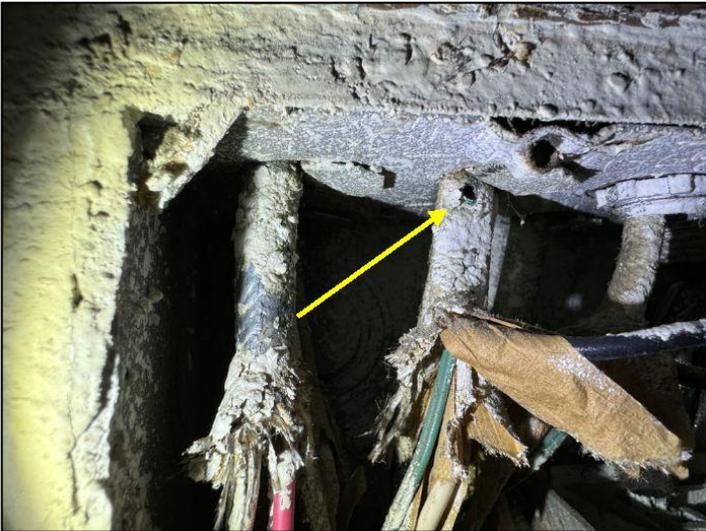
- Conductor in panel observed as pierced by use of a sharp screw at the time of the inspection. This is a safety issue and possible fire hazard, recommend remediation by licensed and insured electrician to prevent electrifying panel box or other electrical safety hazards. Panel was put back on the wall without the use of pointed screw and is therefore missing a screw at the time of the inspection. The pierced conductor and lack of proper screw should be addressed by licensed and insured electrician.

hole in conductor from pointed screw!

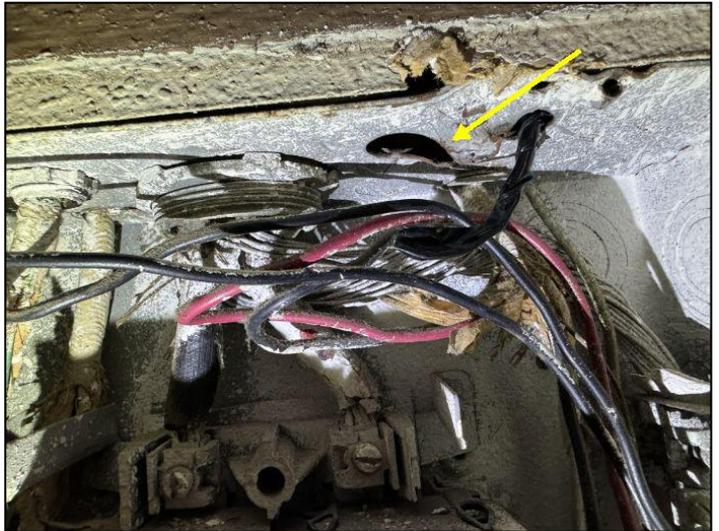
- Hole from unknown reason observed in the top of the electrical panel at the time of the inspection. This is a defect. Recommend remediation by licensed and insured electrician.

Hole in top of panel - apt 3

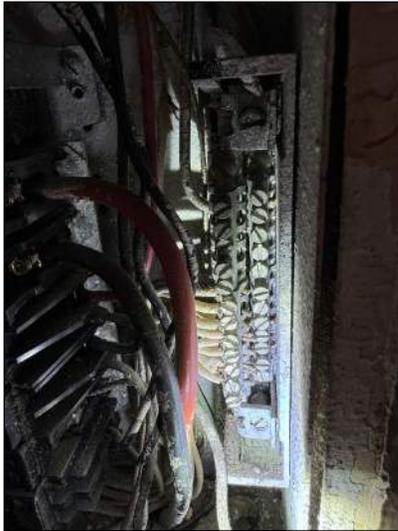
- Double tapped neutrals observed in the sub panels at the time of the inspection. This is a defect and possible safety hazard. Recommend remediation by licensed and insured electrician.

double tapped neutrals - apt 3

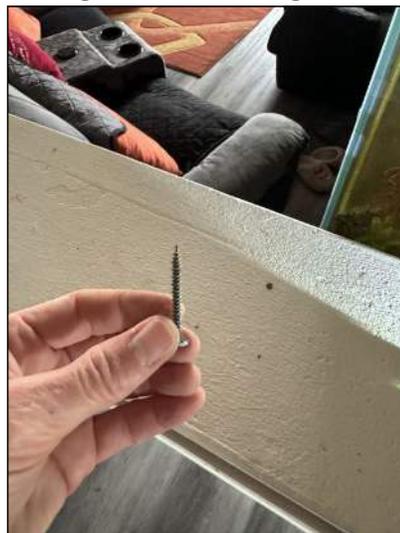
- Sharp-pointed metal screws observed as holing panel cover in place at the time of the inspection. These are a potential hazard as they may puncture wire insulation and electrify the panel box, becoming a shock or electrocution hazard. These screws should be replaced with approved, flat-tipped screws by licensed and insured contractors.

dangerous screw in electrical panel - apt 3

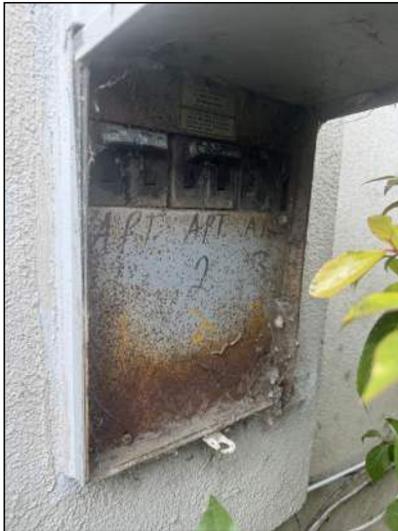
- Rust observed on the main panel dead front at the time of the inspection. Important to monitor and prevent all moisture from entering the electrical panel box. Recommend further evaluation by licensed electrician.

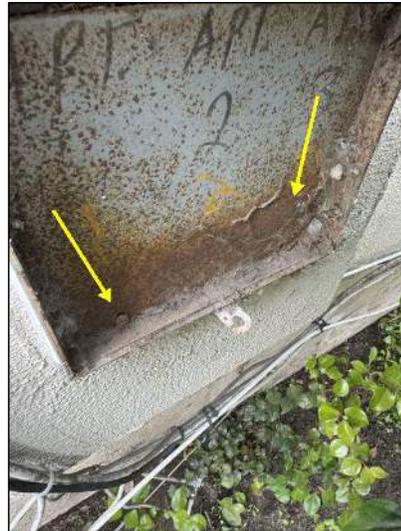
- Main exterior panel observed as exposed to the elements with significant rust at the time of the inspection. Unable to remove rusted screw/cover at the time of the inspection. Recommend licensed and insured electrician inspect the main panel and electrical system as a whole.

rusted shut

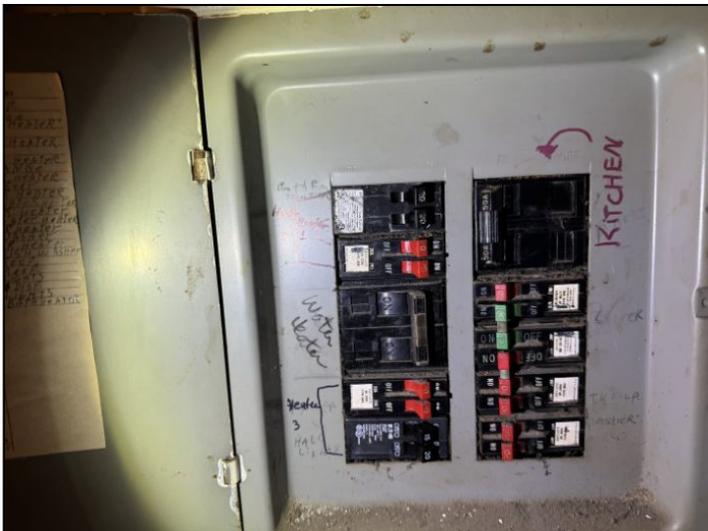
- **Mismatched Breakers**- The electrical panel had multiple brands of circuit breakers present at the time of the inspection. Most panel manufacturers call for specific type and brand circuit breakers to be used. A qualified electrical contractor should evaluate this panel and replace breakers that are not permitted to be used in this panel.

miss matched breakers - apt 1

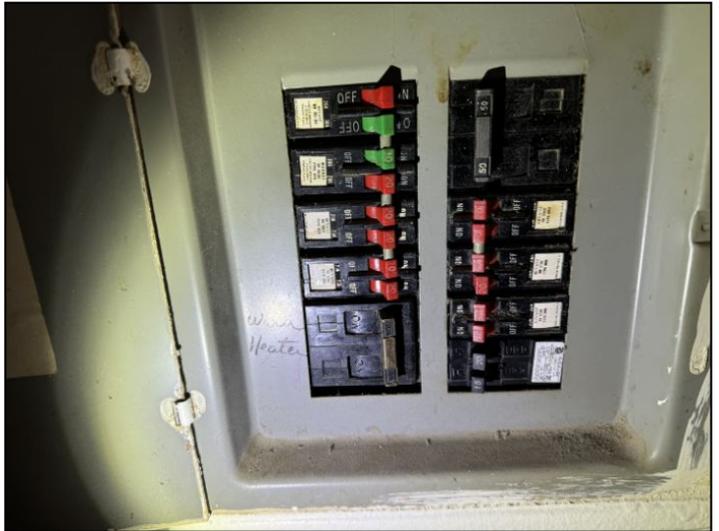
missmatched breakers

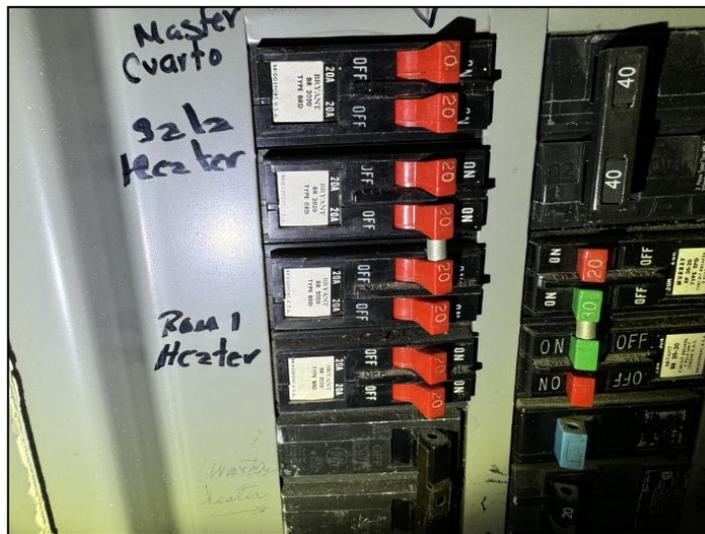
miss matched breakers - apt 3

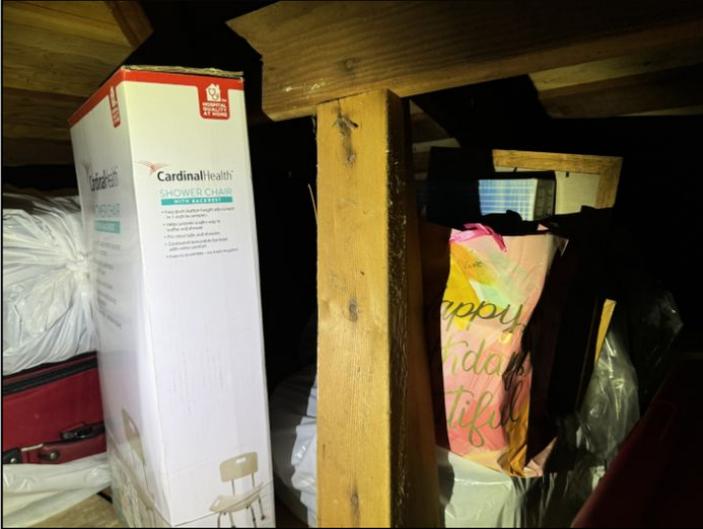
- Personal belongings observed stored in attic and limiting scope of inspection.
- Electrical conductors observed as right next to the access points of the attic at the time of the inspection. It is recommended the conductors be moved 6 ft from the access point and secured at intervals not to exceed 54" to prevent any damage to the conductor when accessing the attic. Any conductors within 6 ft need to be protected with guard strips. Recommend licensed electrician remediate.

tenants belongings

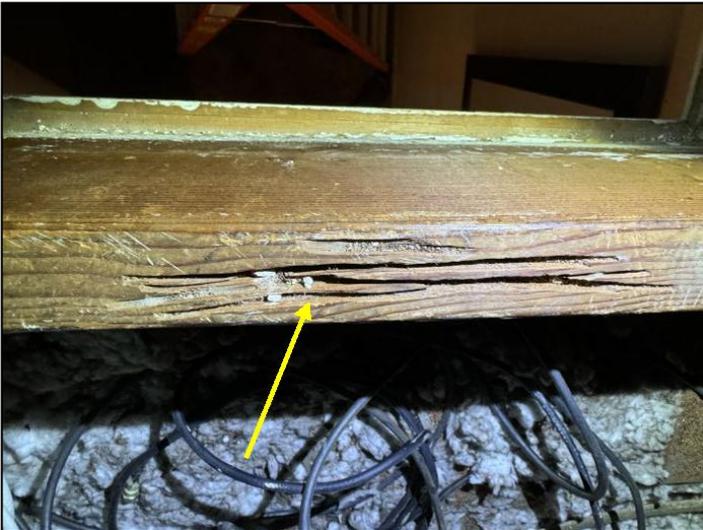
- Evidence of possible wood destroying pest observed at the time of the inspection. Recommend reviewing disclosures and hiring licensed pest professional for evaluation of attic structure and remediation.
- Gap in attic, showing daylight, observed at the time of the inspection. Recommend remediation by qualified contractor to prevent moisture and pest intrusion.

signs of wood destroying pests

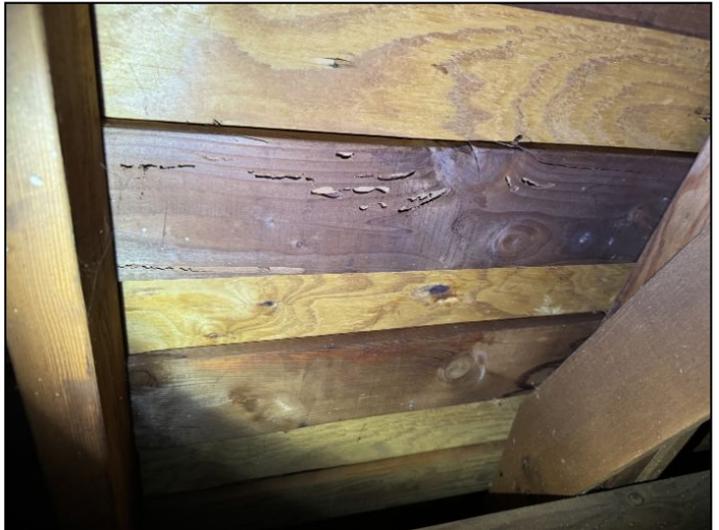
suspected wood pest

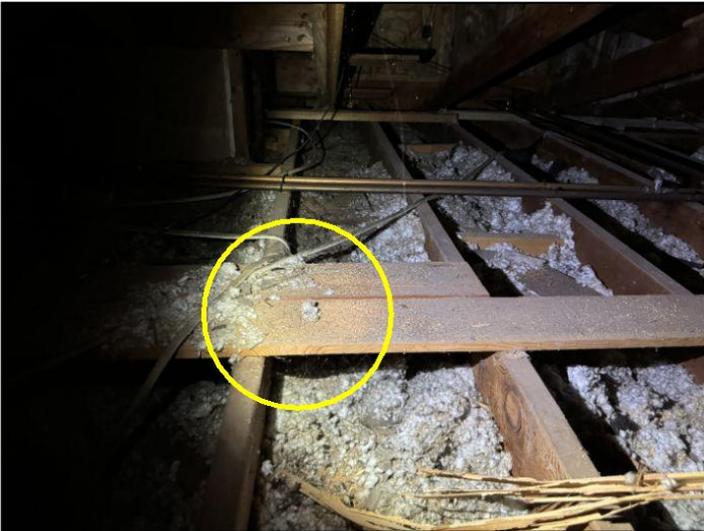
pest droppings

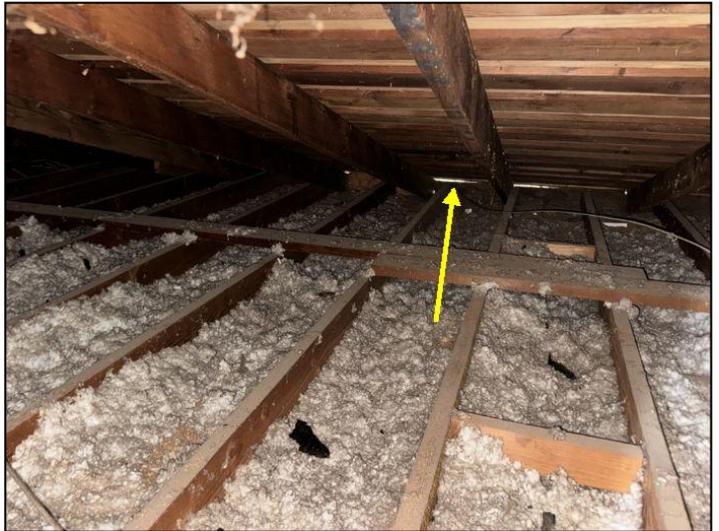
light

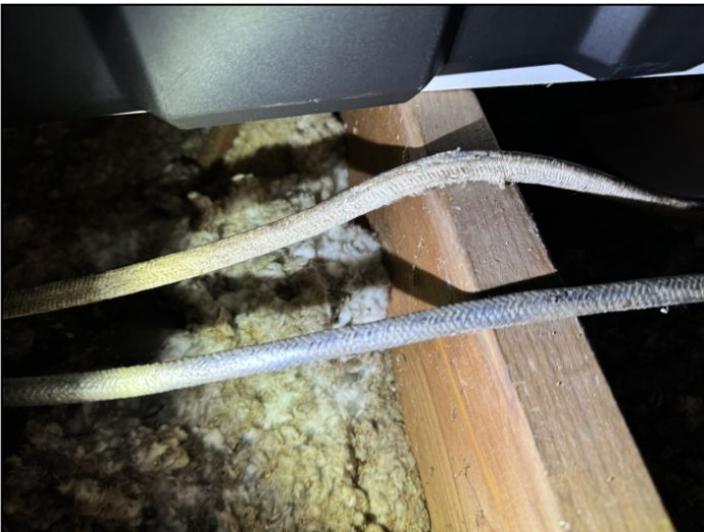
- Outdated cloth wiring observed in the attic at the time of the inspection. Recommend further evaluation by licensed electrician for the need to upgrade of system for function and safety.
- Cloth wiring observed as damaged in the attic at the time of the inspection. This is a defect and possible fire hazard. Recommend remediation by licensed and insured electrician.
- Outdated cloth wiring observed as sandwiched between ceiling joists and plywood for storage at the time of the inspection. This is inviting damage to the conductors and could pose a safety/fire hazard. Recommend licensed electrician evaluate cloth wiring in attic and the removal of all conditions that threaten damaging the wires.

cloth wiring

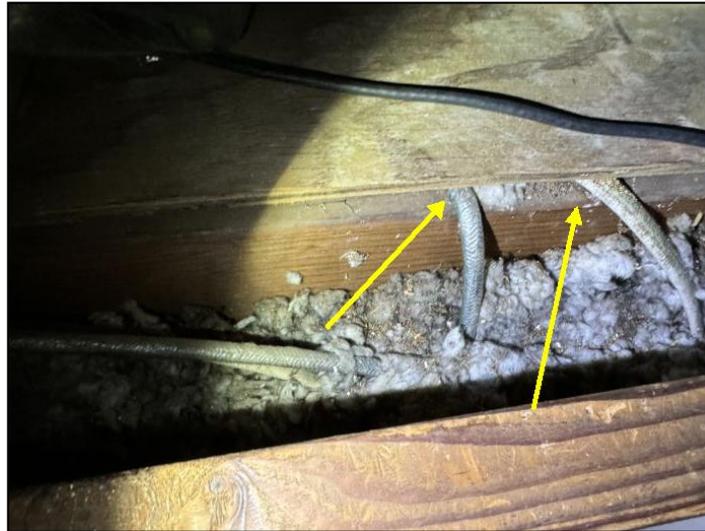
defect - sandwiched cloth wires

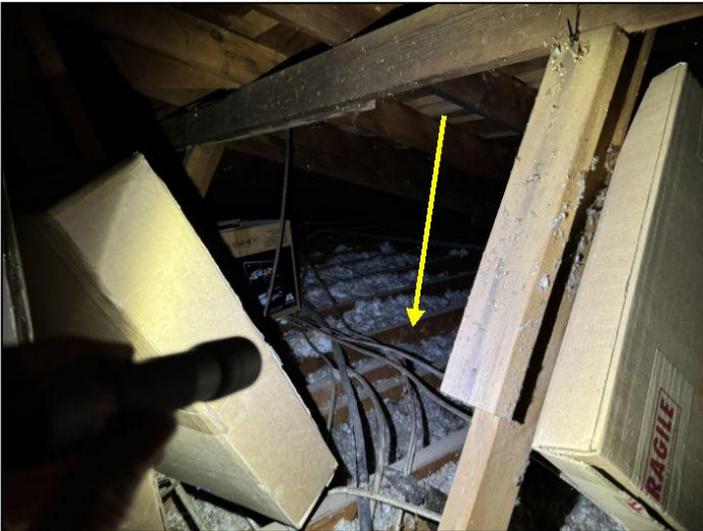
- Missing insulation observed in the attic at the time of the inspection. Recommend hiring qualified contractor for the installation of insulation in the attic to better maintain the home and efficacy of the HVAC systems.

missing insulation

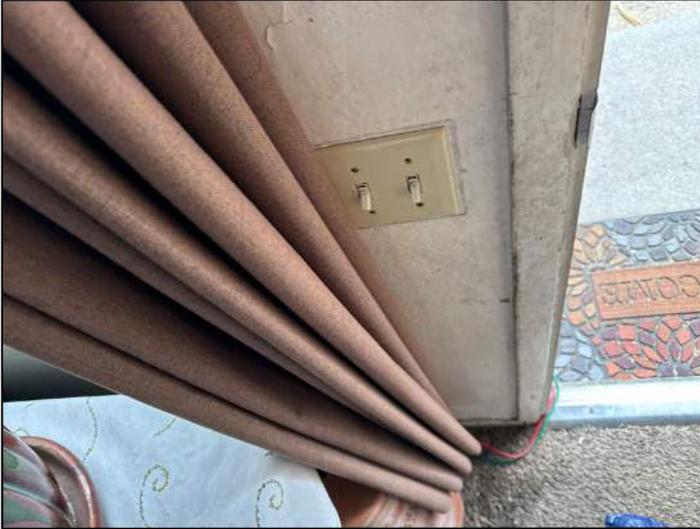
- One or more non functional switches in all apartments at the time of the inspection. Tenant #2 disclosed non functional switches.
- Exposed electrical/missing outlet cover behind couch in apt 3 at the time of the inspection. Possible safety defect, recommend remediation by licensed and insured electrician.

Non-functional light switch

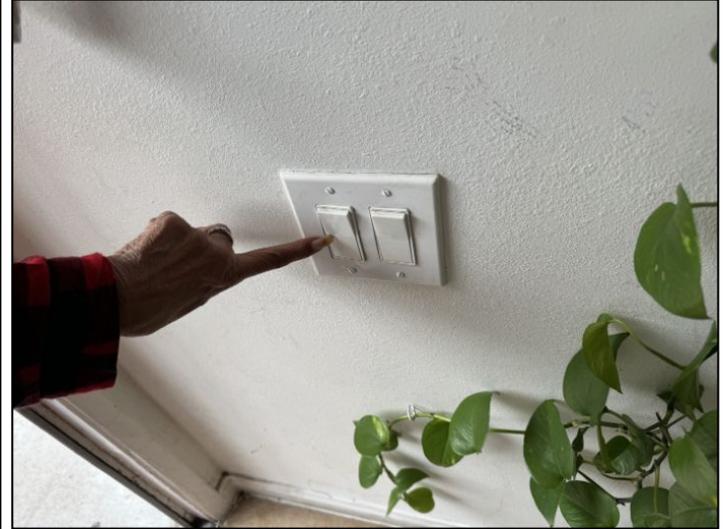
non functional switch apt 2

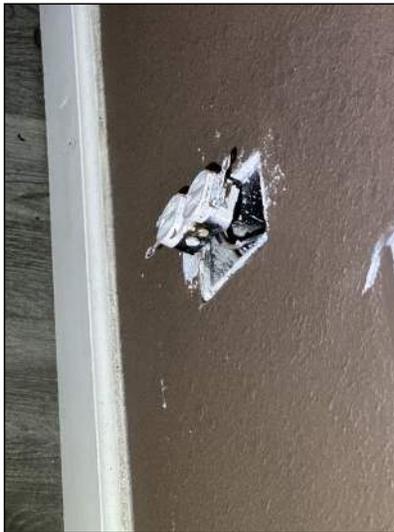
apt 3 - exposed electrical

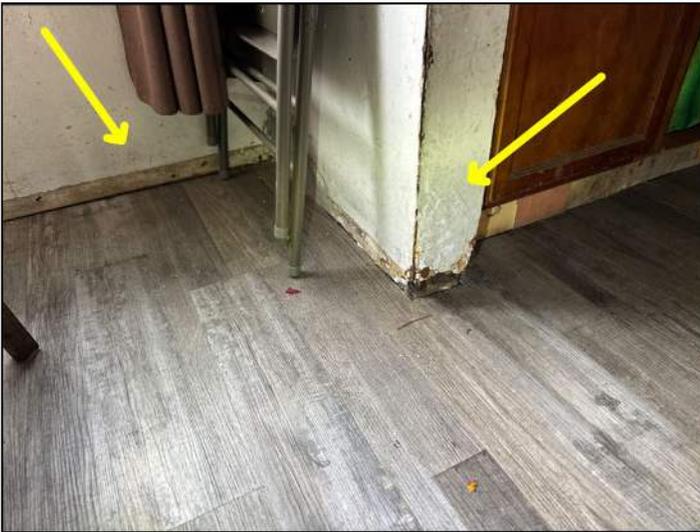
- Incomplete/improper repair job of the baseboards noted in multiple areas throughout the home at the time of the inspection. Recommend remediation by licensed professional.
- One or more unfinished drywall patches observed at the time of the inspection. Recommend hiring qualified professional to patch and paint.
- Damage to walls observed at the time of the inspection. Recommend remediation by licensed and insured contractor.
- Possible microbial growth observed at the time of the inspection. Recommend having entire building tested and treated for possible microbial growth.

damage to walls-apt 1

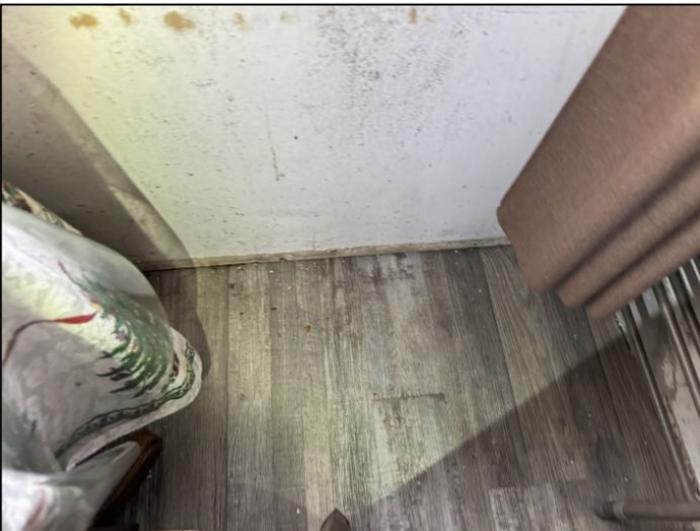
interior walls/possible micorbial growth- apt 1

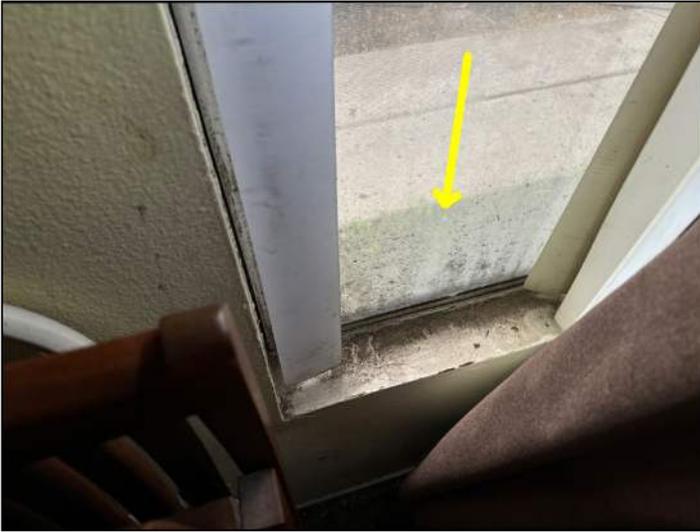
- Possible microbial growth observed on many of the window sills and the window treatments throughout the building at the time of the inspection. Recommend remediation by a qualified contractor.

possible microbial growth-apt 1

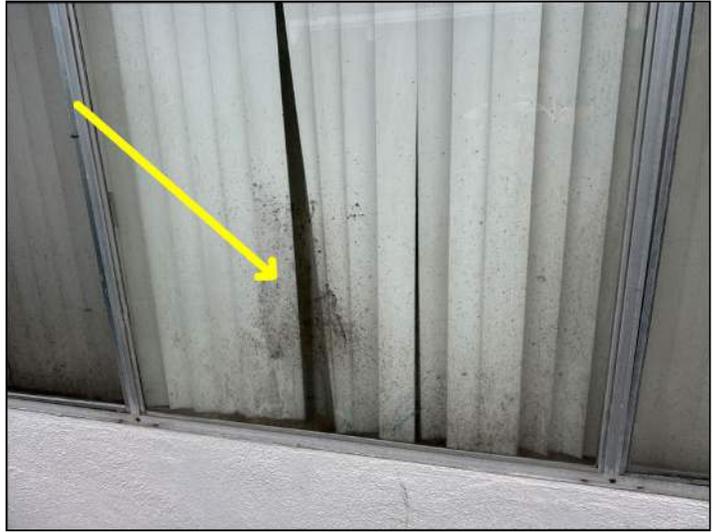
possible microbial growth

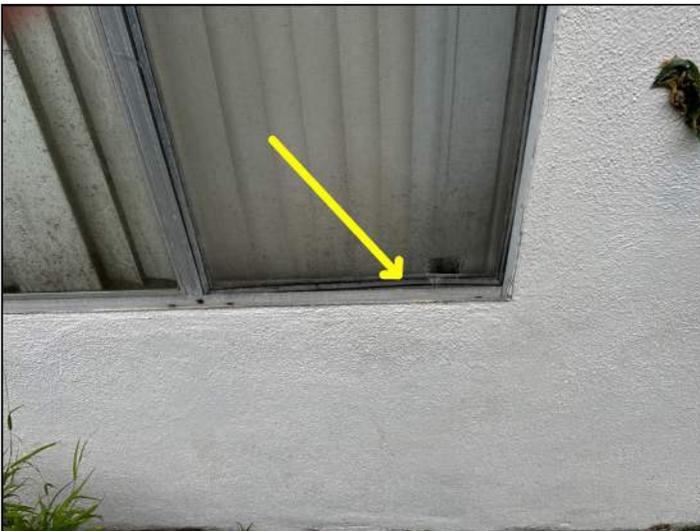
- Damaged/missing screens observed at the time of the inspection. Recommend fixing and replacing all missing/screens by licensed professional.
- Significant damage to window sills observed in apt 3 at the time of the inspection. Recommend evaluation of reason and remediation by licensed and insured contractor.

Broken screen

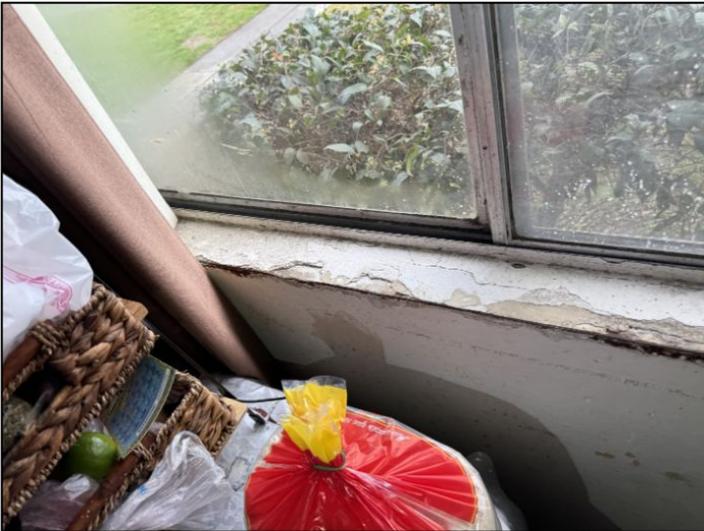
- Significant damage observed to window sills at the time of the inspection. Recommend remediation by licensed and insured contractor.
- Many of the sliding windows were not functional at the time of the inspection. Recommend licensed contractor evaluate the need to replace existing sliding windows and doors.

damage/difficult windows

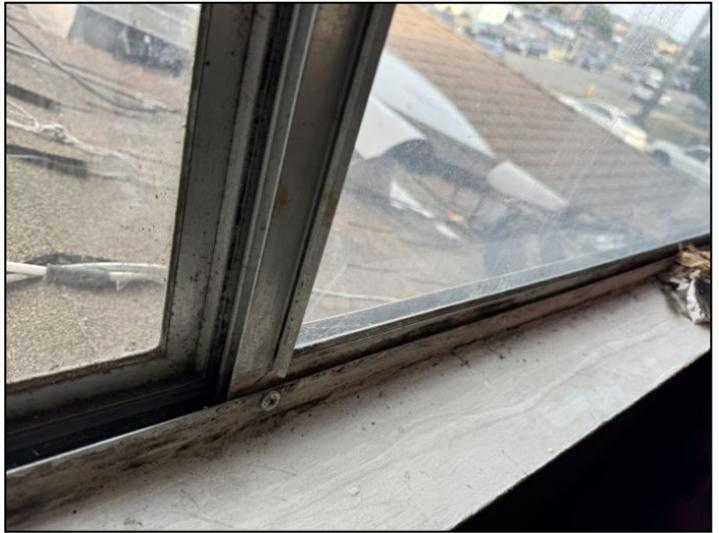
screwed shut- apt 3

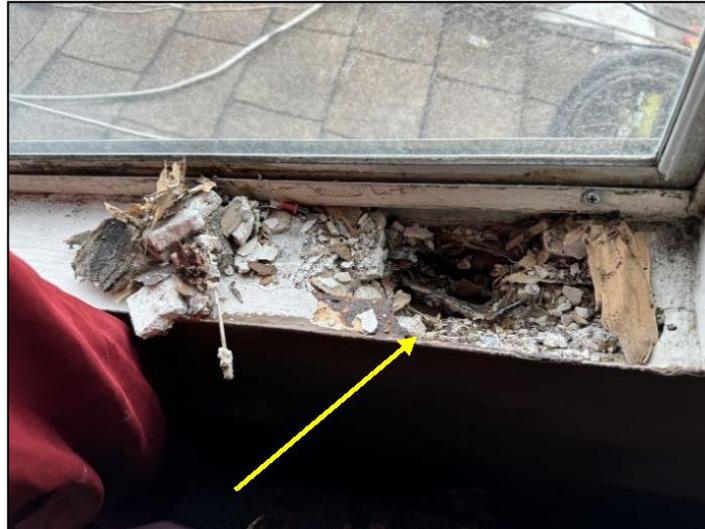
damage to window sill - apt 3

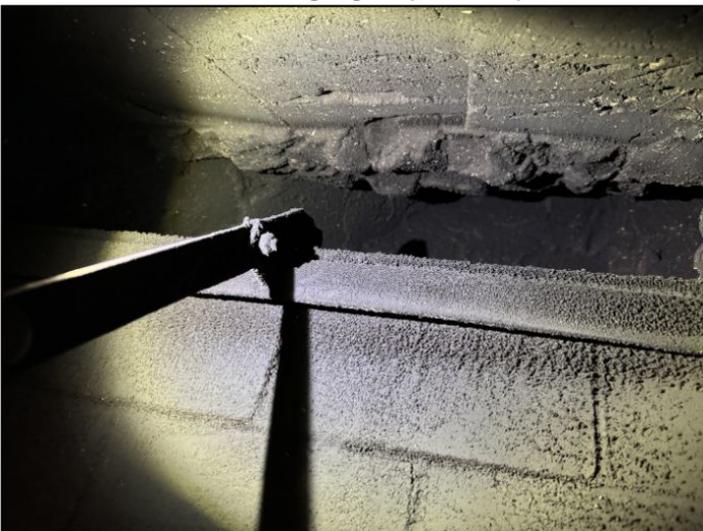
- Significant build up observed in the fireplace/chimney at the time of the inspection. Recommend servicing and inspecting of masonry fireplace by qualified professional.

build up- apt 2

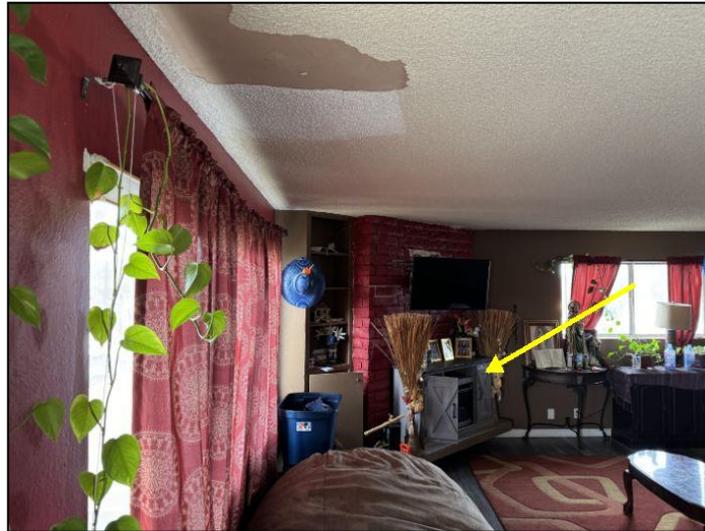
apt 3- fireplace obstructed

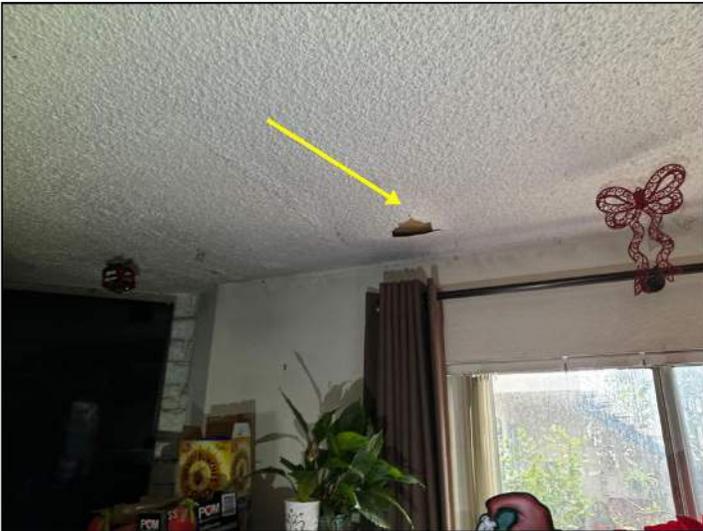
- Acoustic, possible asbestos containing, ceiling observed as damages and fraying at the time of the inspection. This may be a health/safety defect. Recommend further evaluation for the presence of asbestos and remediation of damages ceilings. Present in all apartments
- see "bedroom ceilings" for patch info

damage to ceiling apt1

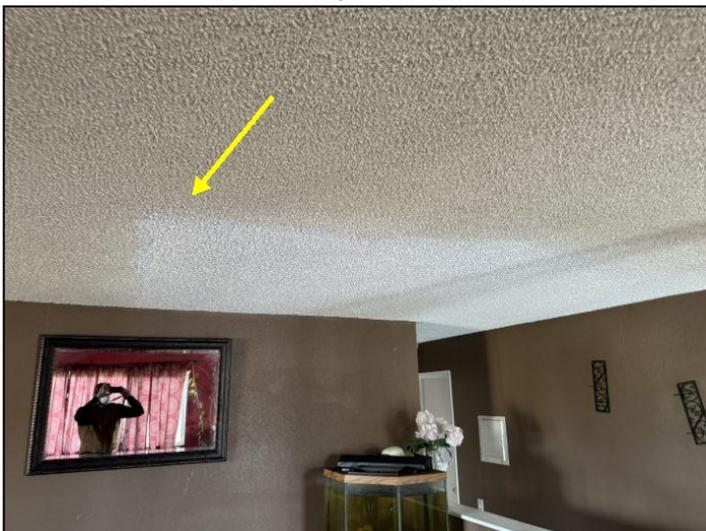
previous patch apt 3

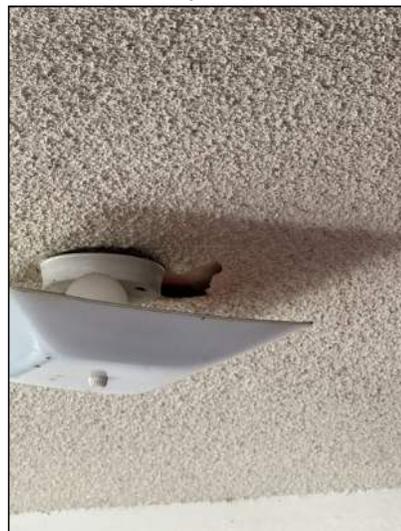
fraying acoustic - apt 3

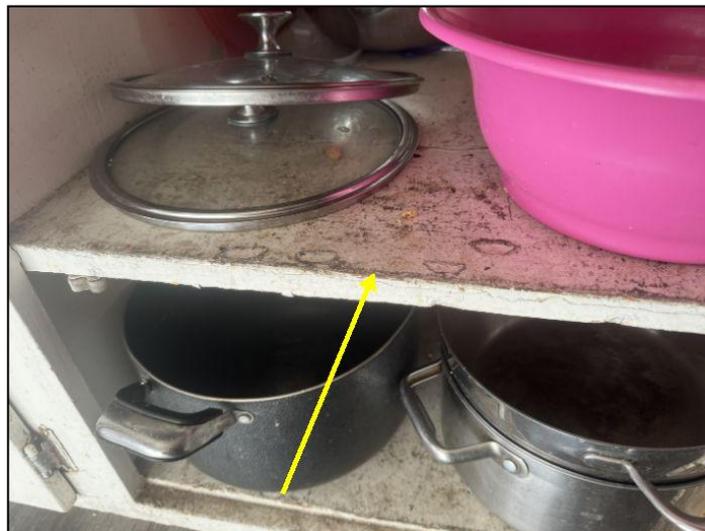
- Suspected microbial growth observed on cabinetry at the time of the inspection. Recommend evaluation and remediation by qualified specialist.

suspected growth - apt 3

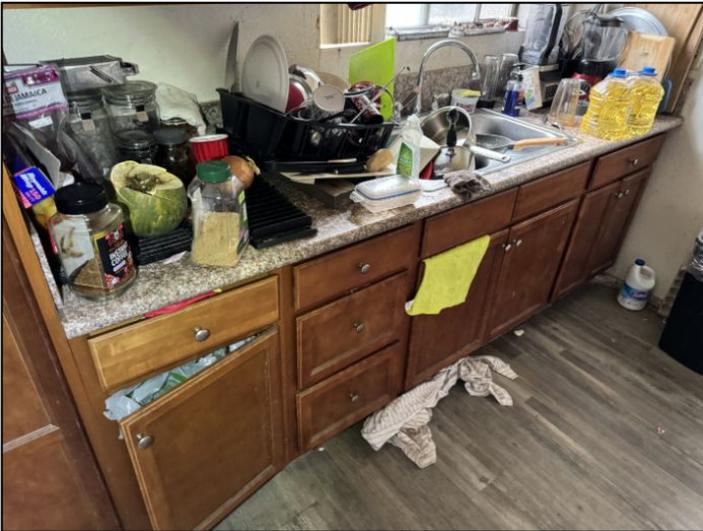
- Personal belongings limited scope of inspection.

belongings

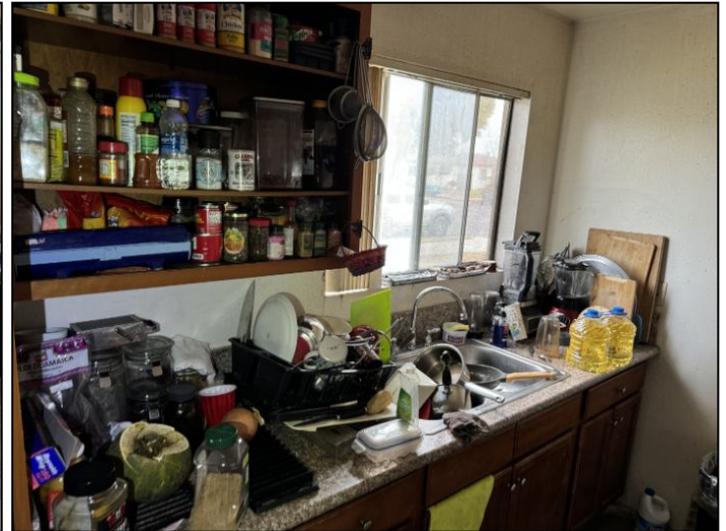
personal belongings-counter/cabinets/floors- apt1

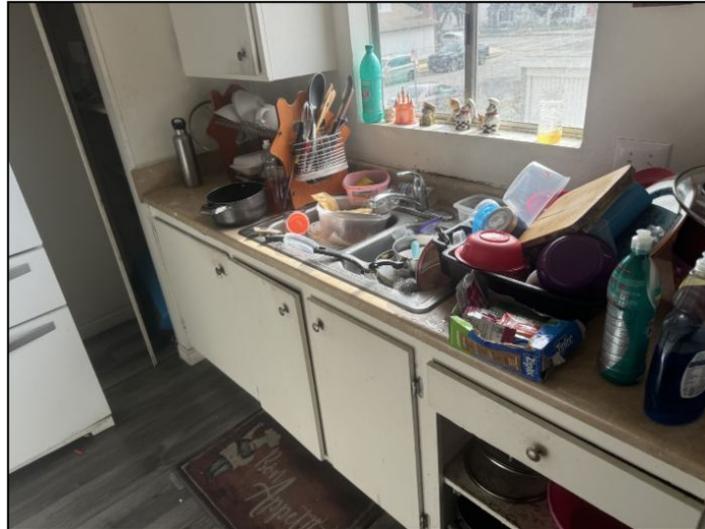
belongings- apt 3

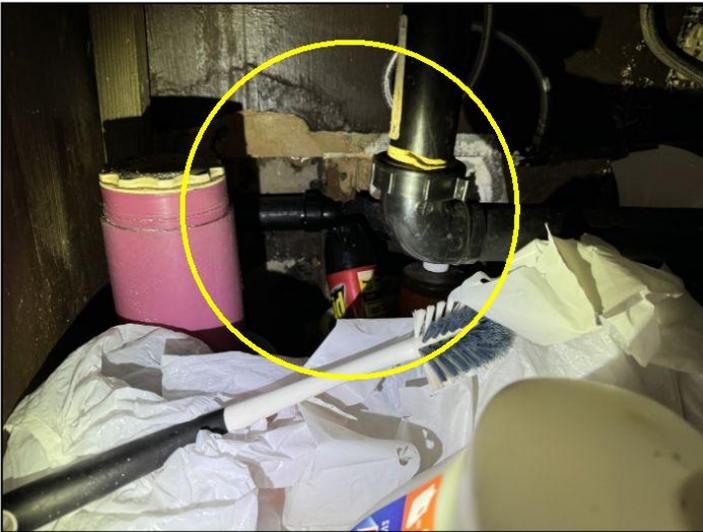
- Hole in wall behind sink at the time of the inspection. Recommend remediation by licensed contractor.
- Over notched wall observed to accommodate drain line at the time of the inspection. Recommend further evaluation/remediation by licensed contractor.

hole back of sink-appt 1/ notched wall -apt 1

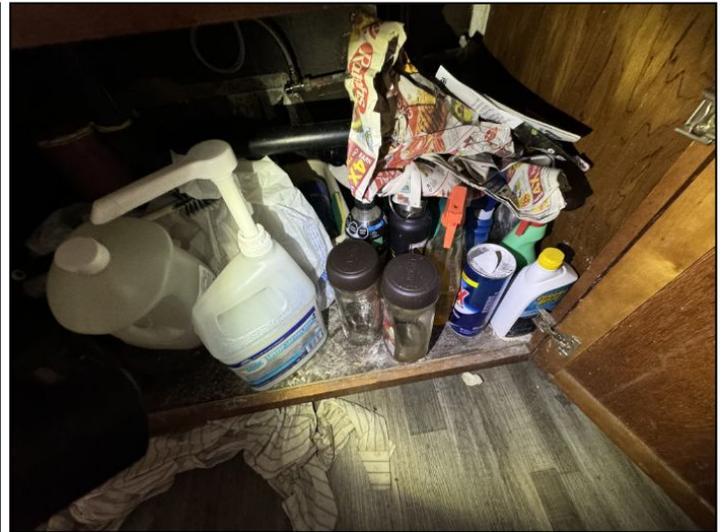
belongings under sink apt1

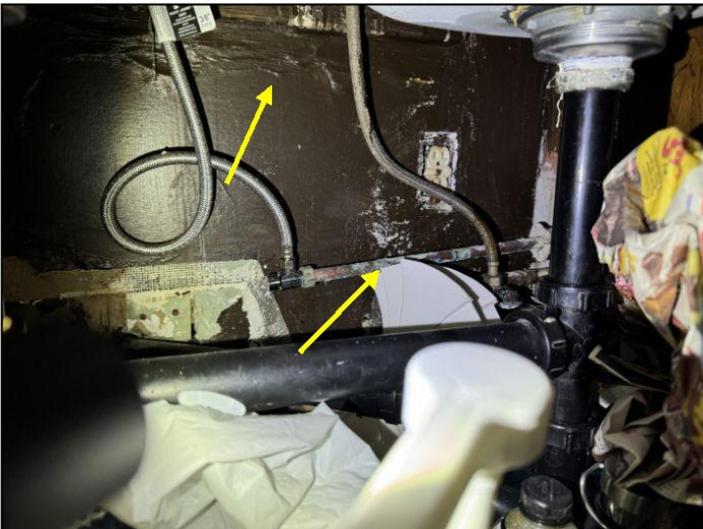
- Signs of moisture intrusion behind kitchen sinks observed at the time of the inspection. Recommend remediation by qualified contractor.
- Cracked caulking observed on kitchen counter at the time of the inspection. Recommend remediation by qualified contractor.

moisture intrusion/corrosion apt1

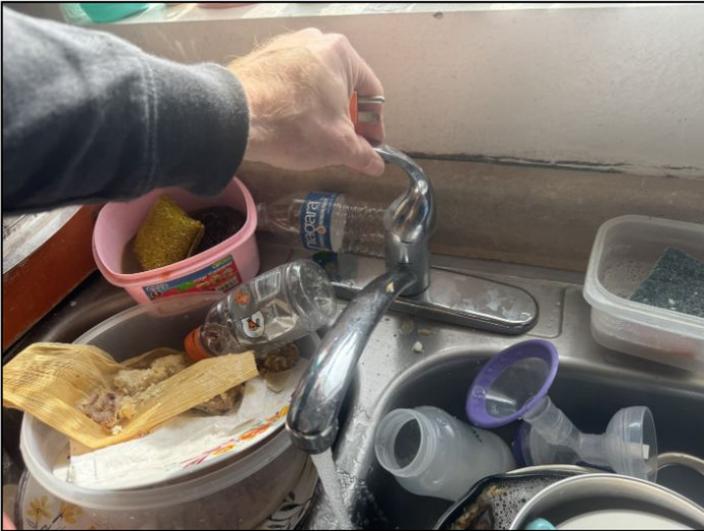
- Loose faucet observed at the time of the inspection. Recommend remediation by qualified contractor.
- Signs of suspected microbial growth under sink at the time of the inspection. Recommend further evaluation and remediation by licensed and insured professional.

loose faucet- apt 3

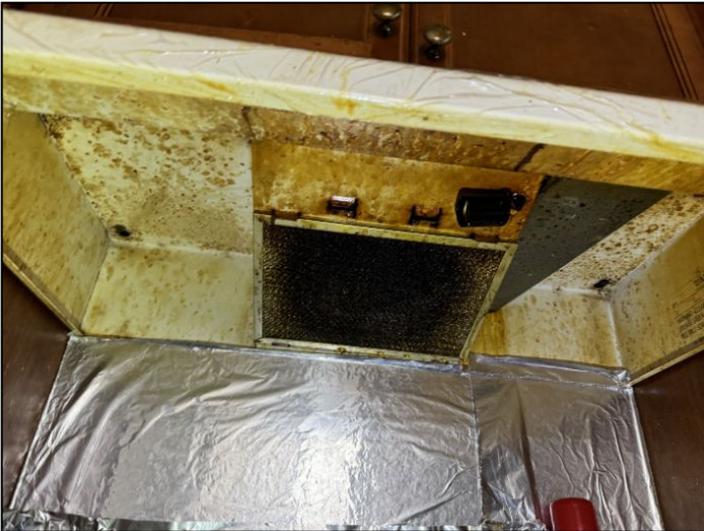
- Significant grease build up on vent and on the cabinetry at time of the inspection. Recommend cleaning and removal.
- Exhaust vent observed as leaking grease at the time of the inspection. Recommend remediation by qualified contractor.
- Exhaust vent observed as not functioning at the time of the inspection. Recommend remediation by qualified contractor.

grease covered- apt 1

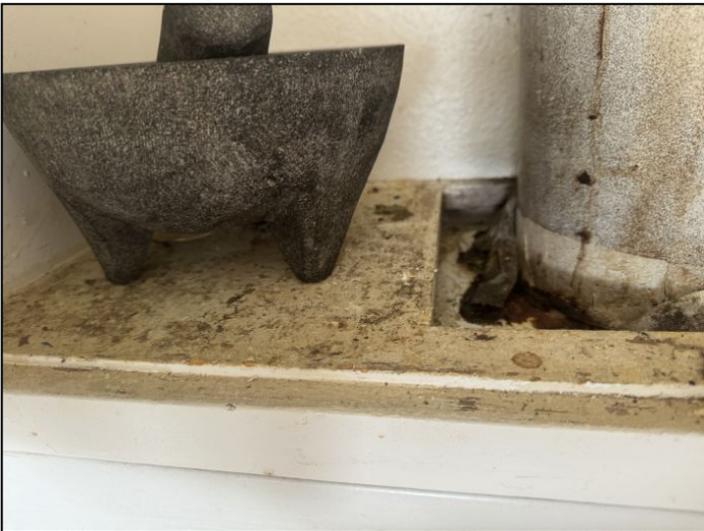
suspected growth/suspected wood pests- apt 3

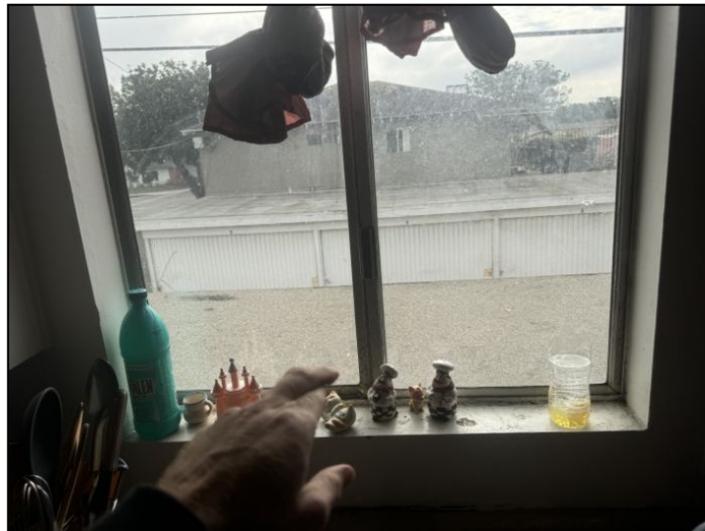
non functional window -apt 3

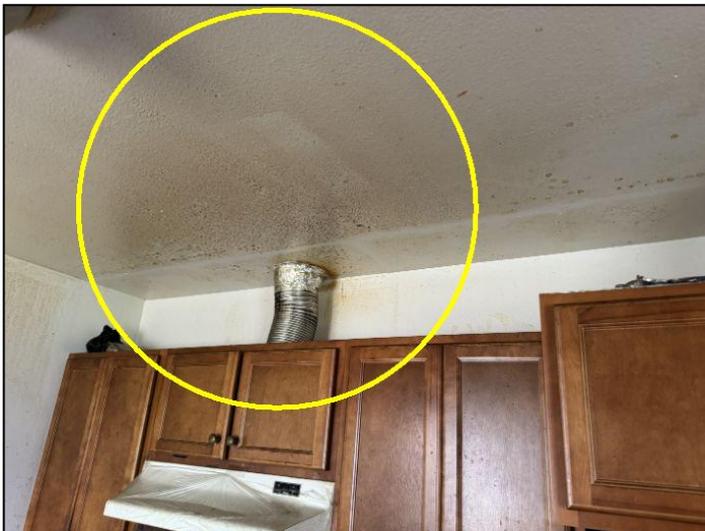
- Significant grease staining in apt. 1 kitchen at the time of the inspection. Recommend remediation by licensed professional.

grease covering kitchen

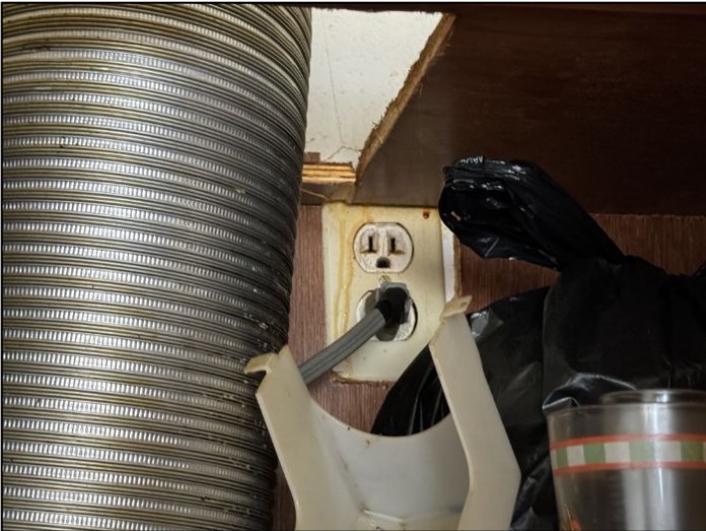
- Dripping grease observed over electrical outlet in the kitchen at the time of the inspection. Recommend remediation by qualified professional to prevent any electrical damage/safety issues.
- Non functional light observed at the time of the inspection.
- Outlet under sink missing cover with signs of rust and moisture intrusion at the time of the inspection. This is a defect/safety issue. Recommend licensed electrician remediate and licensed contractor to prevent further moisture intrusion under sink.
- Extension cord used in a permanent installation. This is a defect, recommend evaluation and remediation by qualified electrician so appliances are able to plug in without the use of an extension cord.

grease on electrical outlet apt 1

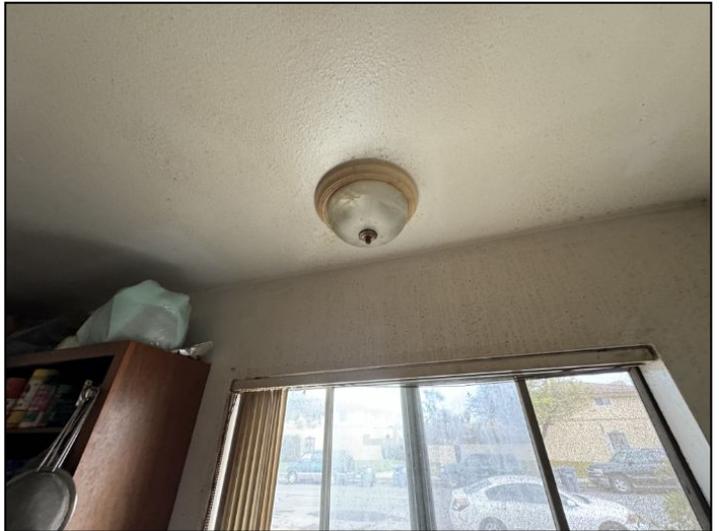
non functional light- apt 1
