SAMPLE REPORT

Confidential Inspection Report

Inspection prepared for: SAMPLE

Date of Inspection: 1/2/2025 Time: 9am

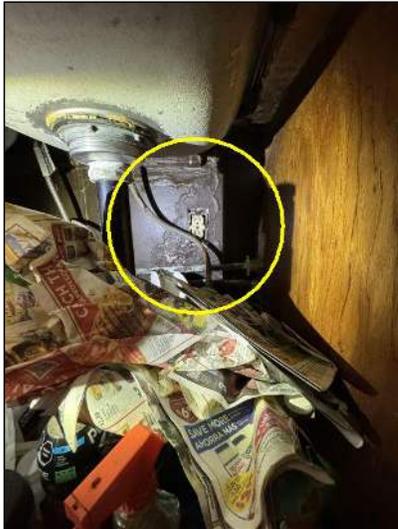
exposed electrical/moisture intrusion- apt 1

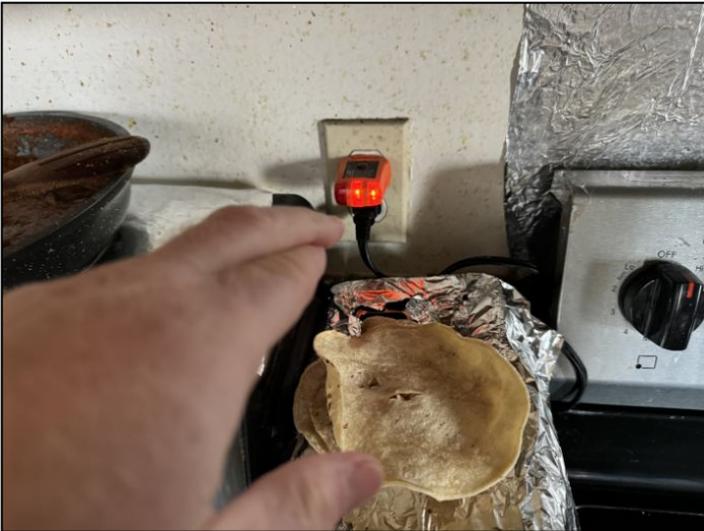
- Missing GFCI protection observed in the kitchen sink at the time of the inspection. For safety, we recommend licensed electrician replace all outlets in the kitchen with GFCI protection to prevent electrical hazard.

no GFCI-apt 1

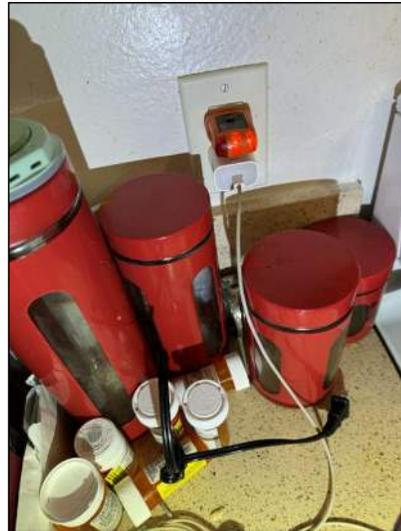
missing GFCI apt 2

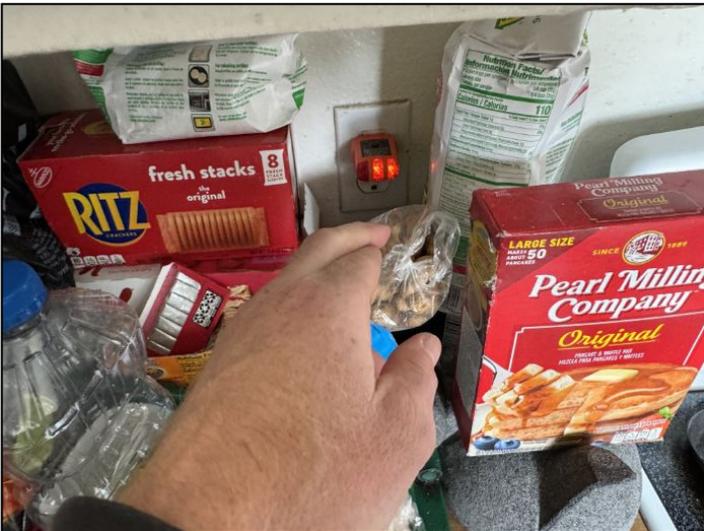
missing GFCI - apt 3

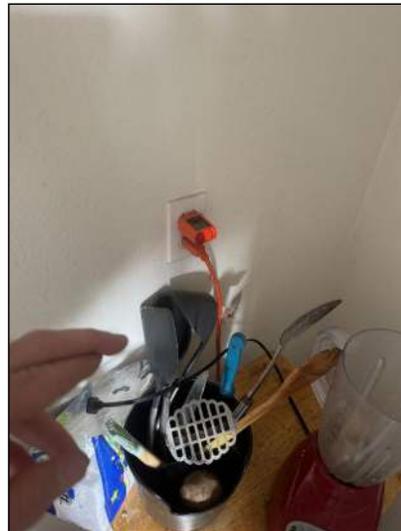
missing GFCI - apt 3

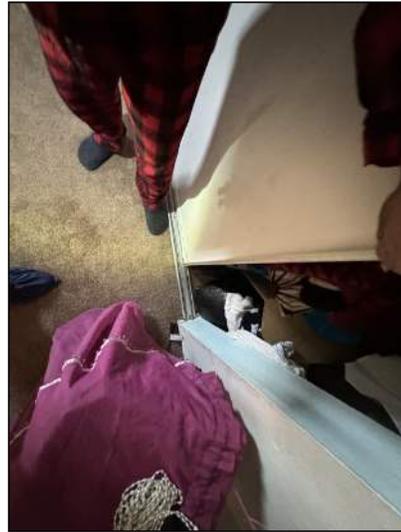
- Significant amount of owners belongings in closets at the time of the inspection. General visual inspection limited.
- Closet door observed as difficult to use at the time of the inspection. Recommend remediation by qualified professional.
- Damage to closet door observed at the time of the inspection.

difficult to use - apt 2

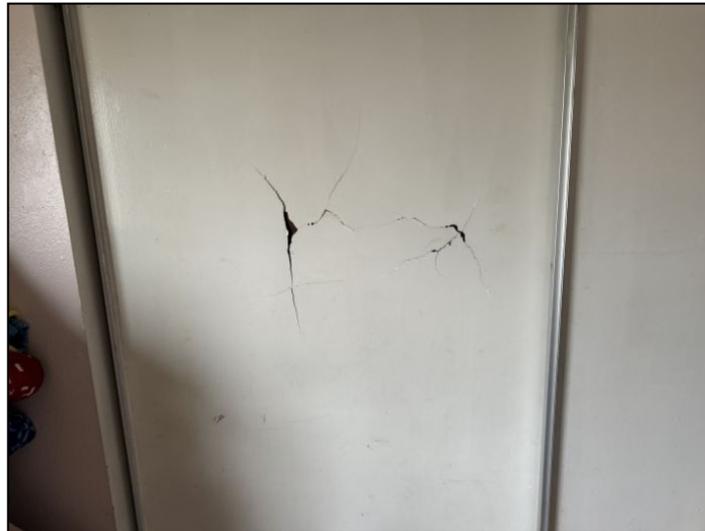
closet door damage - apt 3

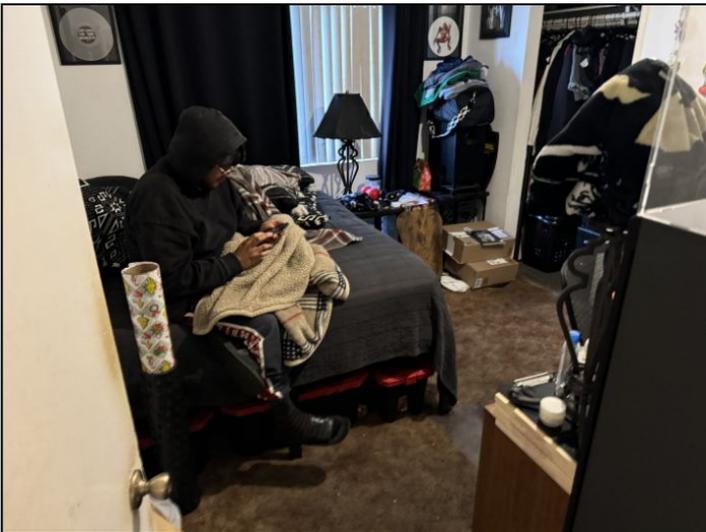
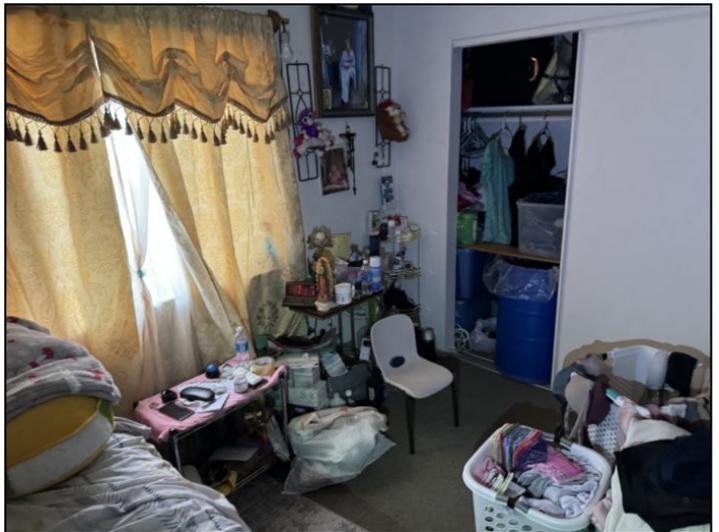
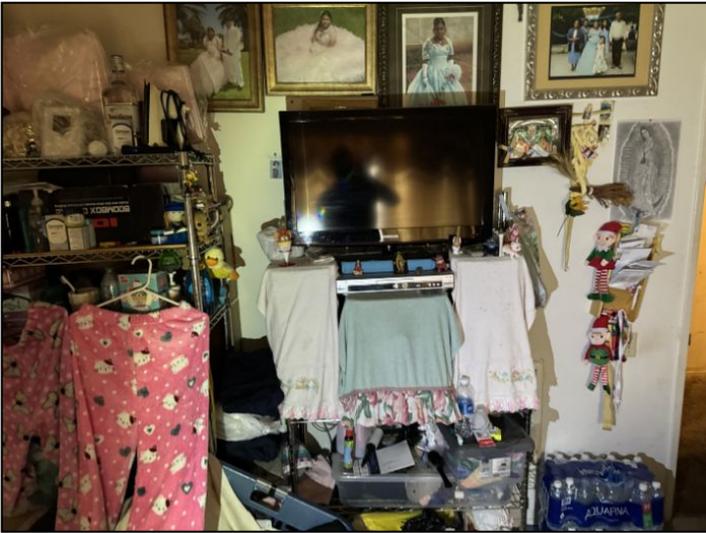
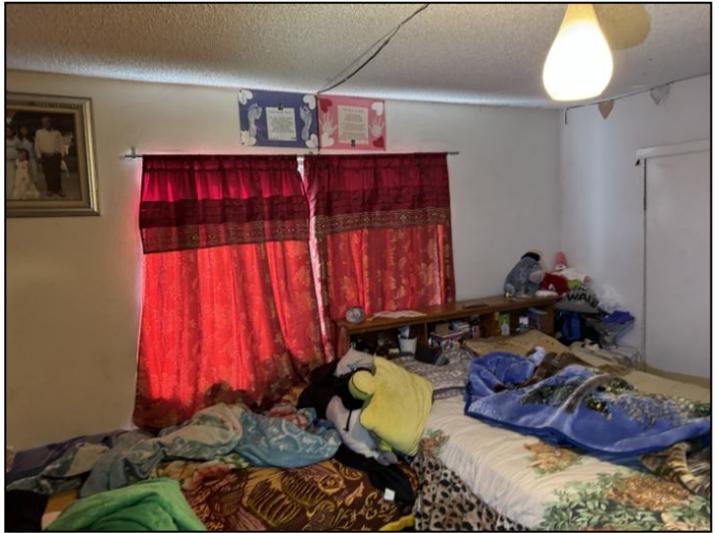
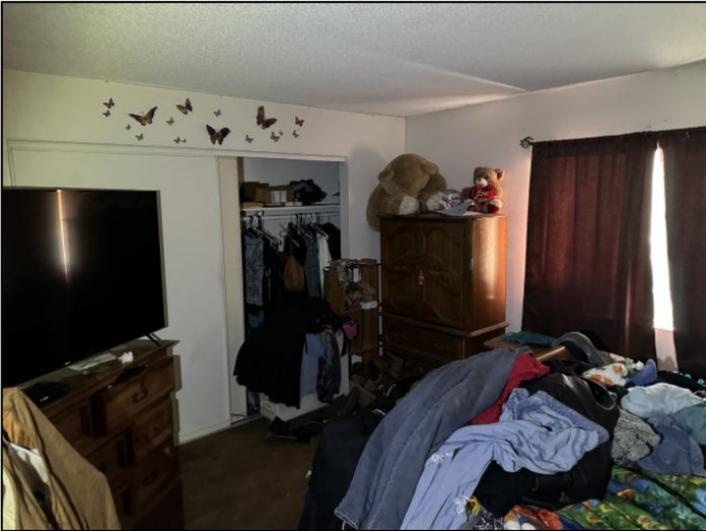
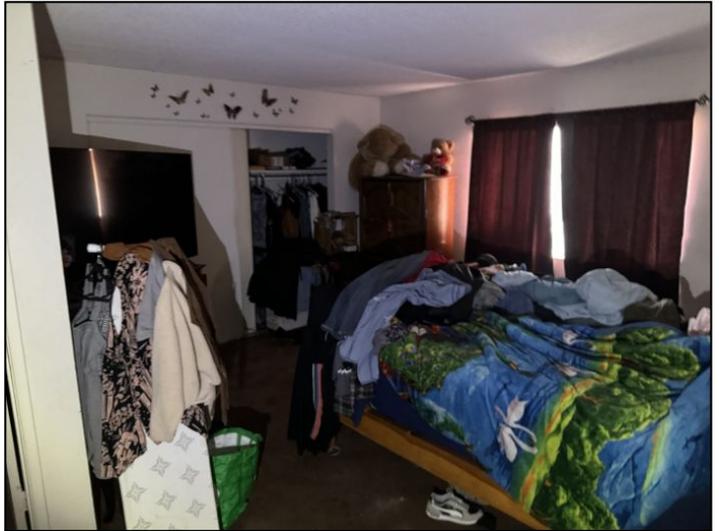
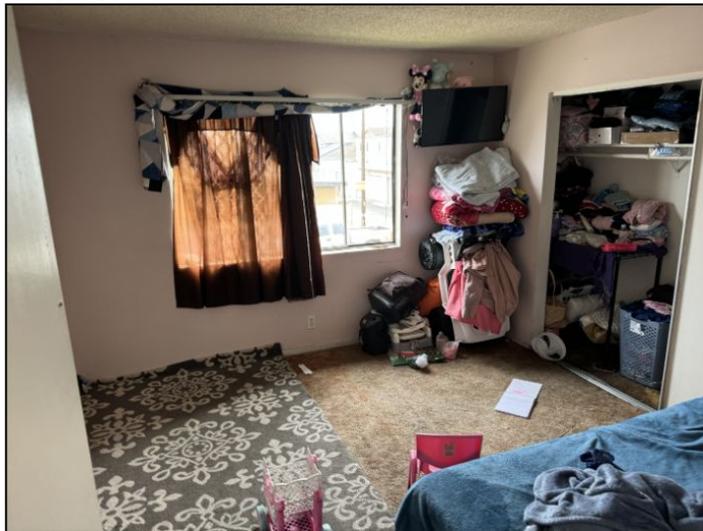
- Excessive personal belongs limited the scope of the bedroom inspection.

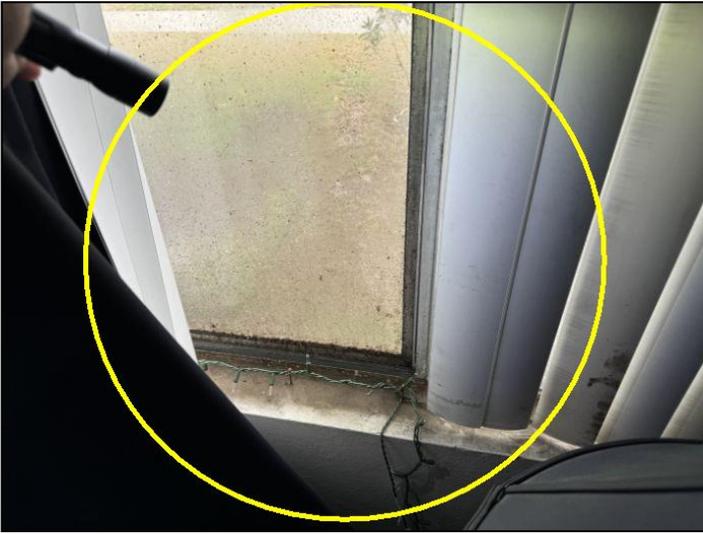
dirt/possible microbial growth/difficult to use -apt 1

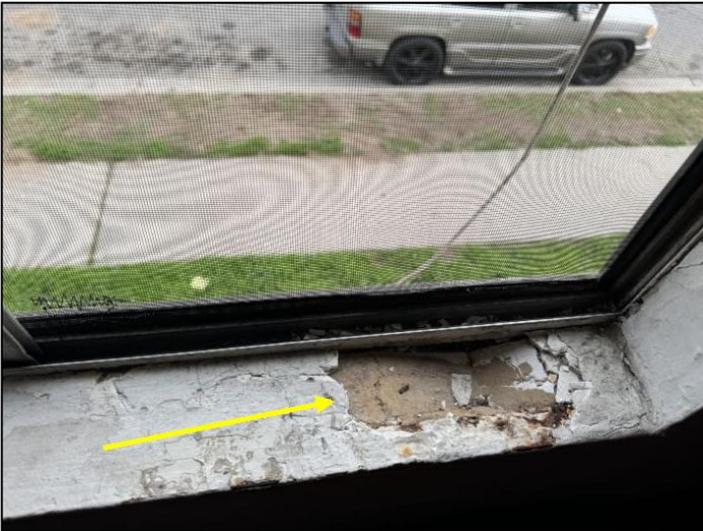
damage to sill - apt 3

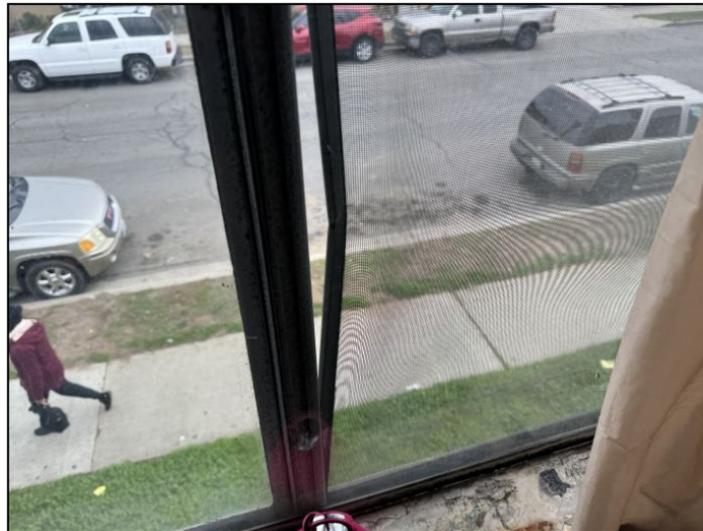
broken screen apt 3

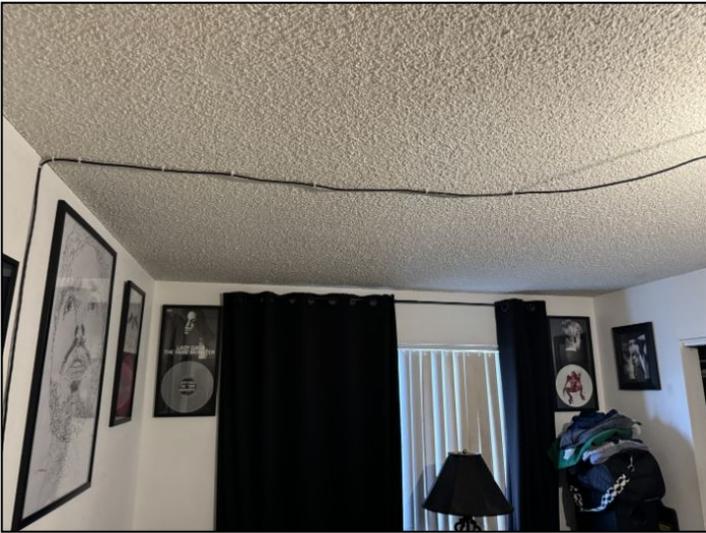
Possible asbestos

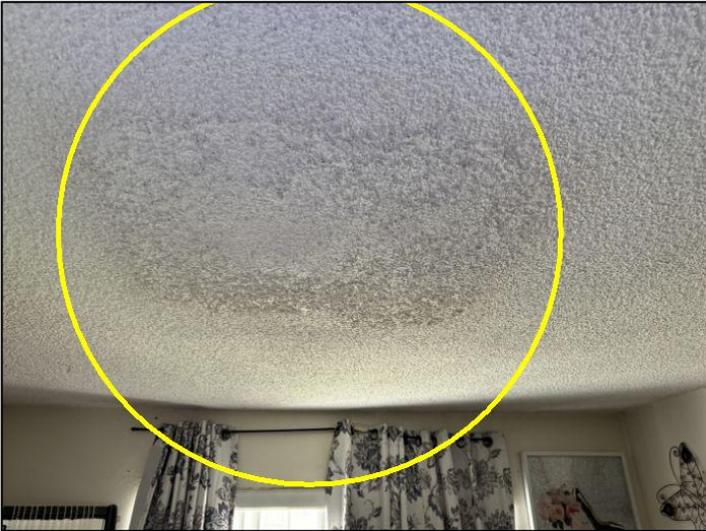
- See "interior ceiling"
- Possible moisture staining in ceiling, dry at the time of the inspection. Recommend licensed and insured contractor further evaluate/remediate.
- Previous patch work observed in the ceiling at the time of the inspection. Significant moisture damage disclosed by tenant. Recommend researching disclosures regarding time period and reason for work.
- Visible staining and possible moisture damage dry at the time of the inspection, on the ceiling, at the time of the inspection. We recommend contacting a qualified contractor to evaluate the roof, the attic and the drywall in this area and repair as necessary.

previous patch job - apt 2

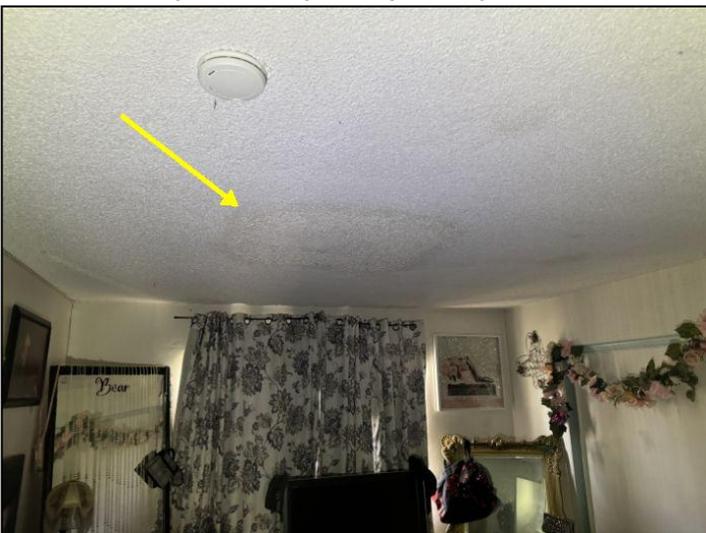
apt 2 previous patch

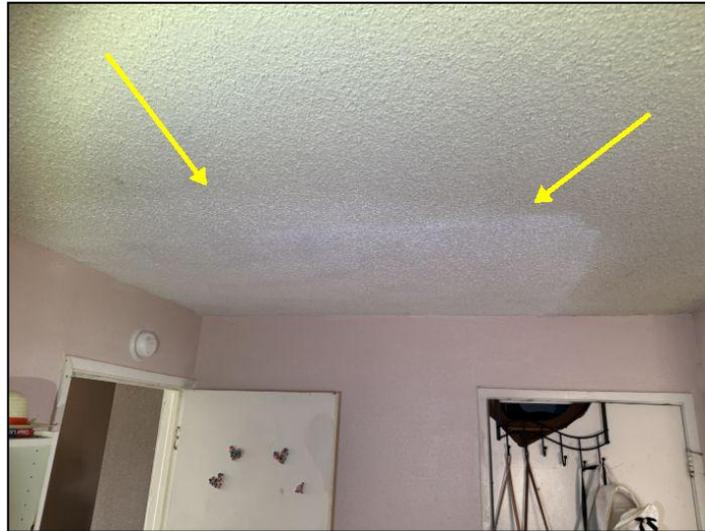
patch work - apt 3

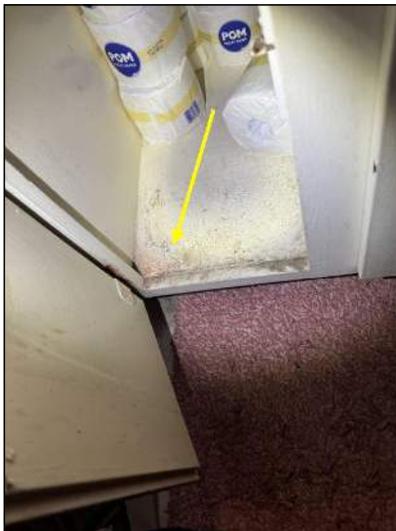
- Suspected microbial growth observed under sink at the time of the inspection. Recommend remediation by licensed and insured professional.
- Damage to cabinet at the time of the inspection. Recommend qualified professional remediate.

possible microbial growth

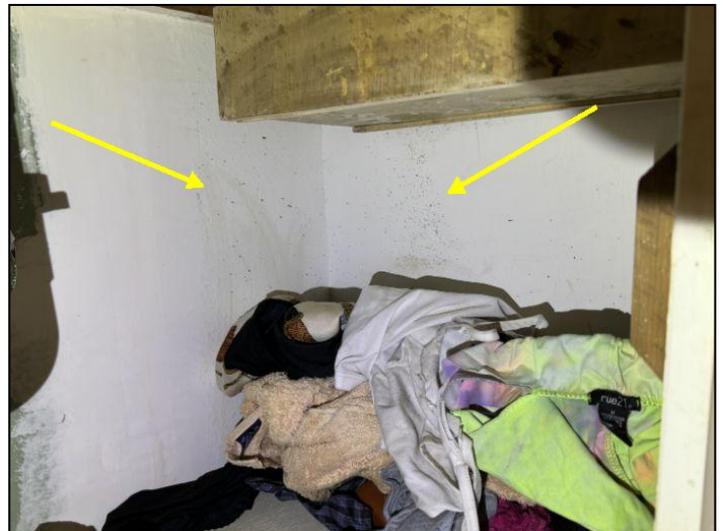
apt 2- suspected microbial growth - apt2

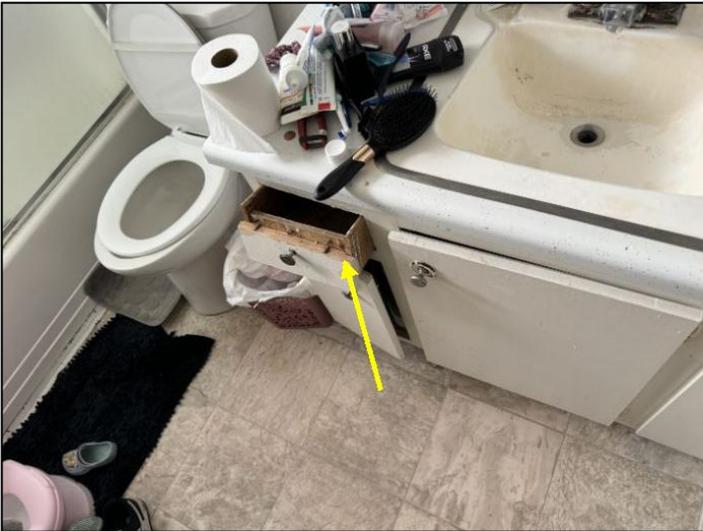
damage - apt 3

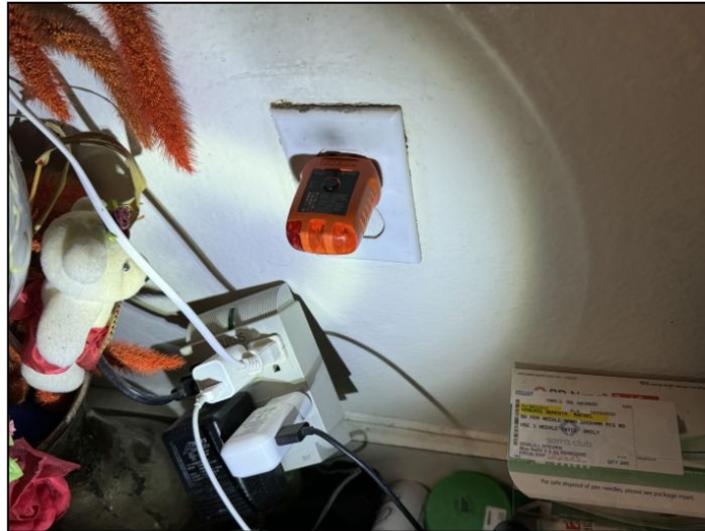
Electrical outlets in one or more bathroom appeared to be in serviceable condition at the time of the inspection but had no Ground Fault Circuit Interrupter (GFCI) protection.

missing GFCI protection-apt1

Although this condition may have been commonly considered safe or acceptable at the time the home was originally constructed, as general knowledge of safe building practices has improved with the passage of time, building standards have changed to reflect current understanding. Consider having GFCI protection installed as a safety precaution for outlets within 6 feet of a plumbing fixture.

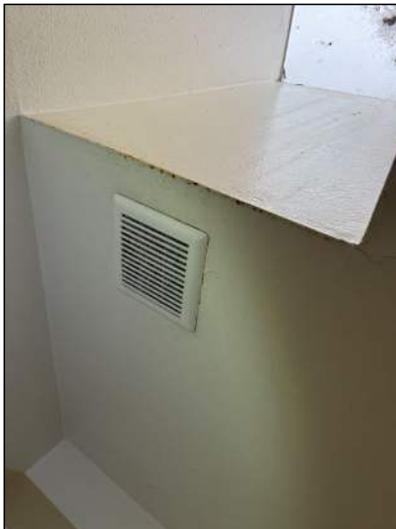
- Bathroom fans observed as dirty at the time of the inspection. Recommend cleaning of fan for efficient ventilation.
- Bathroom fan observed as excessively noisy at the time of the inspection. Recommend remediation by qualified contractor.

apt 1 - dirty fan

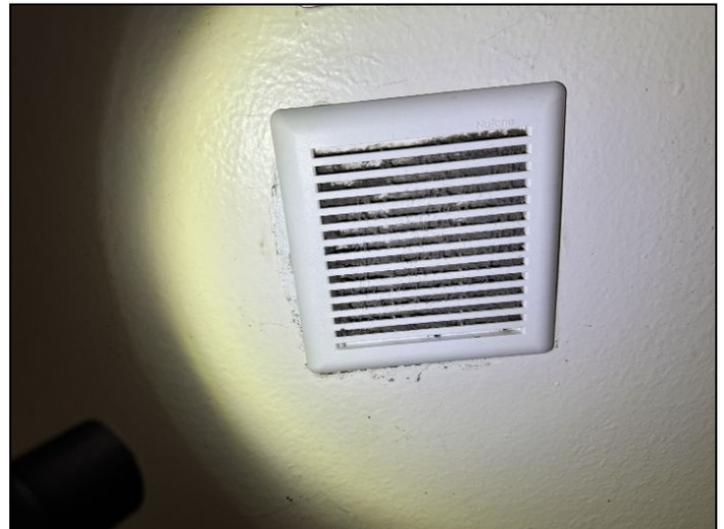
dirty fan- apt 1

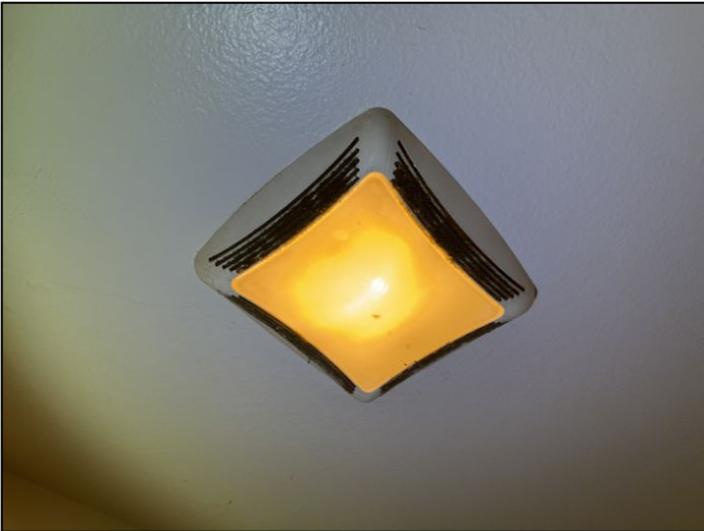
dirty fan- apt 2

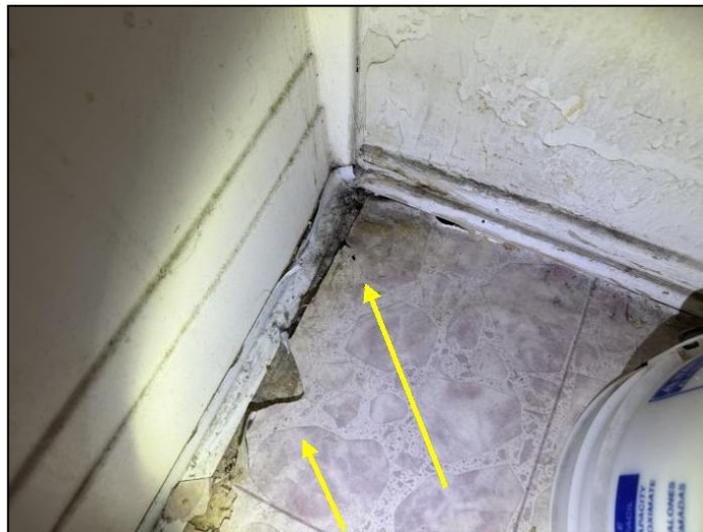
- Numerous cracks noted in the bathroom between the floor and baseboards at the time of the inspection. Recommend remediation by qualified contractor to prevent additional moisture intrusion and damage.
- Moisture damage and cracking observed to the floor next to shower at the time of the inspection. Multiple areas/appts. Recommend remediation by licensed contractor.

floor damage- apt 1

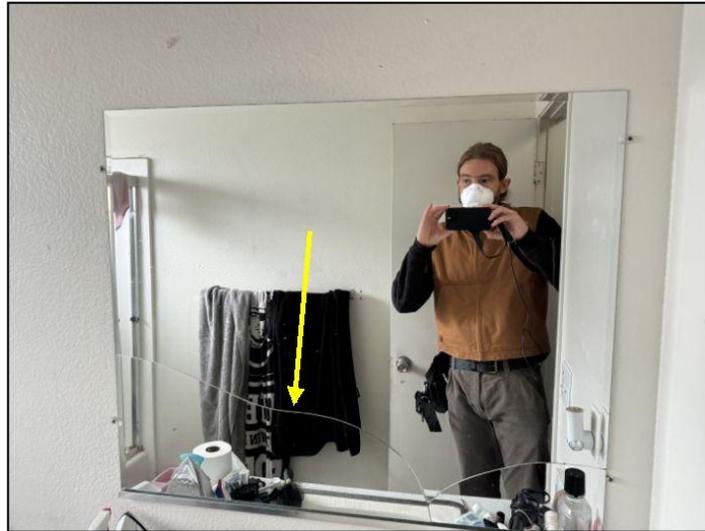
- The mirror glass is cracked.

broken mirror -apt 3

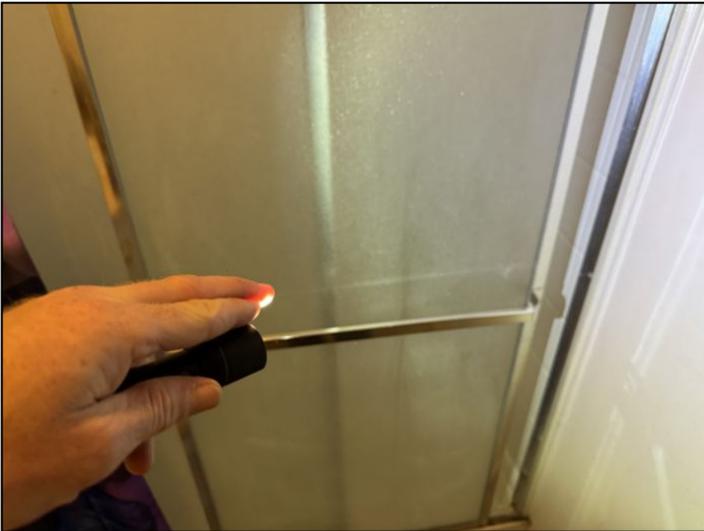
apt 2 non functional door

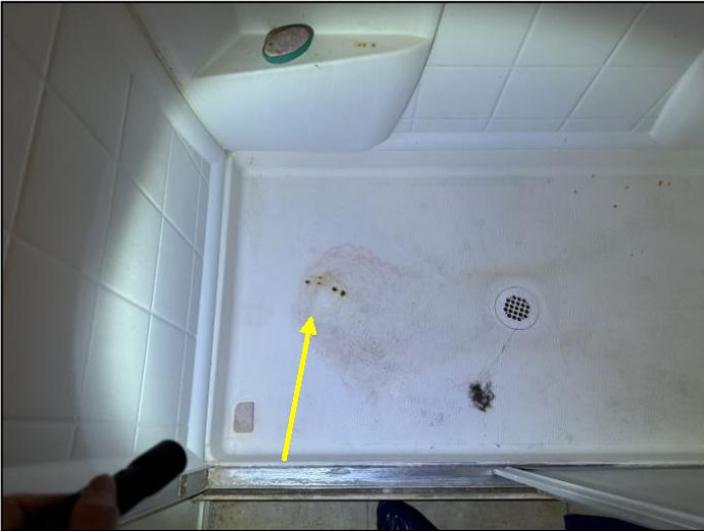
staining in shower - apt 2

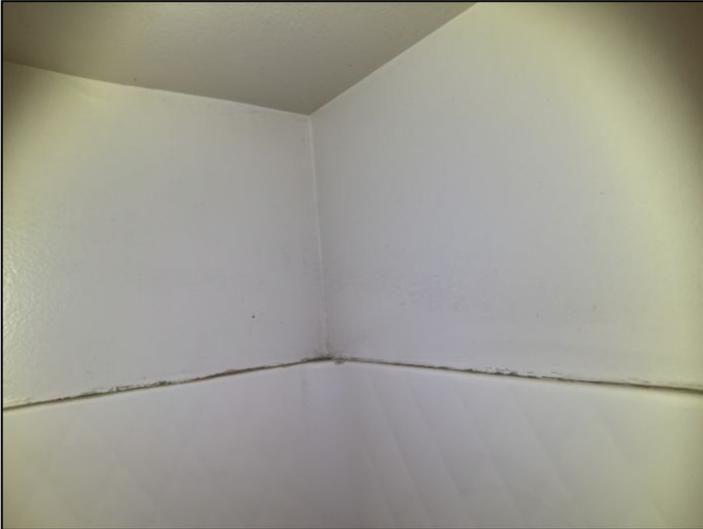
- Cracking in caulking observed at the time of the inspection. Recommend cleaning and replacing all cracked caulking to prevent moisture intrusion. Recommend remediation by qualified contractor.
- Suspected microbial growth observed in the shower at the time of the inspection. Recommend removal and replacement of all dirty caulking to maintain effective water seal. Recommend qualified professional evaluate and remediate.
- Small holes in the shower wall observed at the time of the inspection. Recommend qualified contractor, shower wall penetrations to prevent moisture intrusion.
- Failing waterproofing observed on the exterior shower wall at the time of the inspection. Recommend remediation by qualified contractor.
- Signs of blistering, damage to shower walls observed at the time of the inspection. Recommend qualified contractor remediate to prevent further deterioration.

seal top of shower inclosures

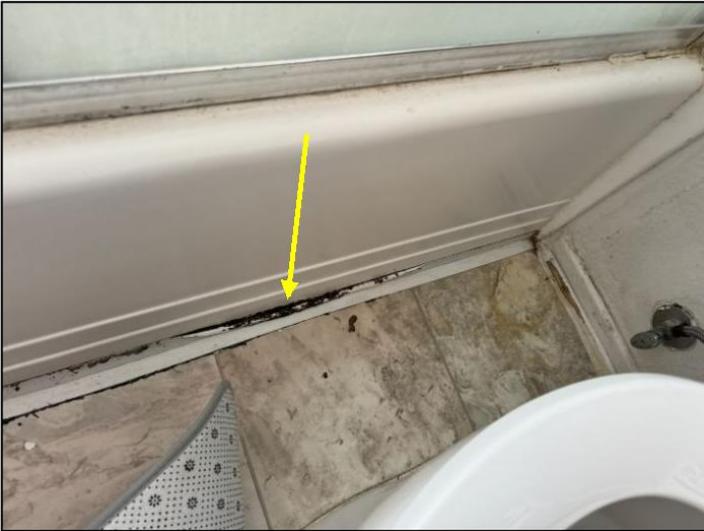
failing sealant - apt 3

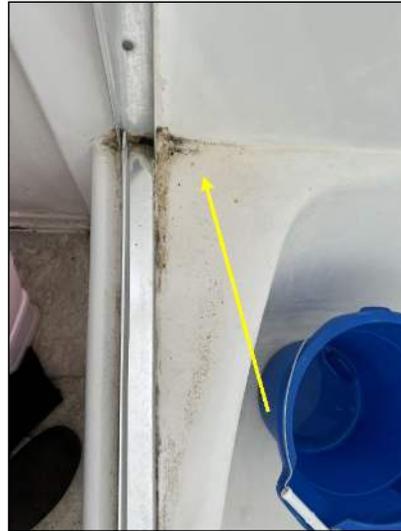
suspected microbial growth - apt 3

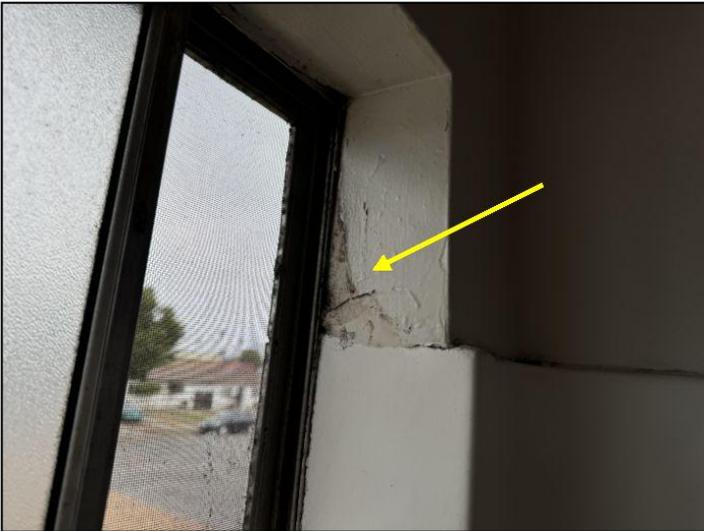
suspected growth - apt 3

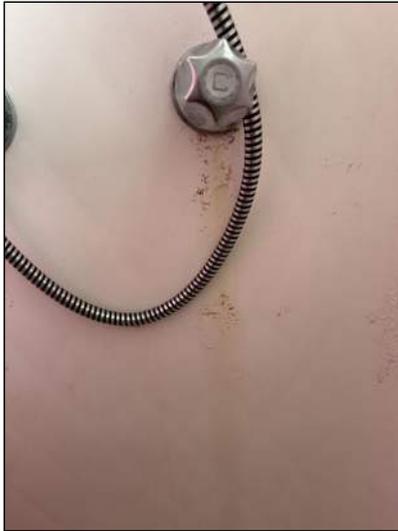
signs of blistering - apt 3

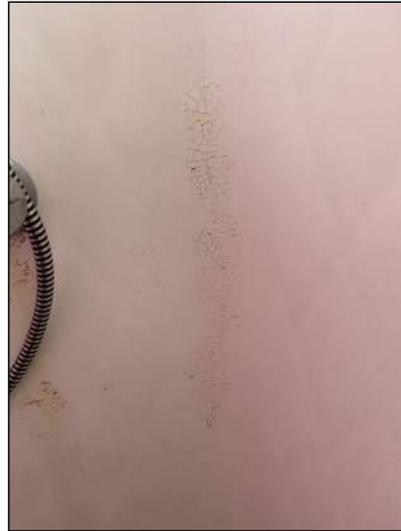
blistering - apt 3

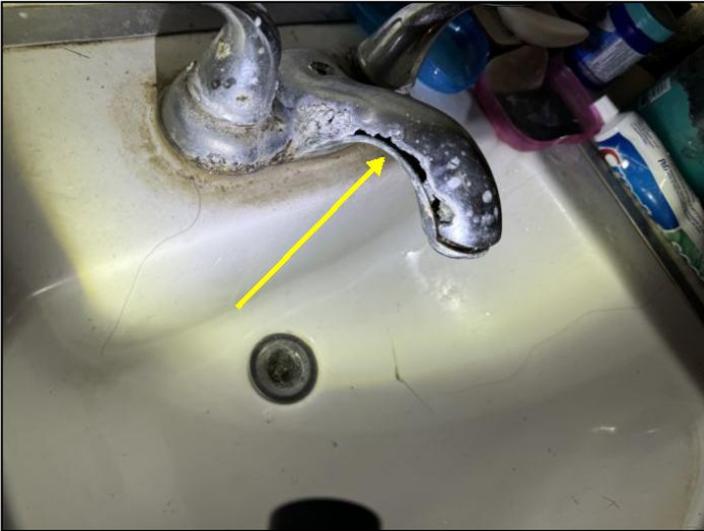
damaged faucet

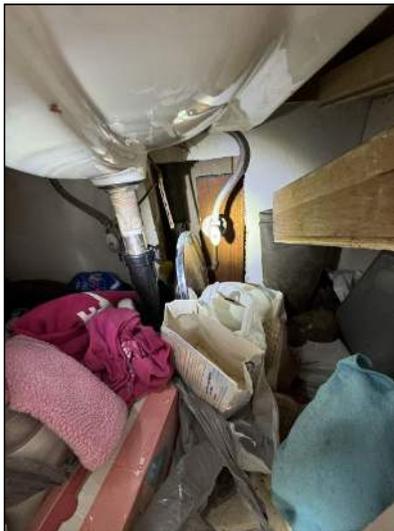
- Corrosion at drain connections observed at the time of the inspection. Cast iron drain lines observed in the wall at the time of the inspection. Recommend further review and remediation by licensed and insured plumber regarding corrosion and expected functional life of the cast iron drain lines.
- Possible microbial growth observed at the time of the inspection. Recommend further review and remediation by licensed and insured professional.
- Sink faucet observed as significantly corroded at the time of the inspection. Recommend licensed and insured plumber for replacement.
- Signs of leaking plumbing below the sink at the time of the inspection. Recommend remediation by licensed plumber.
- Hole in wall behind sink at the time of the inspection. Recommend remediation by qualified contractor.

apt 3 - hole

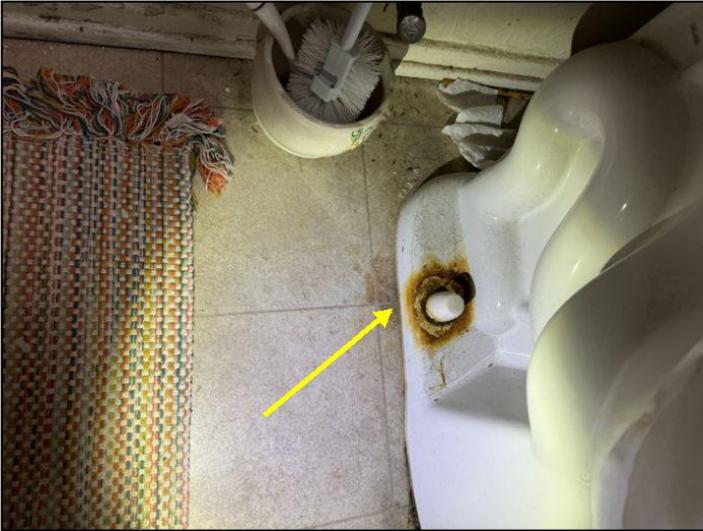
- Moisture and possible microbial growth observed around the toilet at the time of the inspection. Recommend further evaluation by a qualified contractor.
- Rust observed at toilet connection at the time of the inspection. Recommend remediation by licensed and insured plumber.

rust/possible leak- apt 1

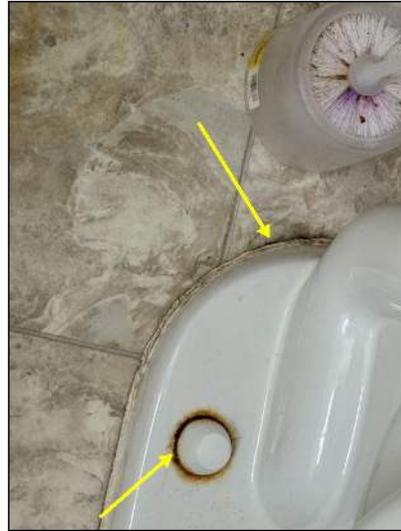
moisture signs - apt 3

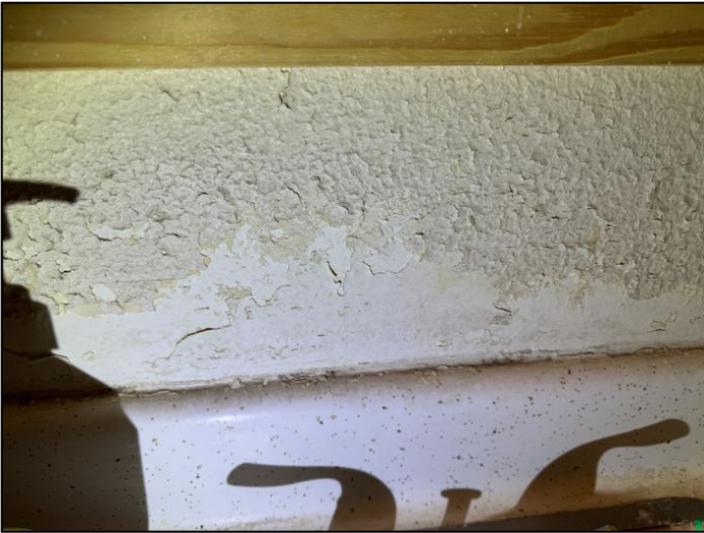
- Moisture intrusion and deterioration of wood observed next to shower door at the time of the inspection. Recommend sealing all cracks and gaps in and around the shower to prevent moisture and intrusion.
- Observed possible microbial growth observed on bathrooms walls and ceilings at the time of the inspection. Recommend further evaluation and remediation by qualified contractor.
- Damage to wall above sink observed at the time of the inspection. Recommend remediation by licensed contractor.

damage to wall- apt 1

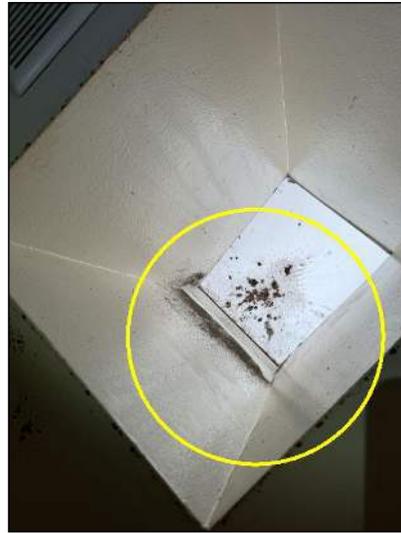
apt one- possible microbial growth

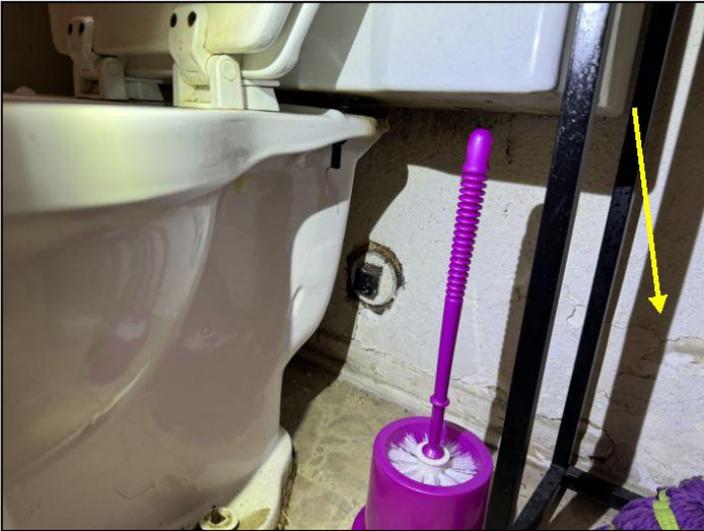
damage to walls-apt 1

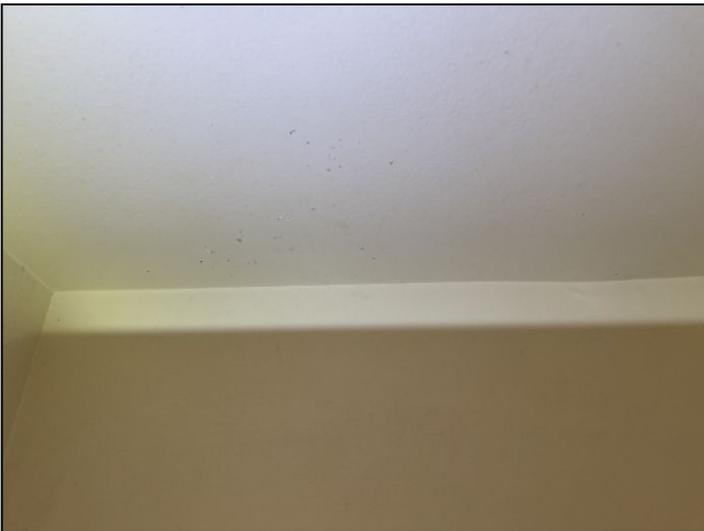
possible microbial growth- apt 1

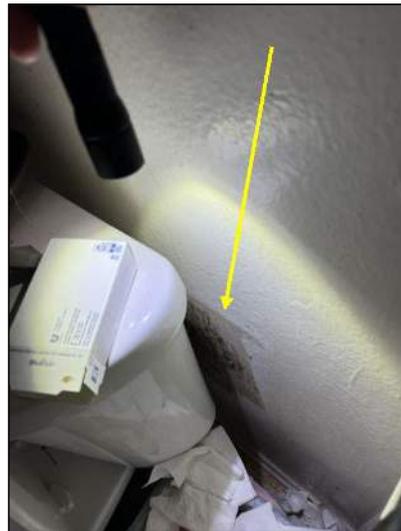
apt 1- possible microbial growth

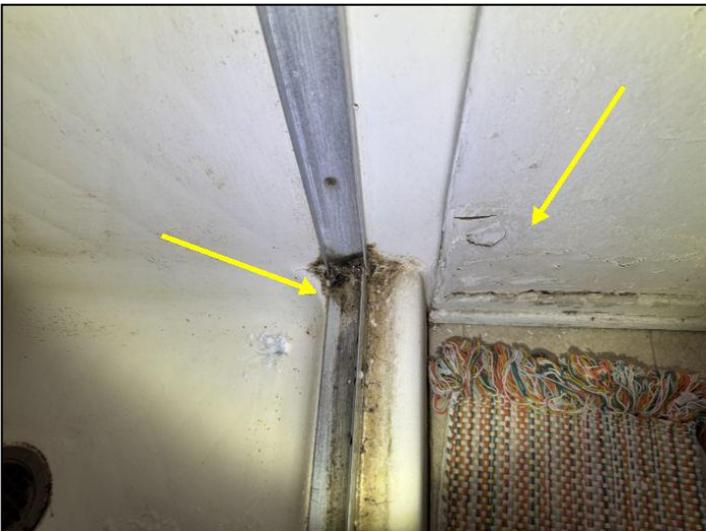
damage to wall/suspected microbial growth

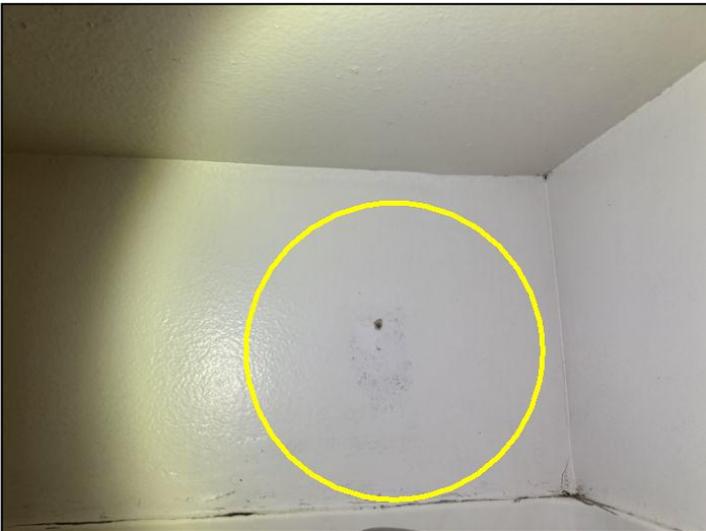
suspected microbial growth -apt 1

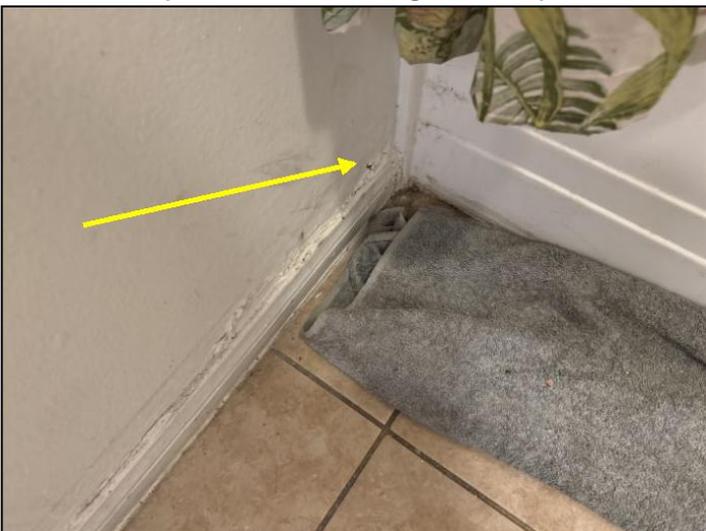
moisture damage- apt 2
