# BEST COAST HOME INSPECTIONS

## Confidential Inspection Report

, Santa Paula, CA 93060

Inspection prepared for: Sample Sample

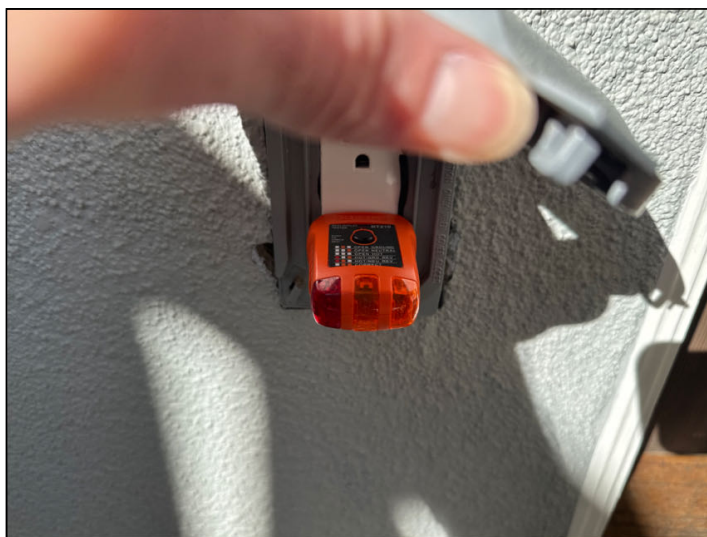
- Open ground three prong outlets present at the time of the inspection. An open ground is when you have a three prong outlet not connected to an equipment grounding conductor. The lack of an equipment grounding conductor will limit the use of certain appliances such as washing machines, computers, etc. that require a ground. Recommend electrician remediate, assess entire electrical system and add **GFCI** protection to all necessary outlets.

*Open ground*

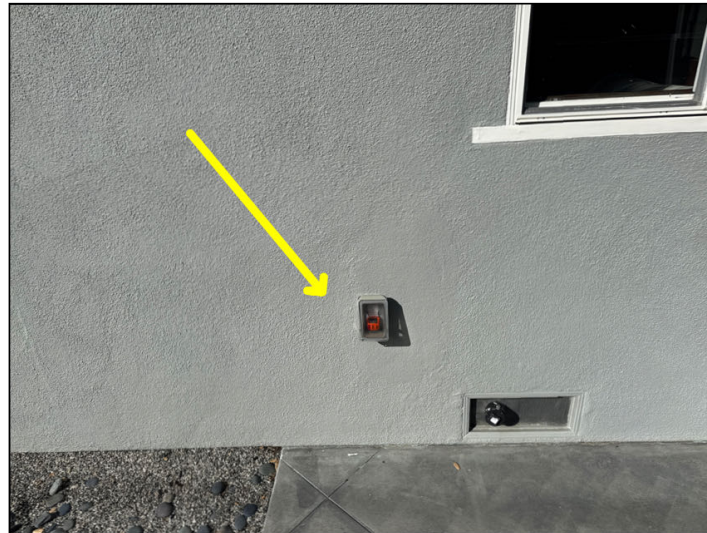
*Open ground*

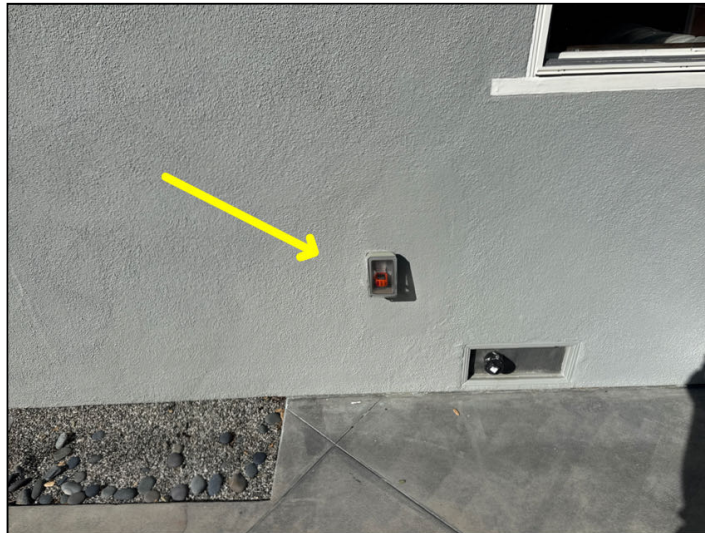
• Missing Ground Fault Circuit Interrupter (GFCI) protection in the home at the time of inspection. Although GFCI protection may not have been required at the time the home was built, for safety reasons, consider upgrading the electrical system to include GFCI protection at the following locations:

*Missing gfci*

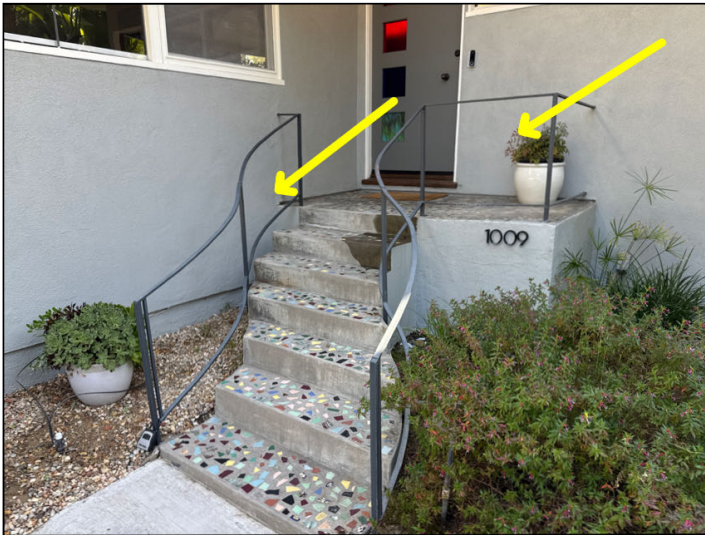
- Spindle spacing exceeds the 4 3/8 inch spacing which is considered safe by today's child safety standards. Recommend remediation by qualified contractor to prevent falling hazard.

Open

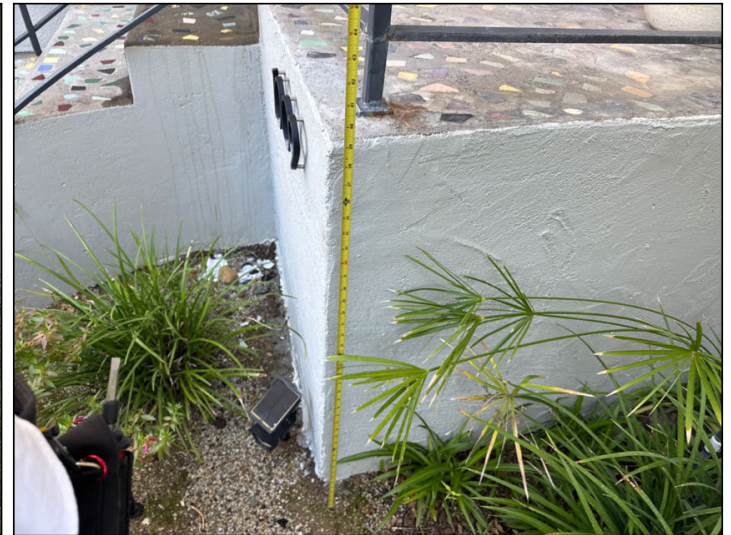
more than 30 inches

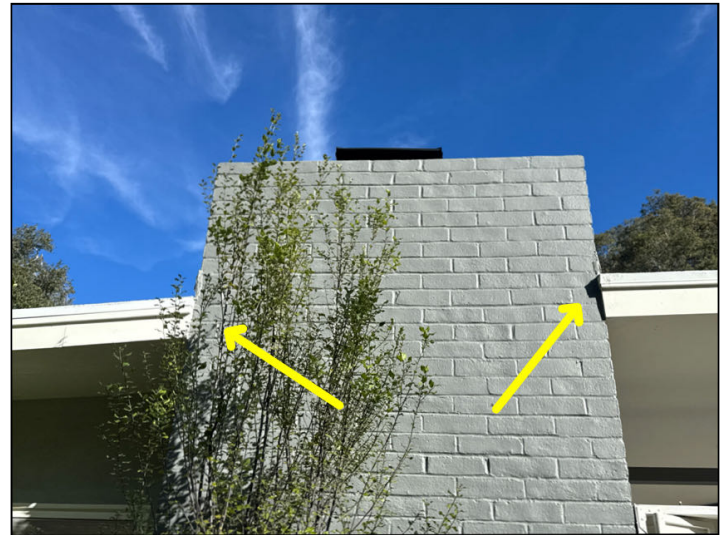
*Touching trim*

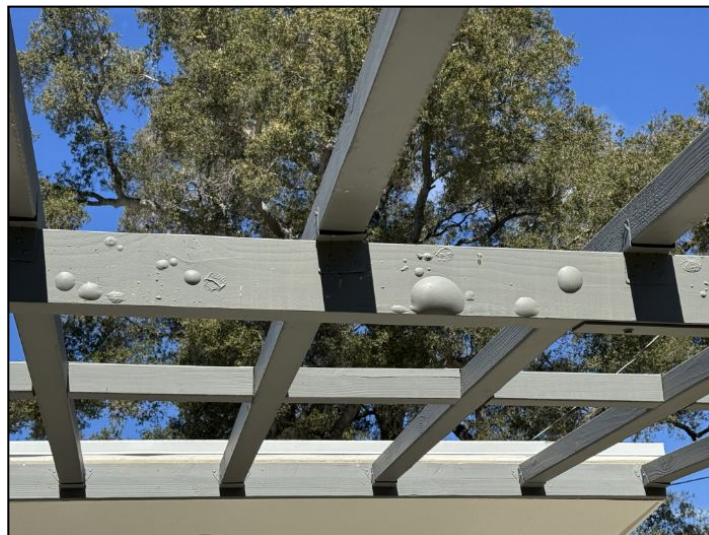
*bubbled paint*

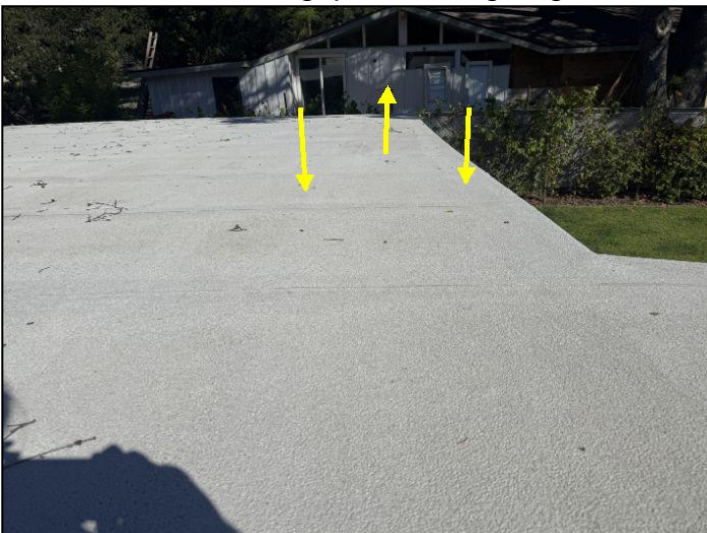
*slight hump*

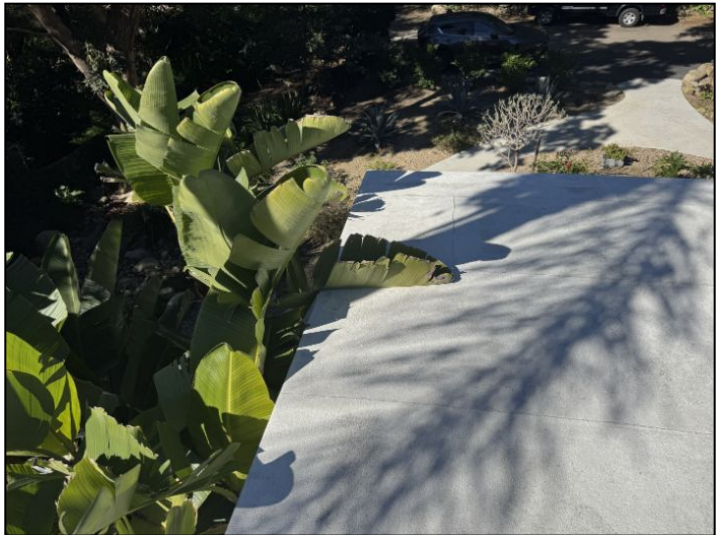
*veg*

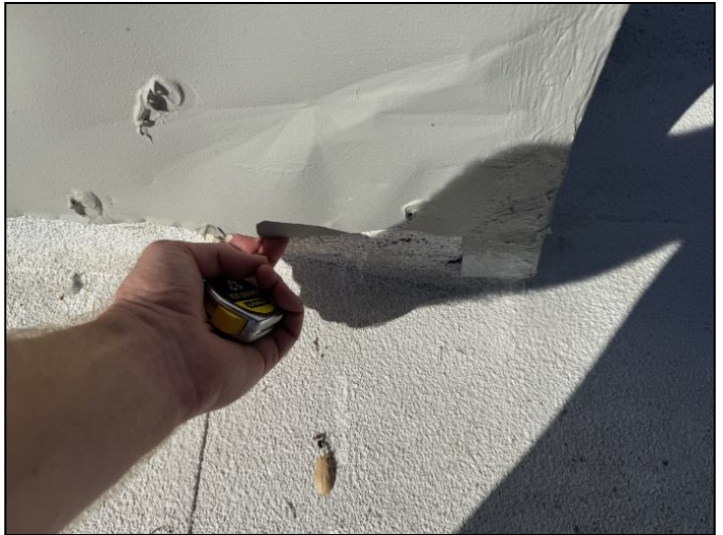
*lifted flashing*

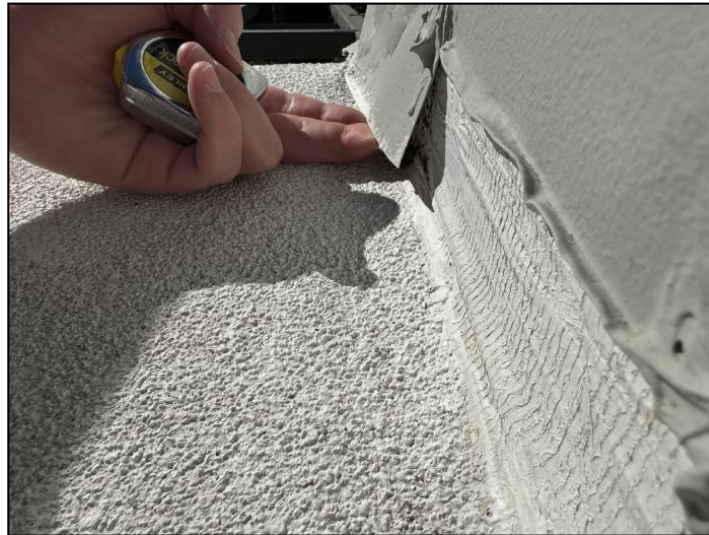
*lifted flashing*

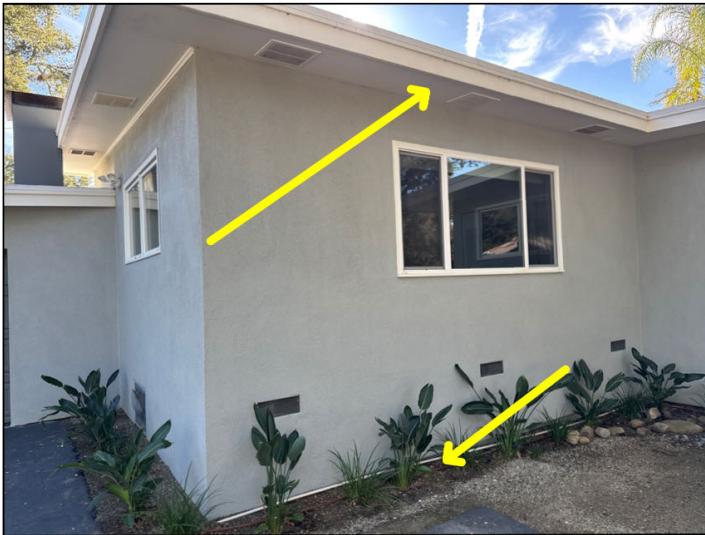
- No roof gutters at time of the inspection- Full installation recommended to keep water away from structure. Water can weaken the foundation and deteriorate the siding. Be sure to install splashblocks or extensions to carry water away. Recommend qualified contractor remediate.

No gutters

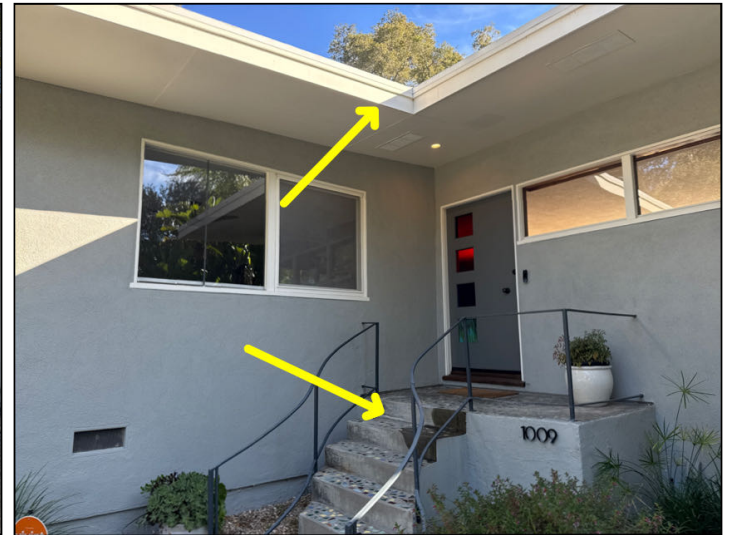
No gutters

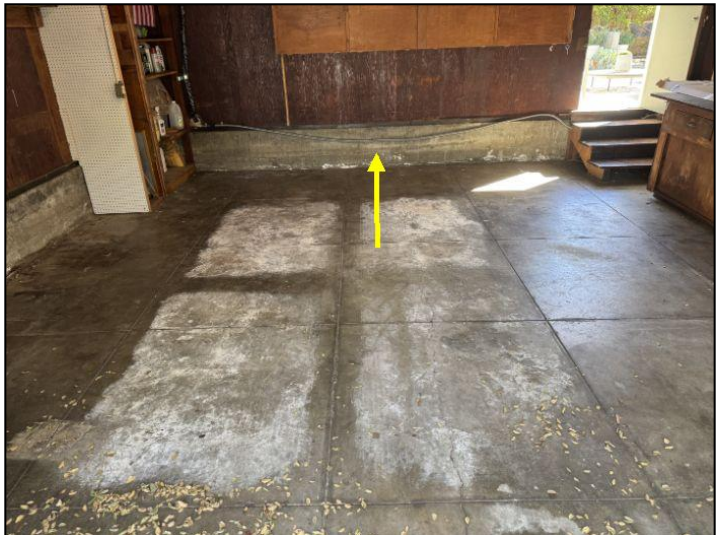
*unsupported mc cable*

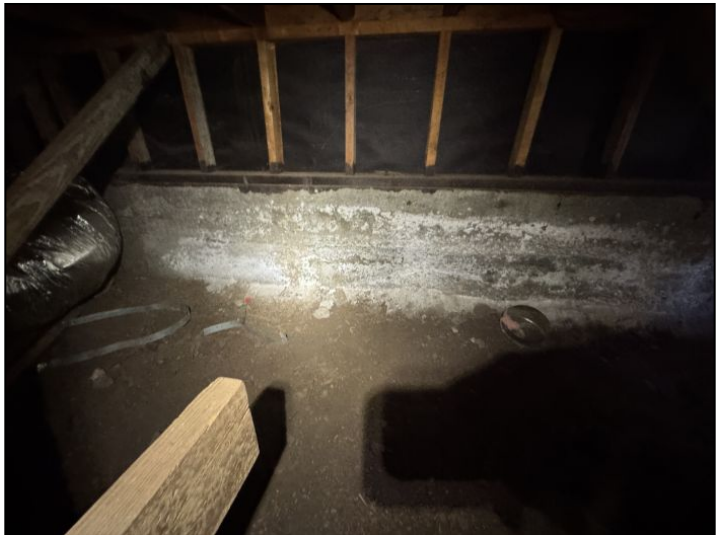
*efflorescence*

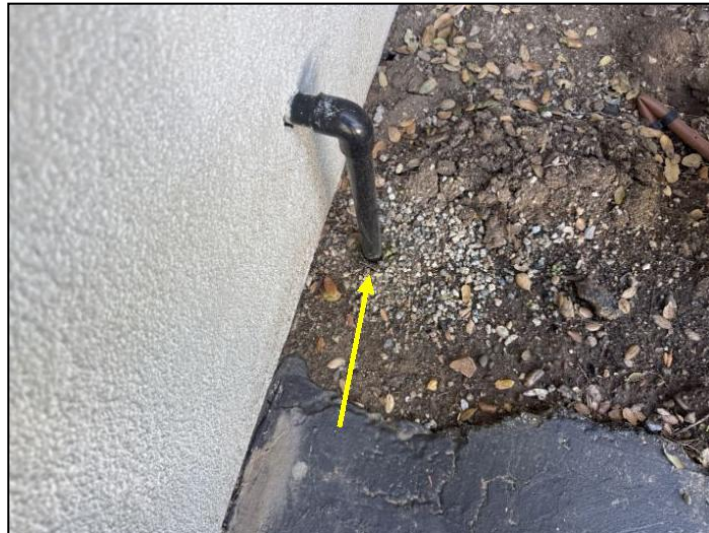
- Condensation line for water heater observed as blocked at the inspection. Recommend cutting it shorter to allow drainage.

*condensation line*

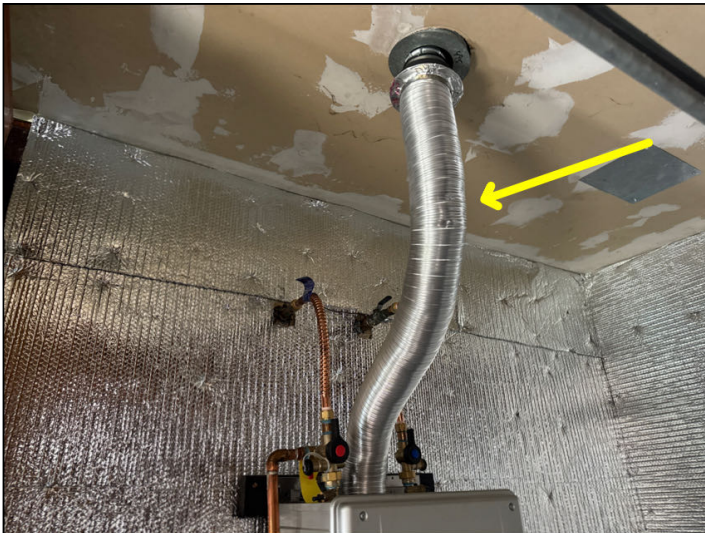
- Unable to confirm, flexible, exhaust vent is double walled, and made for the purpose of combustion venting. Recommend further evaluation of flue and remediation by qualified plumber for safety of use.
- Incorrect use of rubber gasket on combustible flue vent above water heater. Recommend evaluation of water heater flue by licensed and insured plumber for safety of use.
- Recommend full review of water heater for correct materials and clearance to combustibles from the top of the water heater and the interior the of flue enclosure above the garage.

*Not identified as B-vent*

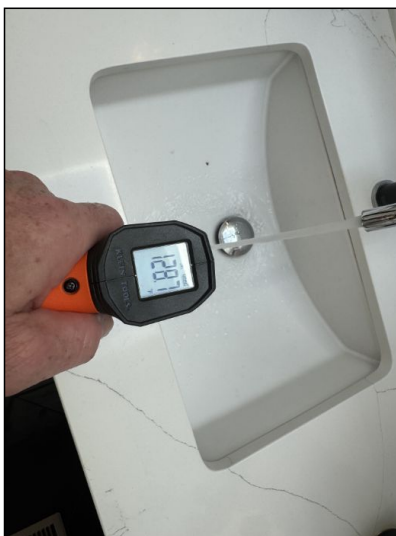
- Water temperature measured at 128 which is a scalding hazard. Recommend reduction of temperature to 120 to prevent scalding.

*128 temp*

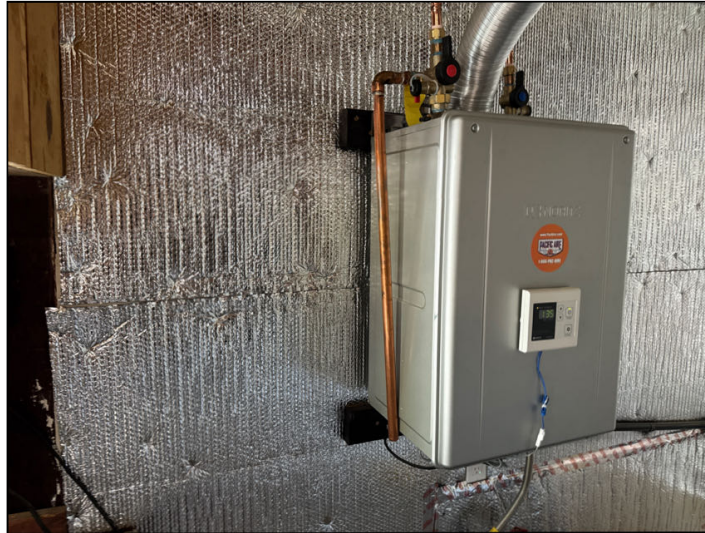
- Recommend **TPRV valve** be extending to the exterior of the structure in an easily viewed area. In the event of failure you can damage the home and any surround belongings. Recommend qualified contractor.

*Tpr extension to exterior*

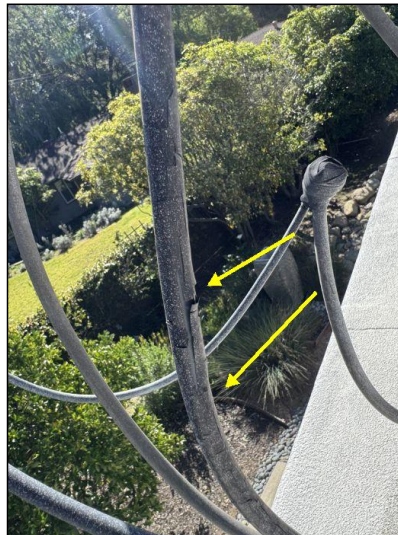
damaged conductors

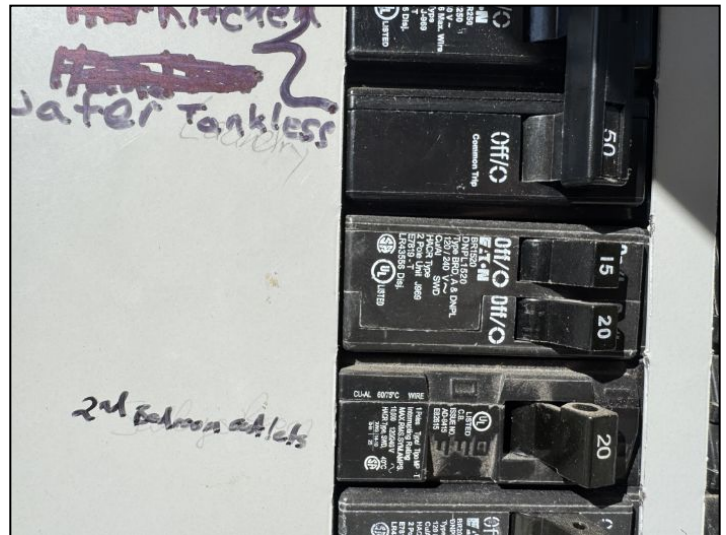
- **Mismatched Breakers**- The electrical panel breakers not labeled for use in the panel at the time of the inspection. Most panel manufacturers call for specific type and brand circuit breakers to be used. A description of allowable breakers on underside of the panel. A qualified electrical contractor should evaluate this panel follow manufacturers instructions and replace breakers not permitted to be used for safety of use of the electrical panel.

Missmatched breakers

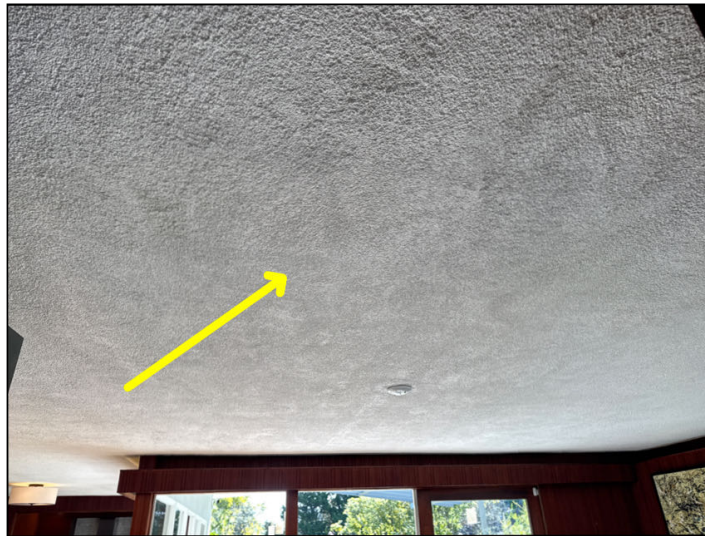
- "Popcorn" textured ceilings observed at the time of the inspection. Due to the age of the home it is possible the material contains asbestos. The U.S. Environmental Protection Agency (EPA) and the Consumer Product Safety Commission report that asbestos represents a health hazard if friable damaged, crumbling or in a state that allows the release of fibers into the air. The client may wish to have this ceiling material tested by a qualified lab to determine if it does contain asbestos. Recommend licensed and insured abatement company for evaluation and removal if decided.

*Popcorn ceiling*

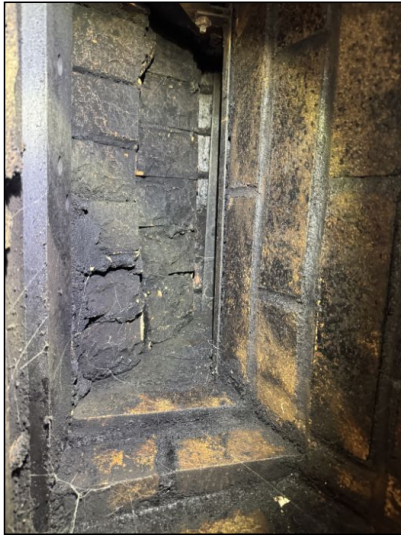
- Gap at hearth observed. Recommend review/remediation by licensed contractor.
- Significant creosode build up inside of the fireplace at the time of the inspection. Recommend cleaning and evaluation of fireplace/chimney by qualified professional.

*build up*

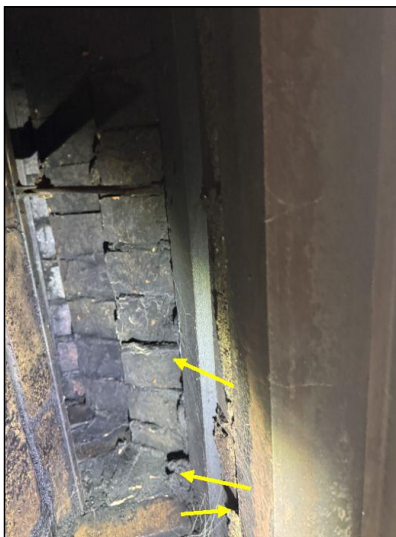
- Missing grout observed in the hearth of the fireplace at the time of the inspection. Recommend remediation by qualified fireplace professional.

*missing grout*

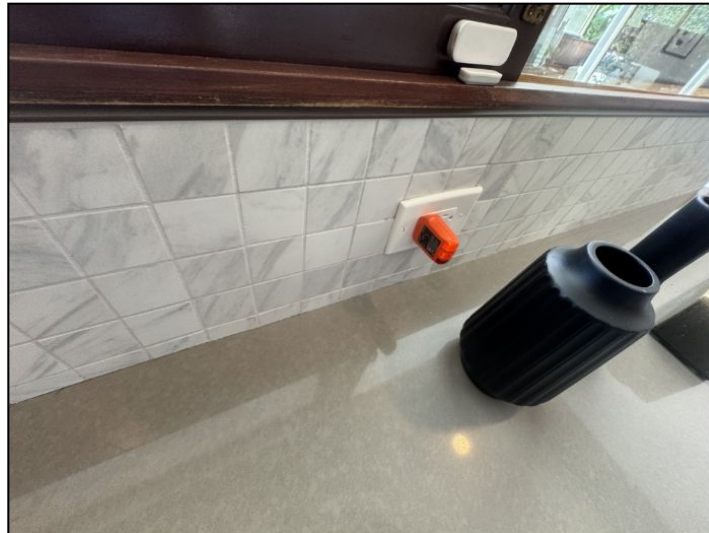
- Missing GFCI protection present in the kitchens at the time of the inspection. We recommend hiring a licensed electrician and installing GFCI protected receptacles for every outlet in the kitchen for safety.

*missing gfci*

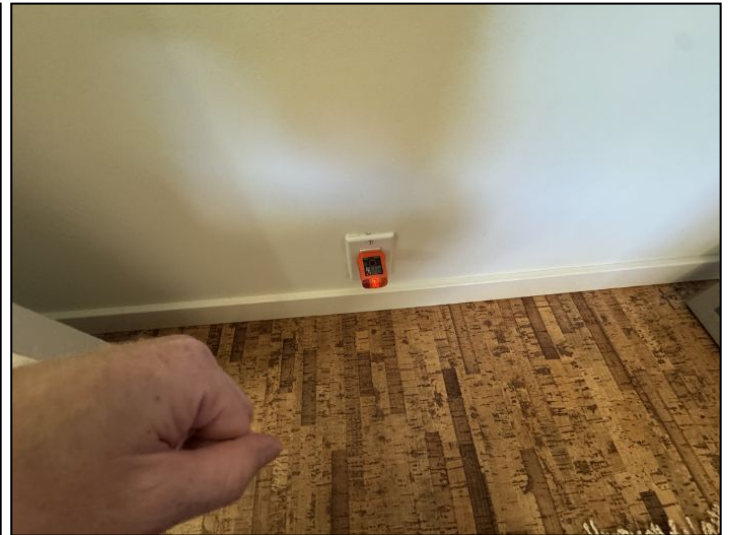
- Open ground three prong outlets noted throughout the home at the time of the inspection. This constitutes a safety hazard. Recommend full electrical evaluation. Recommend remediation by licensed Electrician.

*open ground*

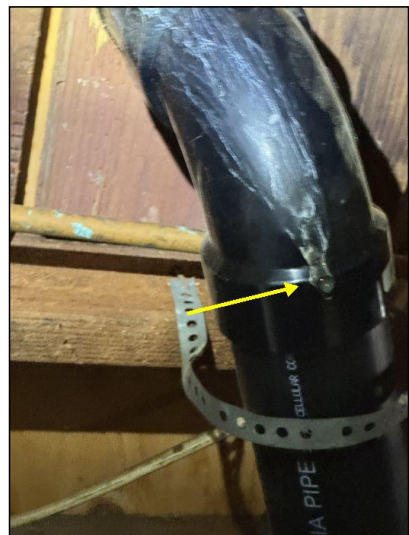
*active leak*

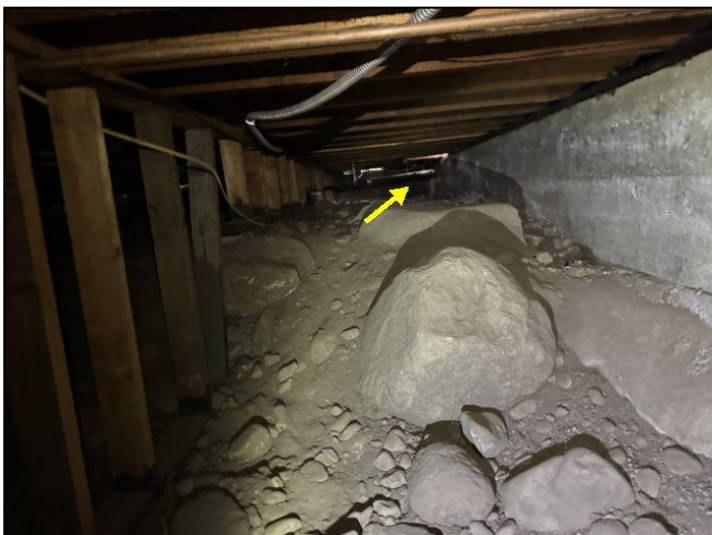
*location of live cut cloth wire*

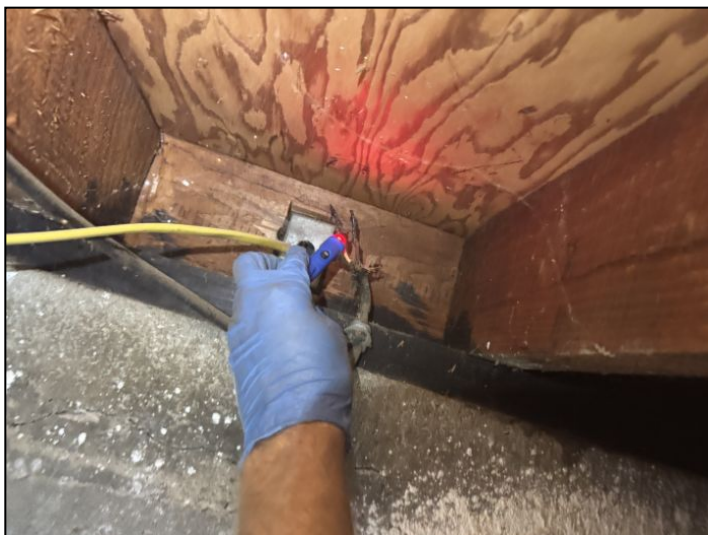
*live abandoned cloth wire!!*

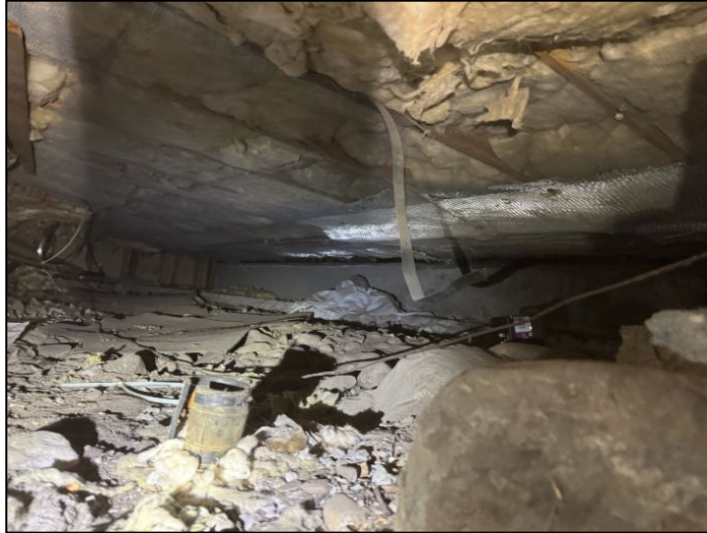
*abandoned materials*
